CONCRETE METALIZING ON THE QUEEN ISABELLA CAUSEWAY

Steven Austin

Texas Department of Transportation

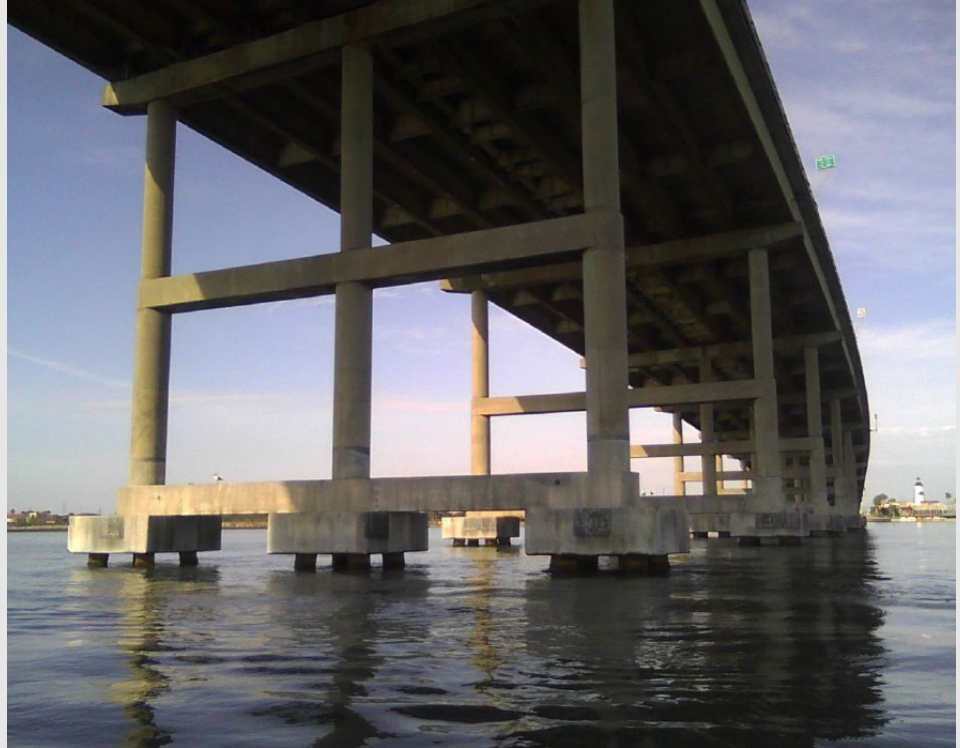
- Cover meter readings indicated cover over 3.5"
- Various crack widths from 0.03" to 0.125".
- No delaminations identified

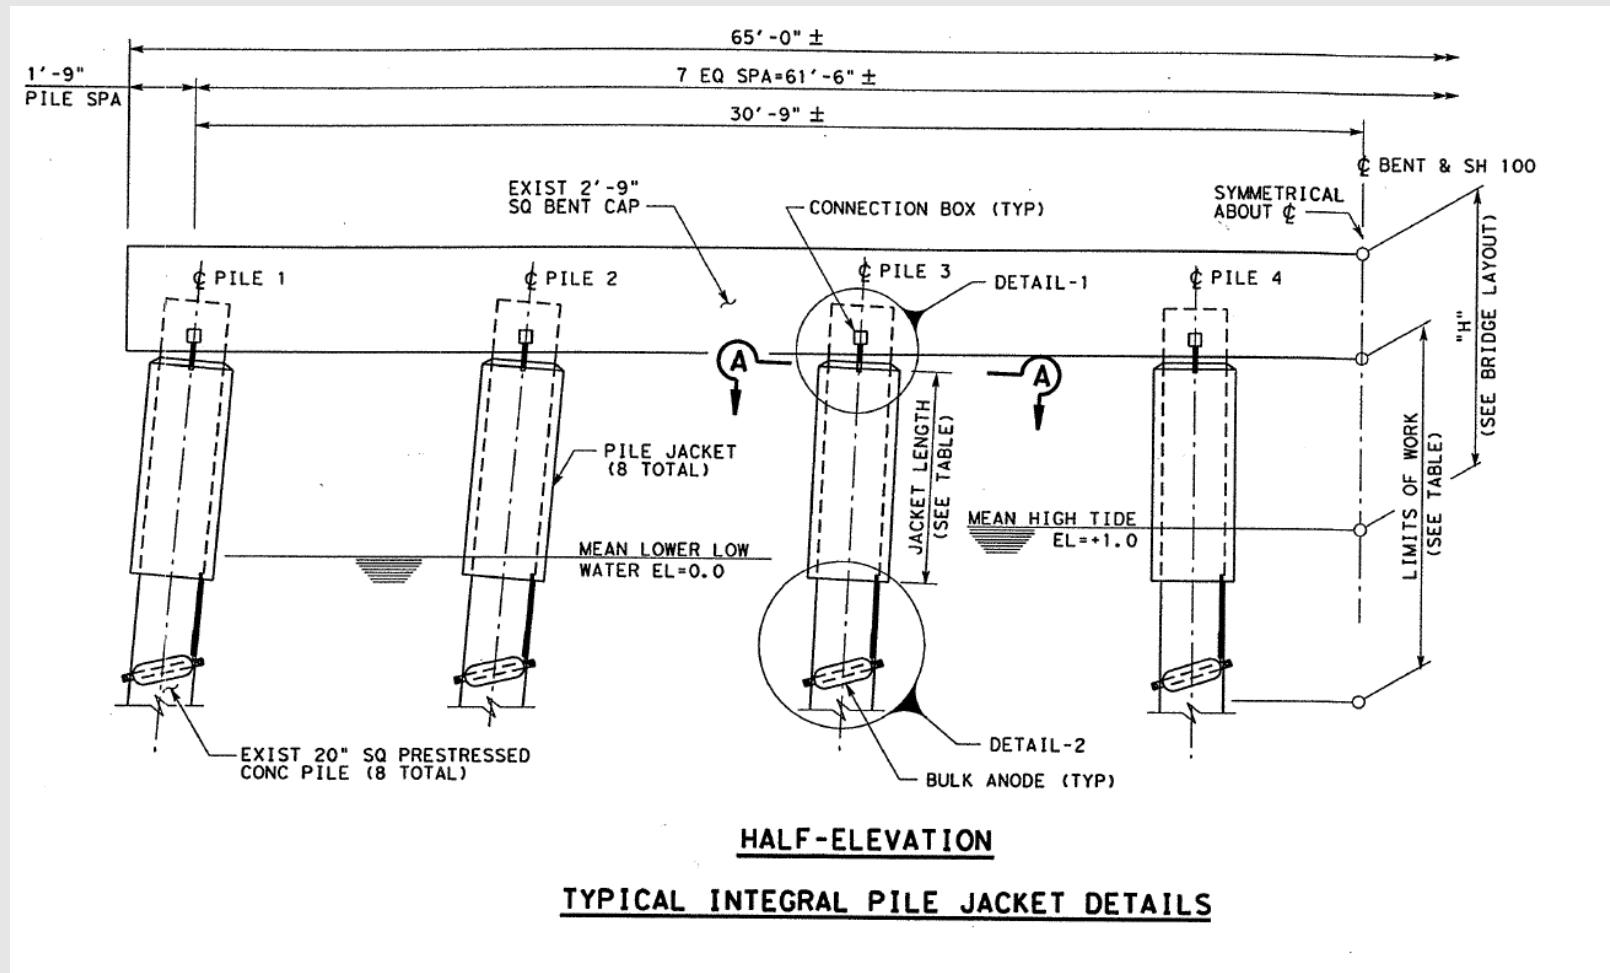
- Assessment to determine effectiveness and remaining life of bridge
- Cathodic protection was effective
- More rapid average consumption of the Al coating compared to the Zn coating
- Recommended re-application to the aluminum-coated bents

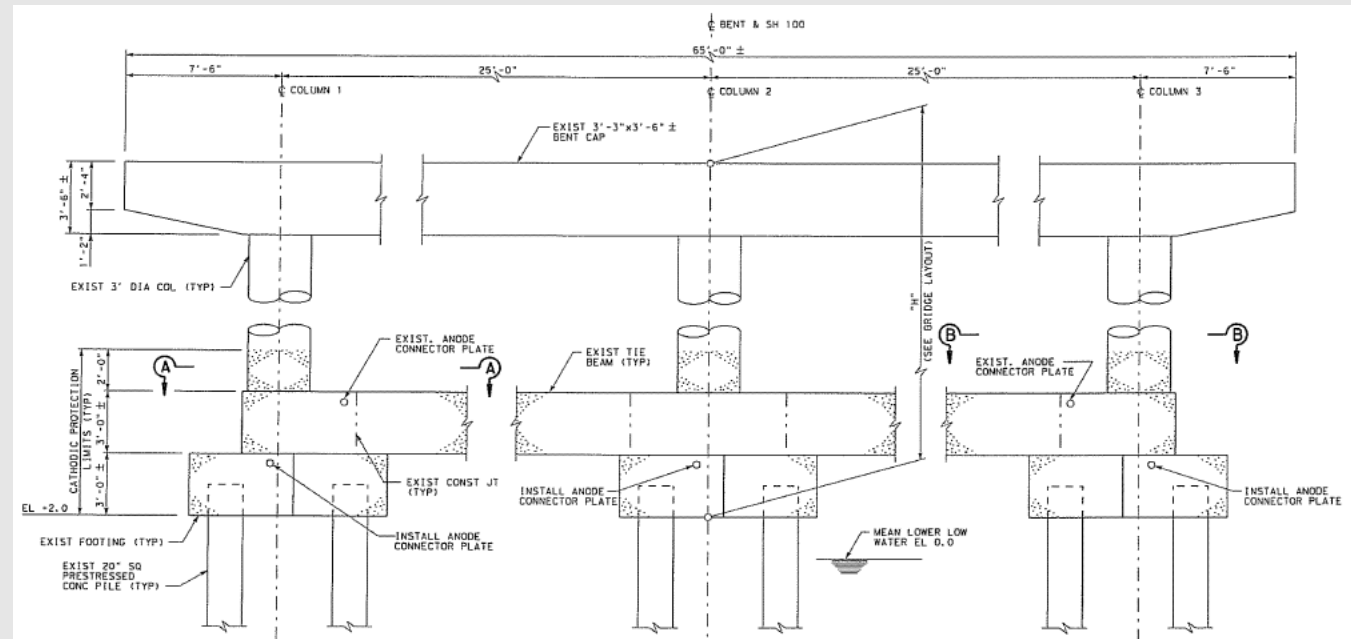
- Found Zn metalizing of 2004/2005 to be completely consumed at some locations.
- 2011 TSZ had nearly twice as much coating blistering as did the 2004/2005
- Half of the 2004/2005 bents tested showed ineffective cathodic protection based on Polarization Testing and Half-Cell potential.

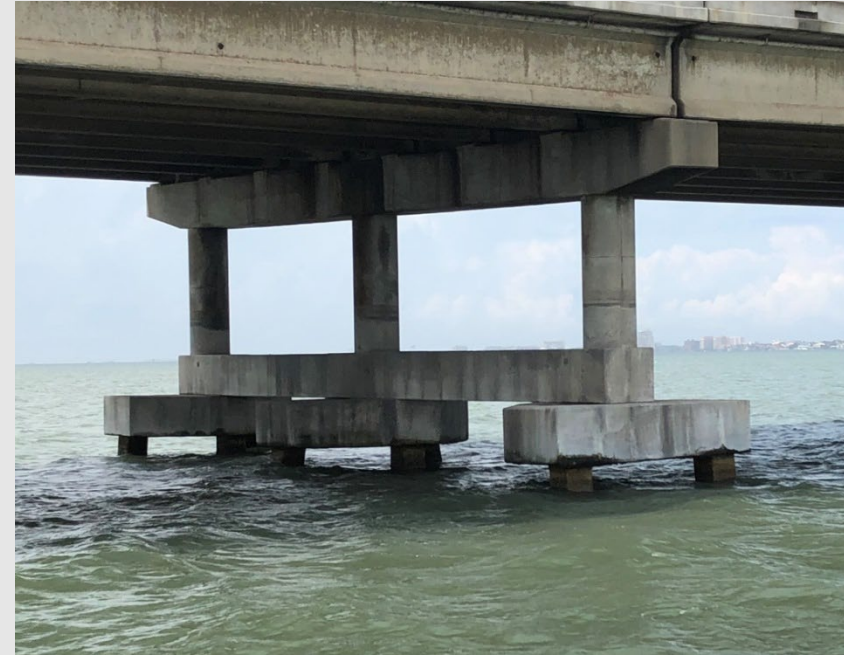
- Performance is not as effective as anticipated likely due to splash zones contributing to quicker consumption of metal coating.
- Life expectancy of TSZ is greater than TSA.
- 15 year life may be achieved but in the case of QIC, new anode connector plates were required after 6 or 7 years.
- Not as effective at mitigating corrosion under conditions of poor construction quality
- Second application is not as effective due to more loss of surface mortar removed during surface preparation.
