# Sunshine Bridge Emergency Repair

Southeast Bridge Preservation Partnership  
Baton Rouge, Louisiana  
4/17/2019

Zhengzheng (Jenny) Fu, P.E.  
LADOTD Bridge Design Administrator

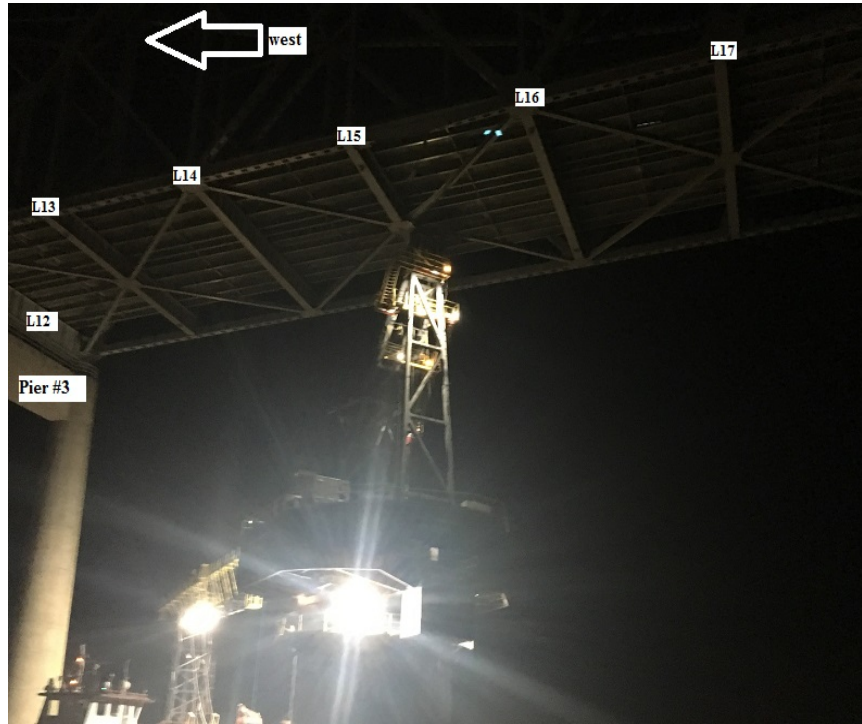
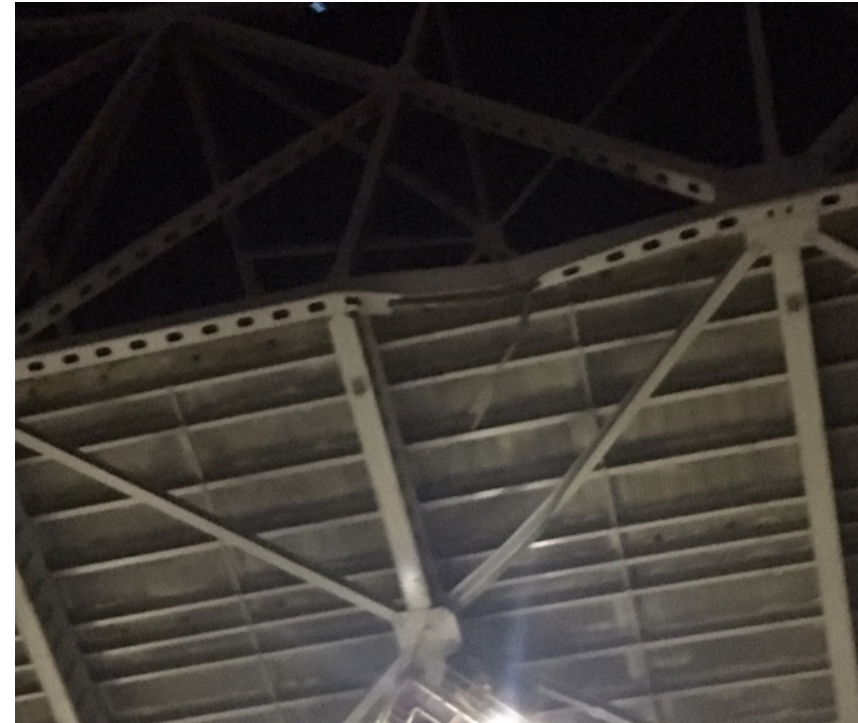
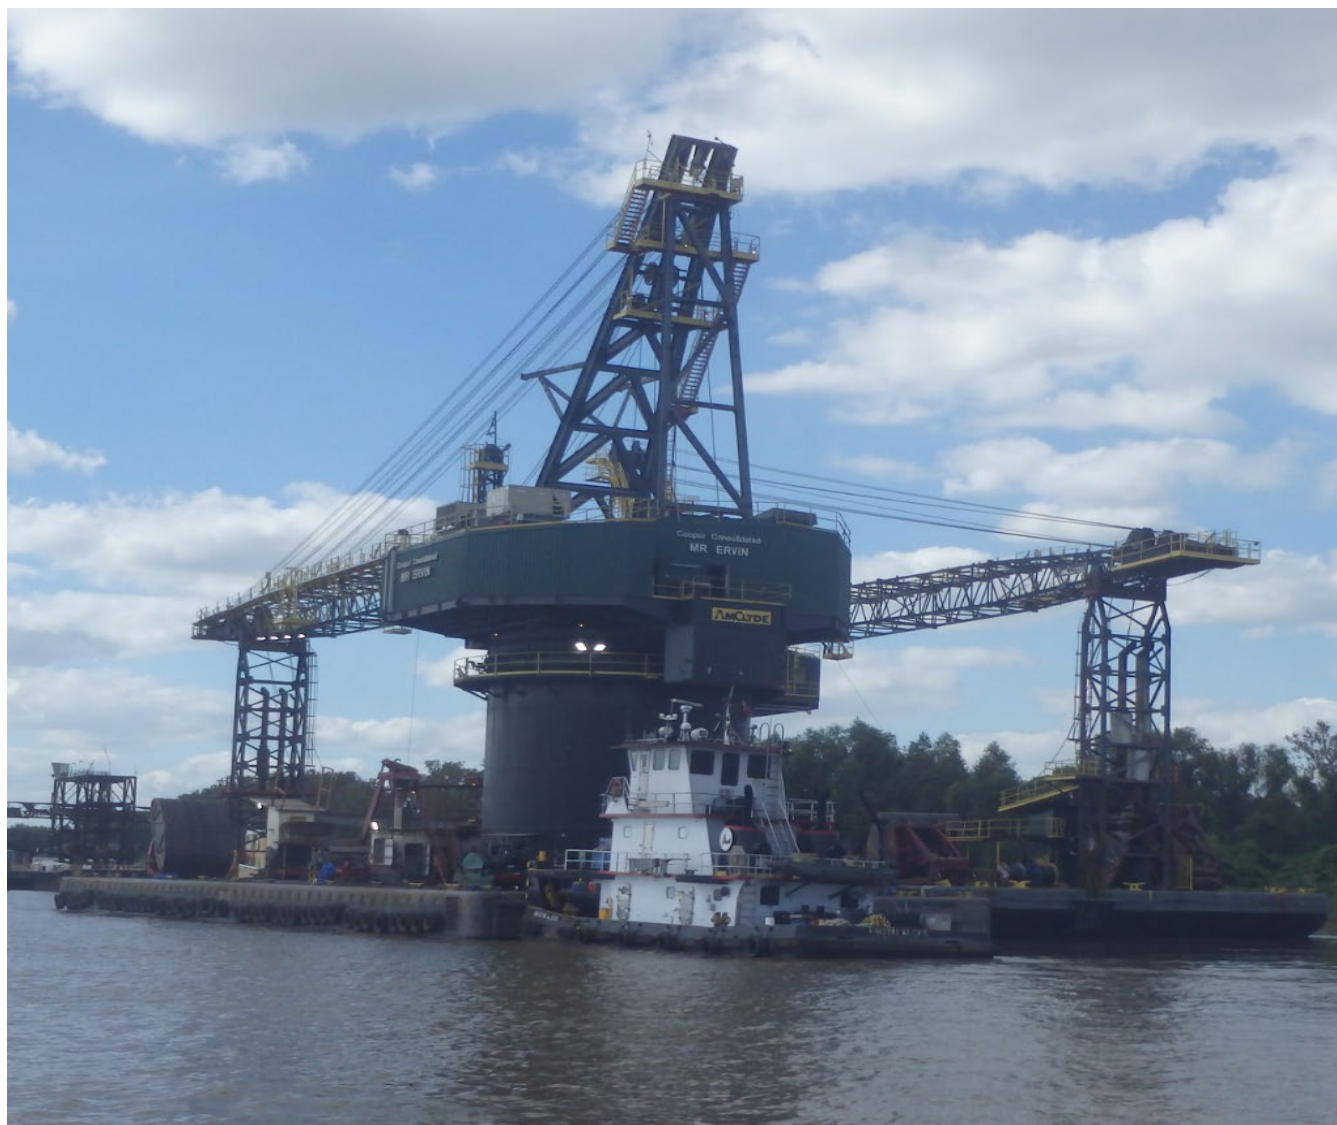
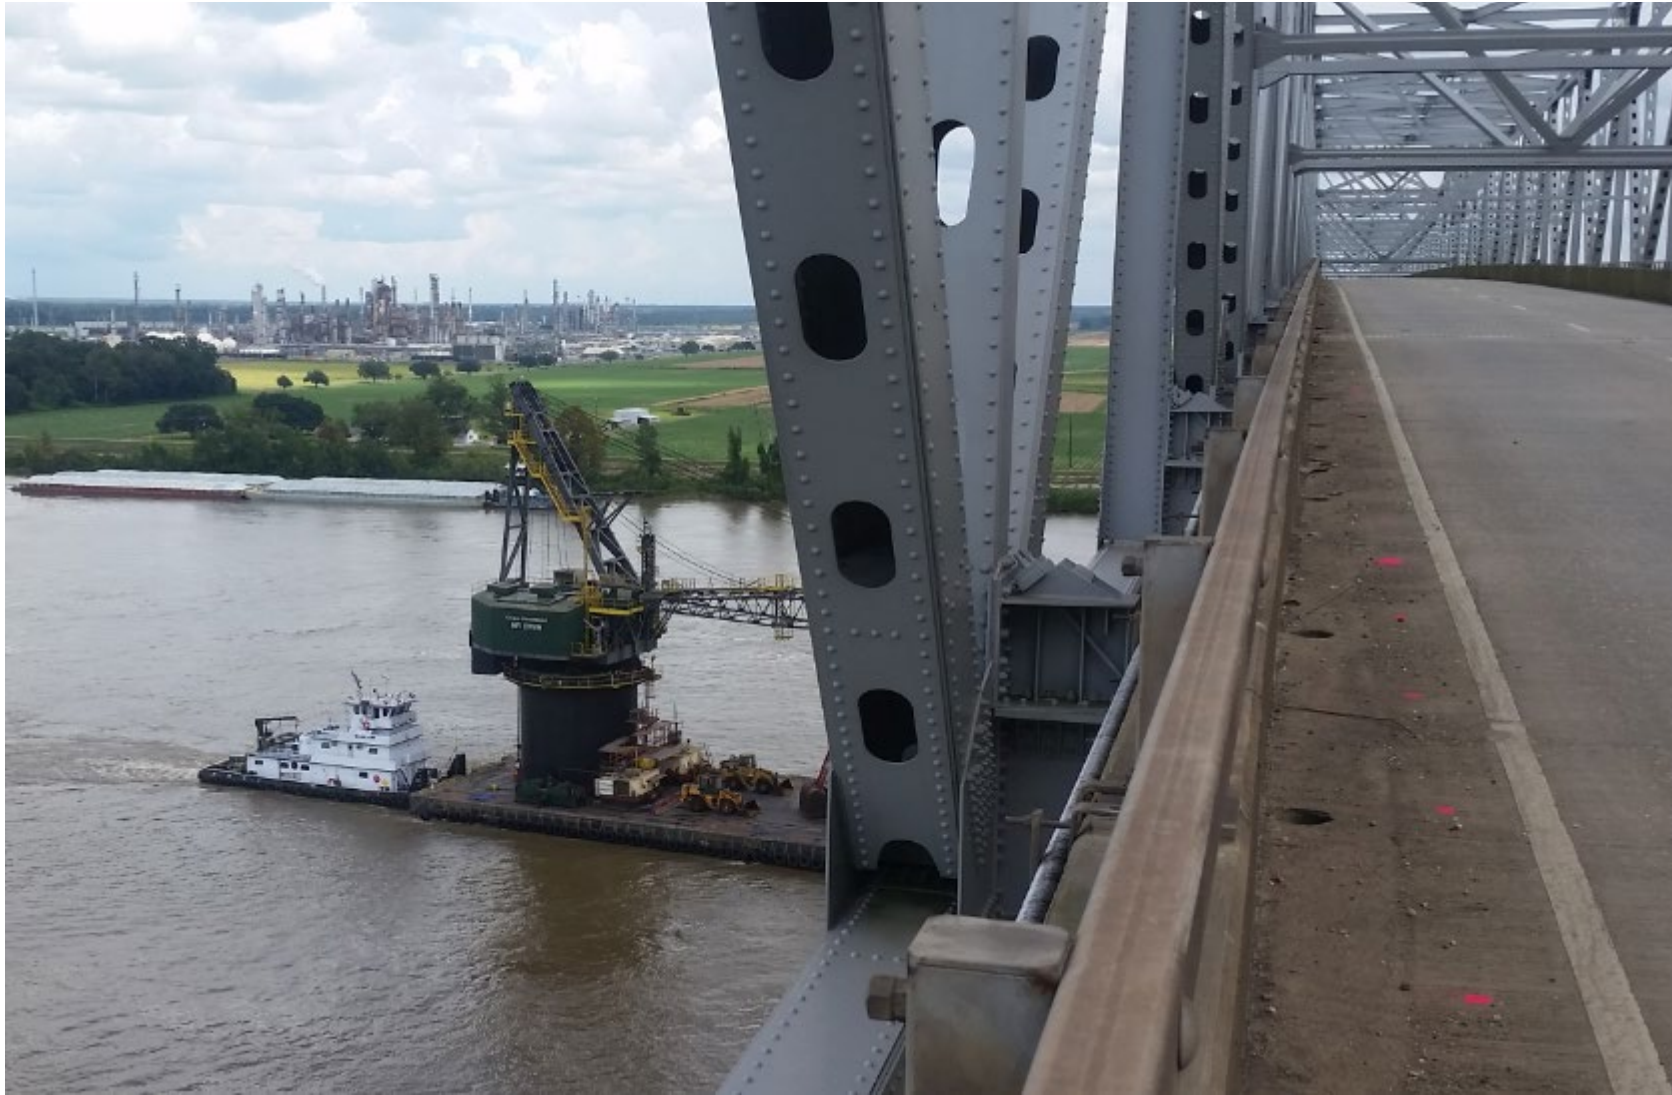
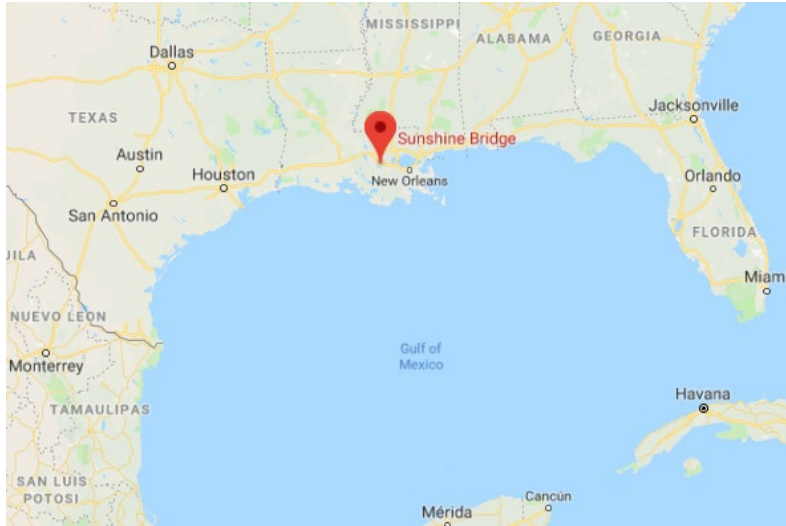
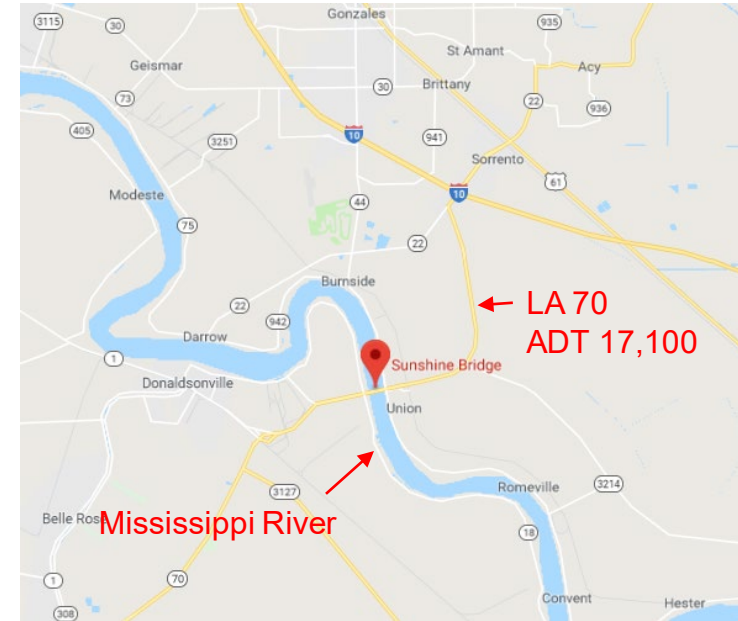
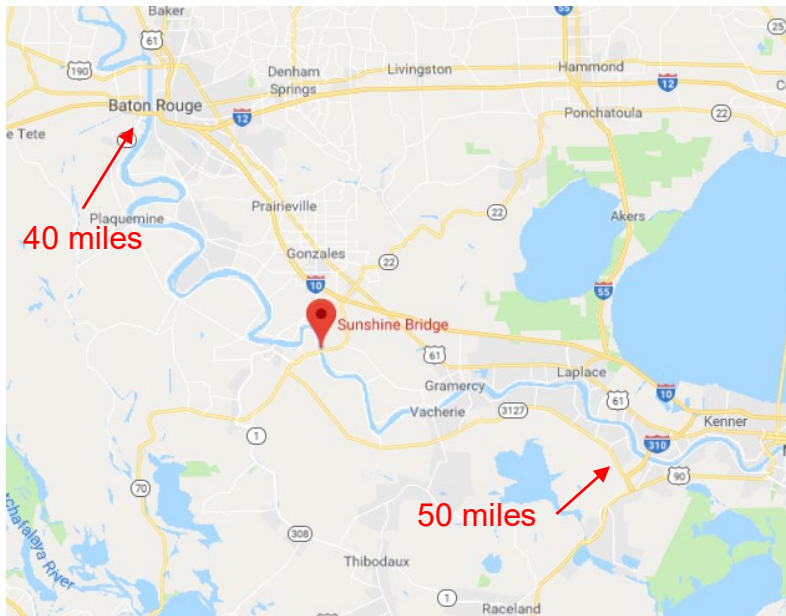
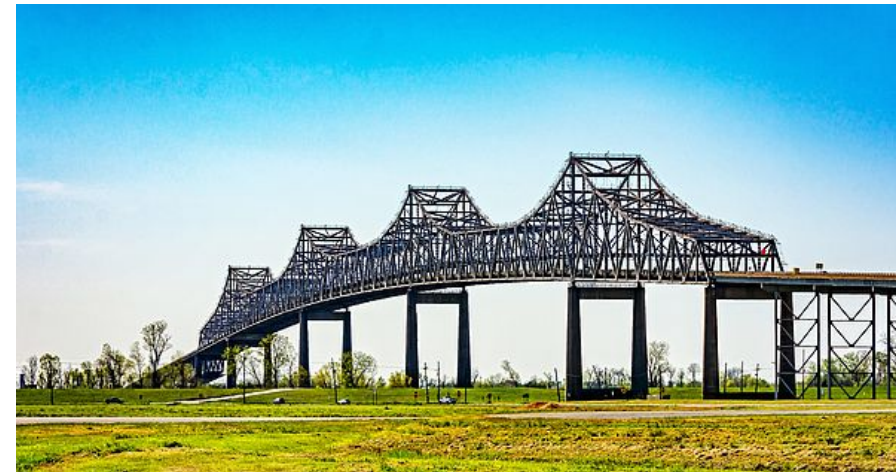
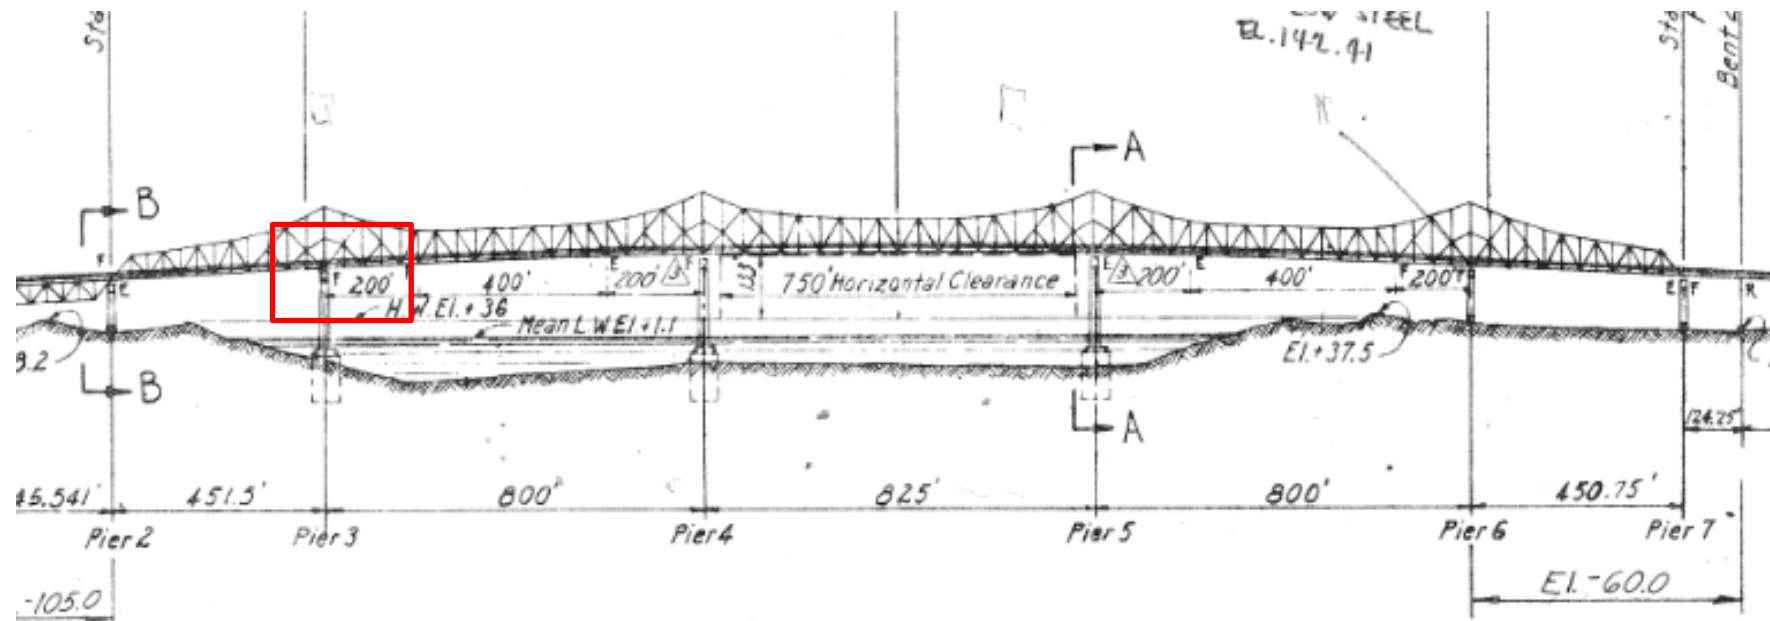
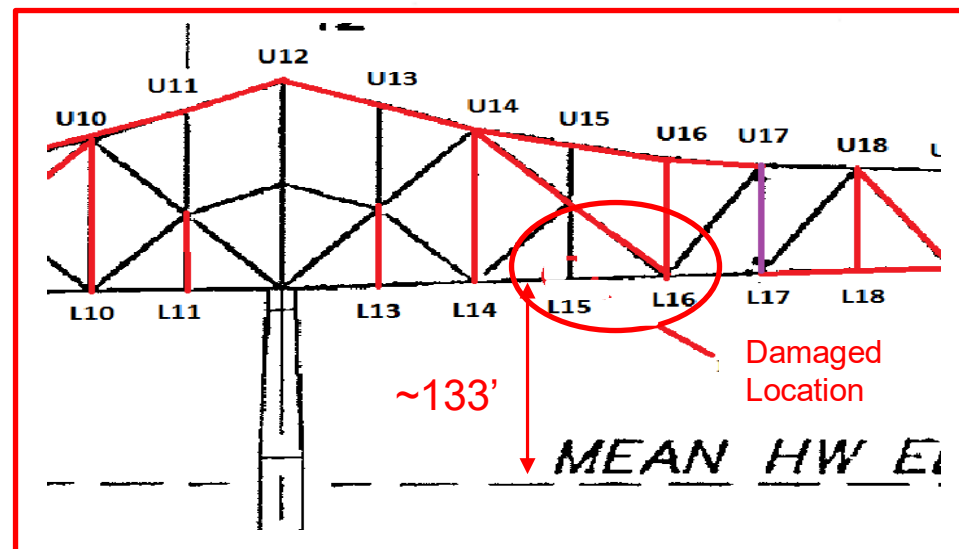
➤ 10/12/18 ~3:00am Sunshine Bridge was hit

**Damaged Bottom Chord L15 – L16**  
**Compression Member**  
**DL = 1.7 Million Pounds**  
**(~142 Elephants)**

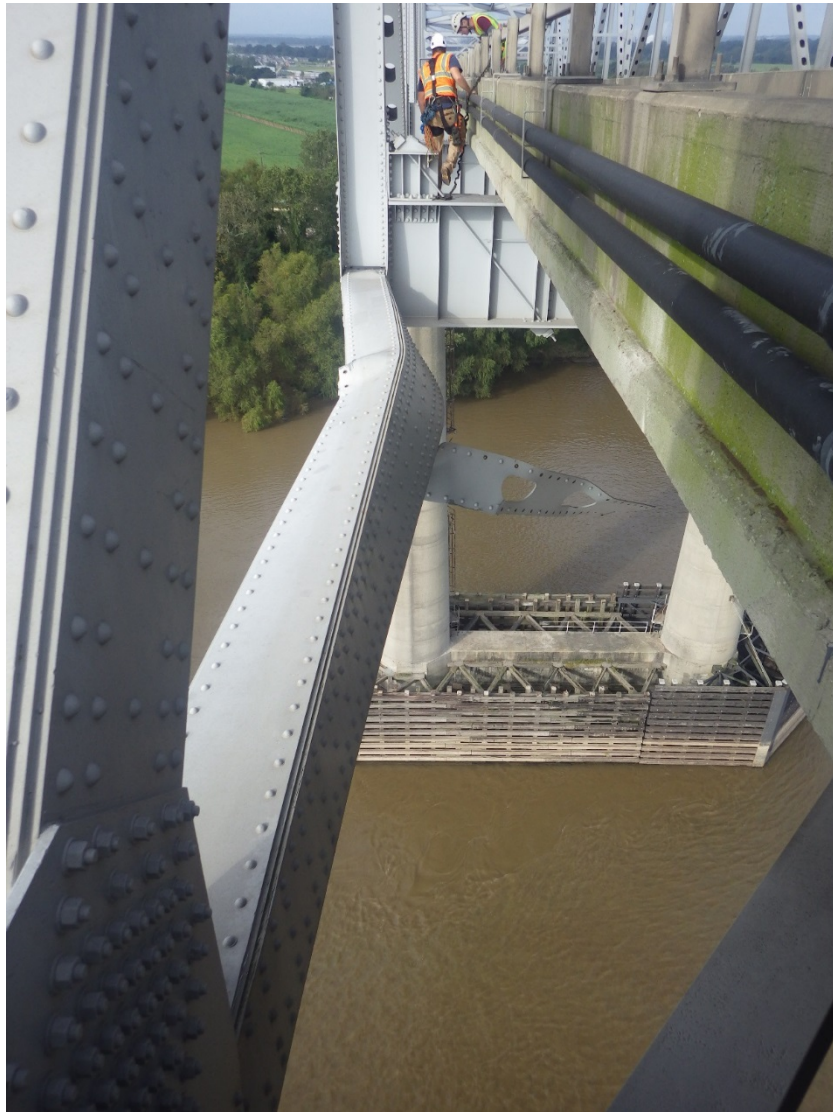
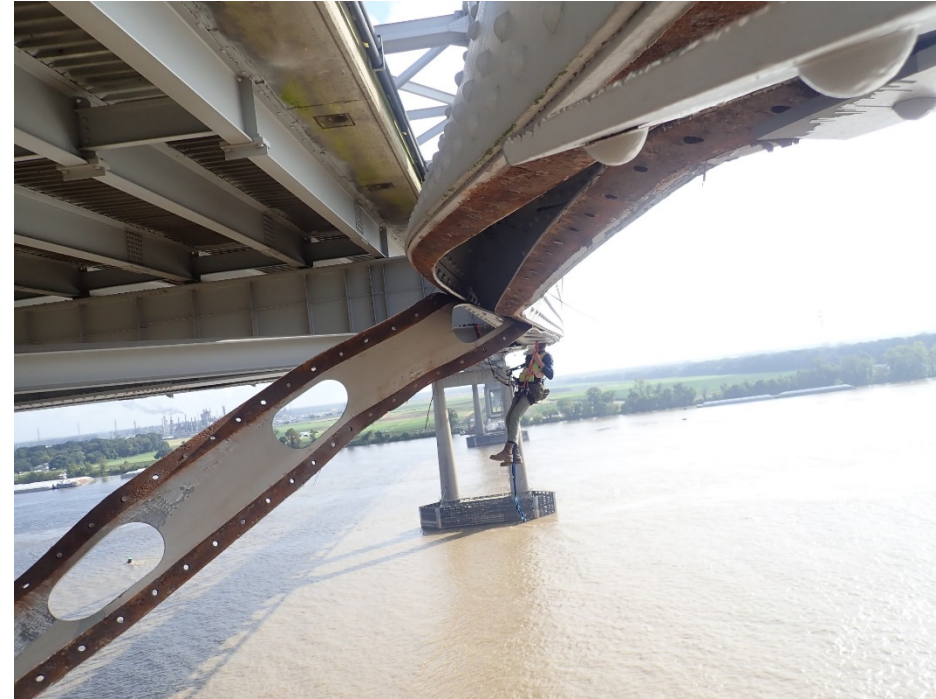
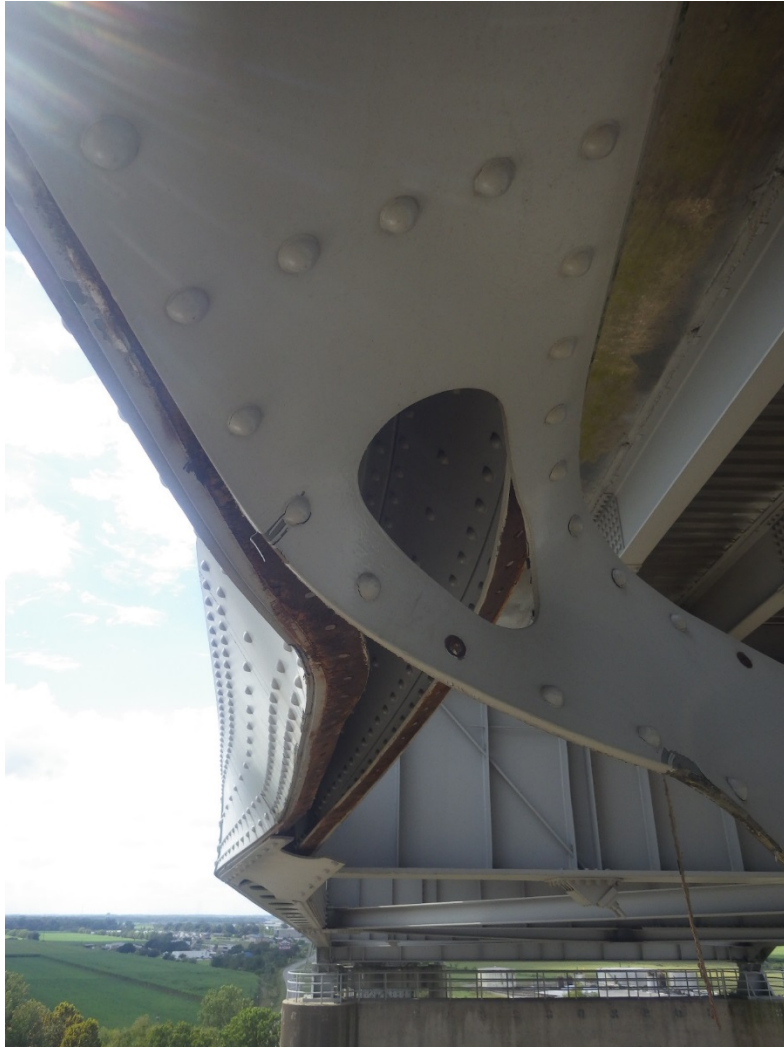
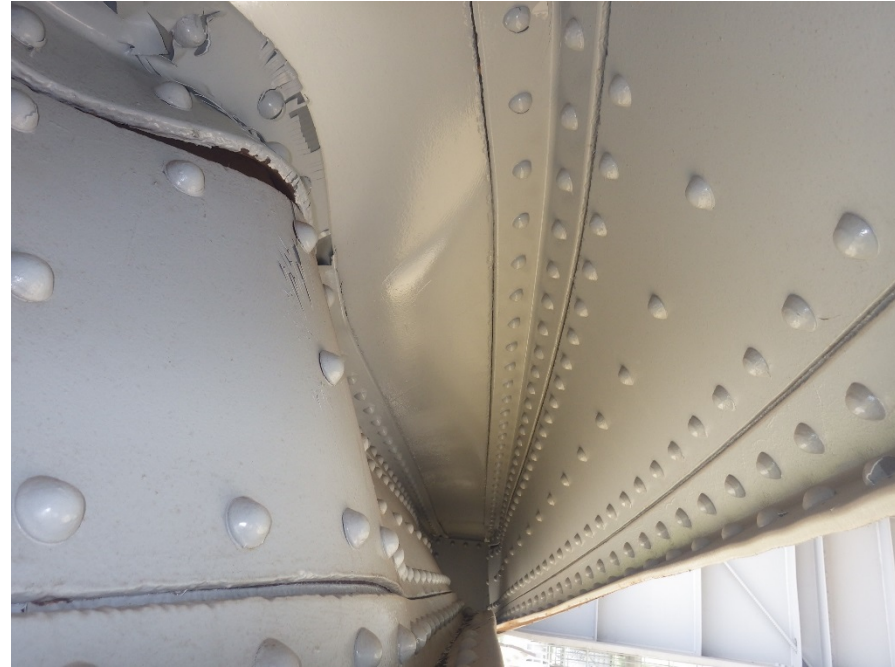
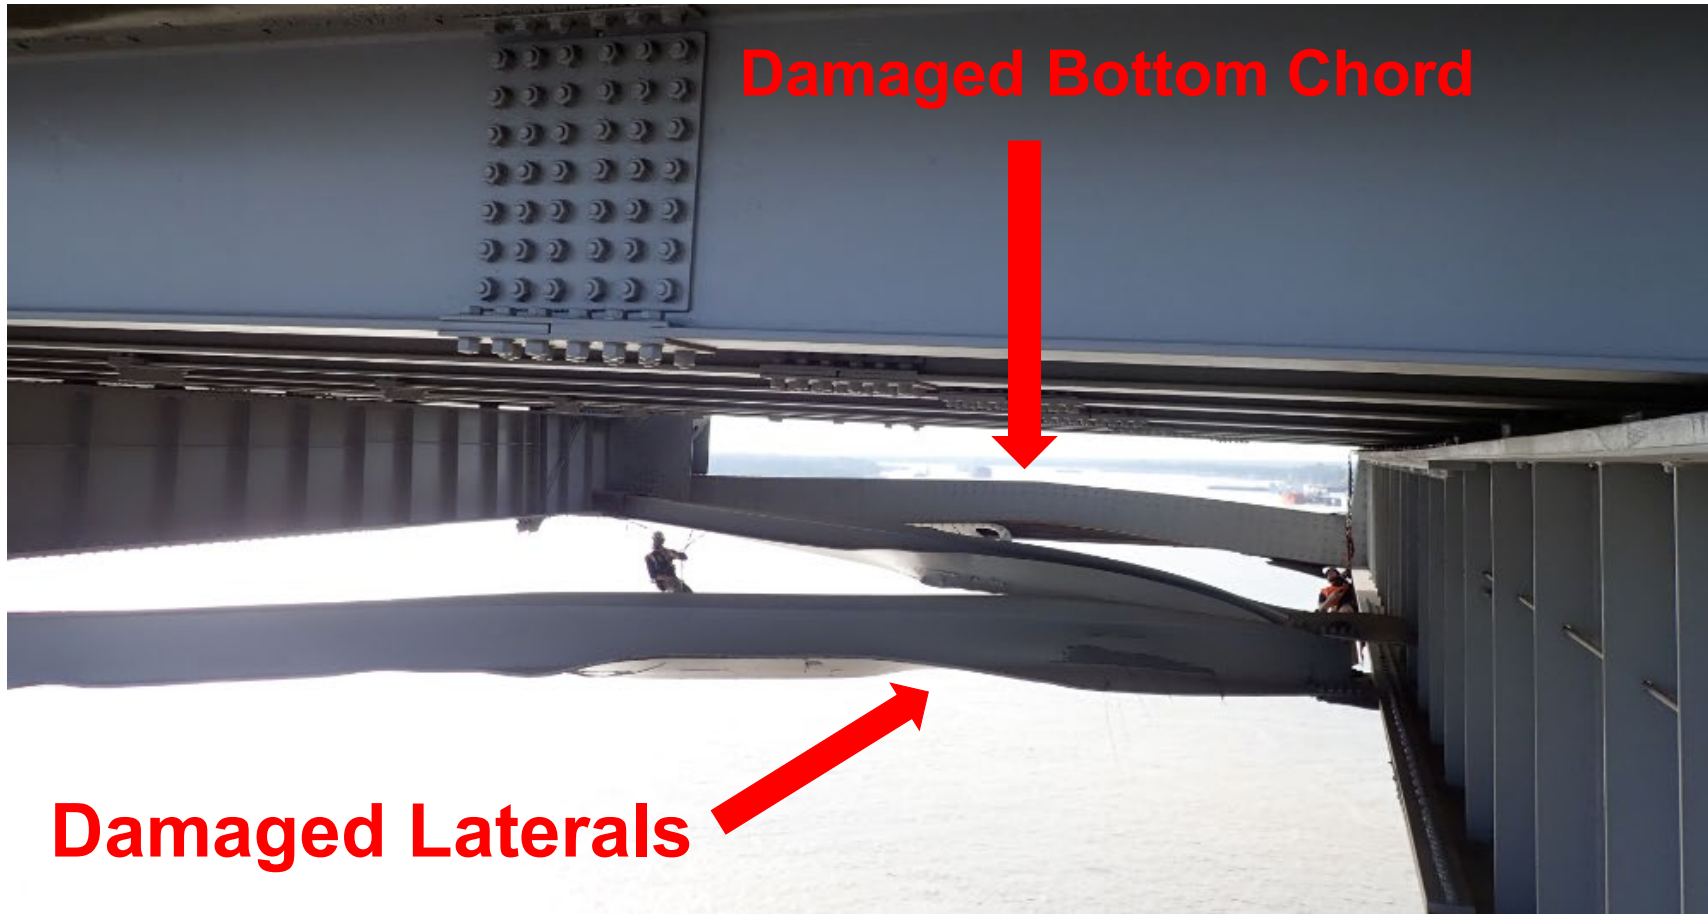
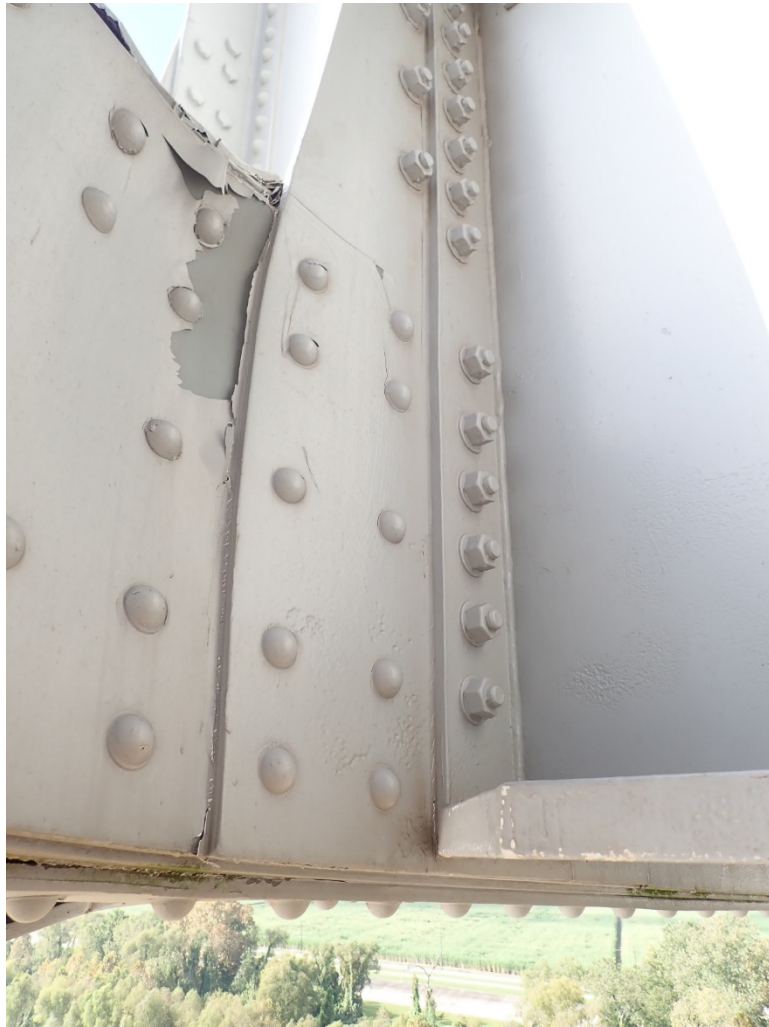
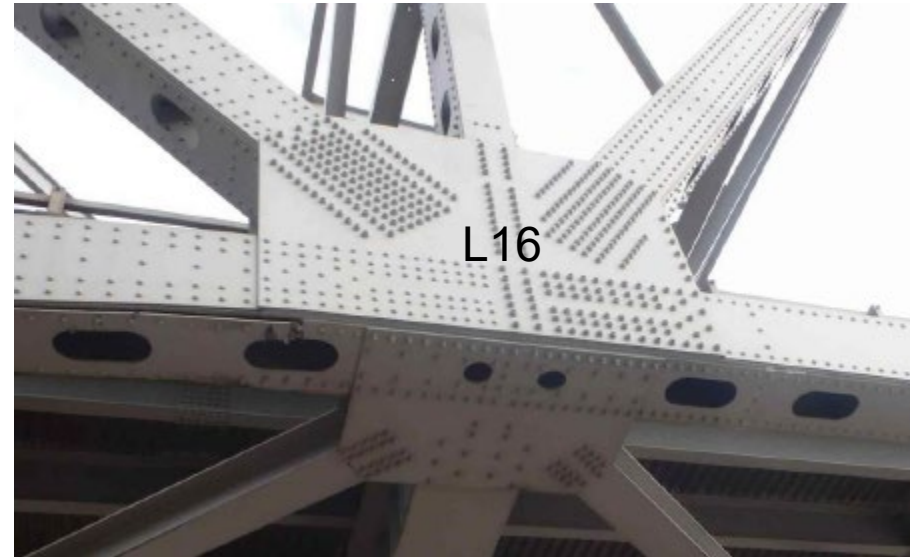
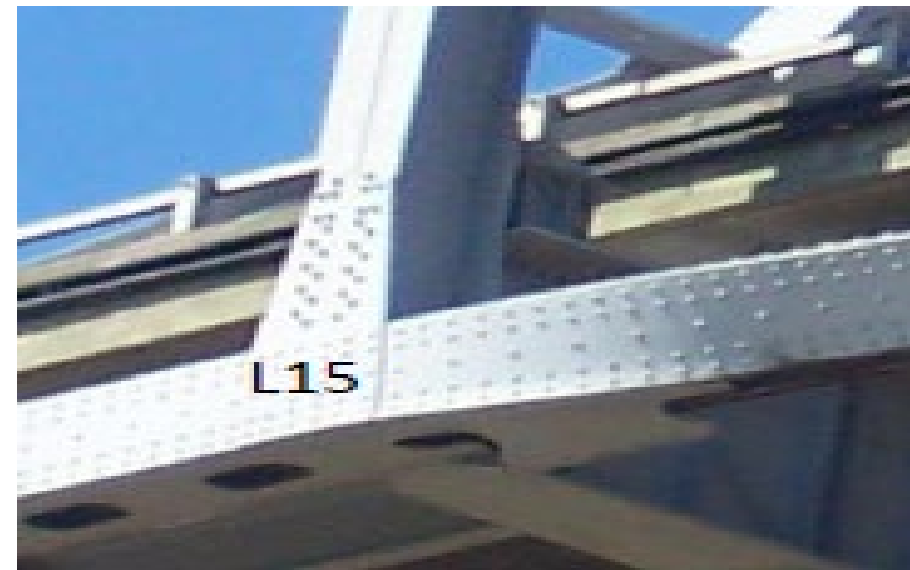
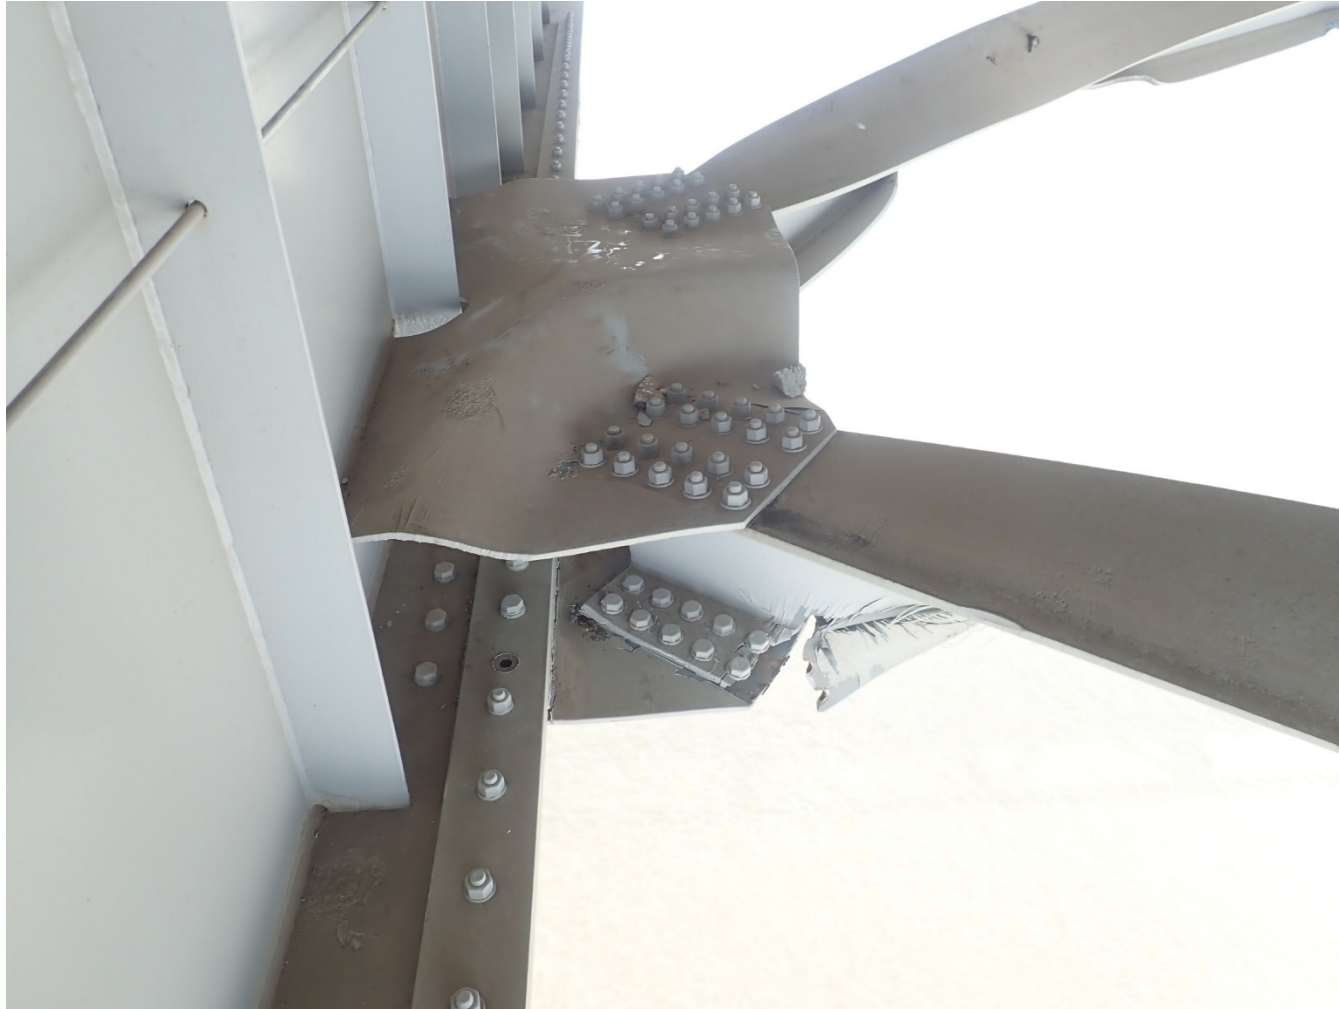
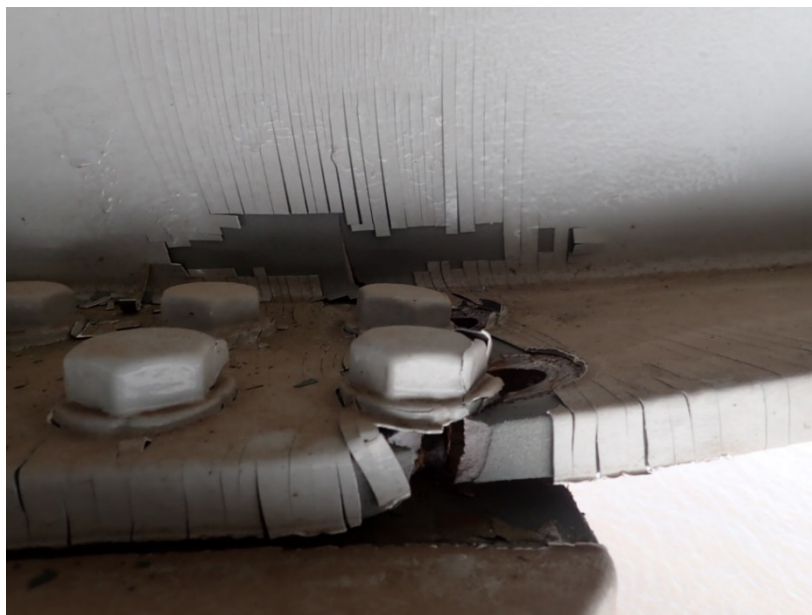
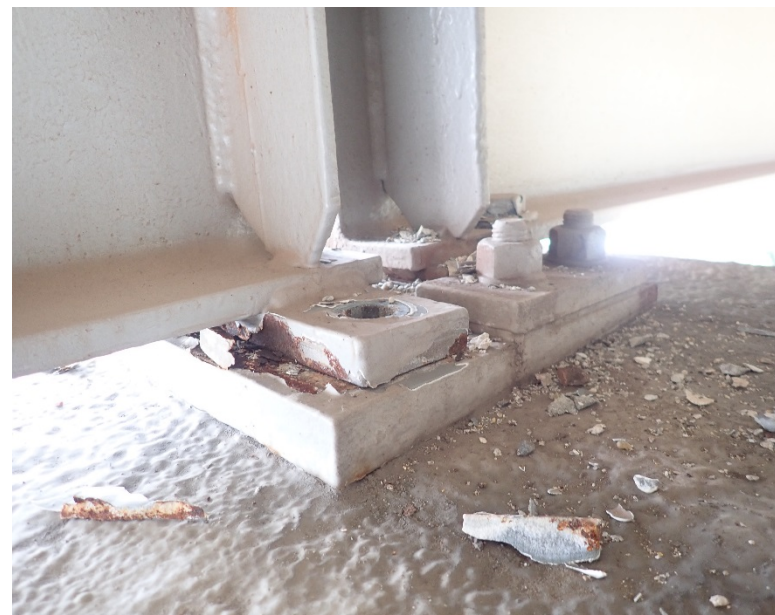
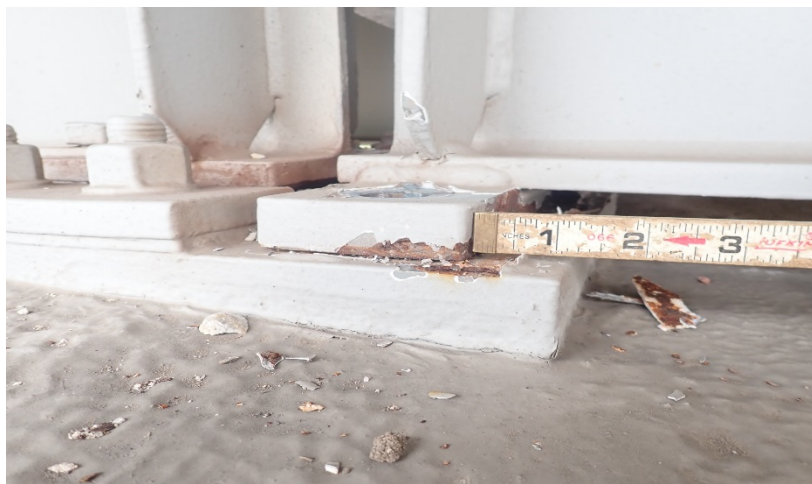
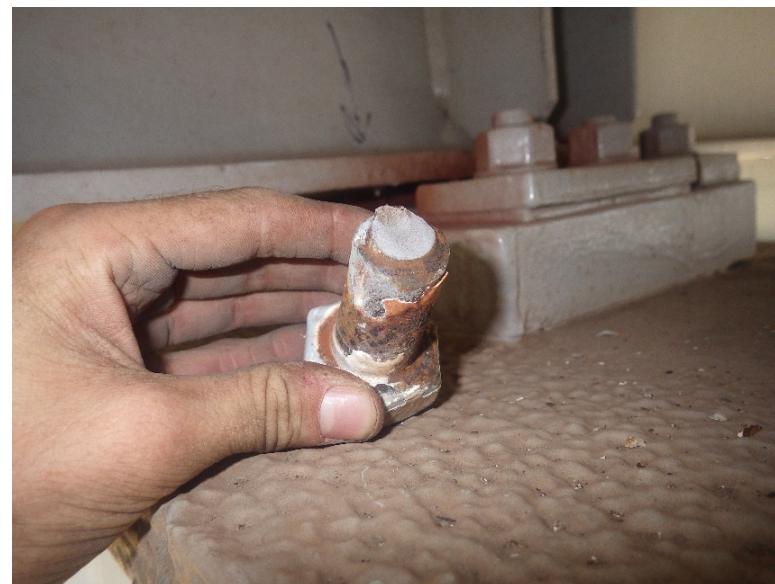
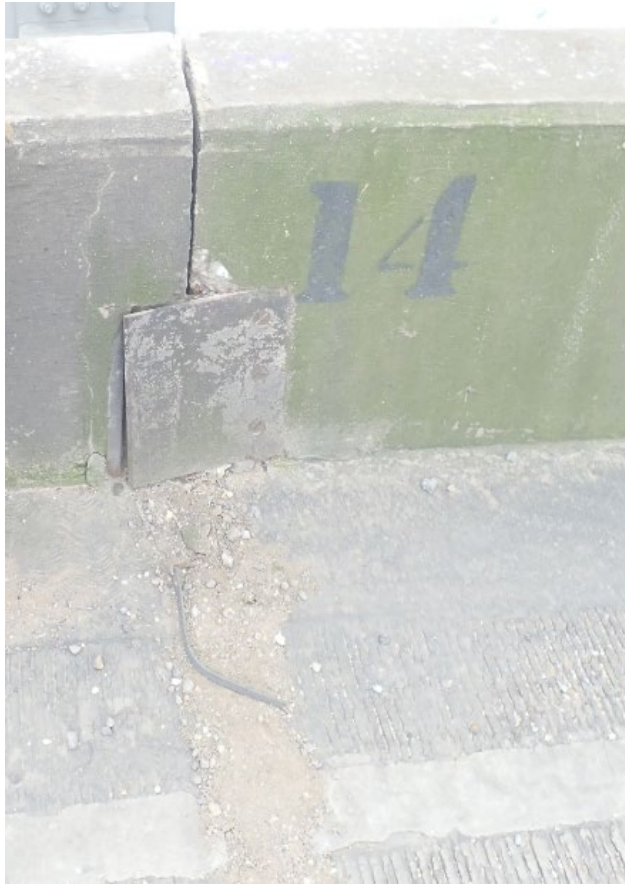
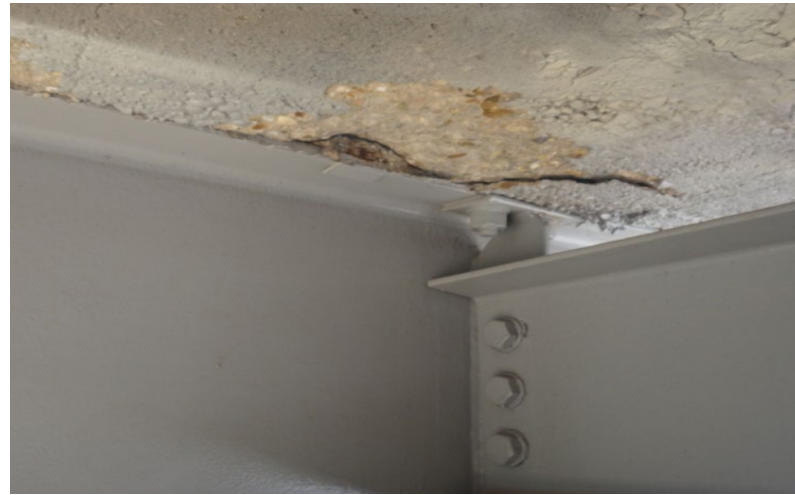
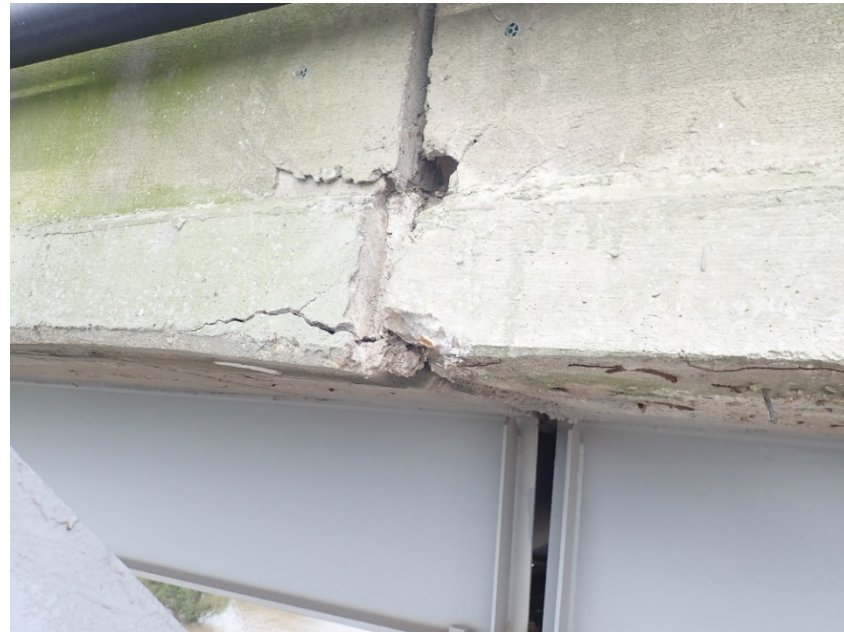
**49 locations**  
**160+ misc. damages**

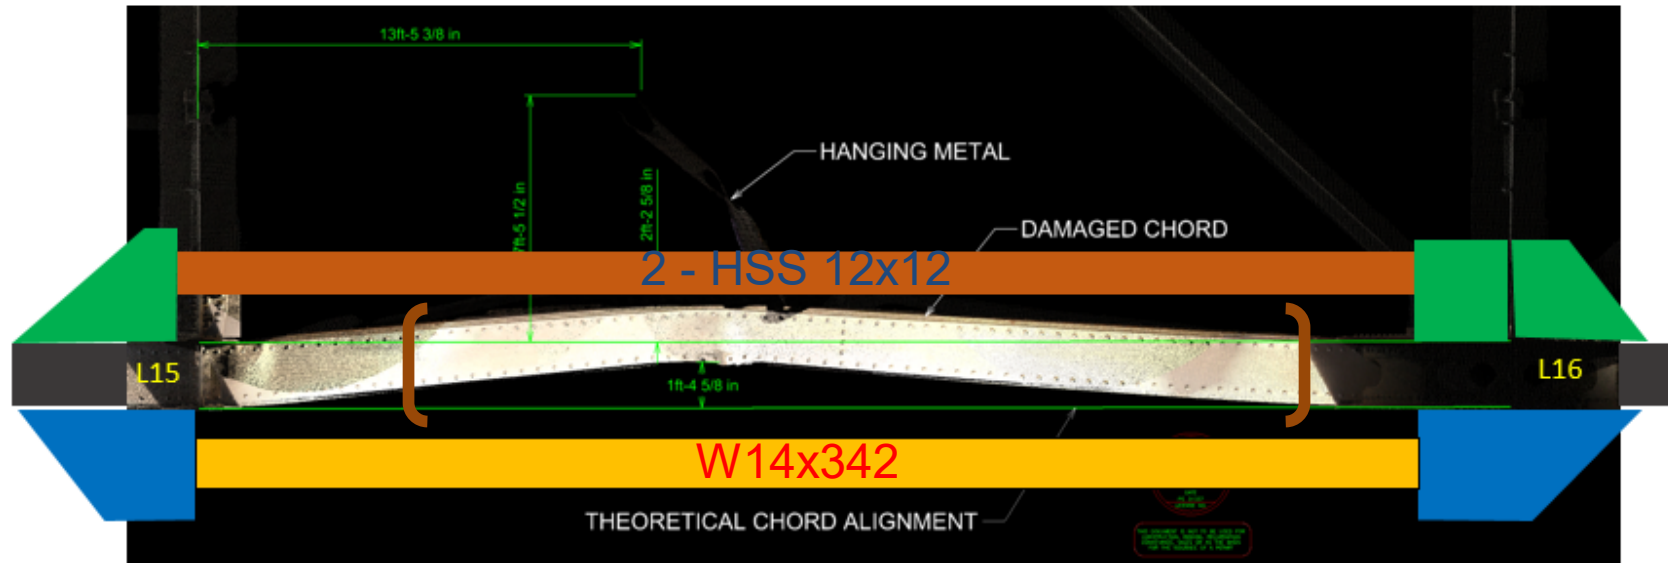
**Panel between L15 – L16 Shorten by ~ 3 3/8'''**

### Repair Steps

1. Design and install jacking frame (load bypass system)
2. Cut middle section of damaged chord
3. Heat straightening remaining ends
4. Jacking the structure to original geometry
5. Install replacement chord and splice ends
6. Transfer load from jacking frame to replacement chord
