Palomino Road Repair Project Using Tire-Derived Aggregate

Palomino Road Slide Repair Project

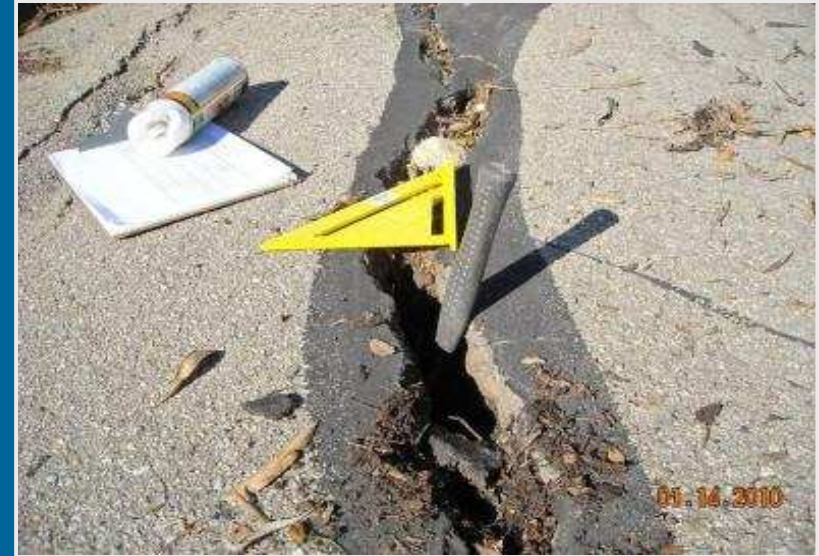
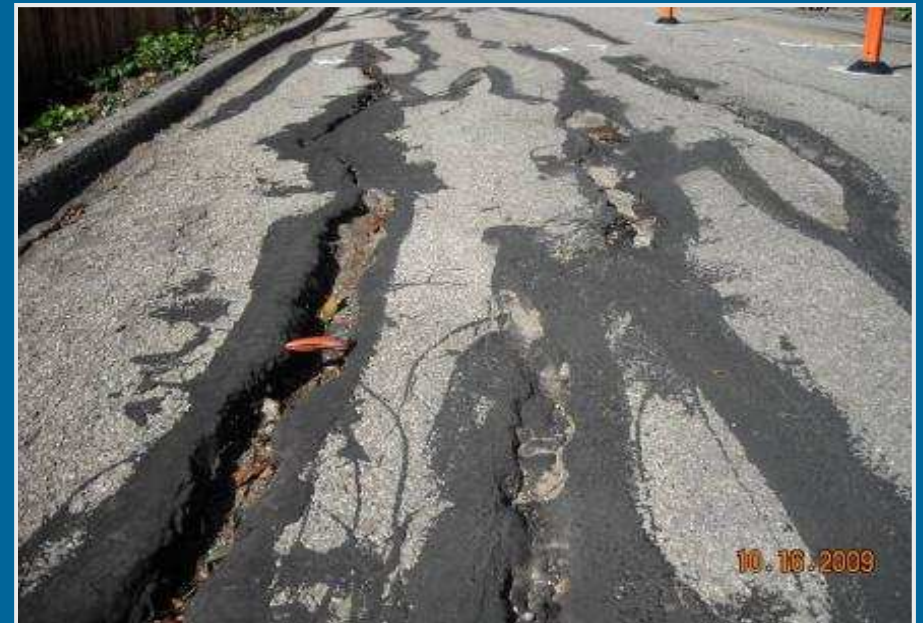
Native Soils at Project Site

- Rincon Shale Formation
 - Marine mudstone and shale that readily degenerates into highly expansive clay
 - These clays expand when wet and then contract when dry, creating vertical cracks that allow water to seep into the ground.
 - Soil failure tendency typified as soil creep slumps and shallow landslides that are generally restricted to depths of 15 feet or less
 - Failures often occur at the interface between the weathered / un-weathered materials, where water has been able to penetrate after a period of rainfall or where percolation of irrigation or runoff water has occurred.
 - Soil readily sloughs when above optimum water content or when consolidated (compacted) to less than 90% of maximum dry density.
