# Repair Procedures: Pros & Cons of Repair Alternatives

**Southeast Bridge Preservation Partnership**  
**Thursday, April 14, 2011**

***Siva Venugopalan***  
*Principal Engineer*  
*Siva Corrosion Services (SCS)*  
[Siva@SivaCorrosion.com](mailto:Siva@SivaCorrosion.com)  
[www.SivaCorrosion.com](http://www.SivaCorrosion.com)

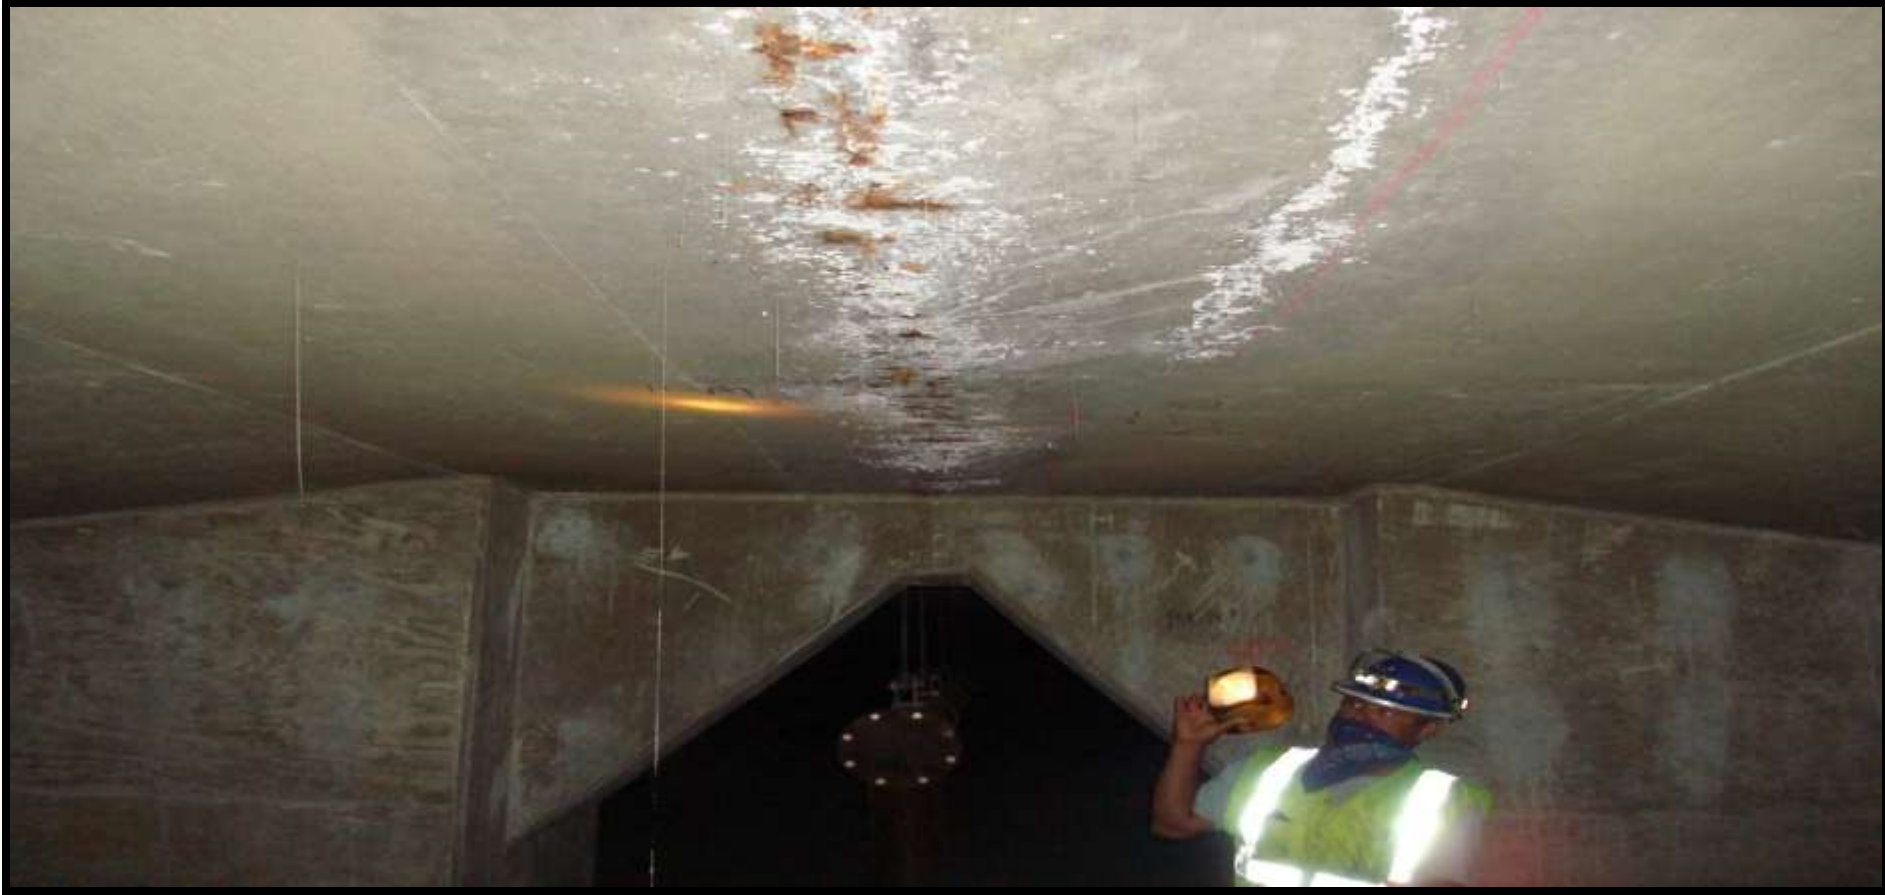
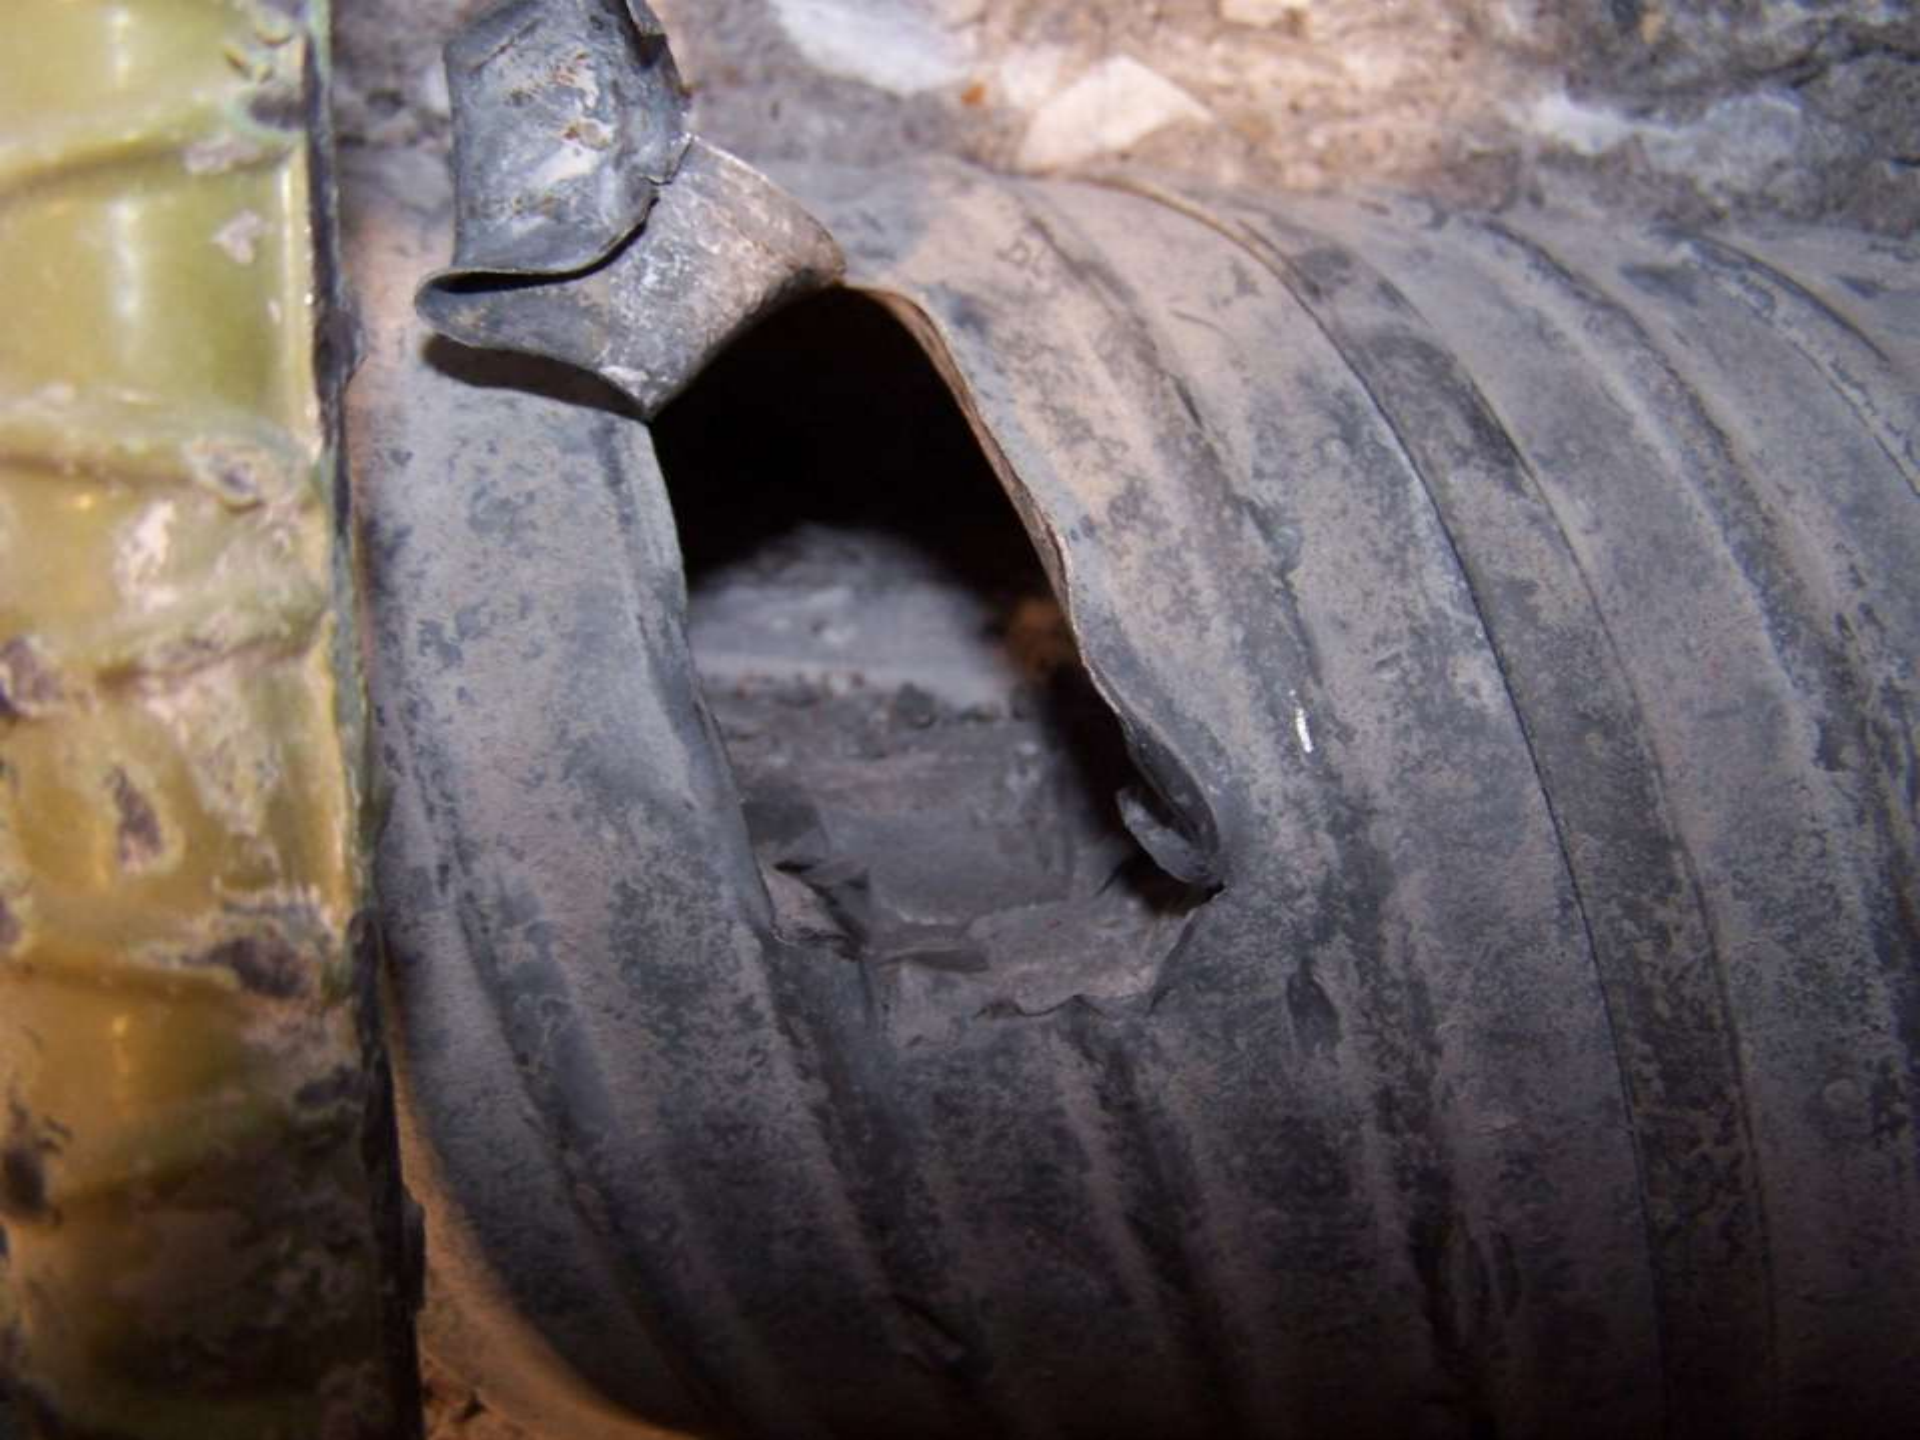
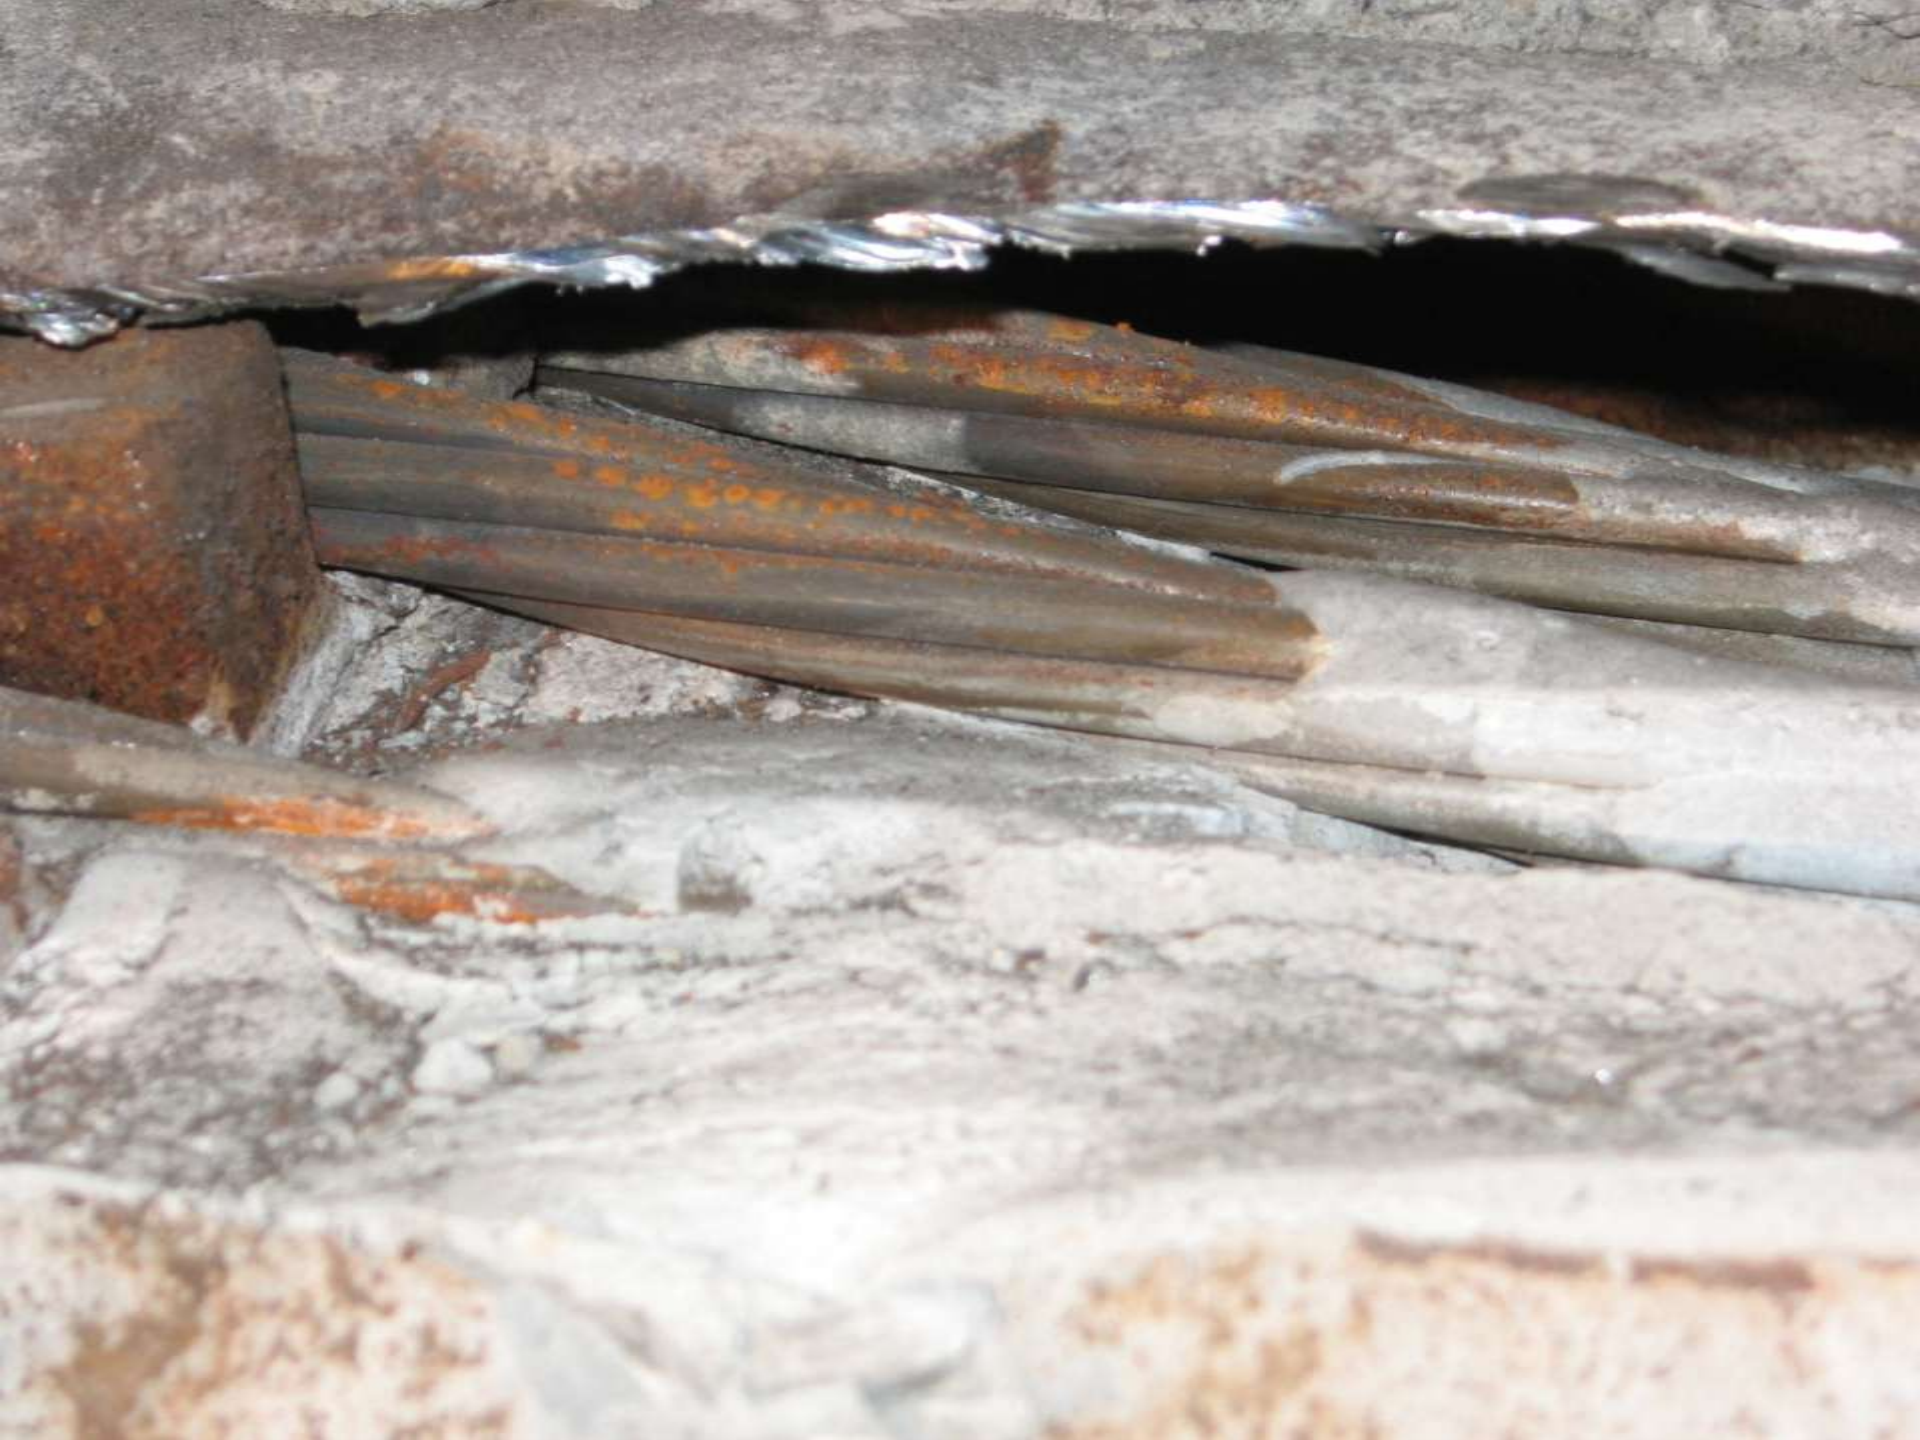
# PT Box Girder – Internal Tendons

Laboratory testing  
to quantify grout  
quality and effects  
on tendons

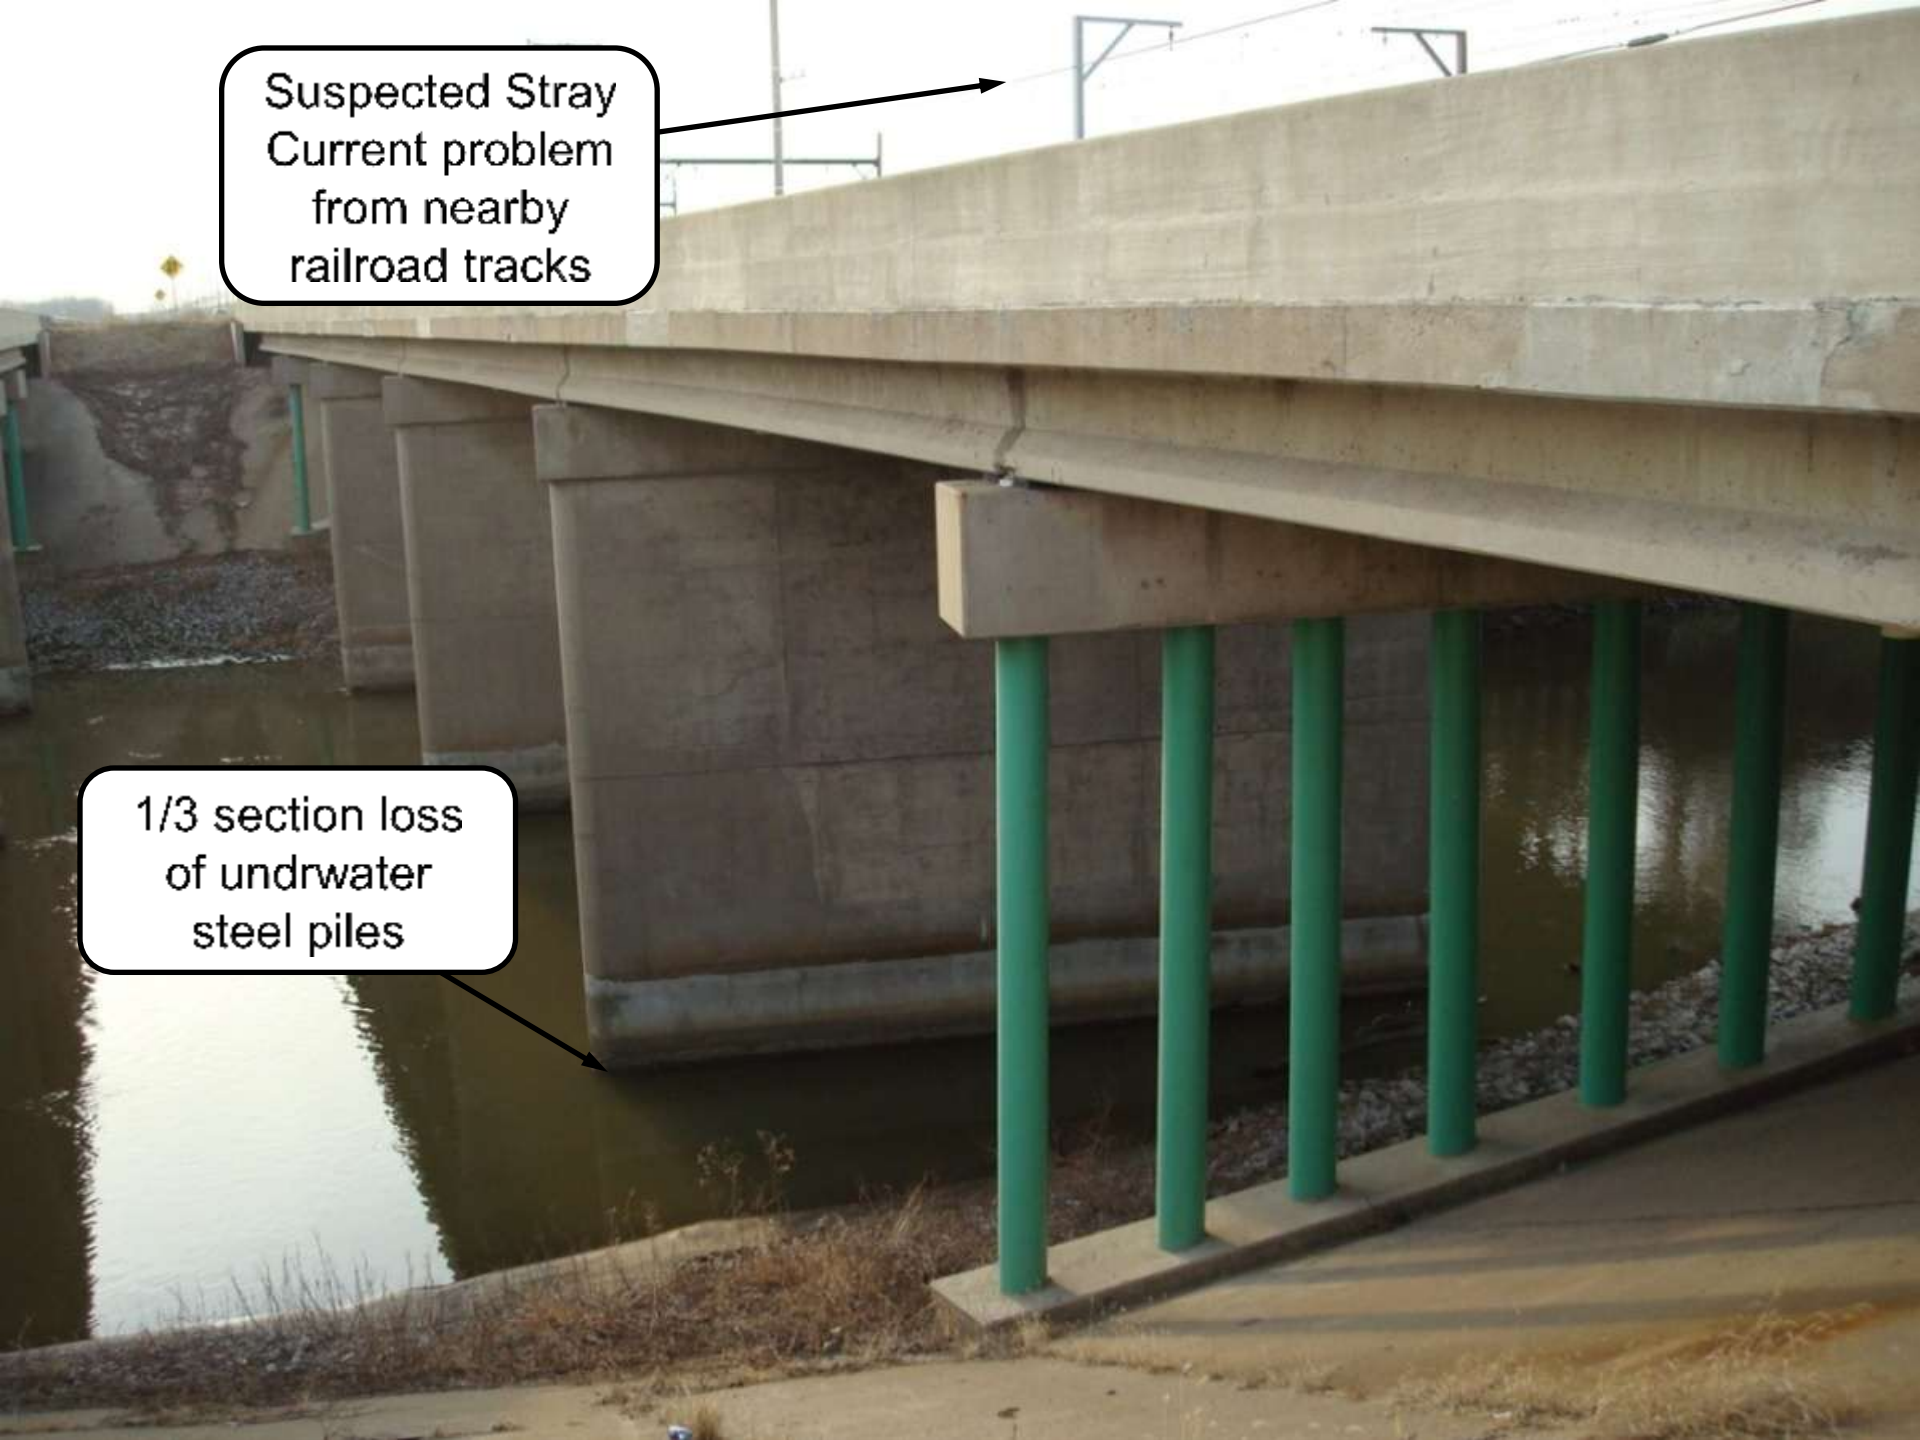
Suspected Stray  
Current problem  
from nearby  
railroad tracks

1/3 section loss  
of underwater  
steel piles

- SCS quantified the extent of deterioration at beam ends and steel piles
- We designed a corrosion mitigation system and developed plans to extend the service lives of pre-stressed beams and steel piles

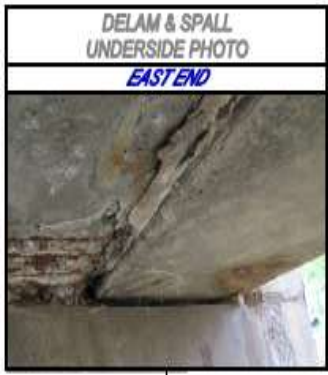
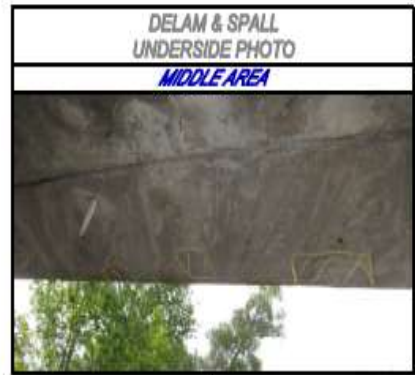
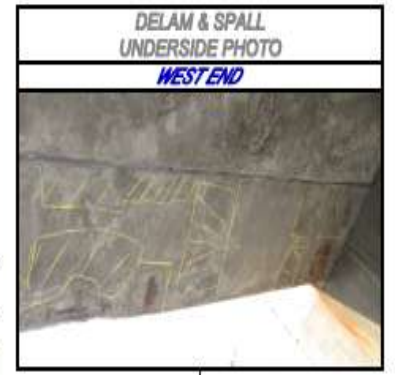
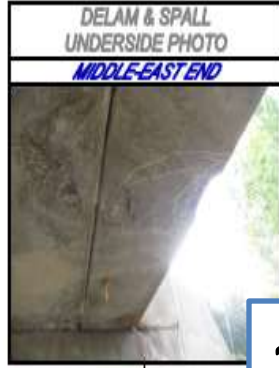
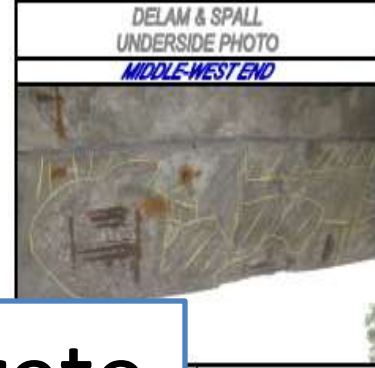
31% Concrete  
Damage

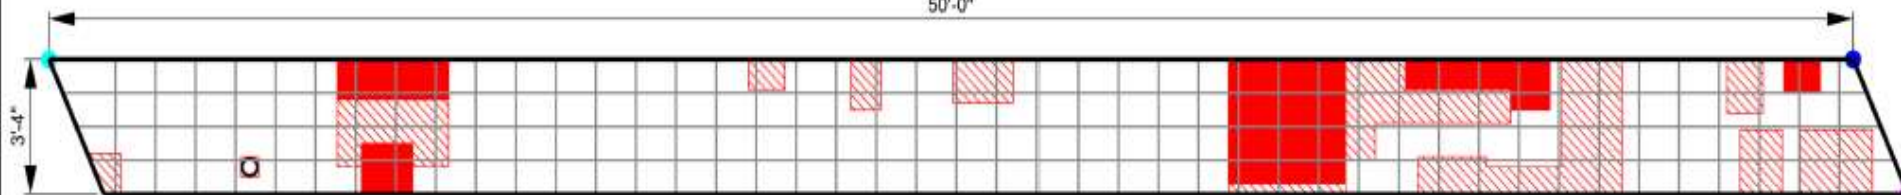
POTENTIAL READING  
BEAM 20

- Visual data – only a small percentage of the beam corroding
- Visual & delam data – 31% of the beam corroding
- Corrosion potential data – 67% of the beam corroding
- Evaluate before visual signs of distress to achieve and exceed service life goals
