Stillwater Bridge, Old Town, Maine

Beam End Treatment

Procedure for Structural Beam End Treatment – Stillwater Bridge

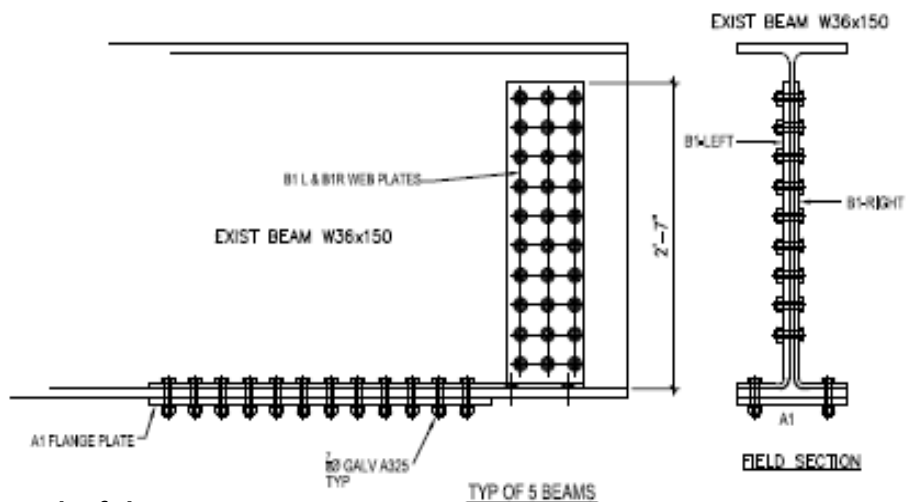
After strengthening all 6 beams ends, the last 15 feet, including the bearings, were blasted and coated.

MaineDOT maintenance crews completed this repair without disrupting traffic in less than 3 weeks, just ahead of the deadline of students returning to University of Maine, Orono.

In order to accomplish a smooth ride over the roadway finger joint, six - 100 ton hydraulic jacks were used to precisely lift each beam in order for shim plates to be placed between the bearing plate and the girder.

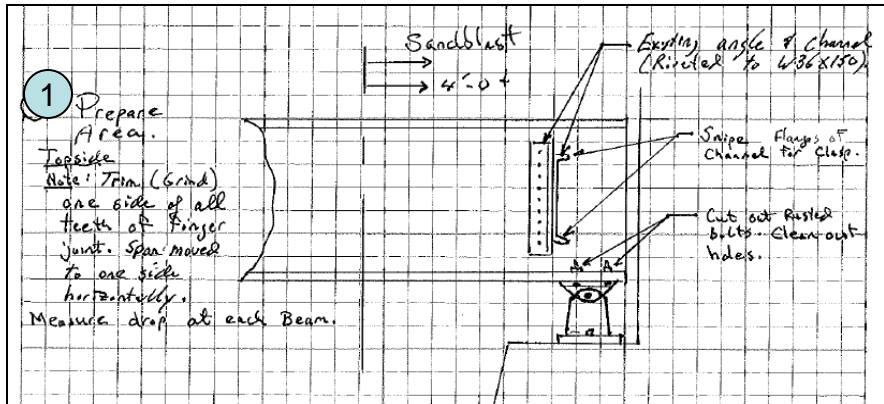
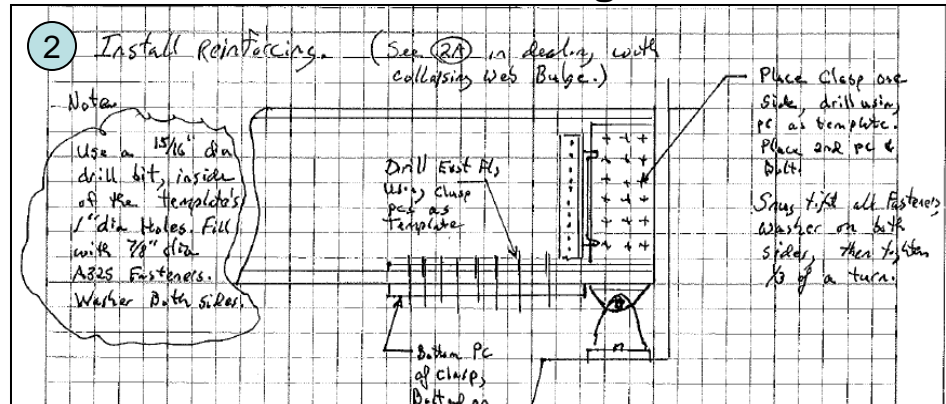
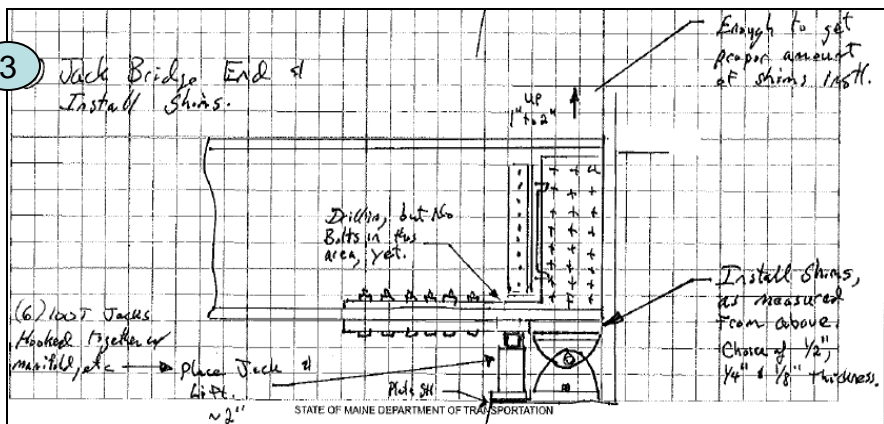
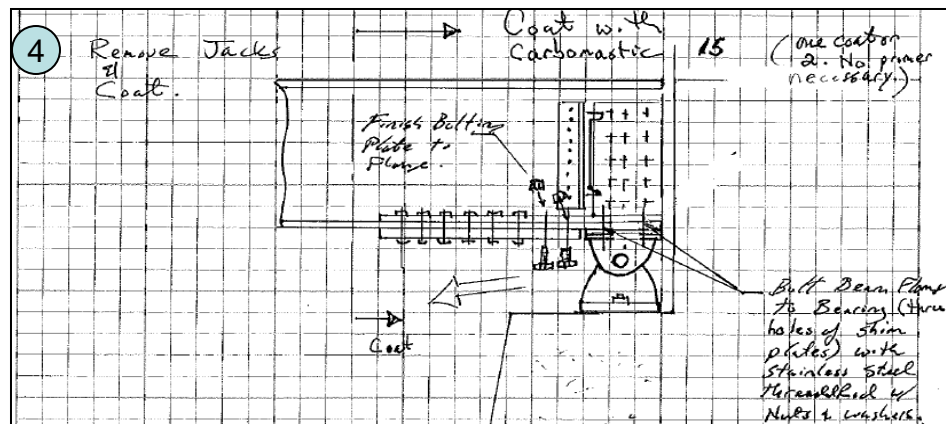
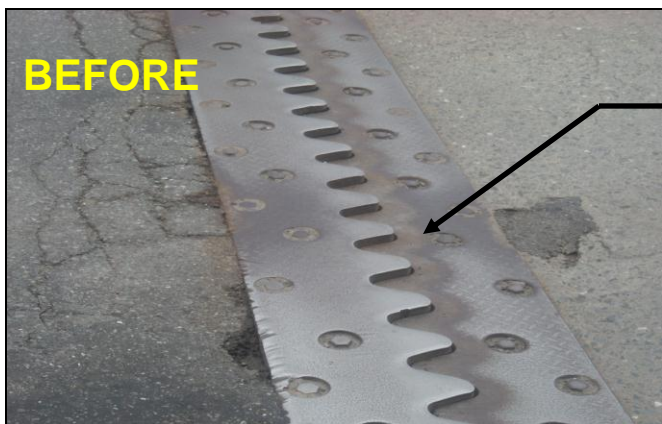
A 3/4" drop from collapsing webs.

A smooth ride after shimming up beneath rocker plates.
