Hawthorne Viaduct Beam Repair Carl Morgan and Mike Faulkner

Multnomah County

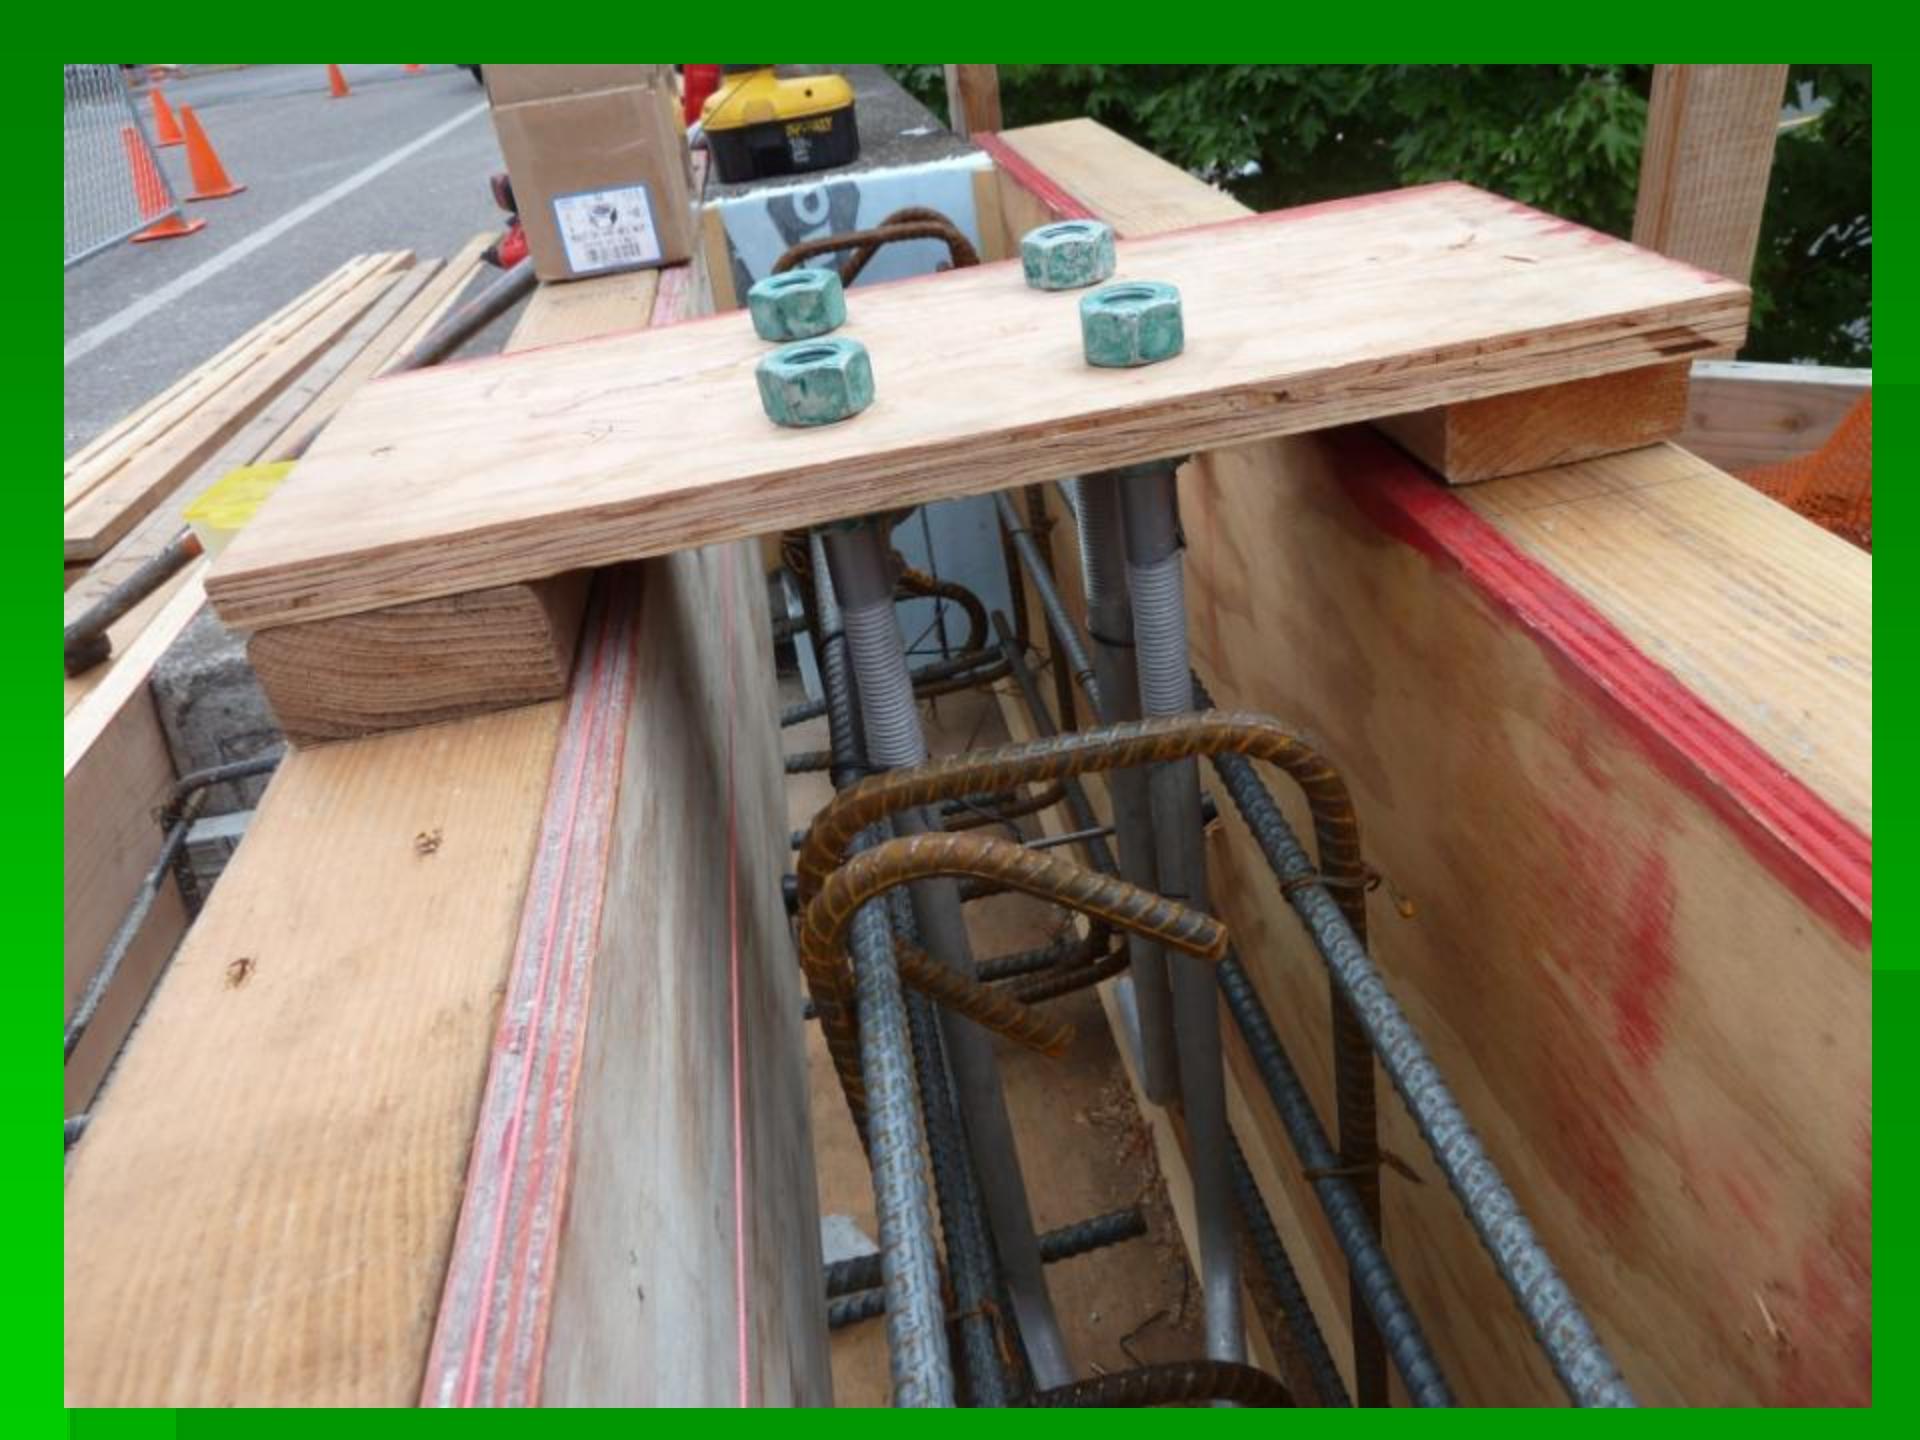
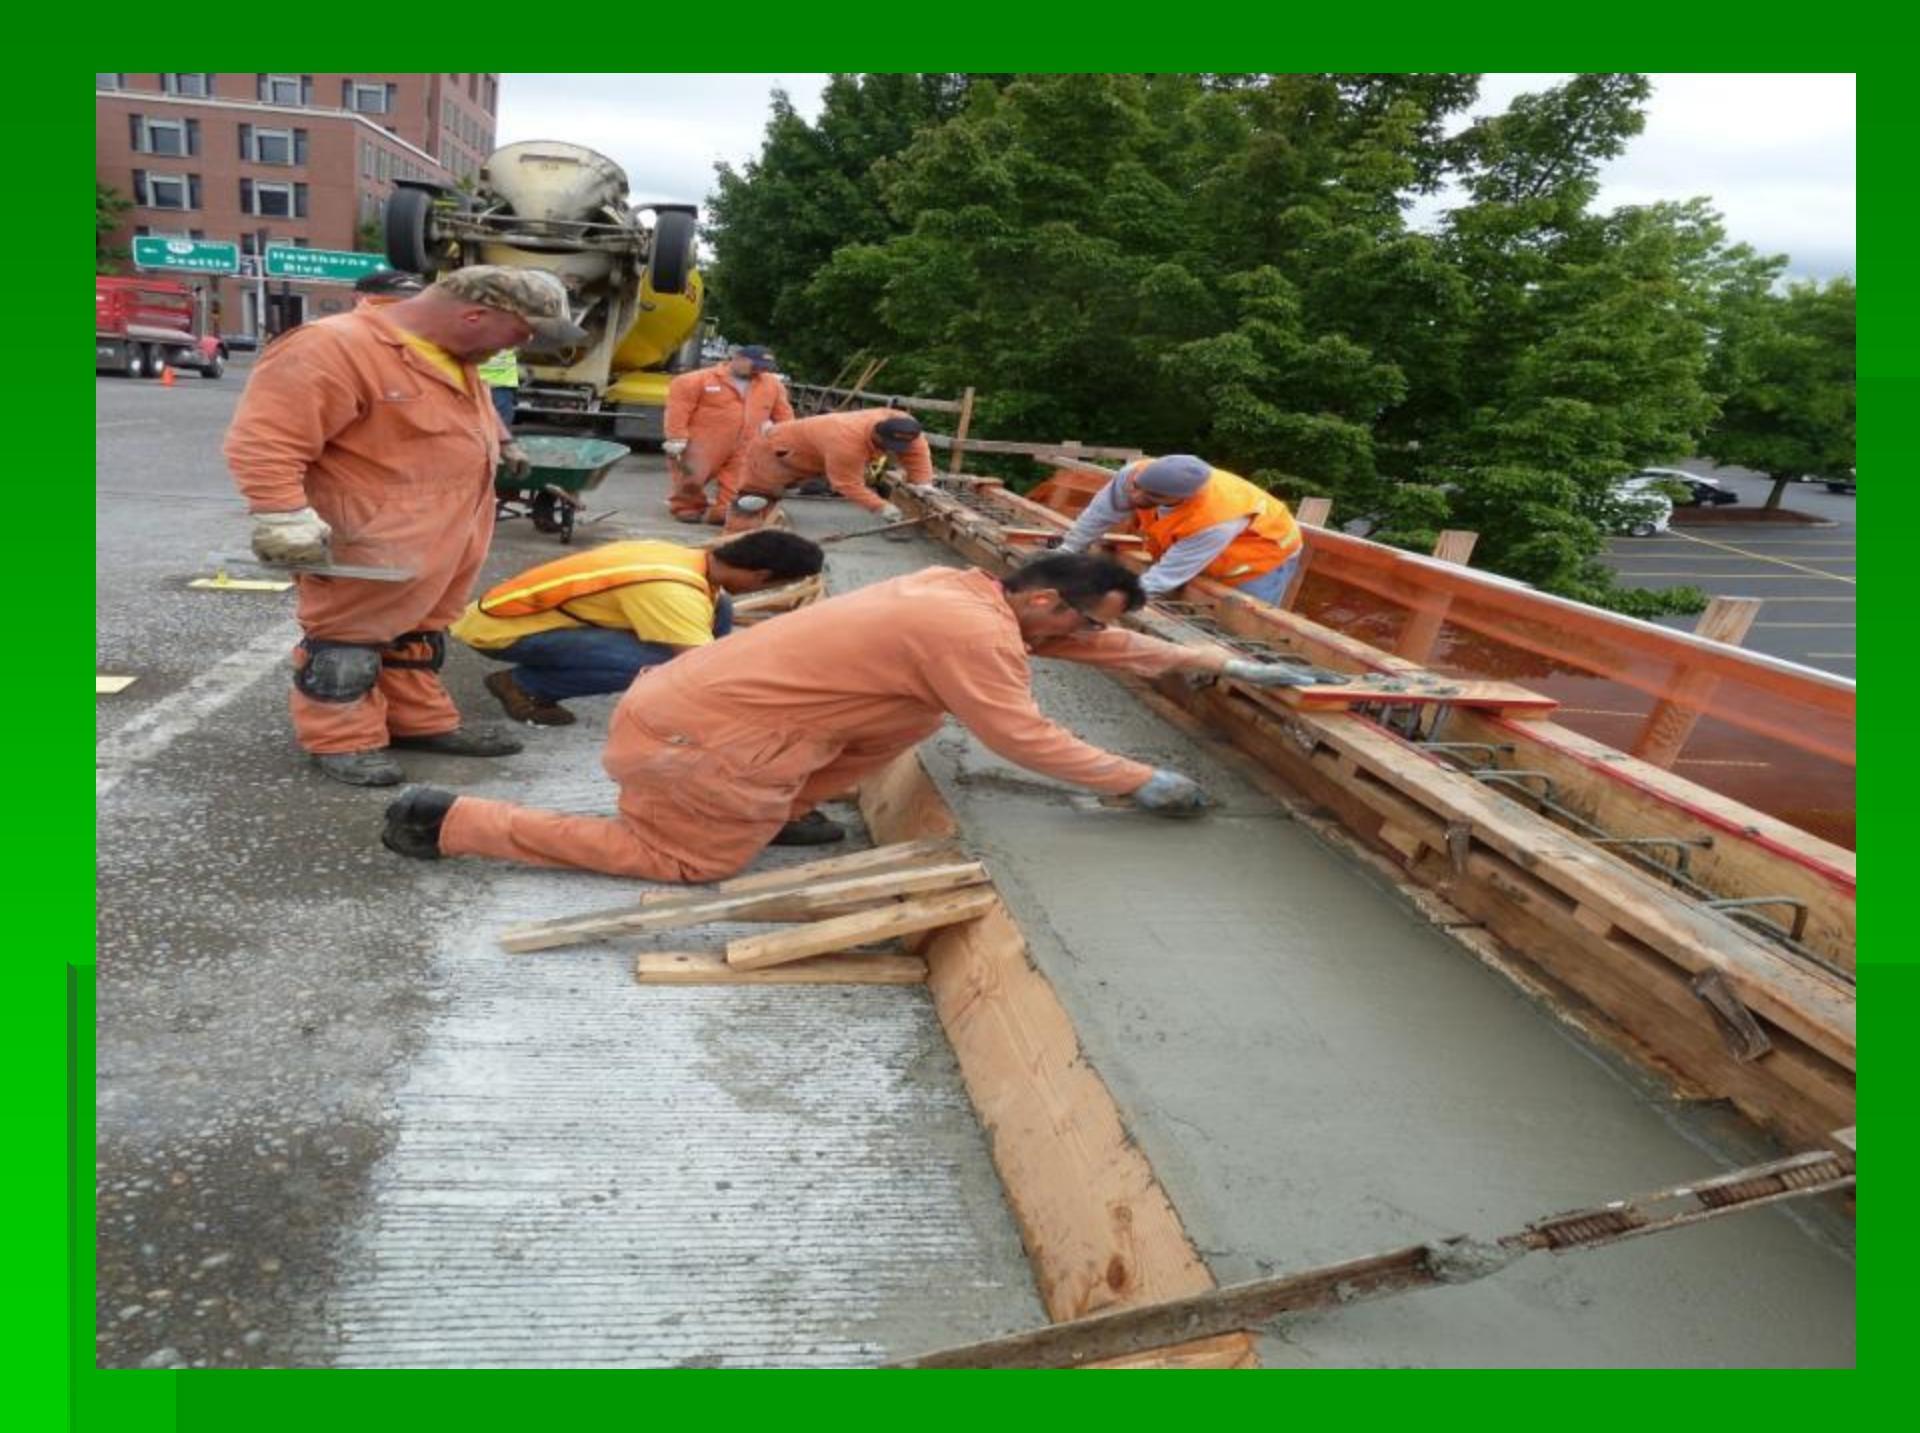
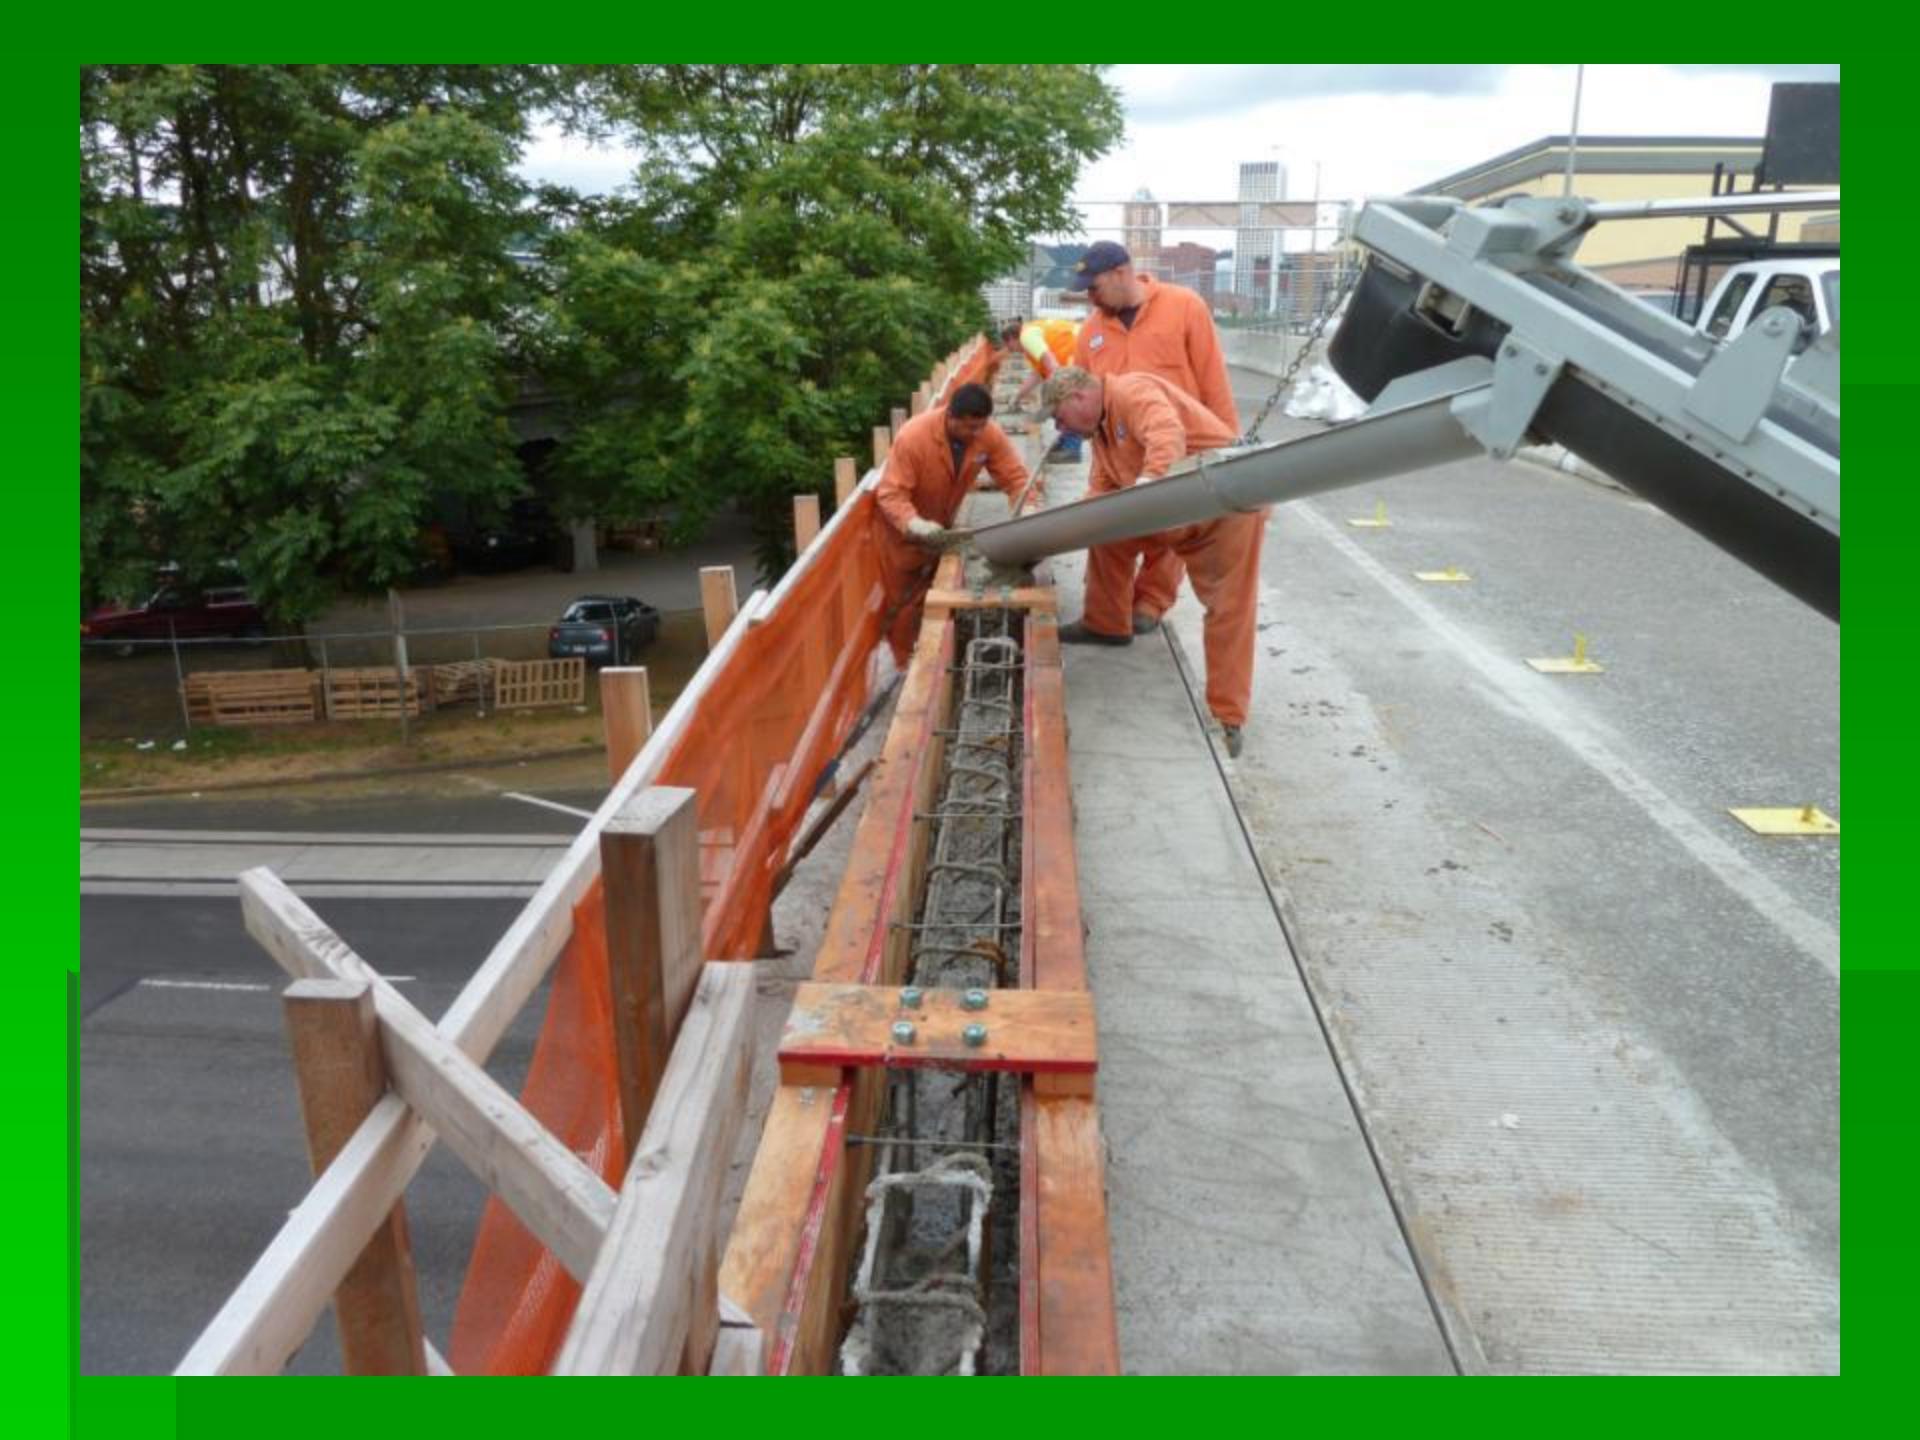
The forms come down

- Strip forms from interior and exterior
- Stripping done in phases
- Concrete finishing applied to everything
- Fluff and buff!

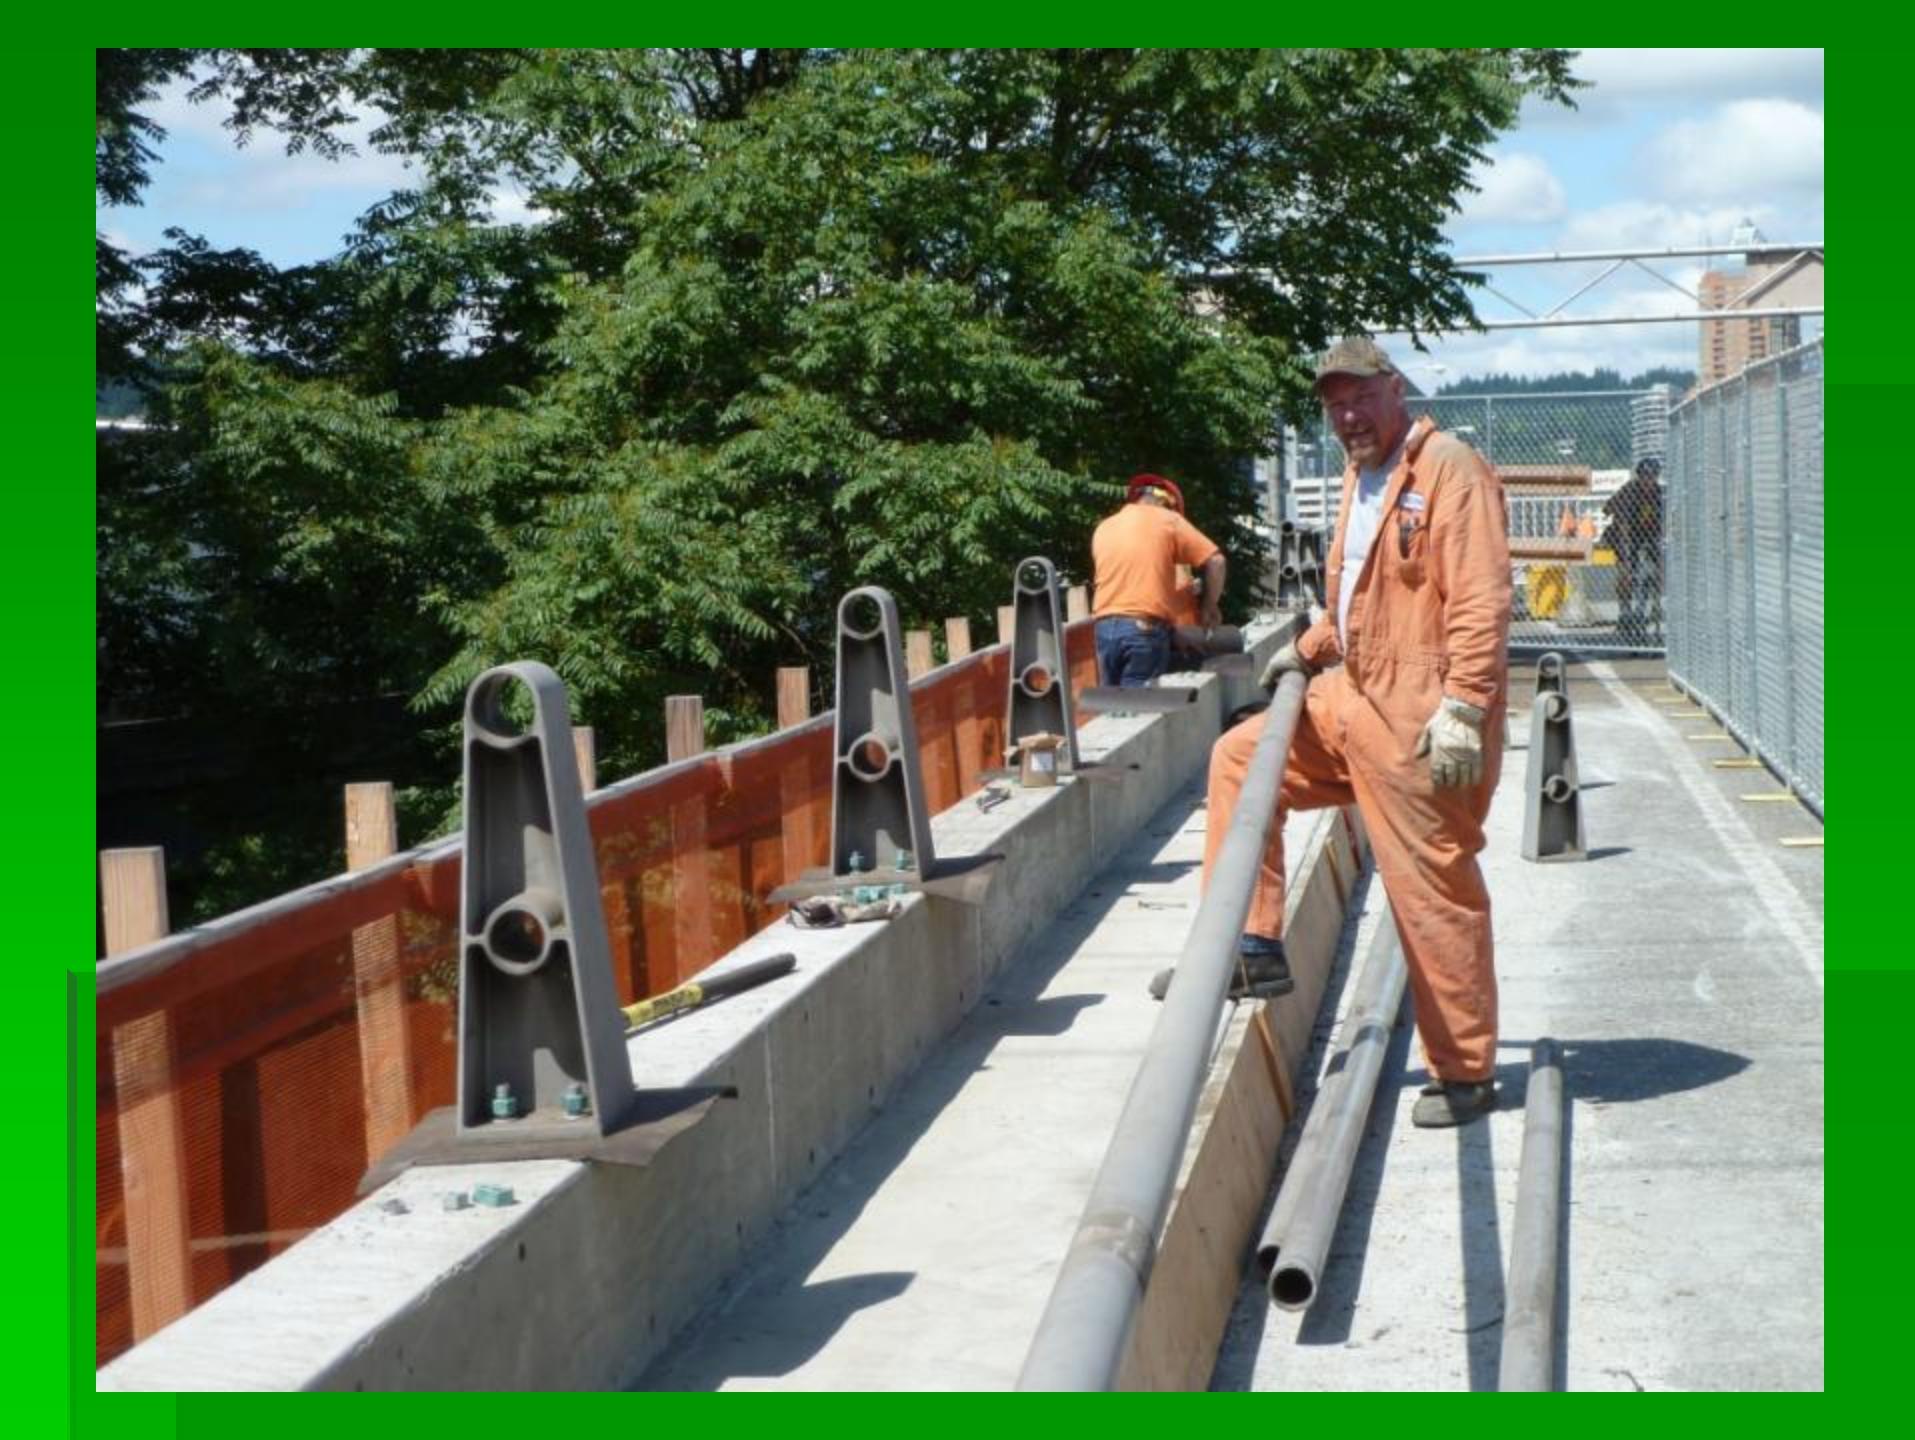
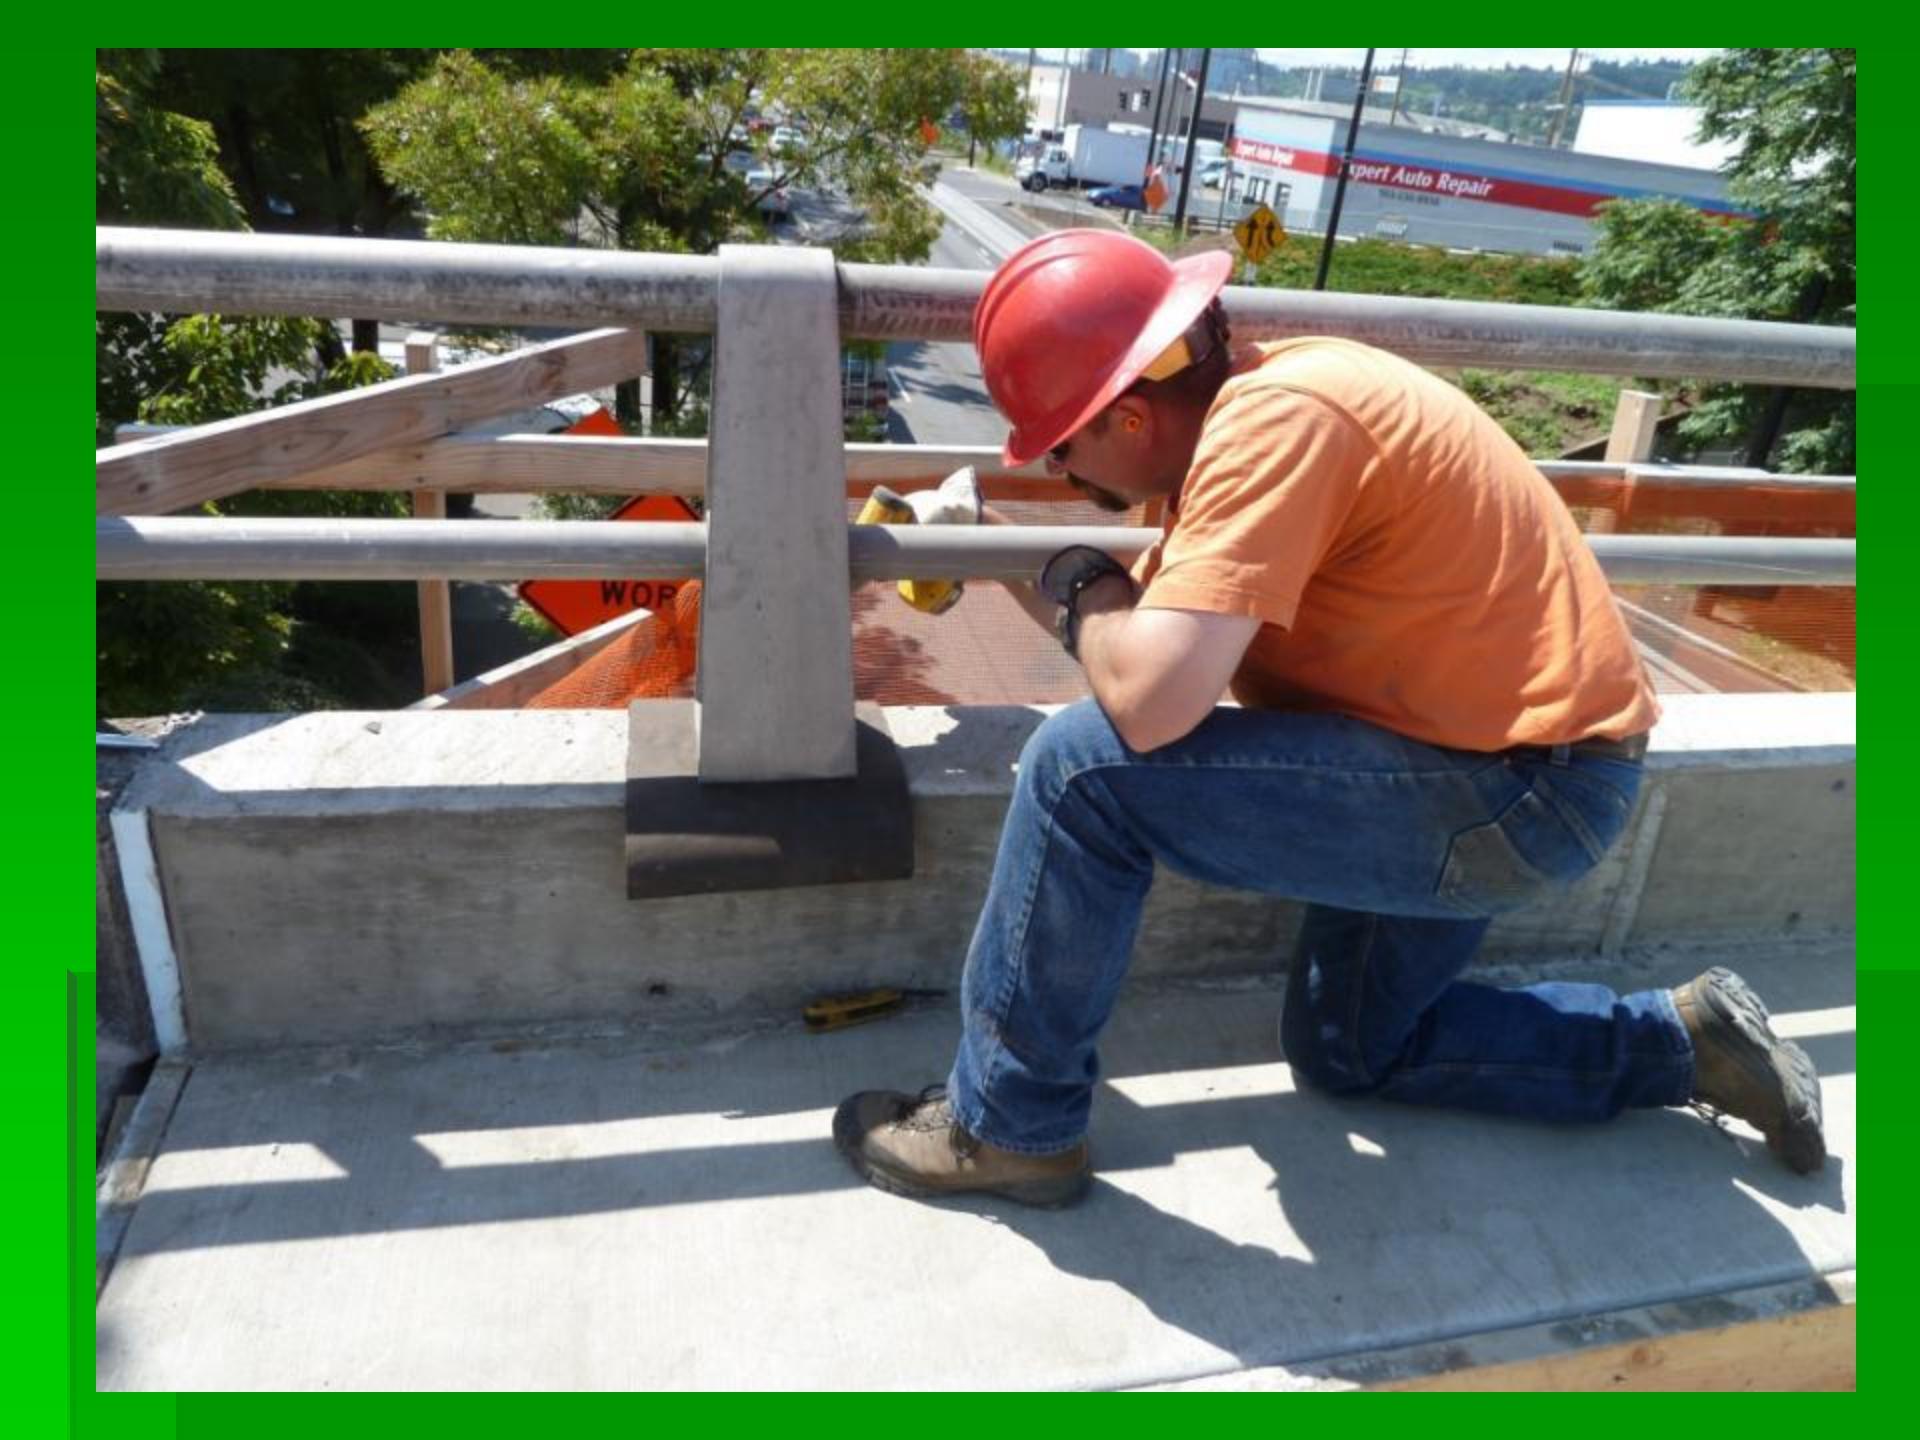
Install the guard rail

Reinstalled post with the rails
