# In Service Replacement of Box Girder Bottom Slab

WSDOT Bridge No. 5/537S - Span 11

Craig R. Boone, P.E., S.E.

2015 Western Bridge Preservation Partnership Meeting  
Portland, Oregon  
May 18-20, 2015

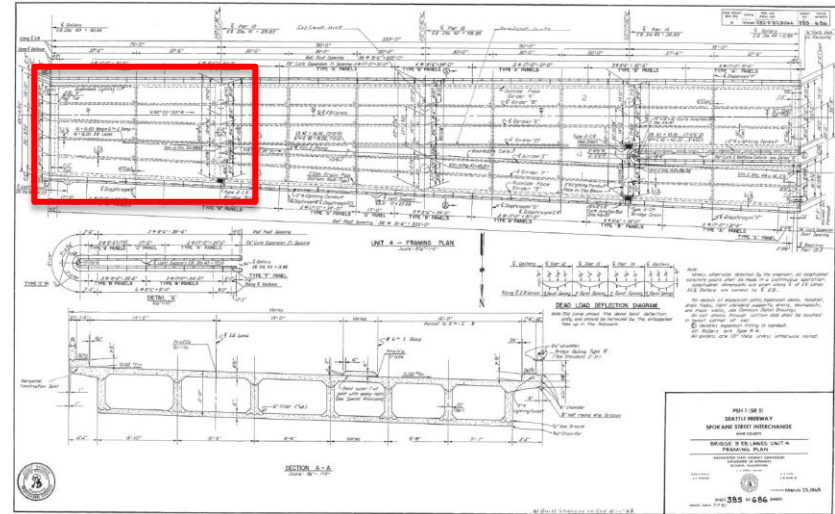
Positive reinforcement to be removed and replaced ((8) #11 bars at each web)

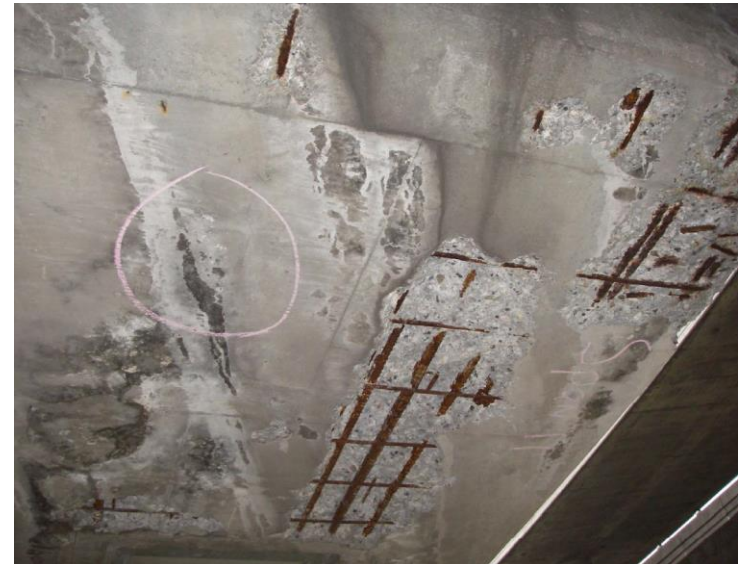
- Span 11 bottom slab had areas of soft and deteriorated concrete (2,340 sf) and areas of spalling with exposed rusty rebar
- Concrete was found to be punky, having a powder consistency
- Large areas of concrete were easily removed up to a depth of 6-inches

- Sounding of the soffit with a rock hammer found that approximately 70% of the Span 11 bottom surface was delaminated

- NBI Superstructure Code = 4 (Poor condition. Advanced deficiencies such as section loss, deterioration, cracking, spalling, or scour.)
- Sufficiency Rating: 34.00
- Structurally Deficient

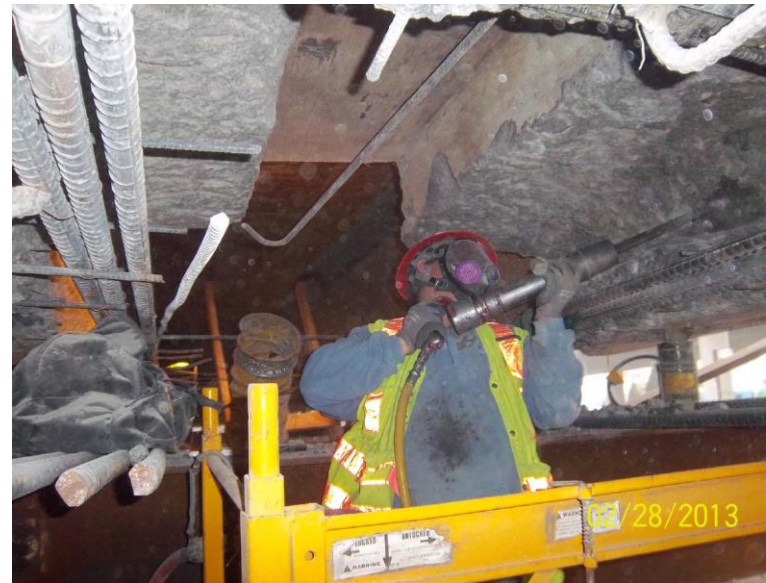
Size of equipment used for removal was limited to 30-lb pneumatic hammers, so as to not damage concrete that was to remain

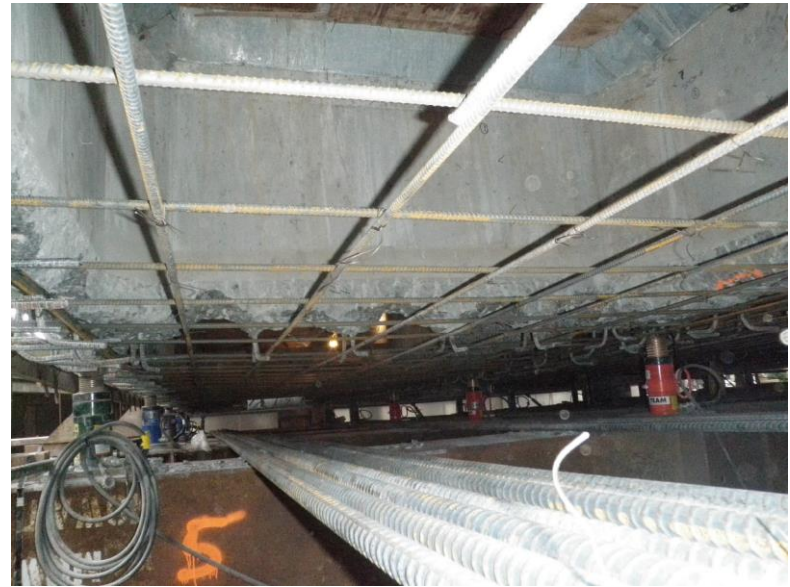
## Placing new reinforcing steel

- Notice the shear keys chipped in to the bottom of the webs.
