Oregon's Approach to Timber Pile Repair

2016 WBPP Annual Conference

By: Travis Kinney, P.E.

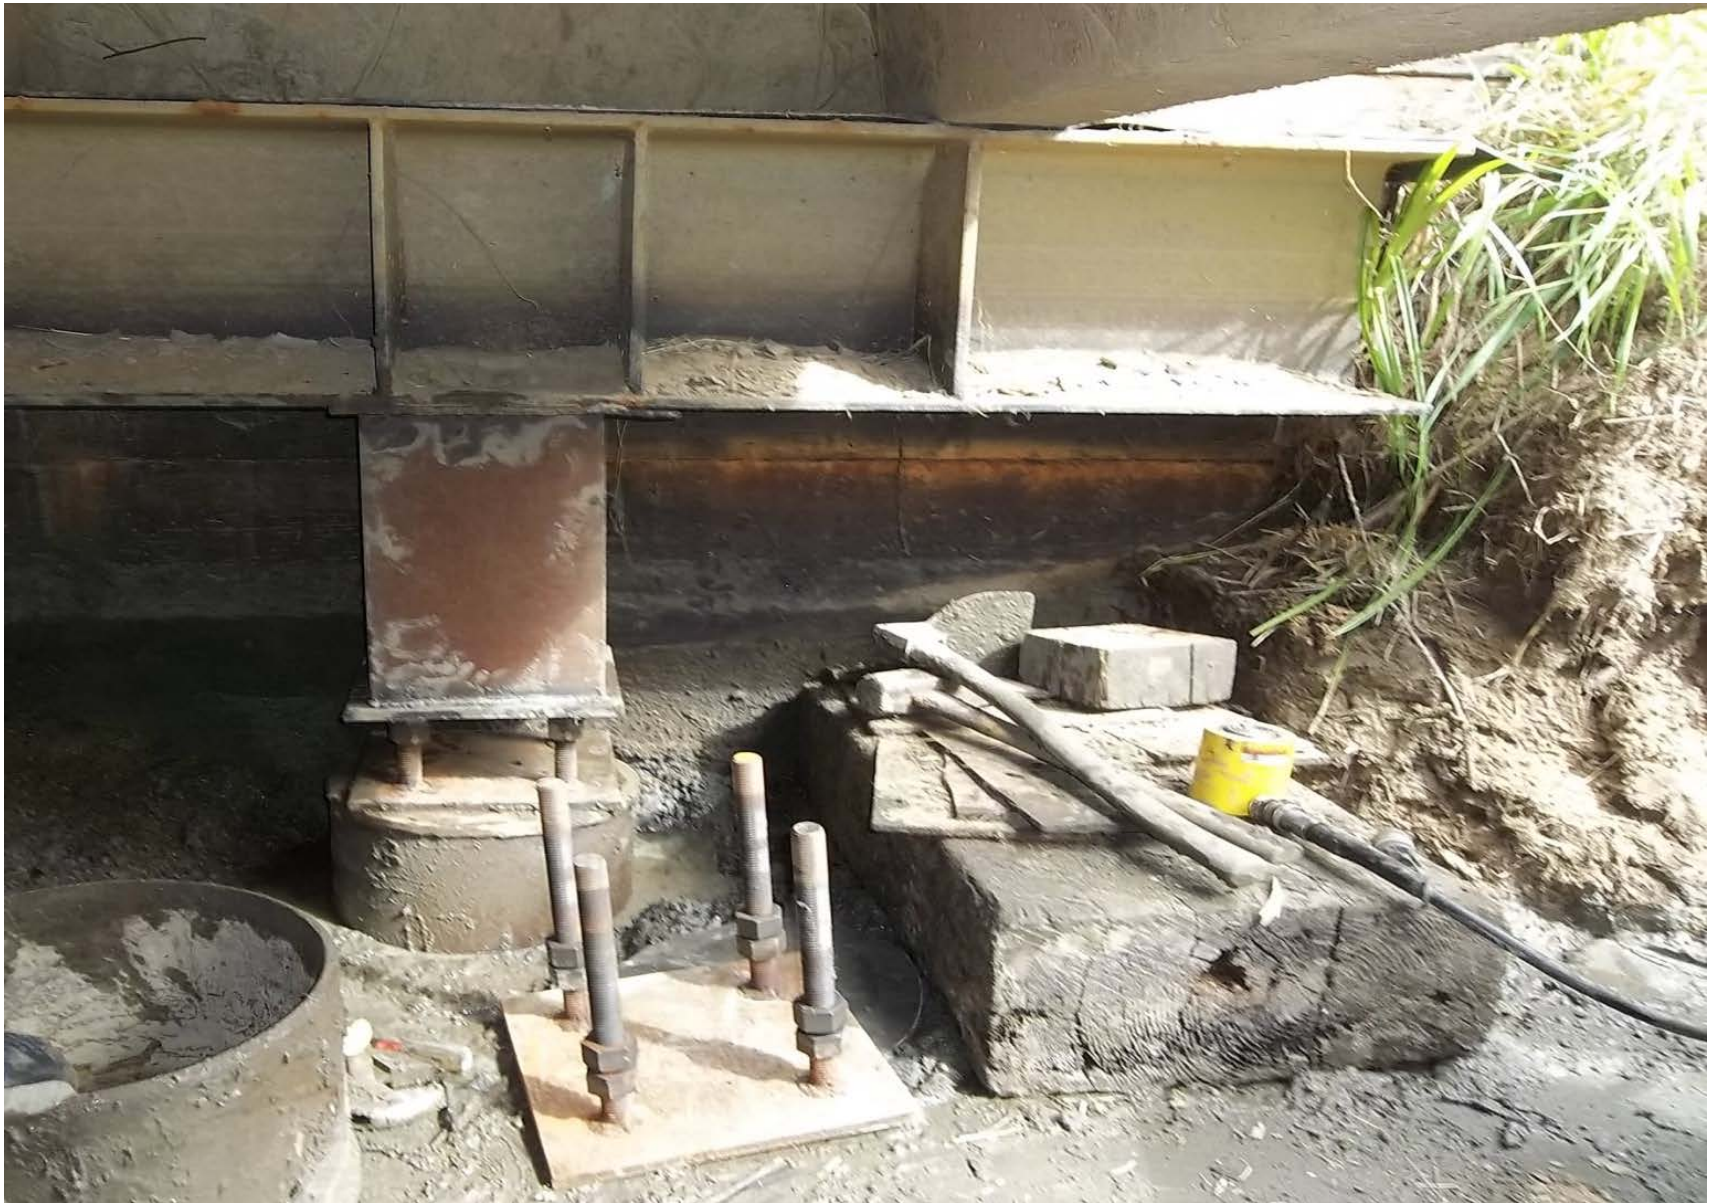
Drawbacks

- Difficult to install in tight spaces (abutments)
- Required excavation to continue at least 2' deeper than rot.
- Typical excavation = 2.5 cu. yd.
- If rot extended more than 2' below ground level then shoring or benching excavation was required.
- 18 cu. ft. of concrete for splice (2,700 lbs.)
- Steel cage difficult to stage.

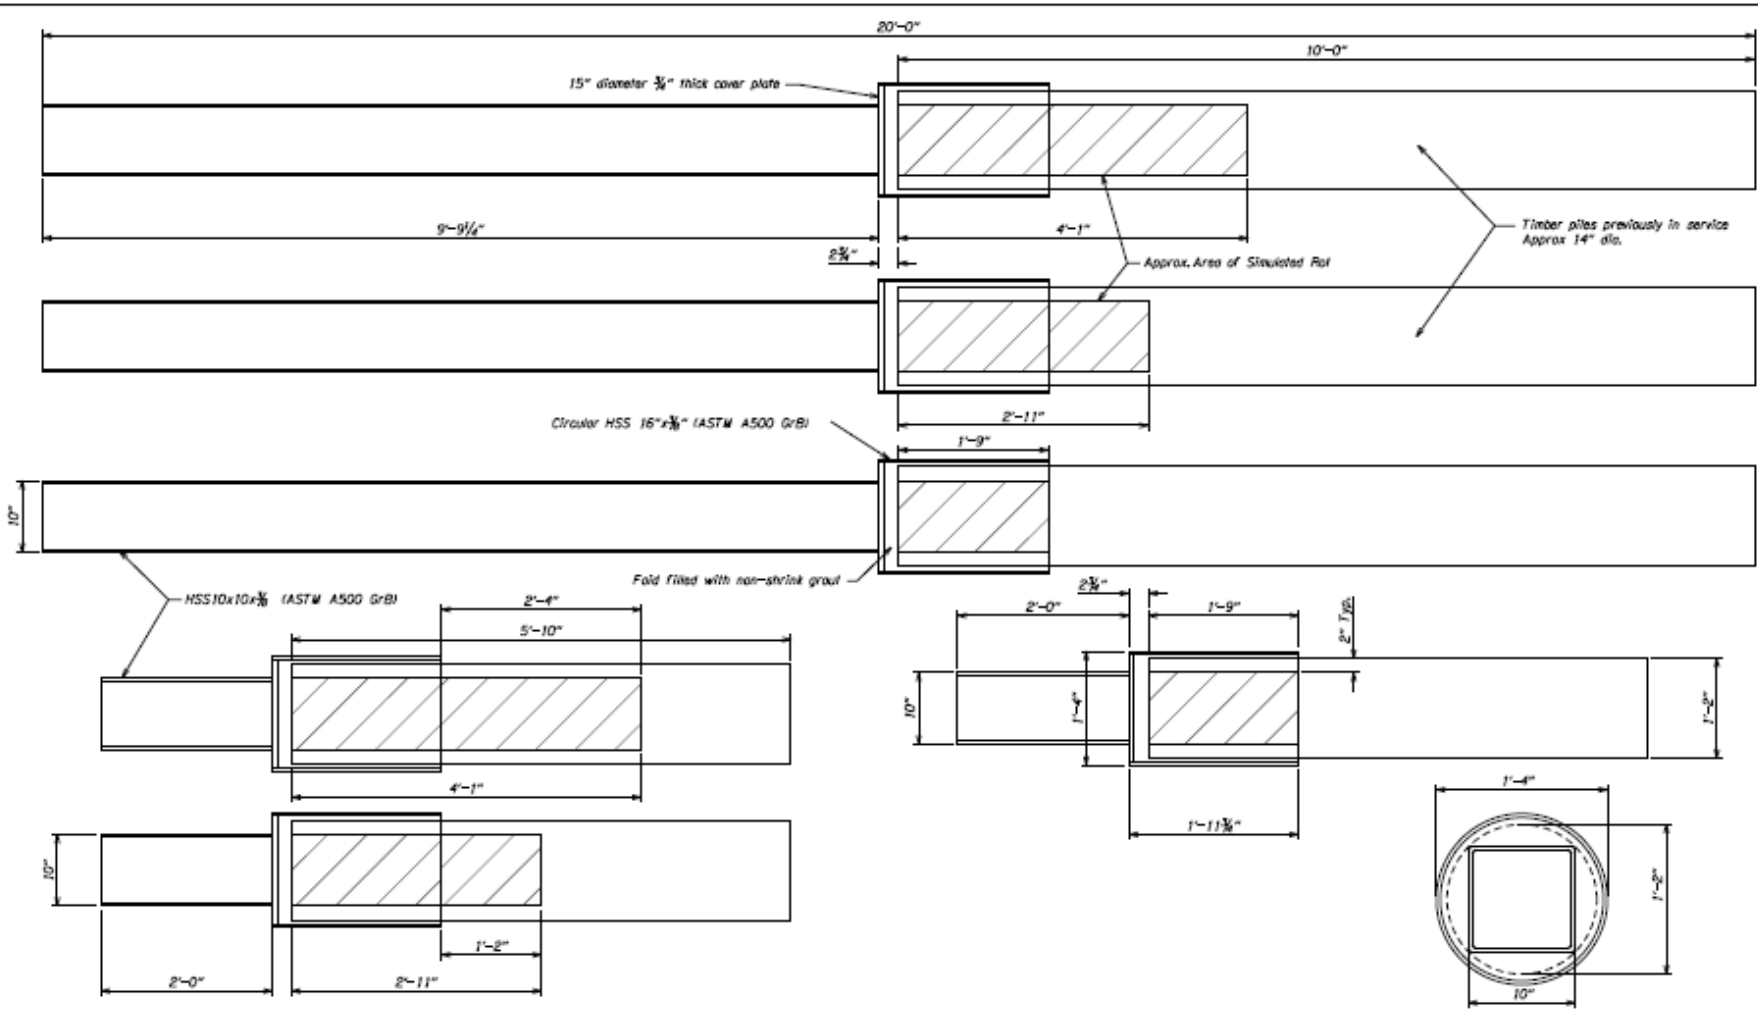
TEST PILE DETAILS

- ODOT contracted with Oregon State University to destructively test pile splice detail.
- 6 piles in total were tested; 3 flexure and 3 compression.
- Rot was simulated to varying depths:
 - 21”
 - 35”
 - 49”

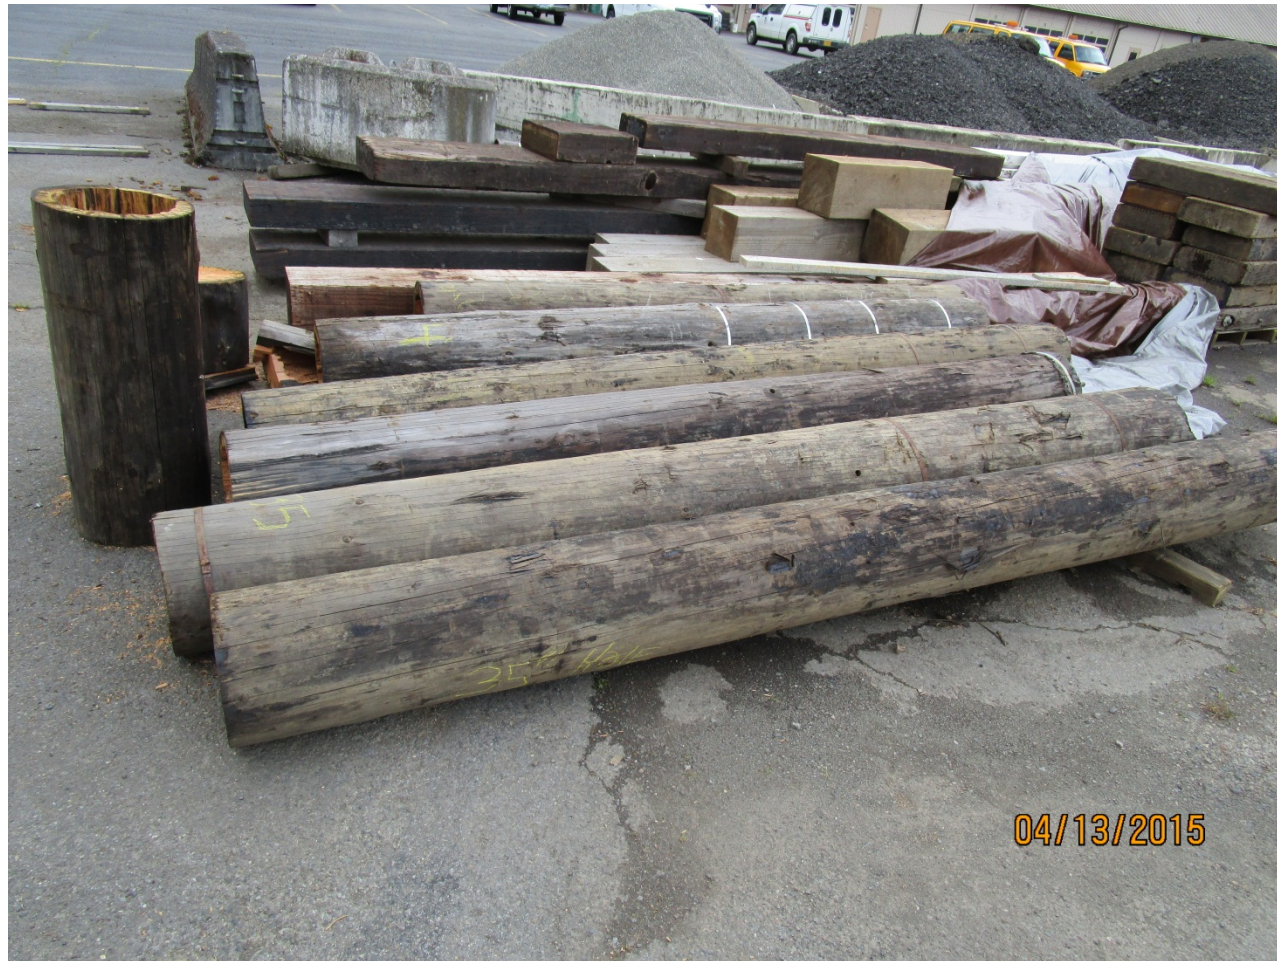
14" dia. piles previously in-service

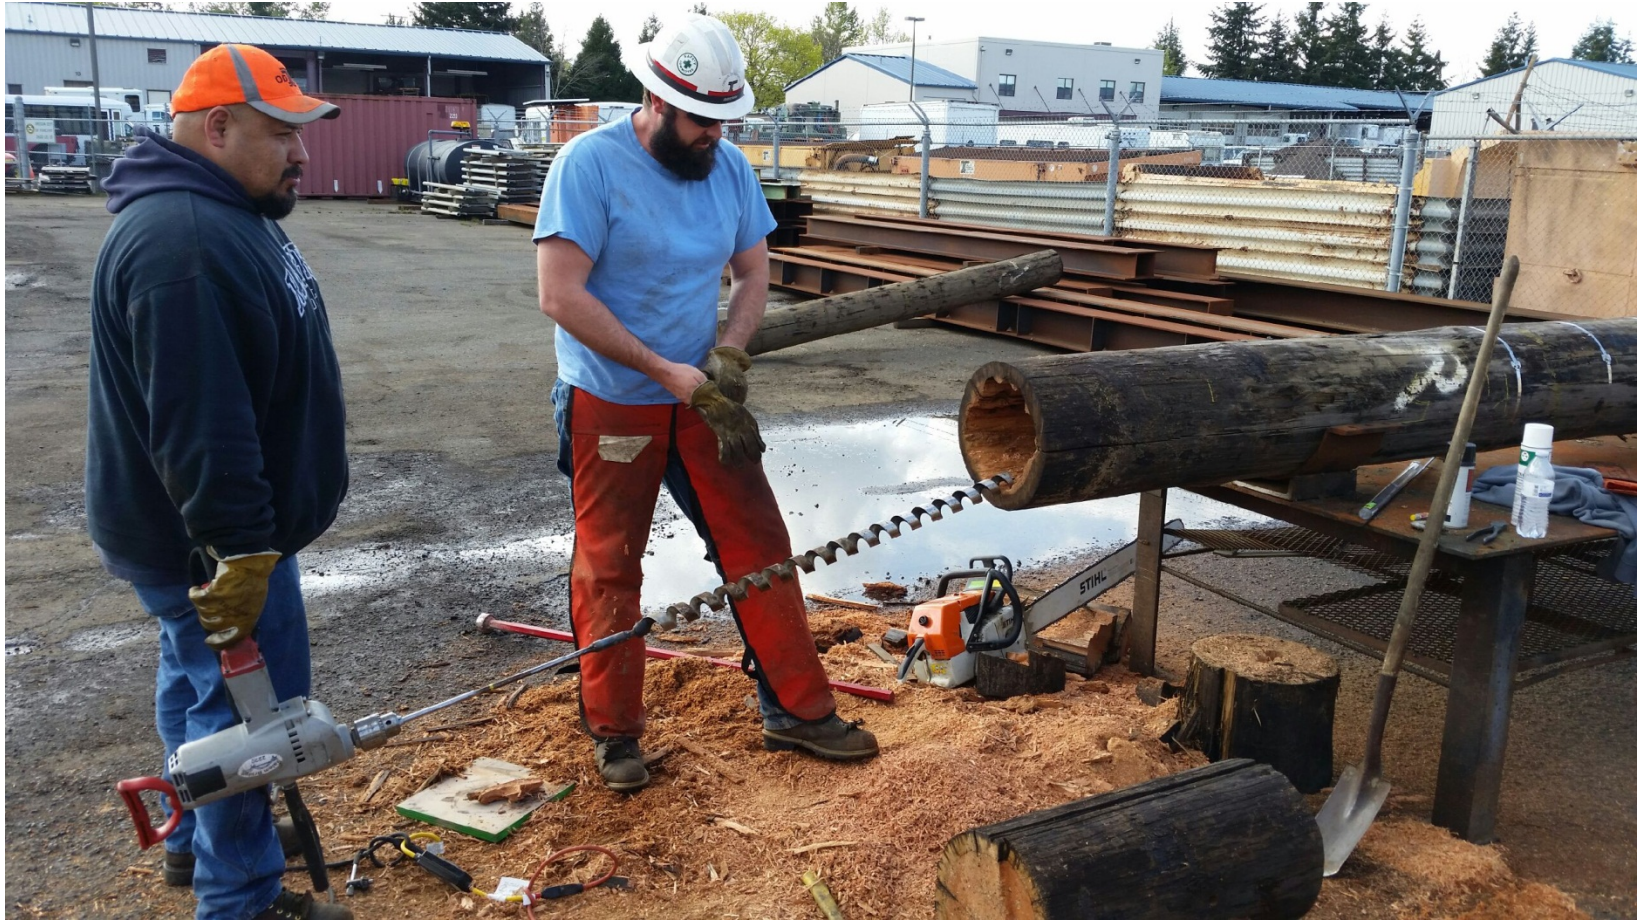
Removed material to leave 2" solid shell.

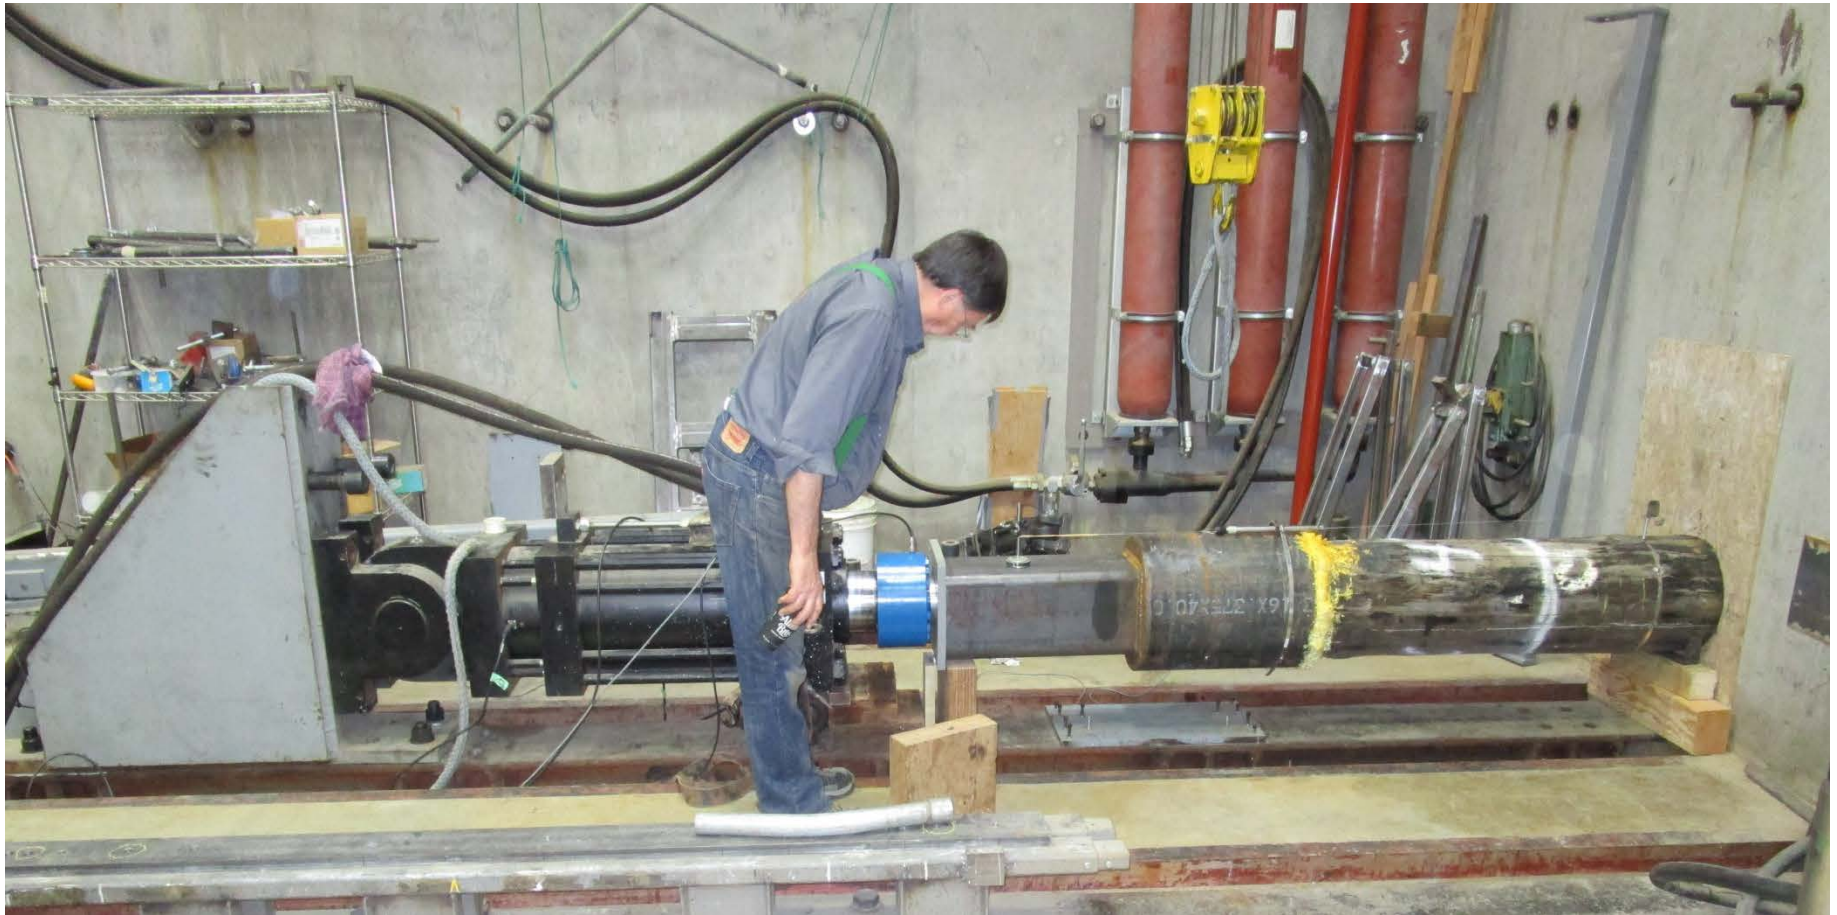
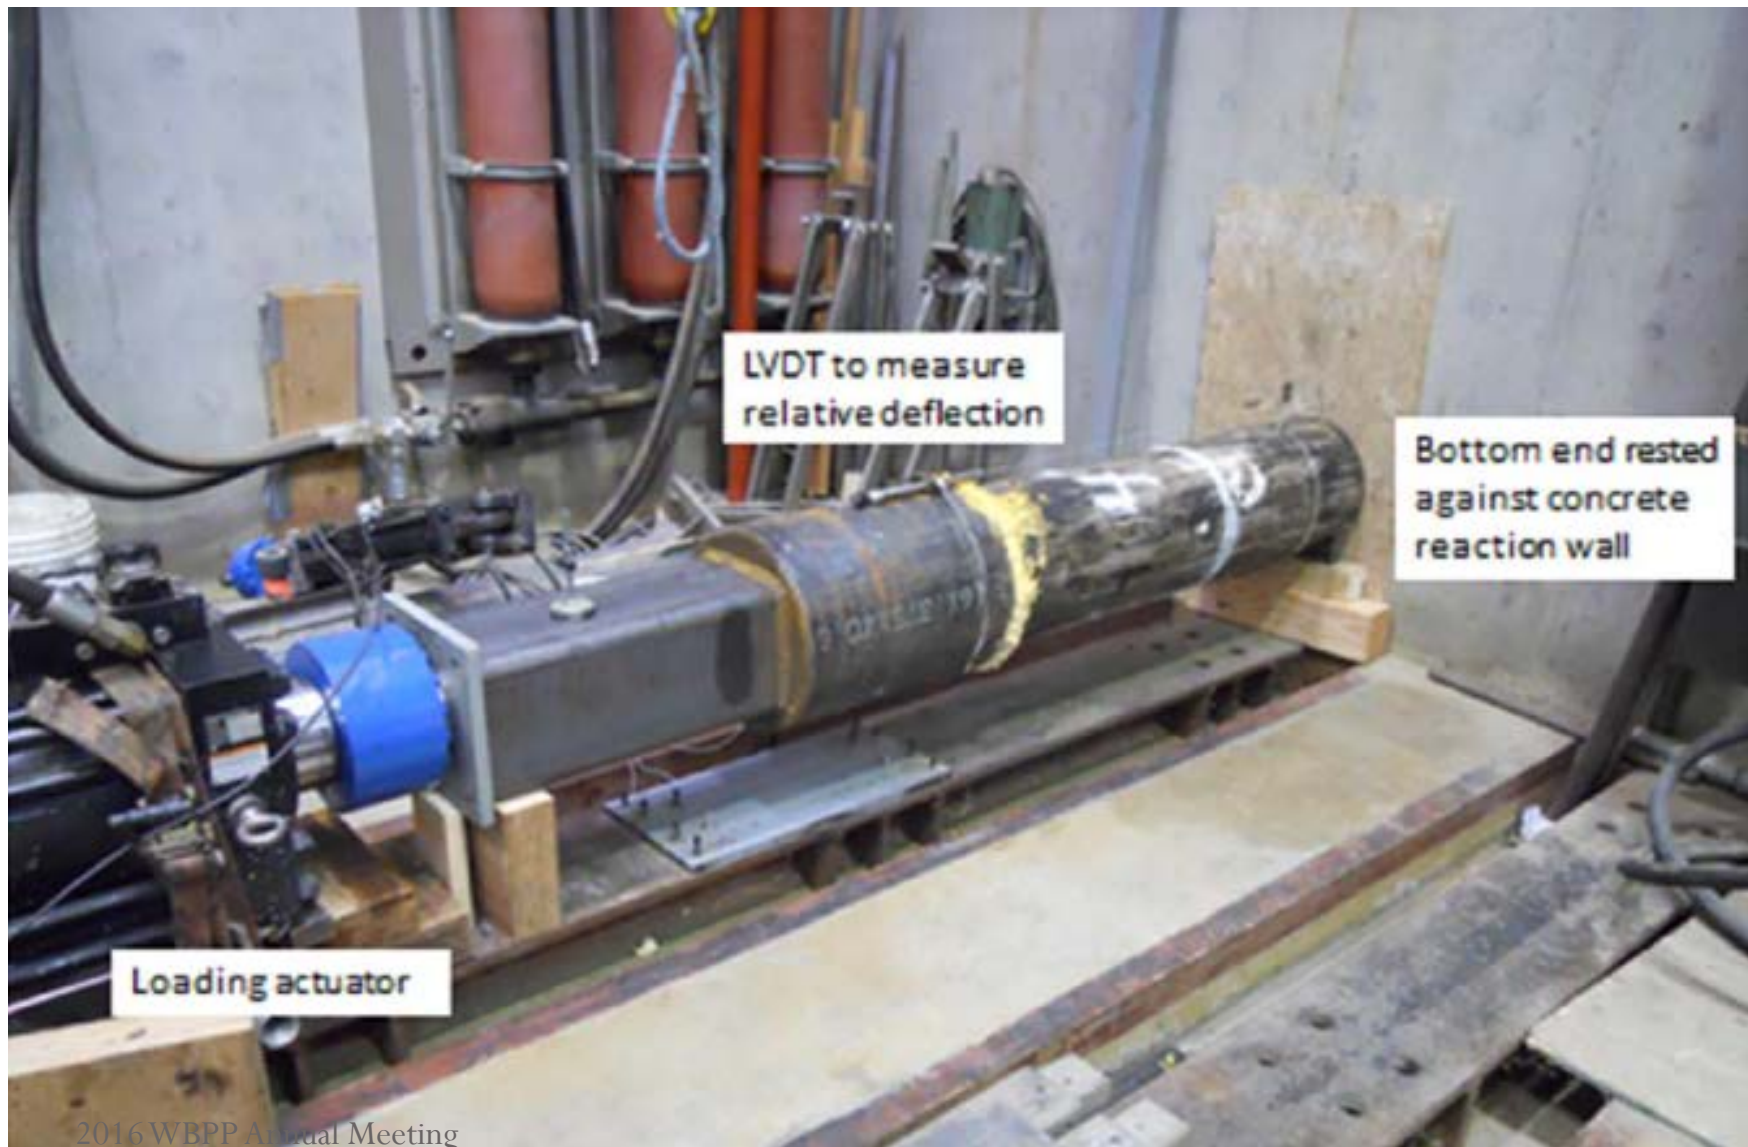
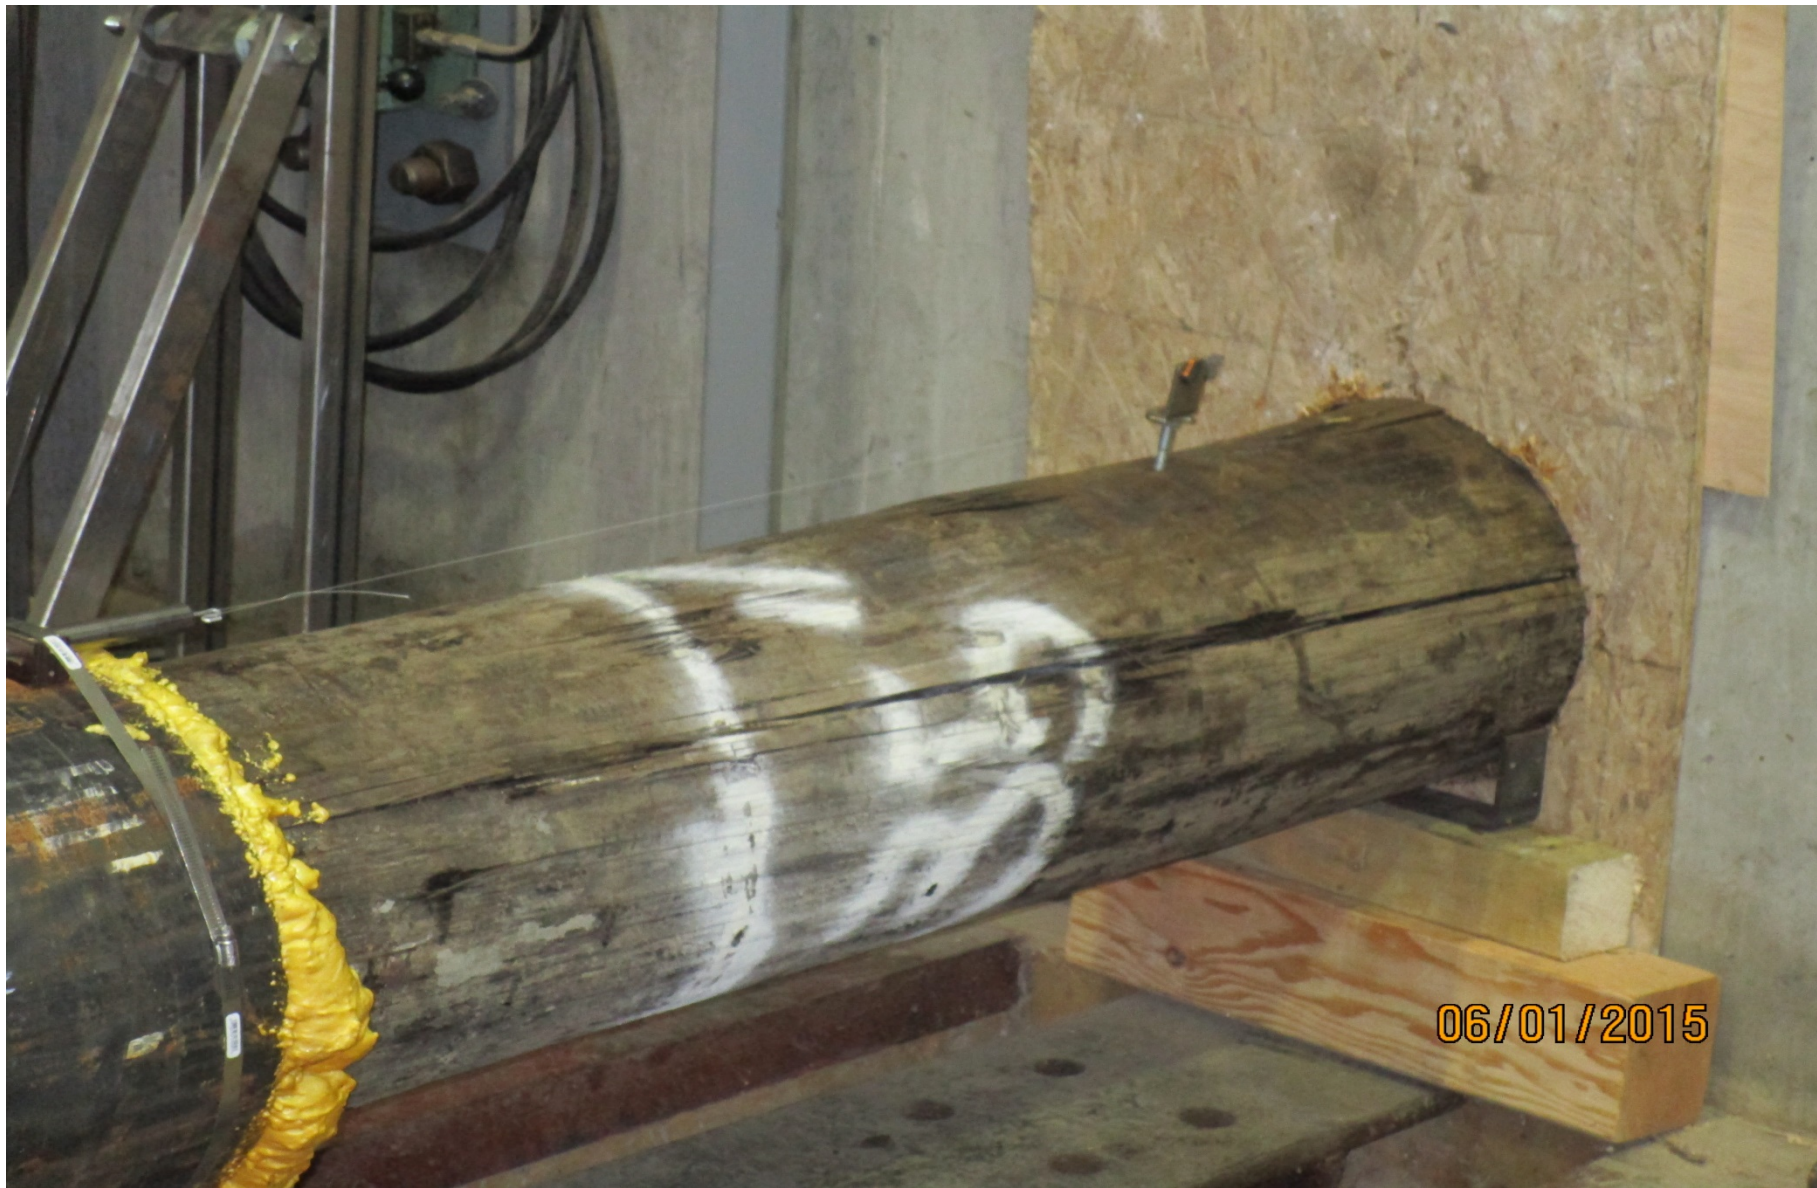
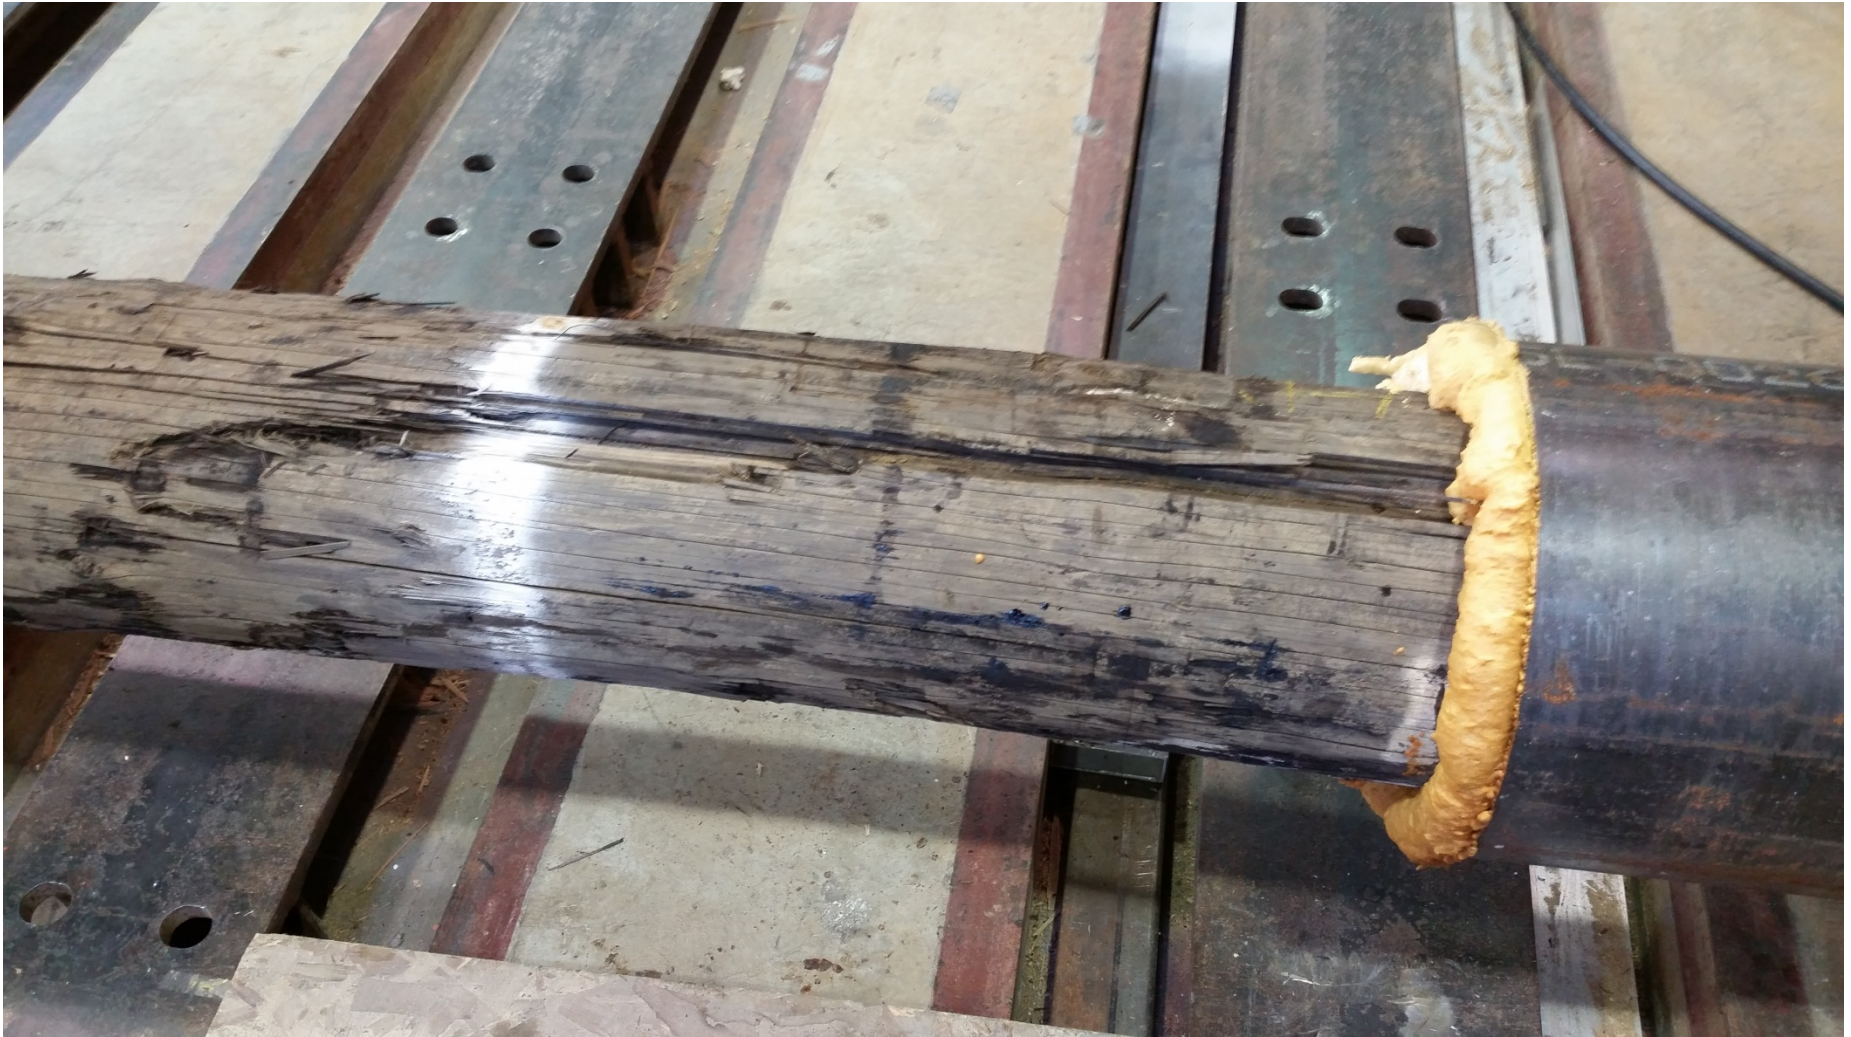
Compression Test Setup

- 13"-14" diameter.
- Core removed leaving 2" shell.
- 8' in length.
- Steel pipe pile Circular HSS 16"x 3/8" (ASTM A500 Gr B)
- Testing cross-sectional capacity and localized failures around splice.
- Predicted failure mode: localized buckling in unconfined timber shell.

Compression Test Results:

- 150 TON (300,000 lbs) actuator was not sufficient to fail any of the test specimens.
- An effect of concrete plug length could not be discerned.

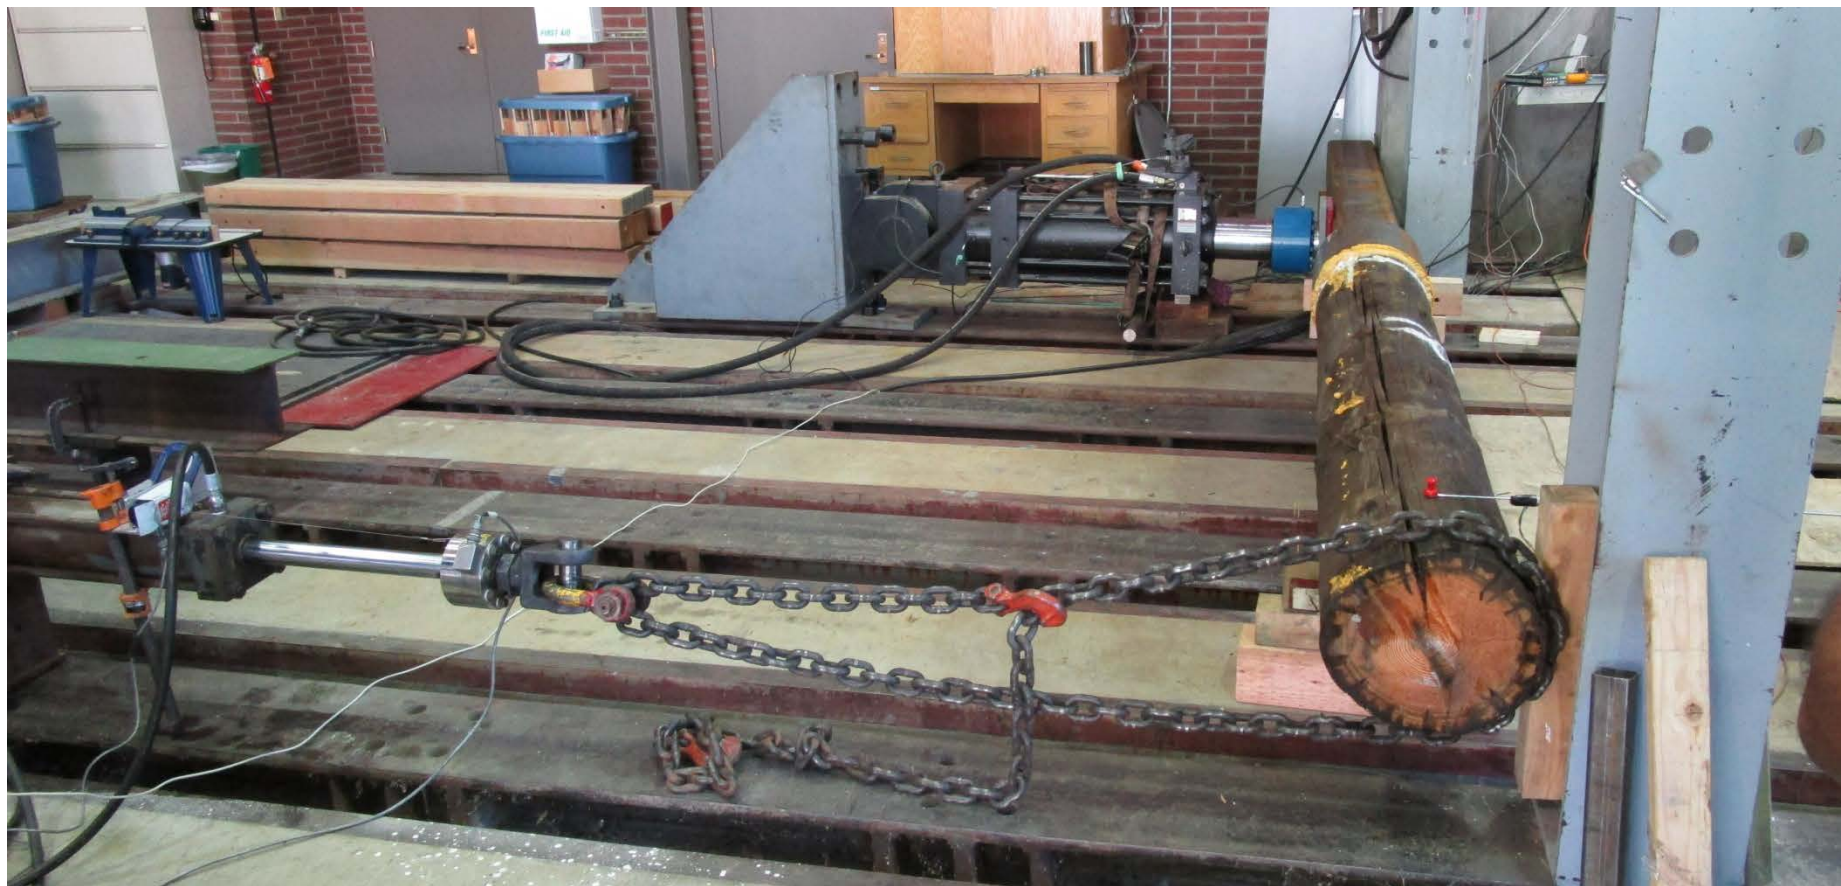
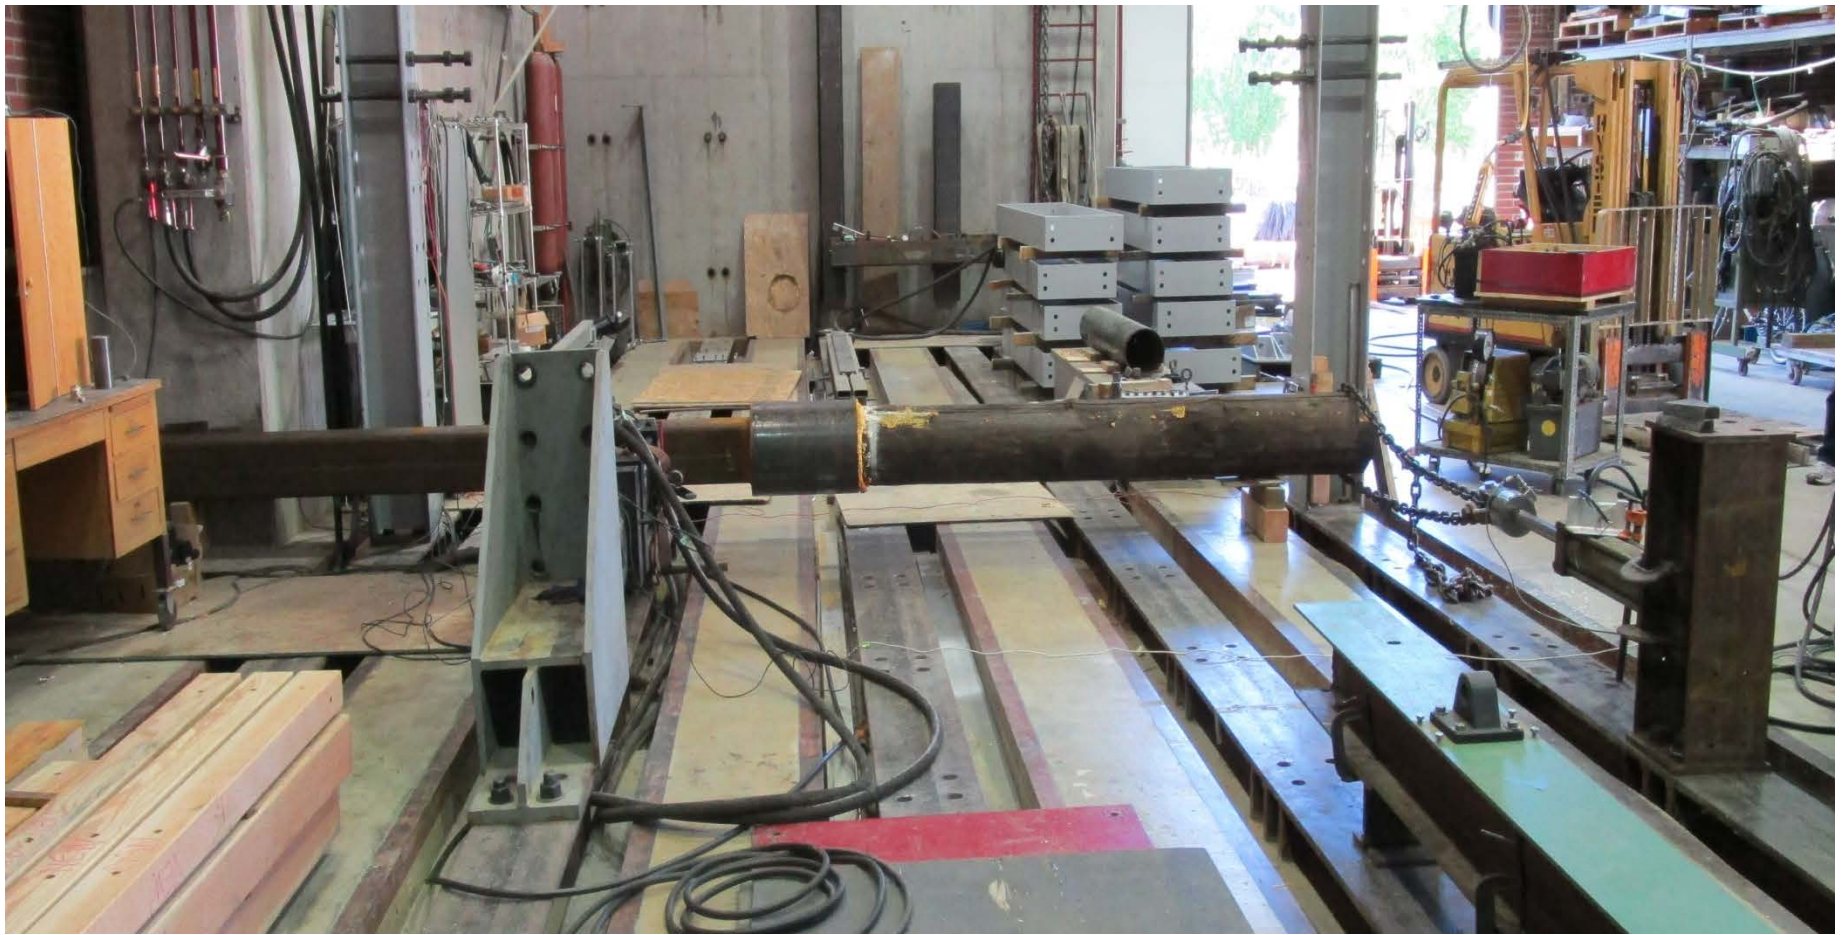
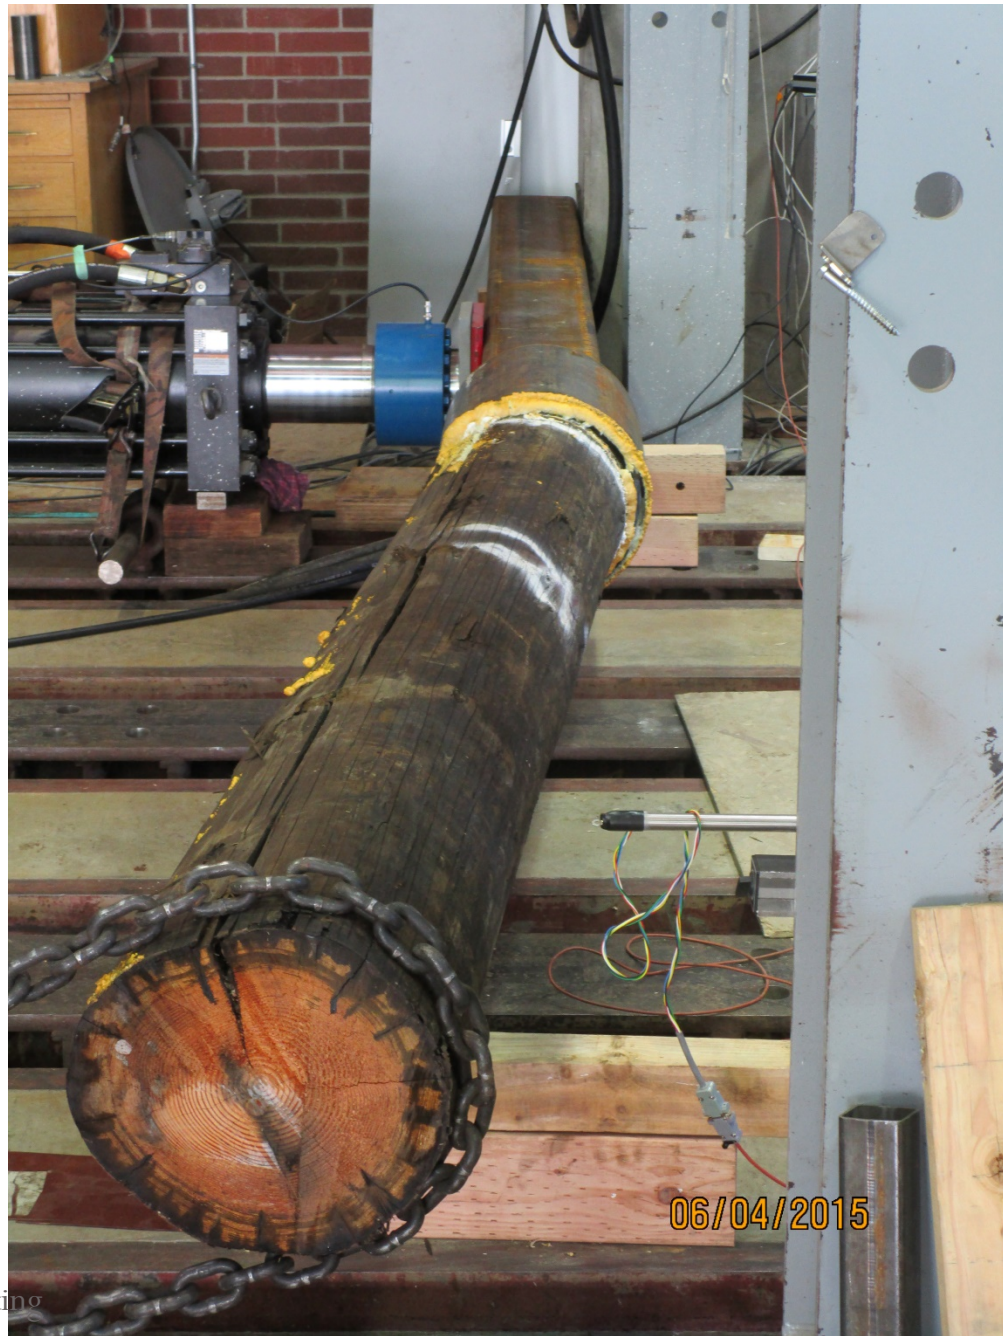
Lateral Test Setup

Bending Test Results

- All three failed at the base of the splice.
- Failure loading consistent with anticipated capacity of un-repaired pile.
- Ductile failure ($>12''$ of deflection at pile end)

- Proposed pile repair can be used to fully restore axial capacity for short columns.
- Lateral demand and remaining capacity should be evaluated as part of repair plan.
- Provide additional lateral support as required.
