Utilizing Unmanned Aircraft Systems (UAS) for Bridge Inspections

Presented by: Sarah Sondag, MnDOT Barritt Lovelace, Collins Engineers Midwest Bridge Preservation Conference

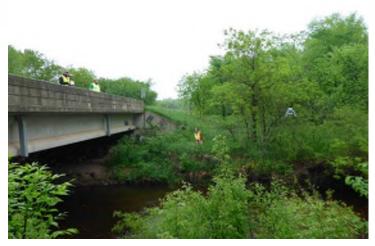
Bridge 13509 – Chisago County

- Small Local Bridge
- Prestressed Concrete Beam Bridge
- National Park Service Permission
- Unable to Fly Under Bridge
- Infrared Images
- Orthographic Mapping

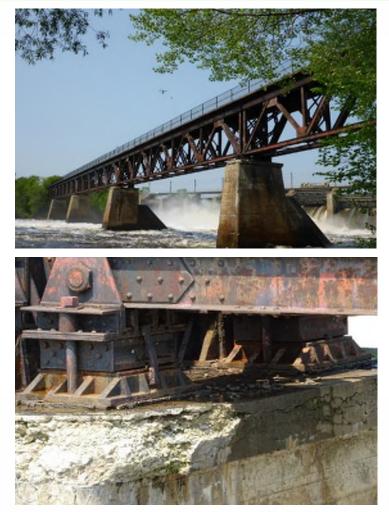
Bridge 49553 – Morrison County Pedestrian Bridge

- Large Steel Truss
- Difficult to access with UBIV
- Great detail in images
- Pack rust visible
- Concrete deterioration visible

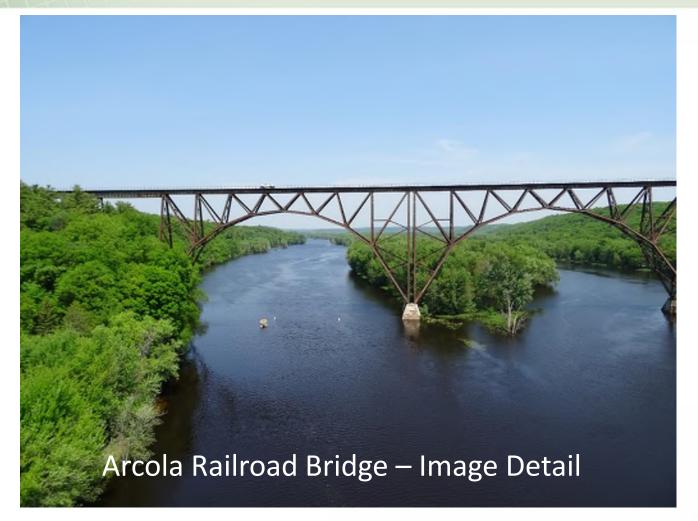
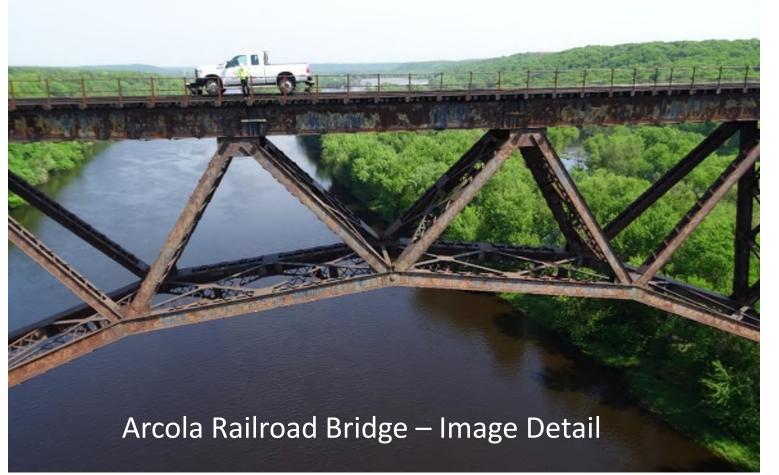
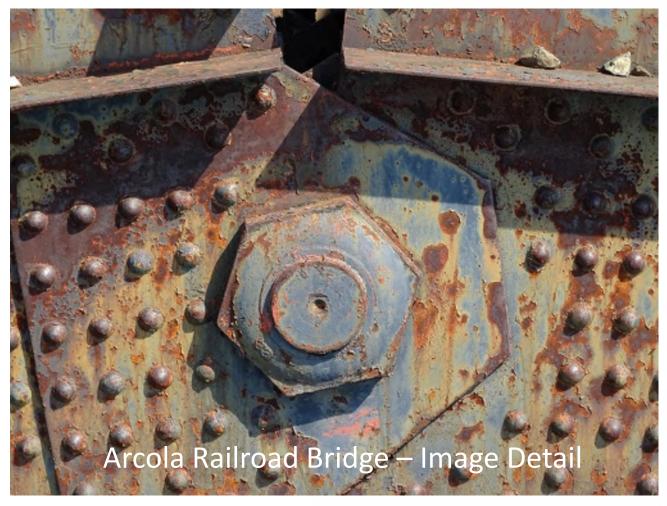
Arcola Railroad Bridge

- Large Complex Bridge
- Normally inspected using rope access
- National Park Service Permission
- Difficult to access

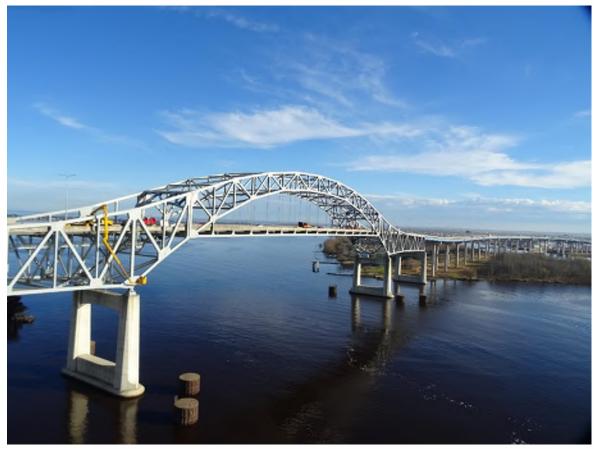
Blatnik Bridge Inspection

- Second Largest Bridge in Minnesota
- Crosses Duluth Harbor adjacent to Lake Superior
- Challenging wind and weather

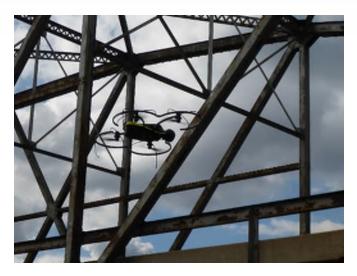
Nielsville Bridge 5767

- Infrared Imaging
- Thermal Camera results were similar to high end Flir cameras
- Drone has the ability to map chain drag markings for quantities in CAD
