BUREAU OF BRIDGES

and STRUCTURES

MDOT Training and Sharing of Best Practices

2018 NBPPC

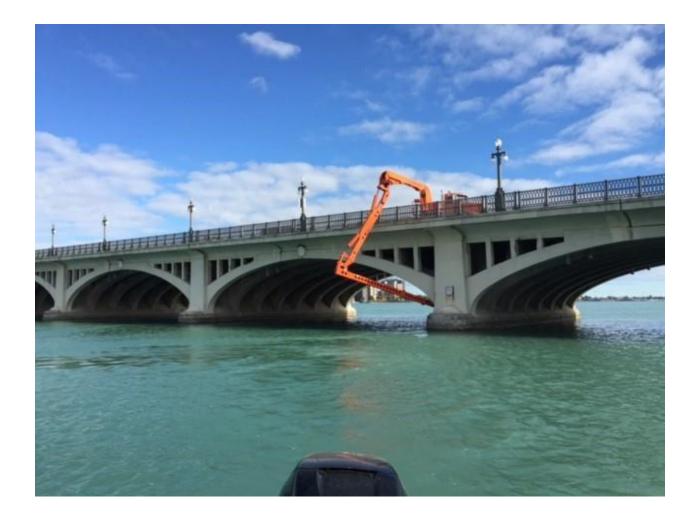
- Underbridge Inspection Aerial Unit
- Emergency Response
- Support Bridge Inspection

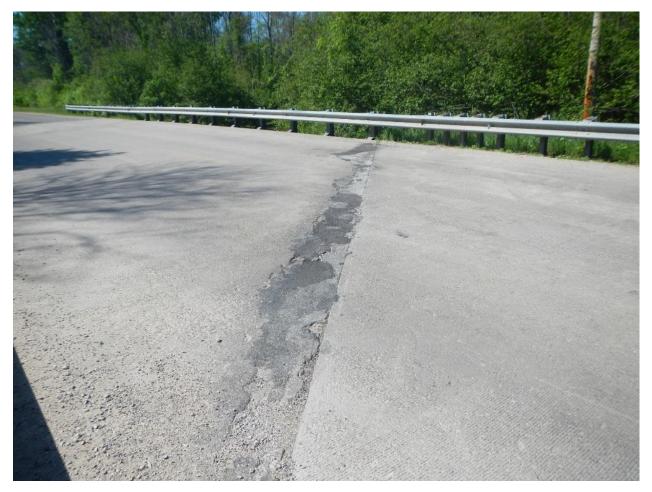
Local Agency – Scoping

- Missaukee County Road Commission
 - 13 Mile Rd over Butterfield Creek
 - Bridge Deck Rating lowered from 6 to 4
 - 62 feet long x 31 feet wide
 - Adjacent Box Beam Bridge

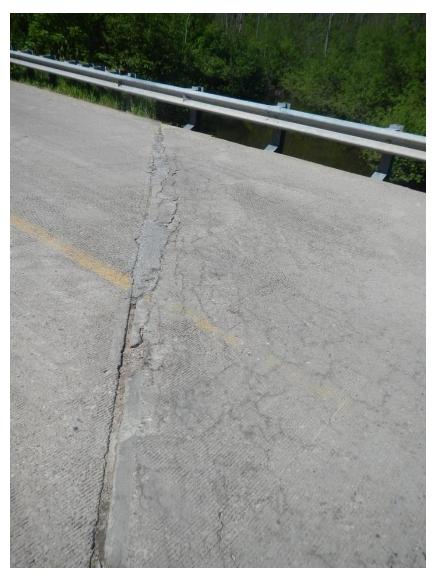
Local Agency – Scoping

- Inspector Comments
 - Concrete Overlay Severe Map Cracking
 - Heavy Spalls Patched with HMA Cold Patch at Joints

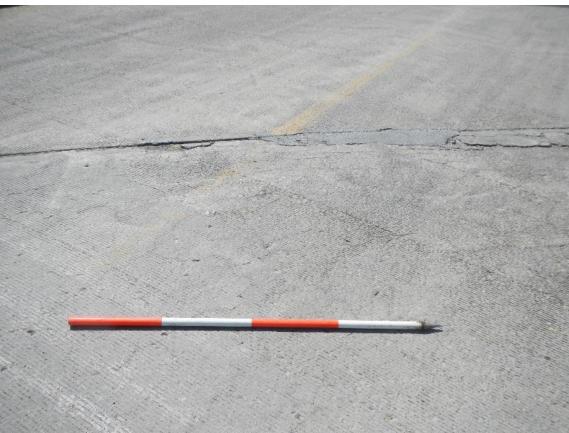
Local Agency – Scoping

- Field Meeting 9/26/2016 Recommendations
 - Sound Bridge Deck
 - Replace Delaminations
 - Replace End Joints
 - Apply Thin Epoxy Overlay

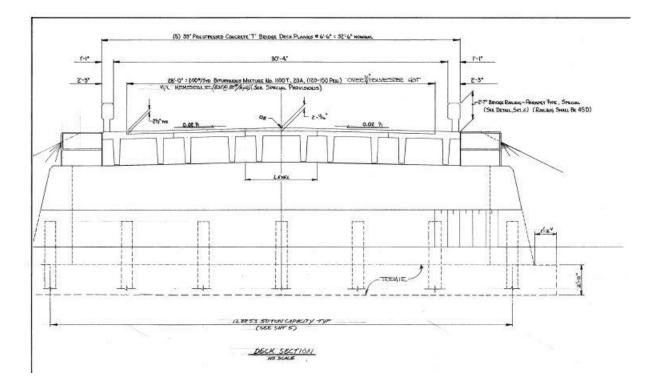
- St Clair County Road Commission
- Kilgore Rd over the Pine River
- Adjacent Double T Superstructure – Deteriorated and Leaking Joints
- Built in 1989 Comprised of 5 Double T's
- HMA Overlay

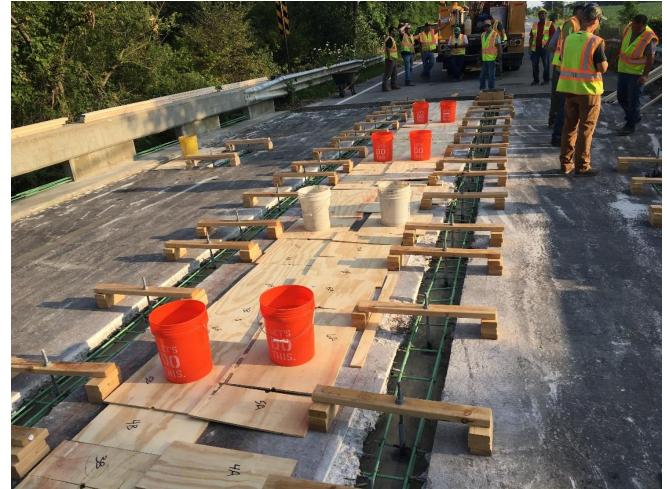
- St Clair County Road
 Commission
- Traditional Repair Latex Modified Concrete
- Experimental Repair Ultra High Performance Concrete (UHPC)

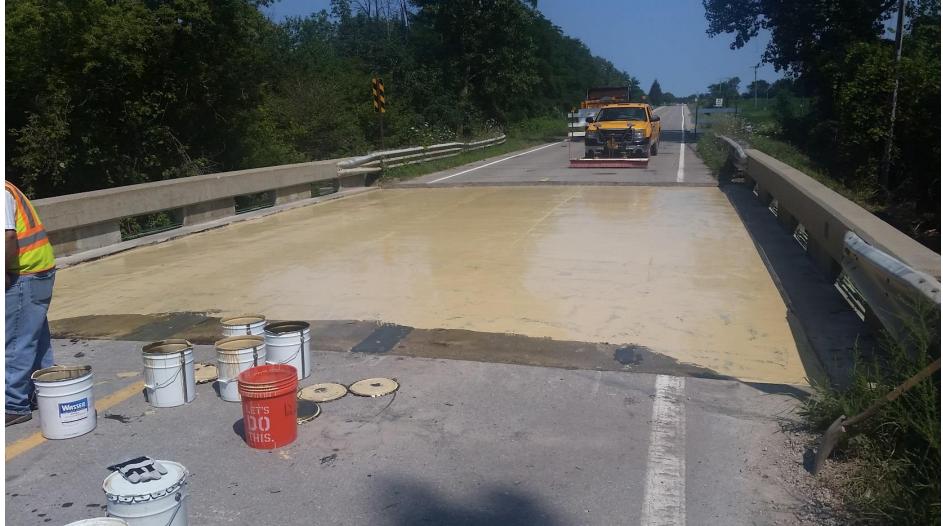
Field Application of Non-Proprietary Ultra High Performance Concrete

- MDOT Experience with UHPC
- SPR-1637 Development, Characterization and Applications of a Non-Proprietary Ultra High Performance Concrete for Highway Bridges
- January 2018 Concrete International Article

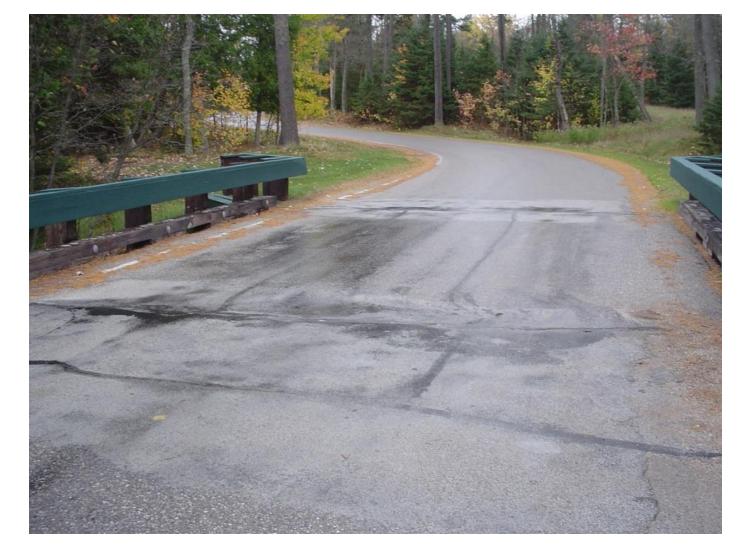
US-2 Roadside Park in Naubinway

B05 of 49022

- Constructed in 1990
- Timber Superstructure comprised of 2 x 12 timbers spanning 24 feet nailed together.
