# Nondestructive Testing to Better Define Repair Quantities

Brian Pailes, PhD, PE, NACE CP-4

Vector Corrosion Services

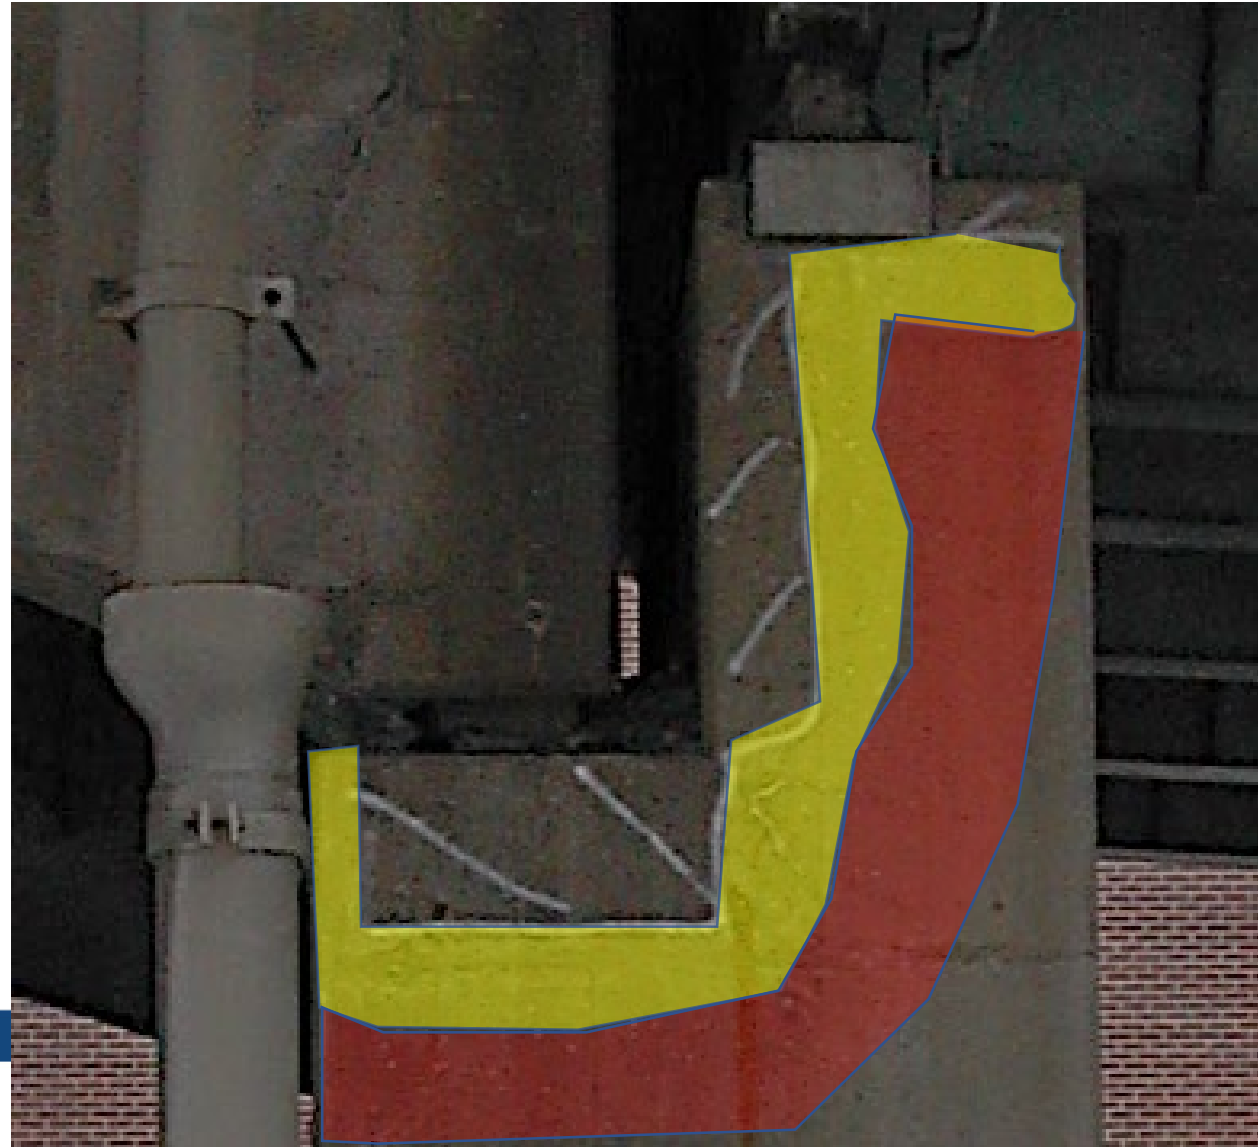
**Large Near surface  
Delamination**

**Extent of delamination  
beyond what sounding  
can pick up**

**Corrosion is active but  
has not formed  
enough iron oxide to  
create significant  
cracking**

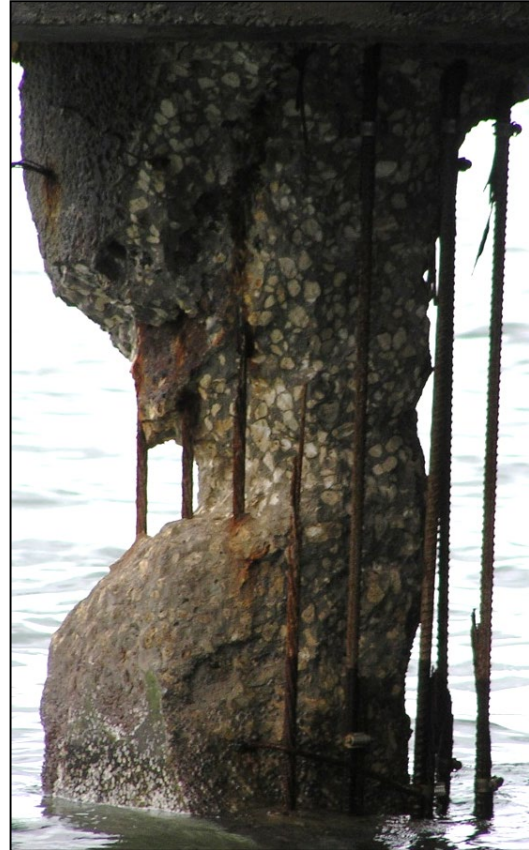
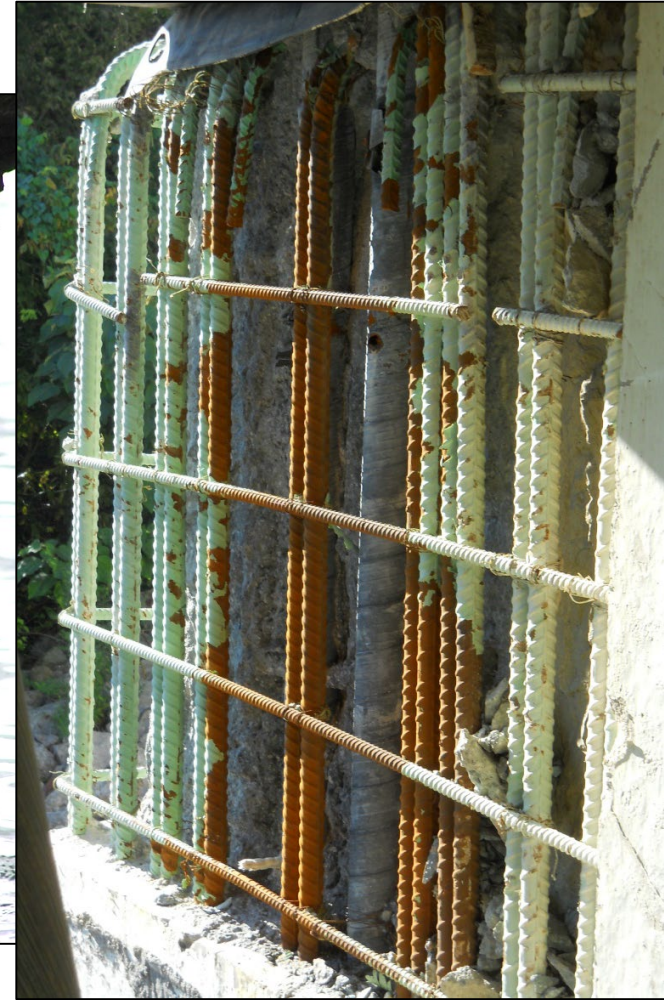
# Visual Inspection

- Rust staining
- Cracking
- Spalls
- Exposed steel
- Water infiltration
- Efflorescence

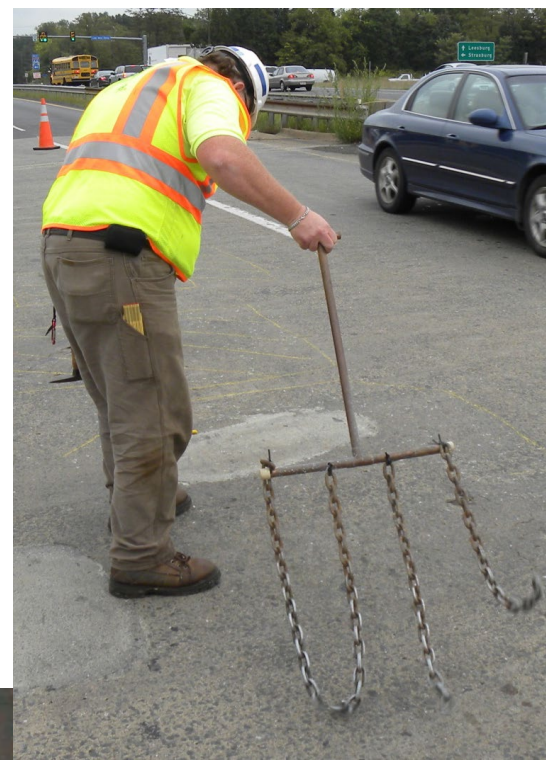
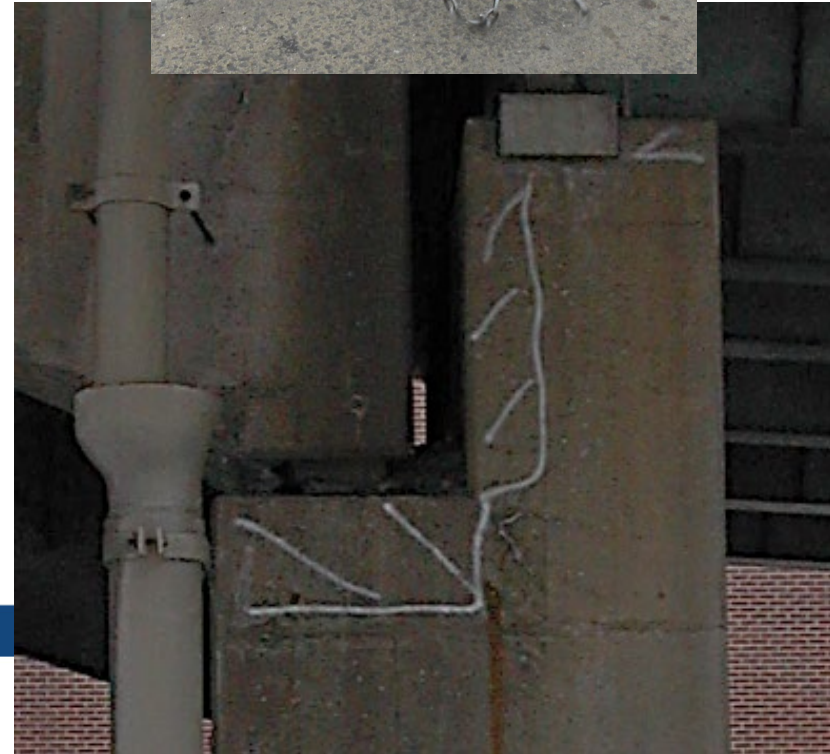
# Sounding Survey

- Hammer sounding or chain drag
- Locates areas of large near surface delaminations
- Incipient delaminations cannot be identified
- **False positives are rare**
- False negatives are common

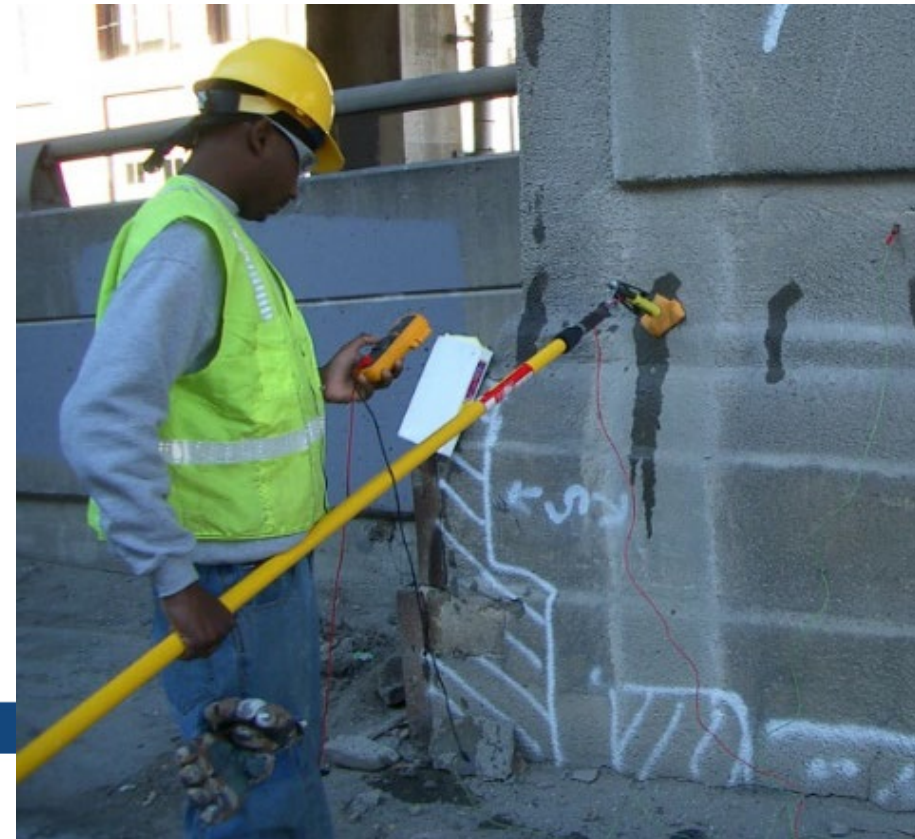
# Corrosion Potential Measurements

- ASTM C876 - also known as half-cell potential
- Determines probability of active corrosion

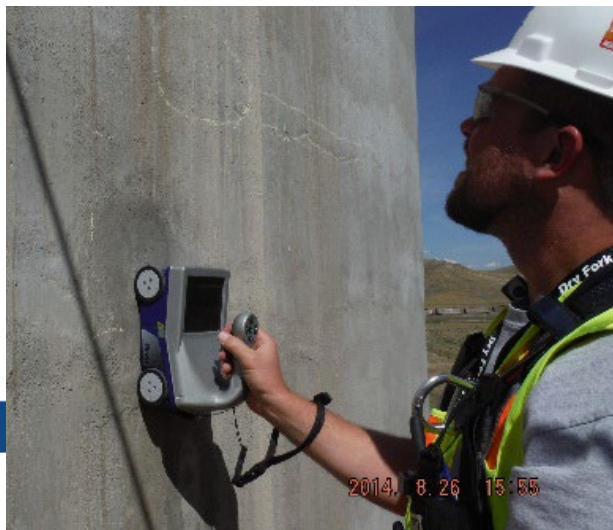
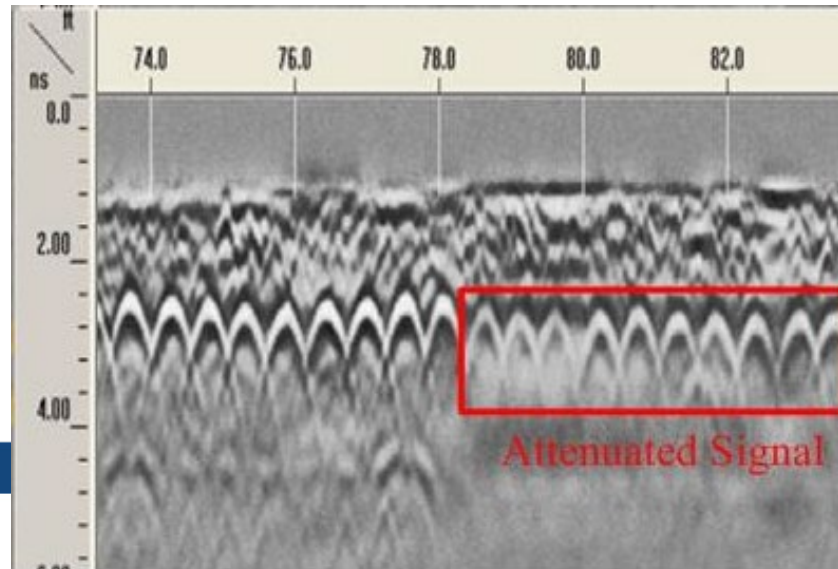
# Ground Penetrating Radar

- Electromagnetic evaluation of concrete
  - Reinforcement layout
    - Location of embedded metals
  - Cover Depth
  - Qualitative condition of reinforced concrete
    - Chlorides, moisture, and concrete deterioration attenuate GPR signal

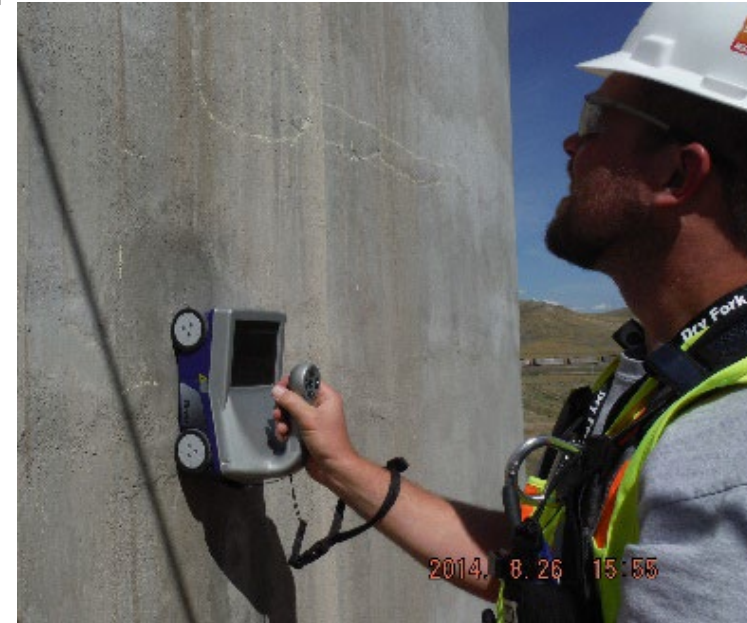
# Cover Depth Survey

- Cover depth is an important factor in the service life of a structure
  - Reduced cover depths allow for chlorides and carbonation to reach steel faster

$$C_{(x,t)} = C_o \left( 1 - \operatorname{erf} \frac{x}{2\sqrt{D_c t}} \right)$$

$$t = \frac{1}{D_c} \left[ \frac{x}{2 \times \operatorname{inverf} \left( 1 - \frac{C_{x,t}}{C_o} \right)} \right]^2$$

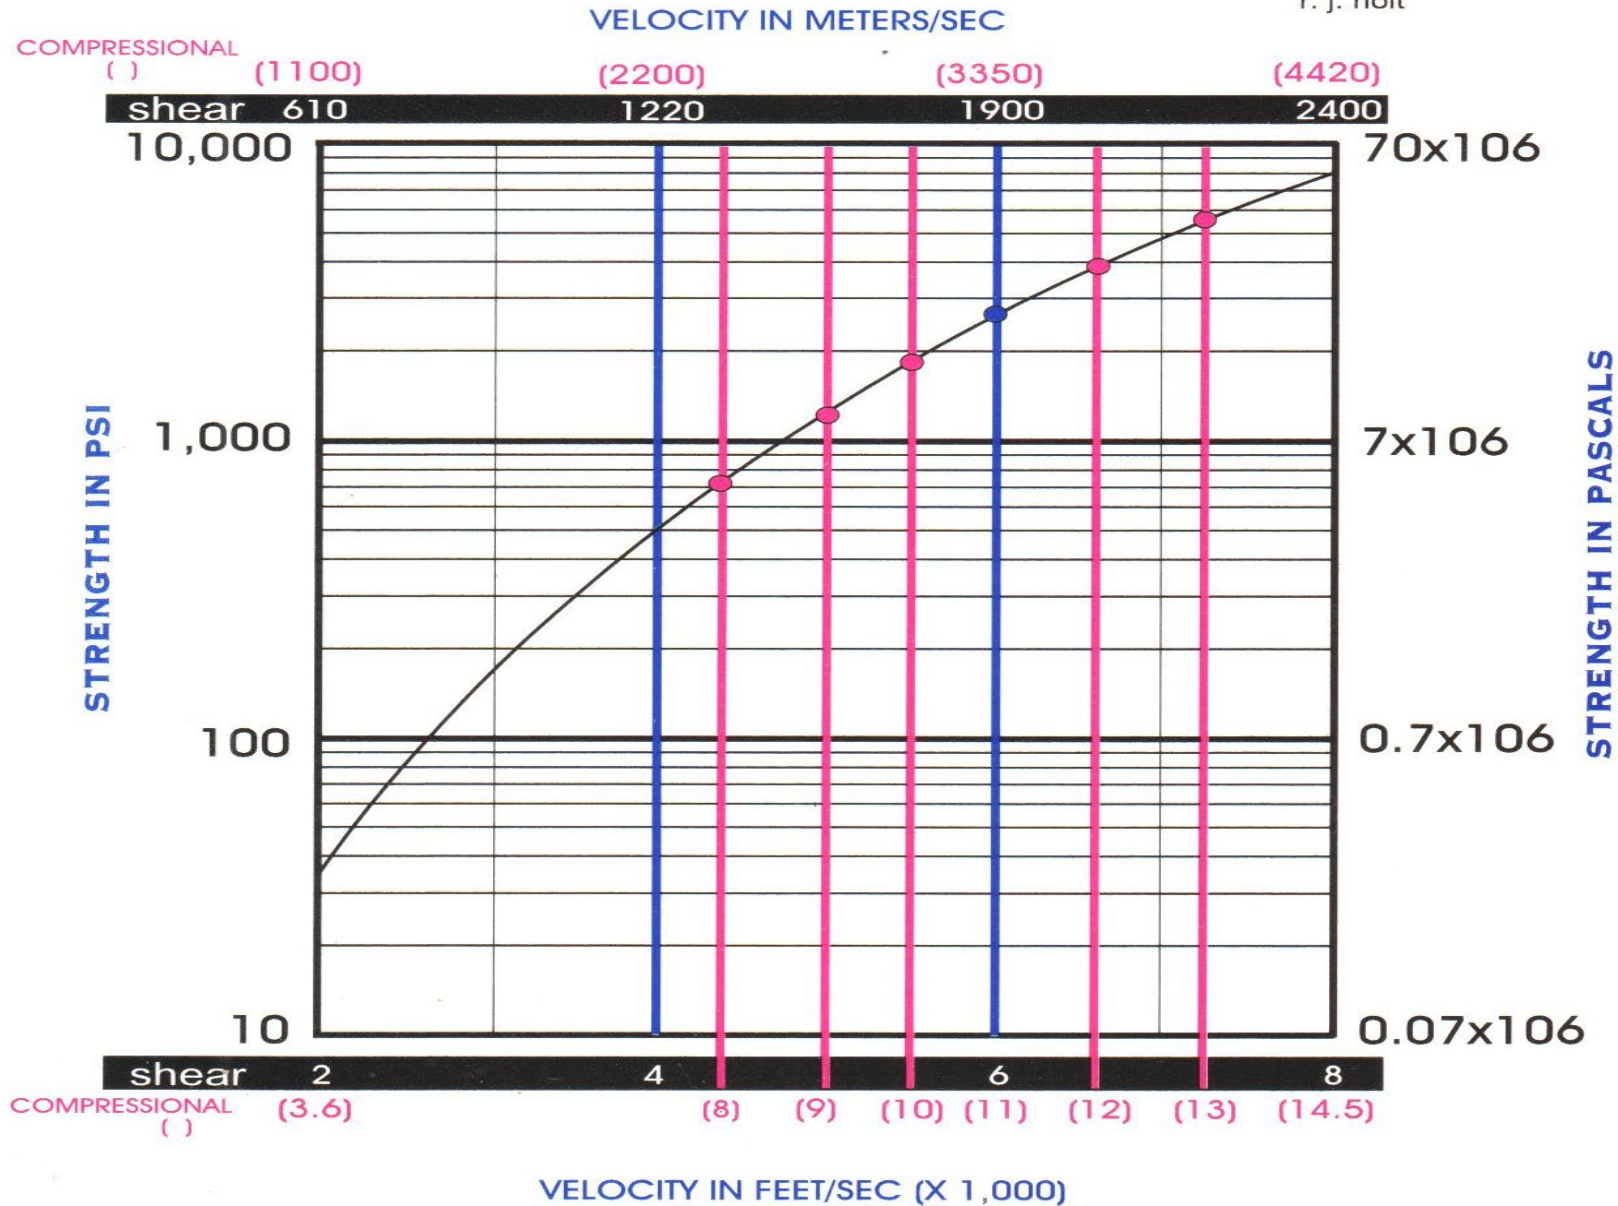
# STRENGTH OF CONCRETE VERSUS VELOCITY

CURVE IS FOR THE RATIO:  $V_{\text{SHEAR}} / V_{\text{COMPRESSIONAL}} = 0.55$   
WHICH IS EQUAL TO A POISSON'S RATIO OF 0.28

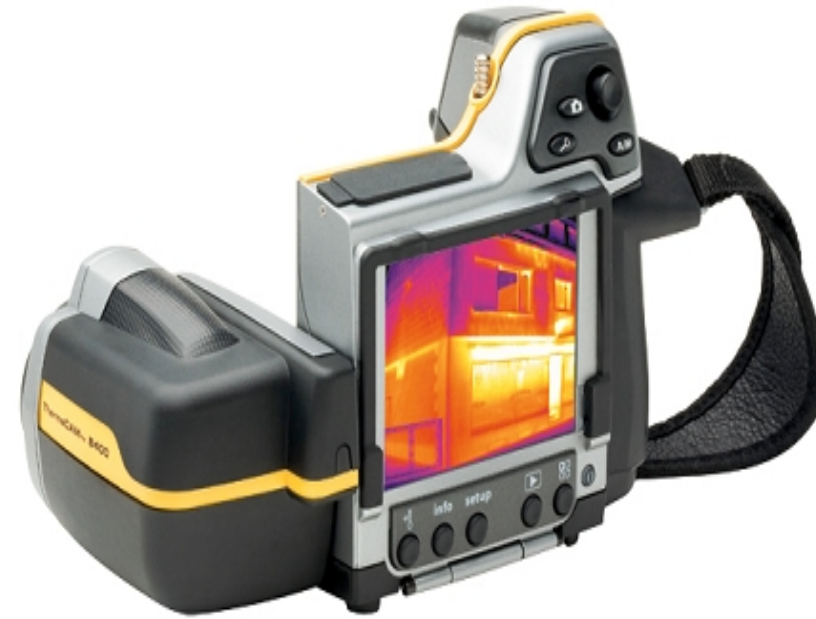
# IR – Equipment

- Delaminations have different thermal properties than sound concrete
  - Result of air-gap caused from the separation of the concrete
  - In the morning sun, delaminations heat up faster than sound concrete section
  - During evening cooling, delaminations cool down faster than sound concrete section
  - Allows for very quick assessment of large areas
  - Results are similar to chain drag and hammer sounding

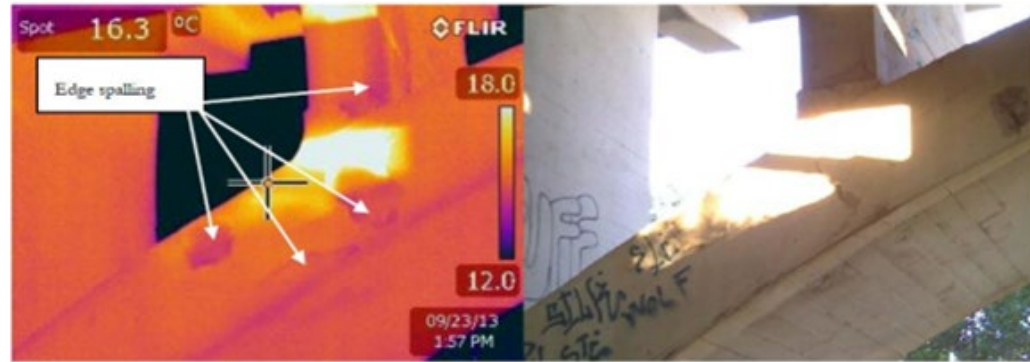
Figure 2: Upstream: Arch Spalling under Spandrel Columns A (left) and B (right)

- Hammer sounding survey done several years prior
- Wanted to know growth of deterioration from last survey
- IR provided a quick method to resurvey the concrete

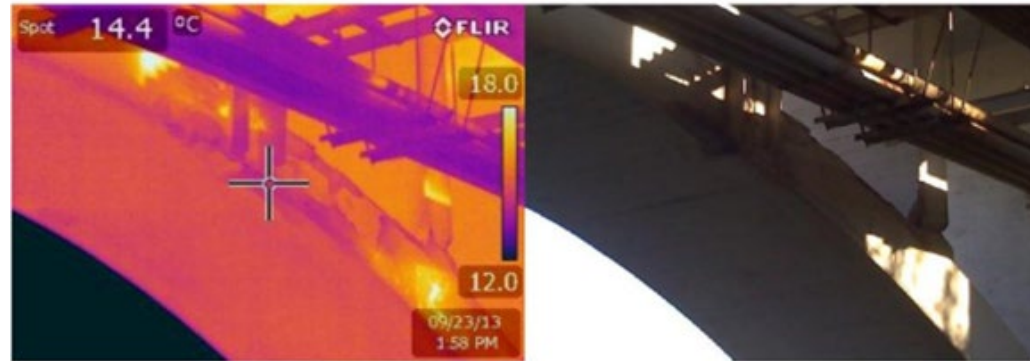
Figure 3: Upstream: Arch delaminations around pipe bracket and corners
