Nondestructive Testing to Better Define Repair Quantities

Brian Pailes, PhD, PE, NACE CP-4

Vector Corrosion Services

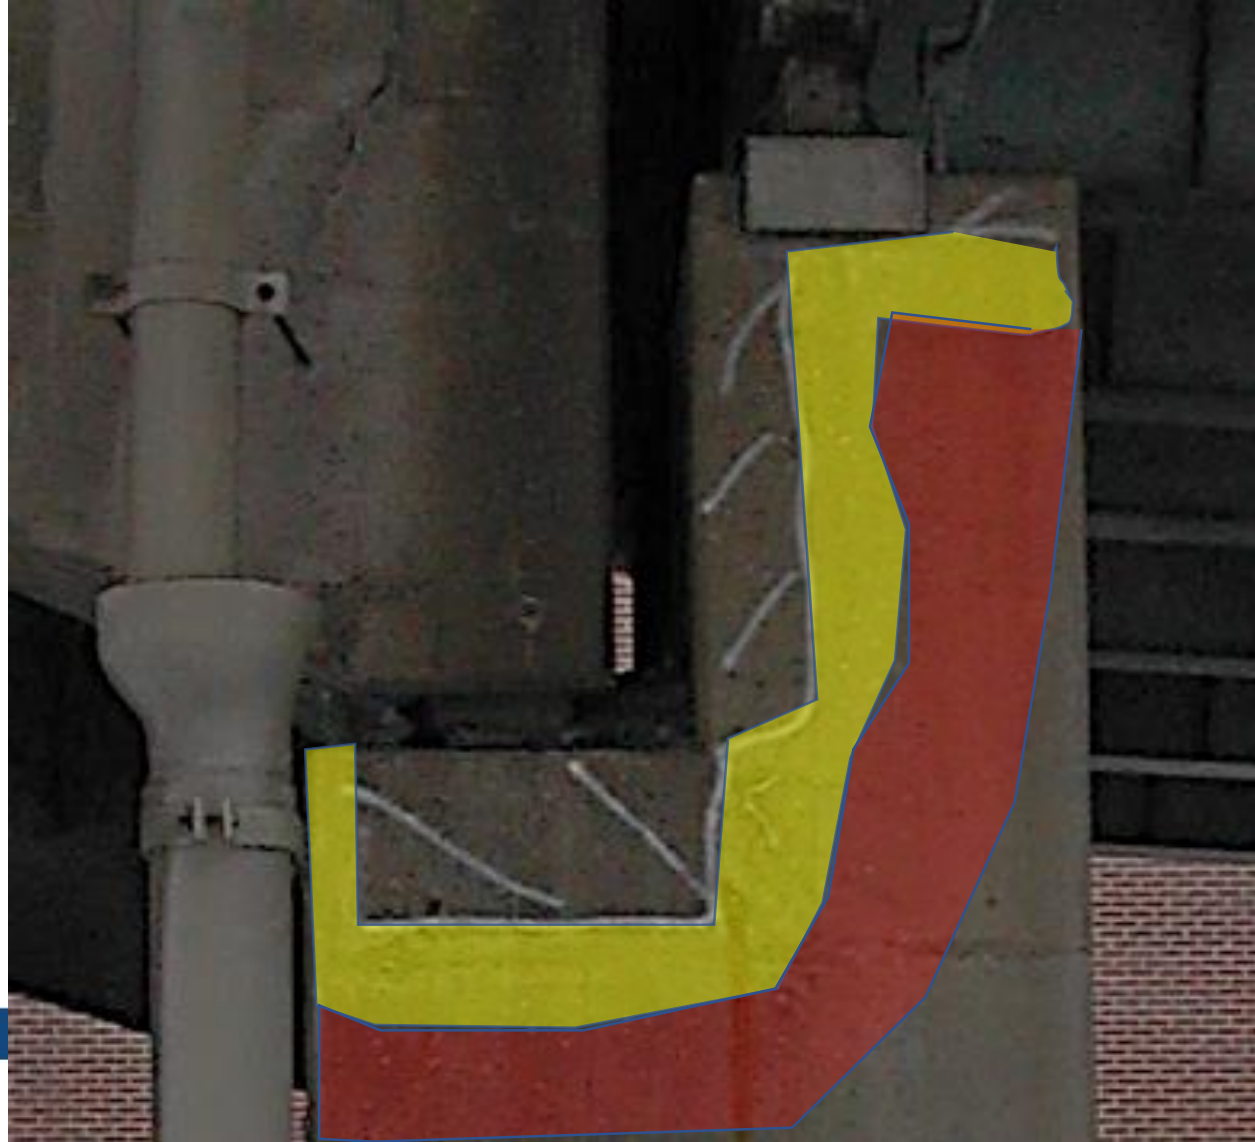
What is really happening in the concrete?

**Large Near surface
Delamination**

**Extent of delamination
beyond what sounding
can pick up**

**Corrosion is active but
has not formed
enough iron oxide to
create significant
cracking**

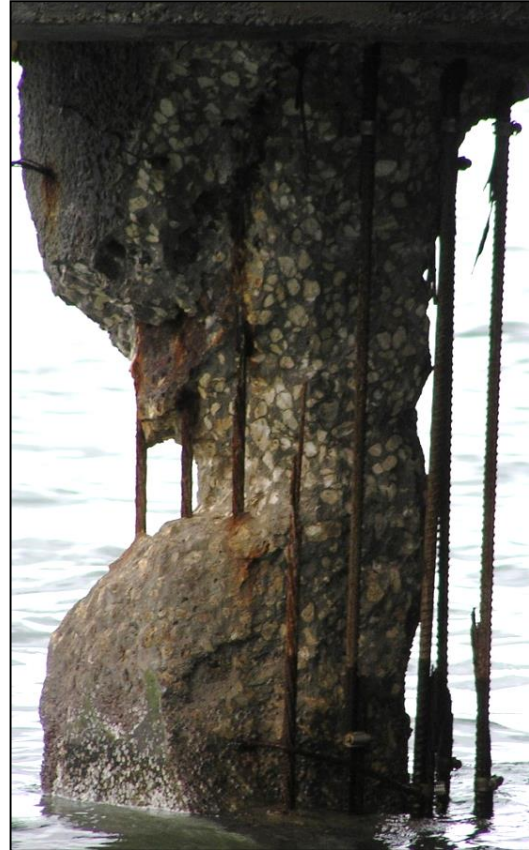
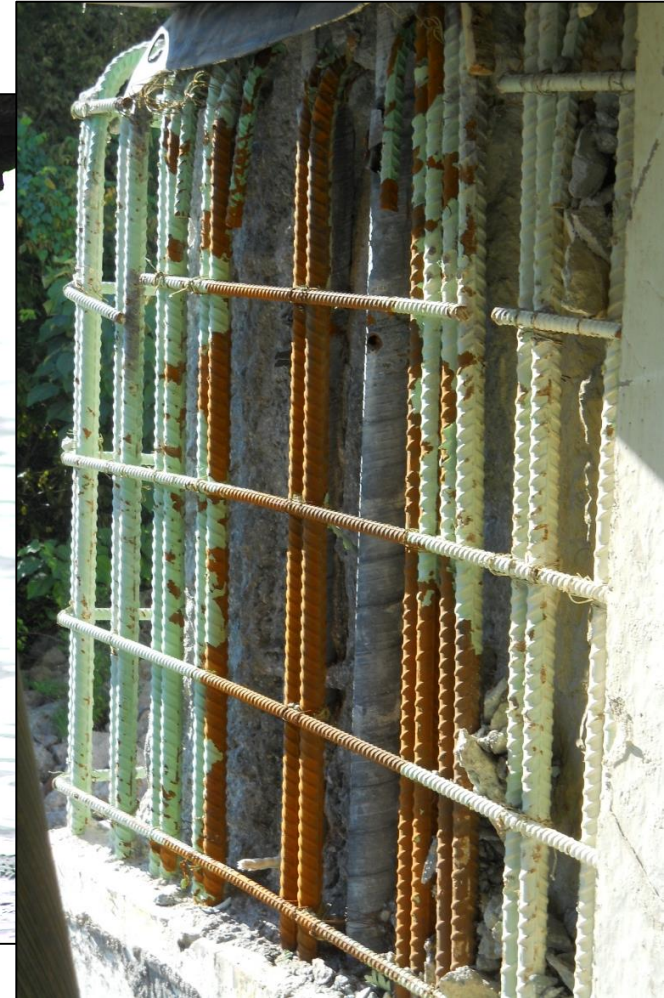
Visual Inspection

- Rust staining
- Cracking
- Spalls
- Exposed steel
- Water infiltration
- Efflorescence

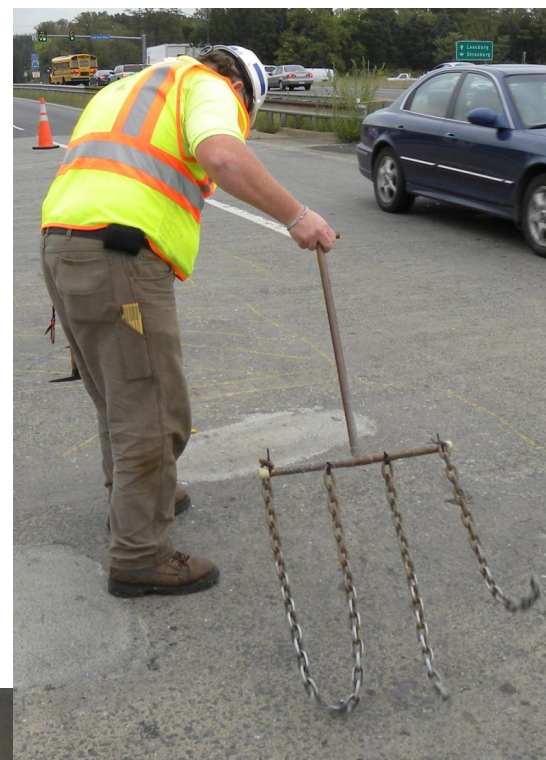
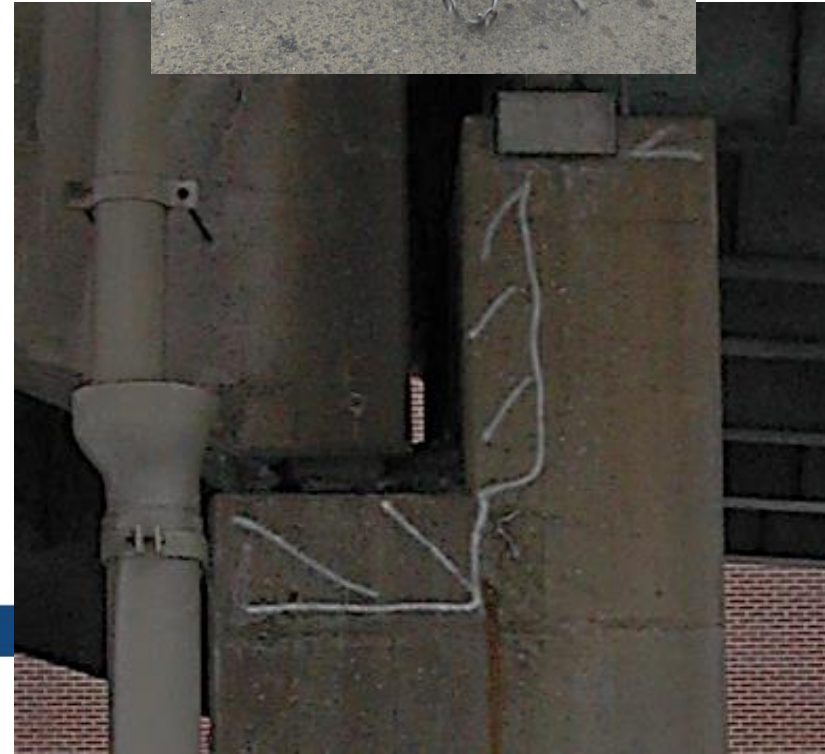
Sounding Survey

- Hammer sounding or chain drag
- Locates areas of large near surface delaminations
- Incipient delaminations cannot be identified
- **False positives are rare**
- False negatives are common

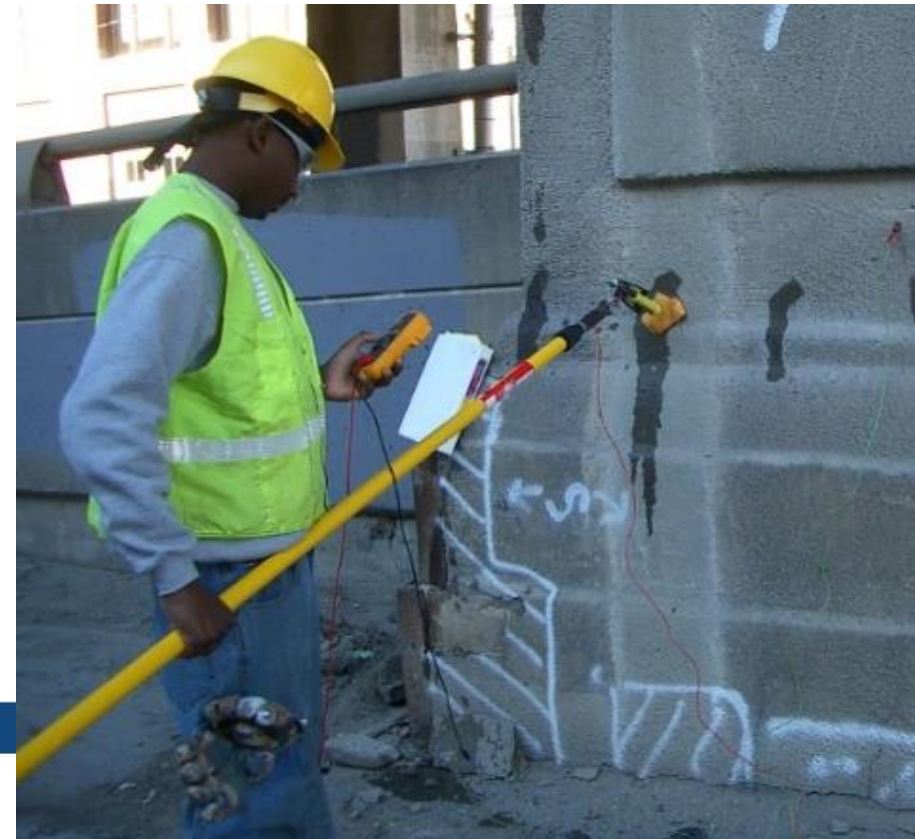
Corrosion Potential Measurements

- ASTM C876 - also known as half-cell potential
- Determines probability of active corrosion

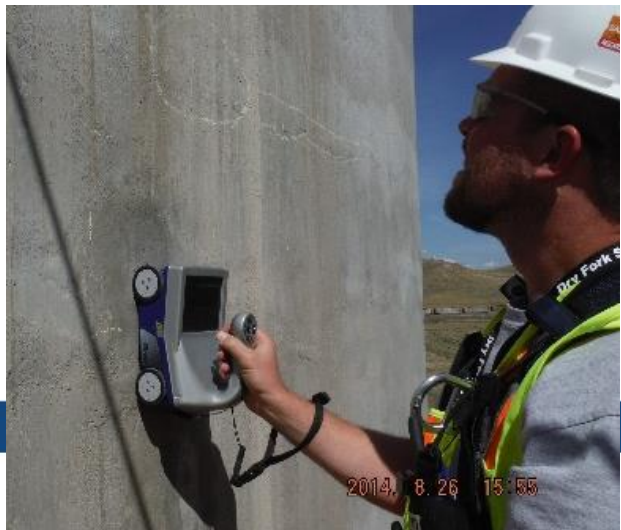
Ground Penetrating Radar

- Electromagnetic evaluation of concrete
 - Reinforcement layout
 - Location of embedded metals
 - Cover Depth
 - Qualitative condition of reinforced concrete
 - Chlorides, moisture, and concrete deterioration attenuate GPR signal

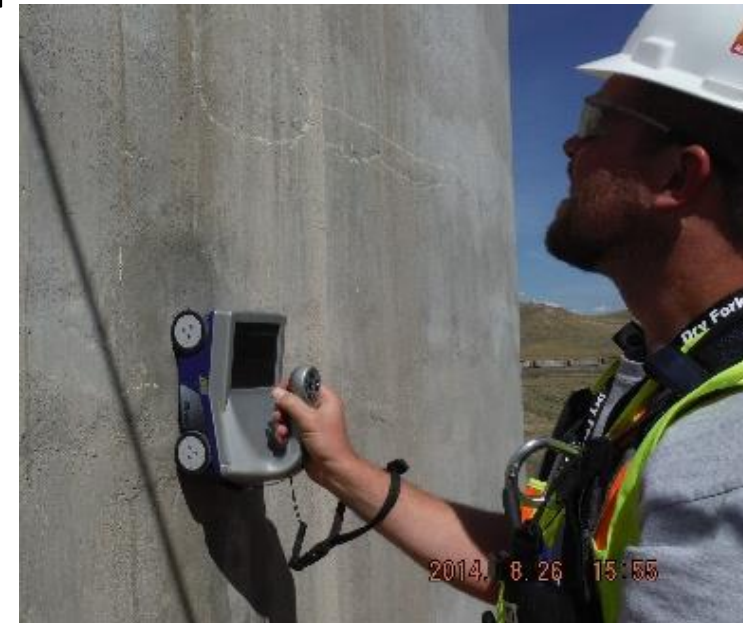
Cover Depth Survey

- Cover depth is an important factor in the service life of a structure
 - Reduced cover depths allow for chlorides and carbonation to reach steel faster

$$C_{(x,t)} = C_o \left(1 - \operatorname{erf} \frac{x}{2\sqrt{D_c t}} \right)$$

$$t = \frac{1}{D_c} \left[\frac{x}{2 \times \operatorname{inverf} \left(1 - \frac{C_{x,t}}{C_o} \right)} \right]^2$$

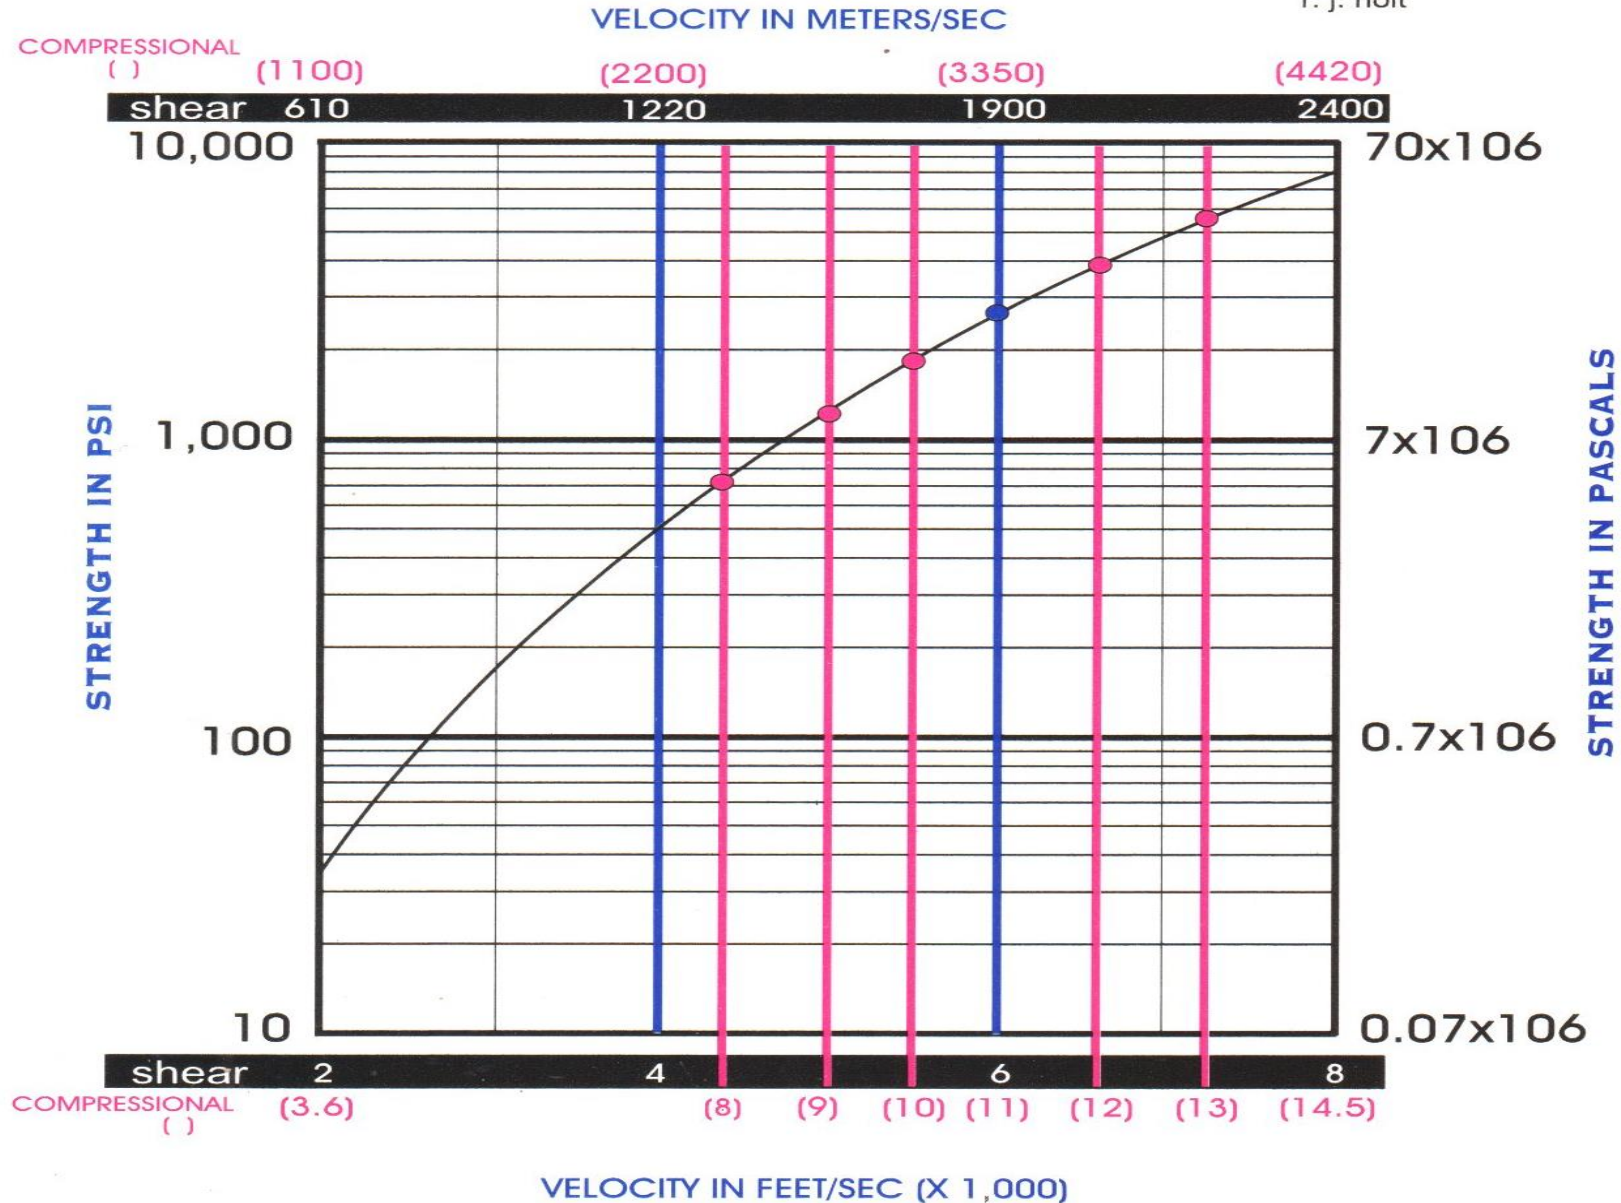
STRENGTH OF CONCRETE VERSUS VELOCITY

CURVE IS FOR THE RATIO: $V_{\text{SHEAR}} / V_{\text{COMPRESSIONAL}} = 0.55$
WHICH IS EQUAL TO A POISSON'S RATIO OF 0.28

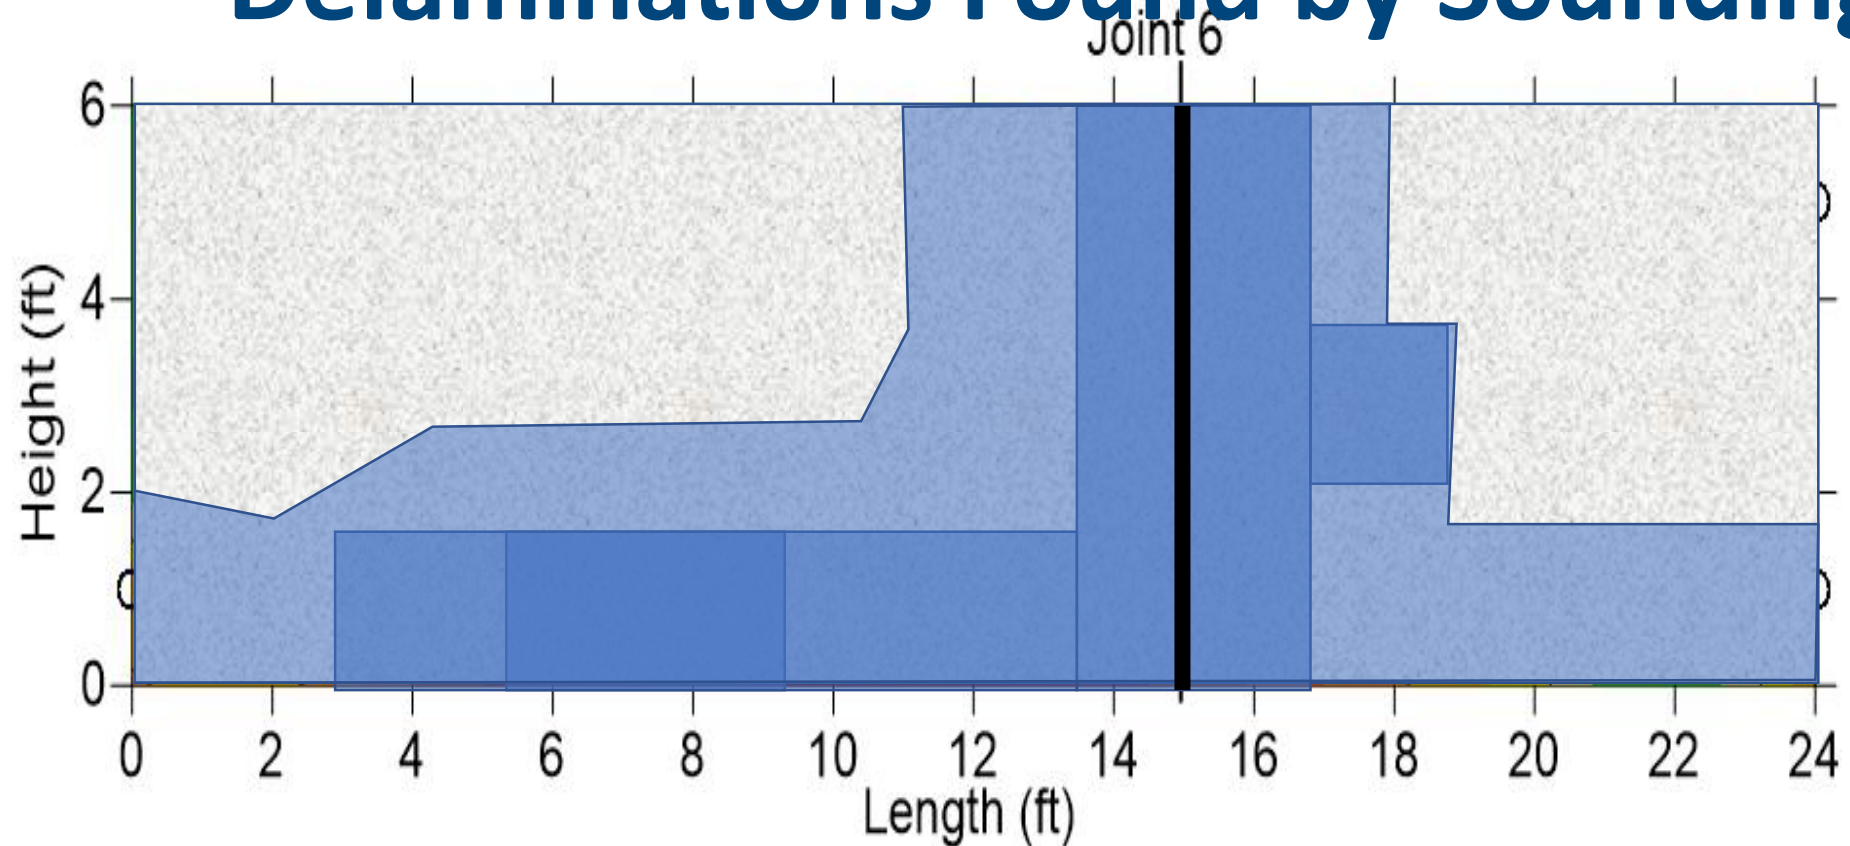
Acoustic In-Situ Compressive Strength Delaminations Found by Impact Echo

Repair Area Delaminations Found by Sounding

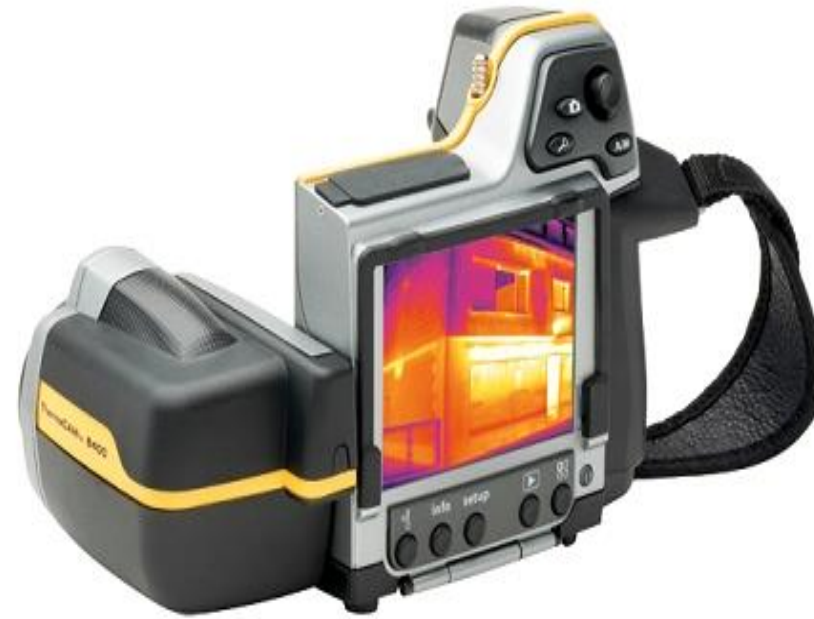
IR – Equipment

- Delaminations have different thermal properties than sound concrete
 - Result of air-gap caused from the separation of the concrete
 - In the morning sun, delaminations heat up faster than sound concrete section
 - During evening cooling, delaminations cool down faster than sound concrete section
 - Allows for very quick assessment of large areas
 - Results are similar to chain drag and hammer sounding

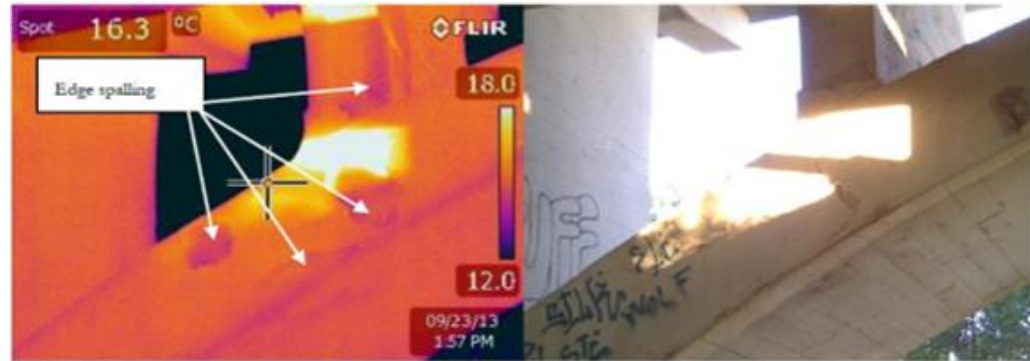
- Hammer sounding survey done several years prior
- Wanted to know growth of deterioration from last survey
- IR provided a quick method to resurvey the concrete

Figure 2: Upstream: Arch Spalling under Spandrel Columns A (left) and B (right)

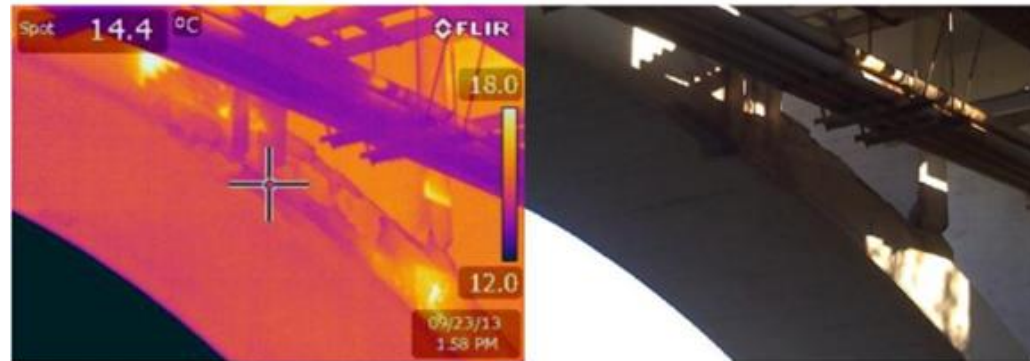
Figure 3: Upstream: Arch delaminations around pipe bracket and corners
