BRIDGE PRESERVATION

**Silane Penetrating Sealers the first
Defense in Bridge Protection**

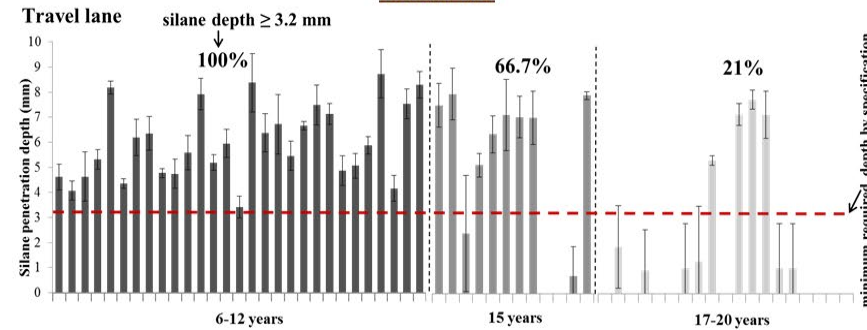
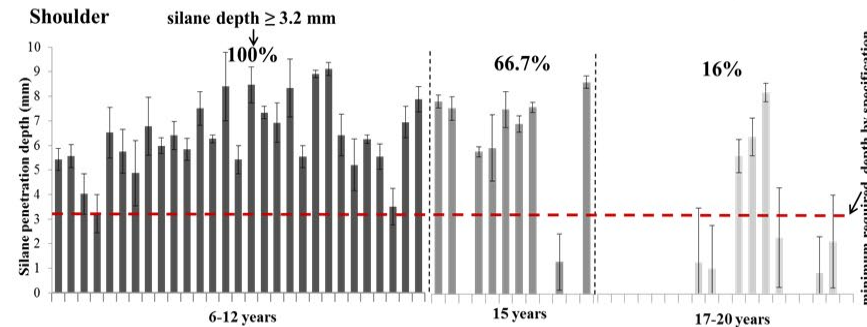
RESULTS

Average silane visual detection depth of samples from bridge decks in travel lane and shoulder

- > After 12 years of service, 100% of the bridge decks were found to have a silane layer greater than the minimum specified value of 3.2 mm
- > After 15 years of service, only 68% and after 17 to 20 years only 16% of the bridges showed evidence of a silane layer greater than 3.2 mm in thickness
- > The average depth of silane is decreasing with time.
- > For bridges with 17 to 20 years of service, the average layer thickness reduced by 75%.
- > Removal of the silane by abrasion was minimal over the first 20 years of service for the investigated bridges
- > The deterioration by the alkaline pore solution appears to be a more important silane deterioration mechanism for these materials and exposure level

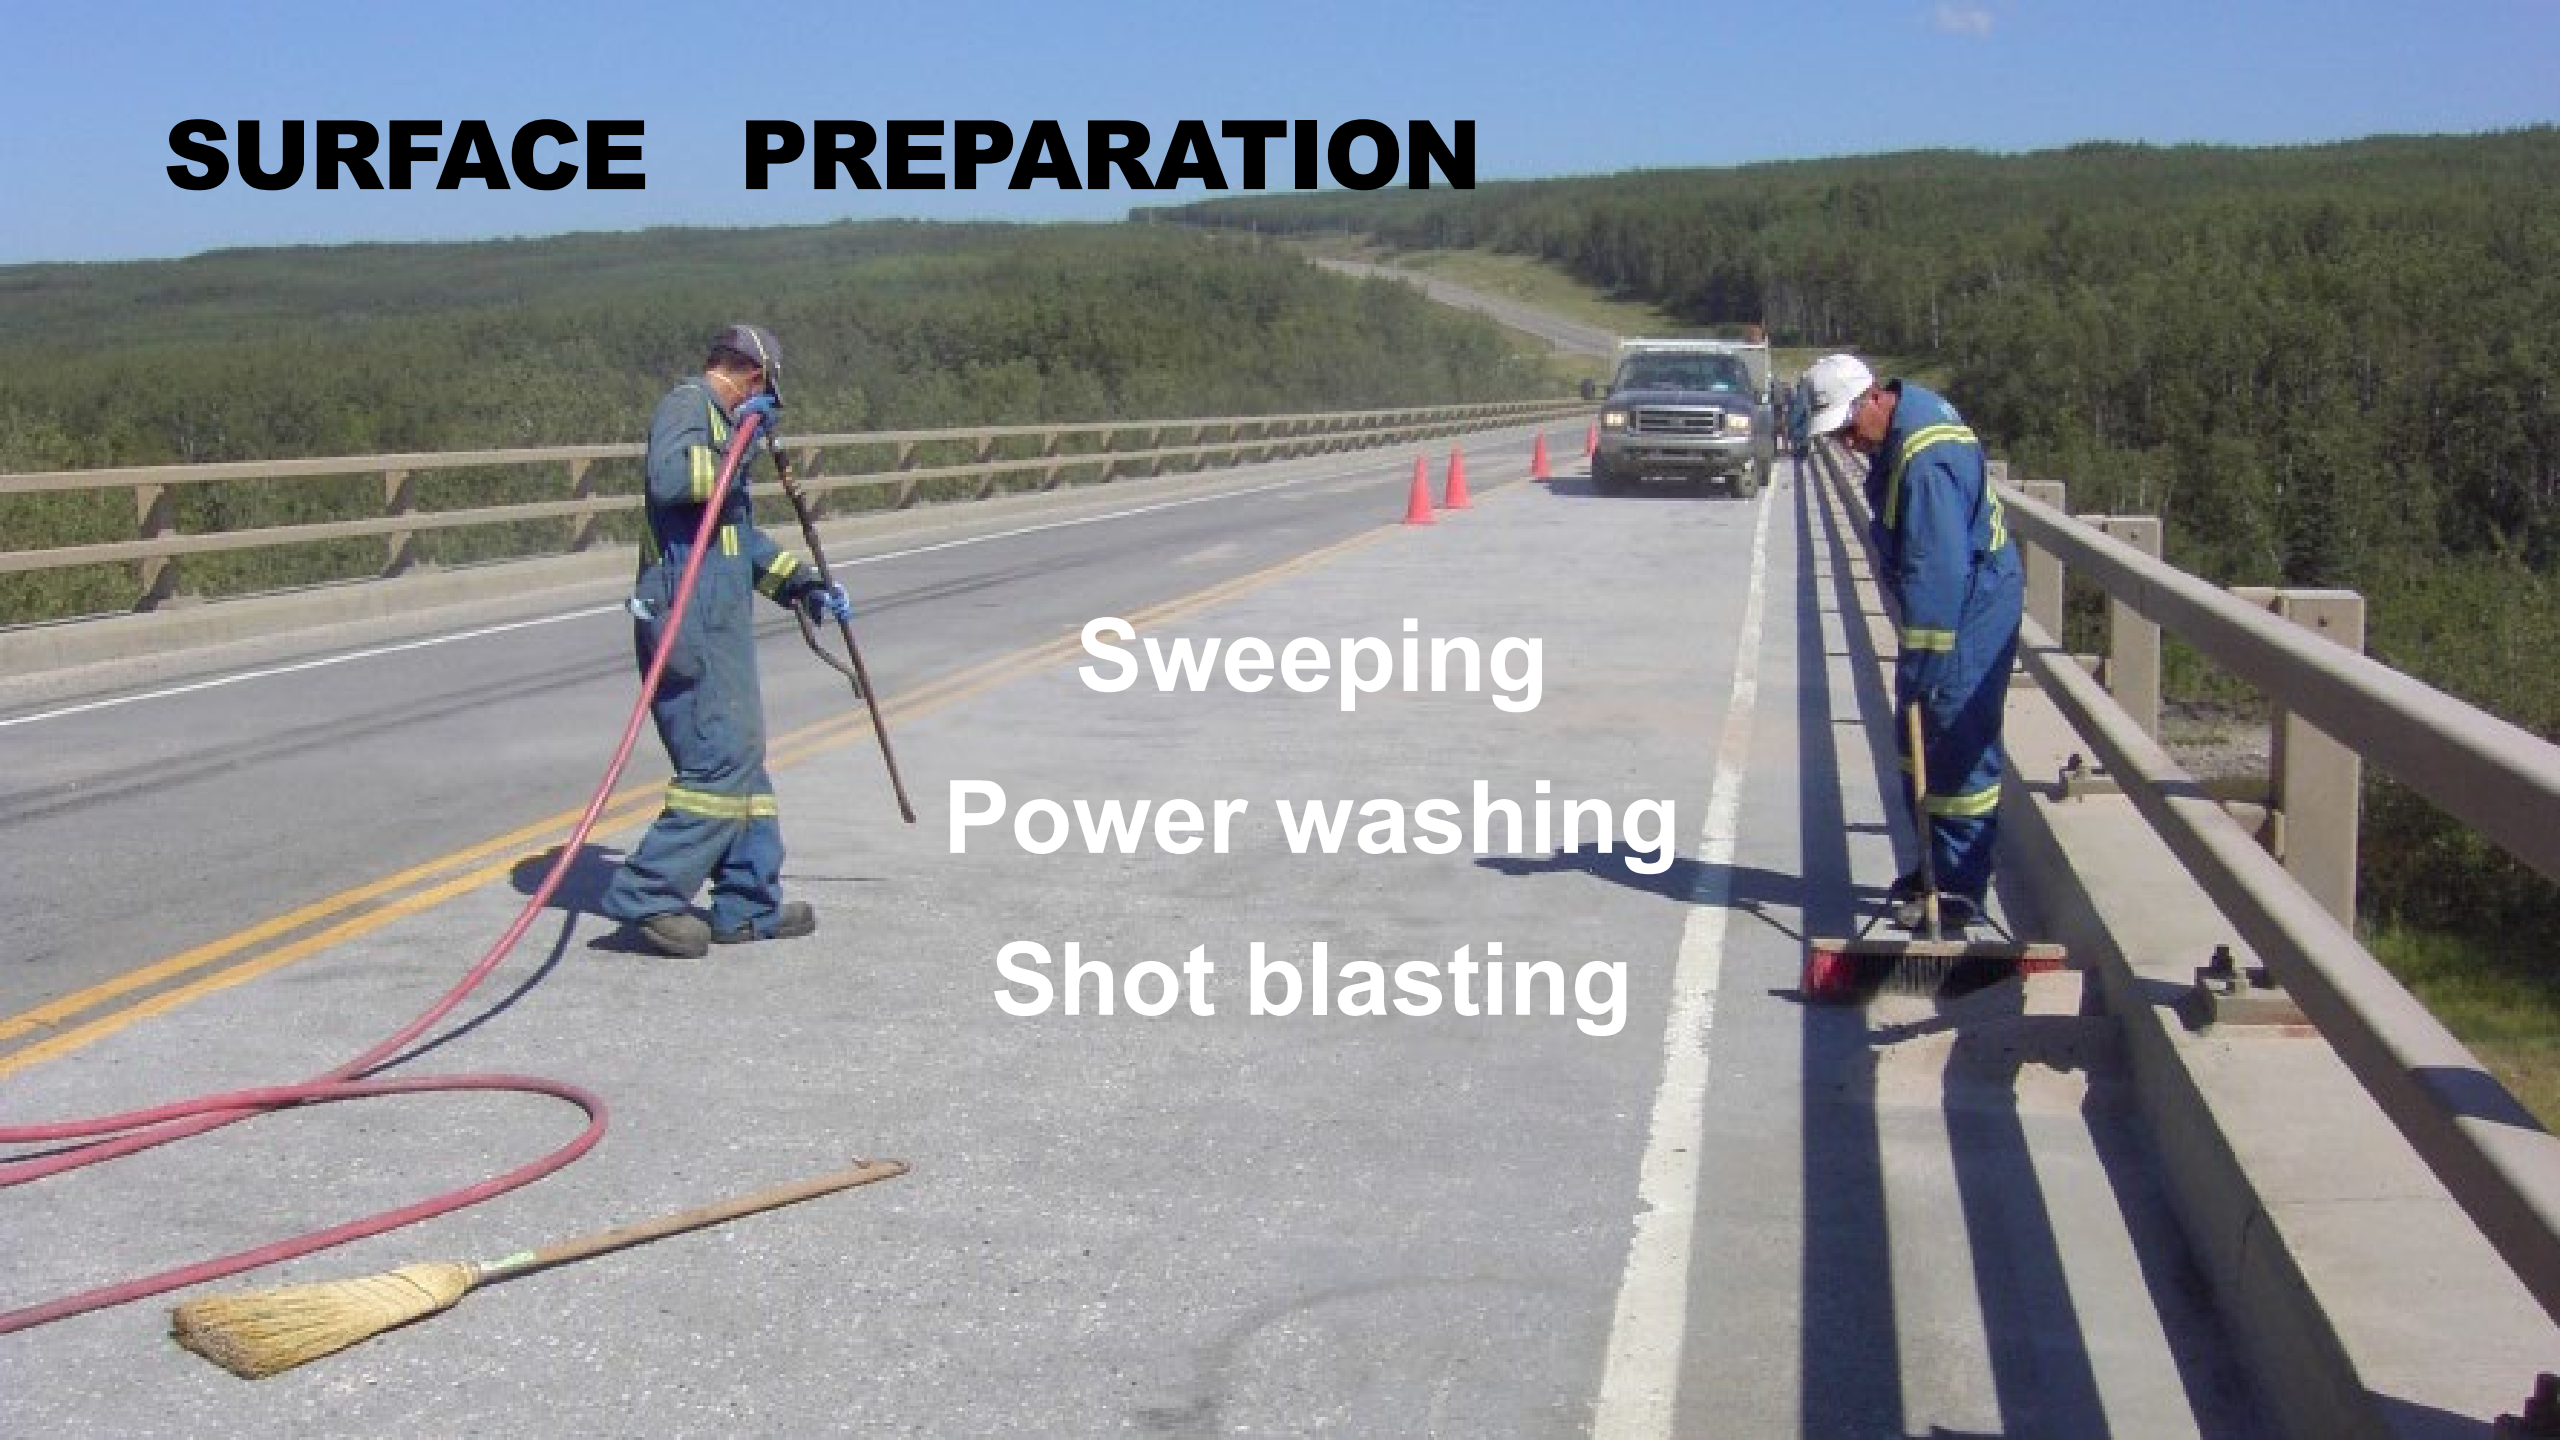
SURFACE PREPARATION

Sweeping

Power washing

Shot blasting

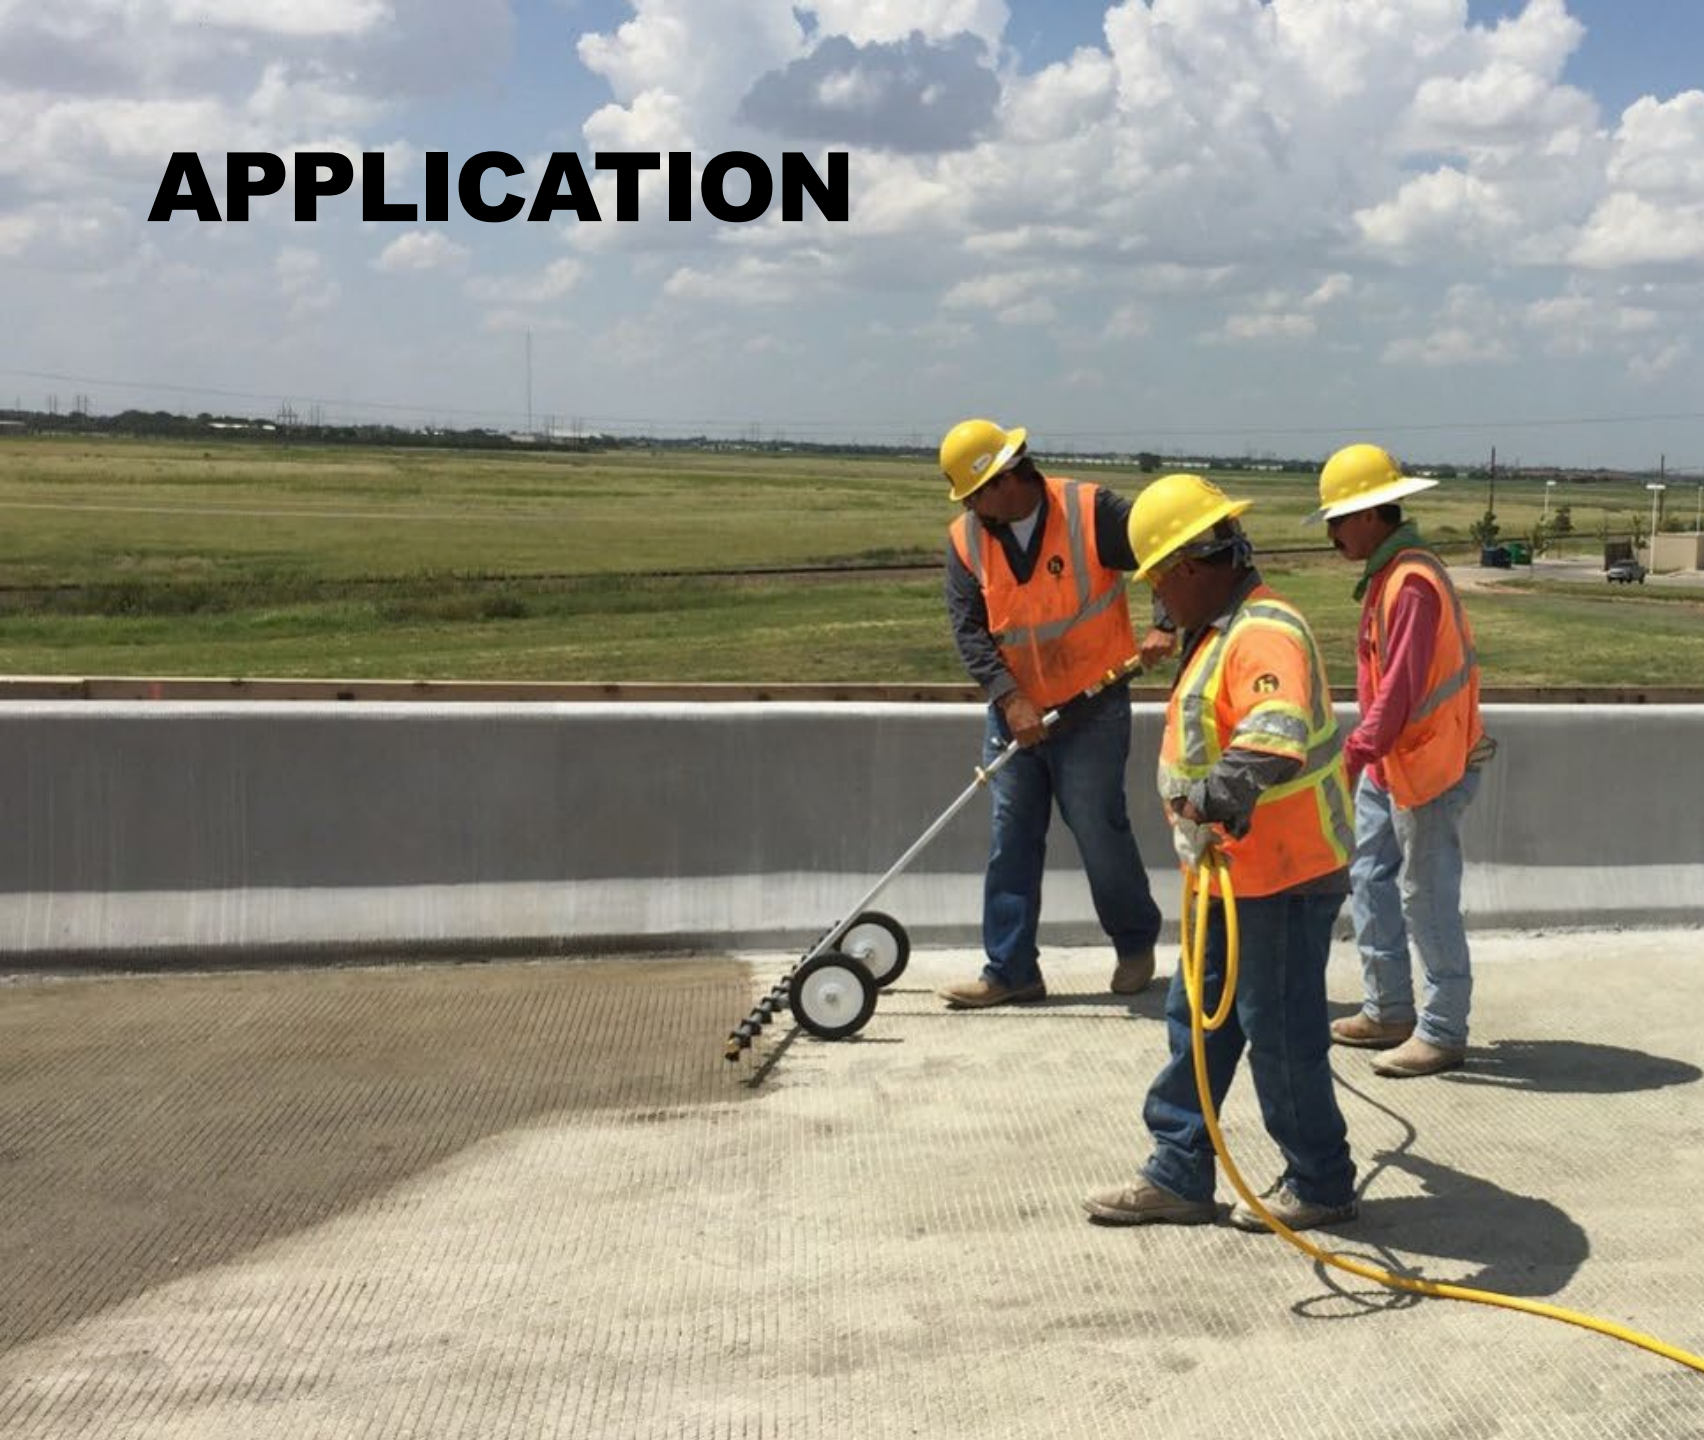
APPLICATION

- Hand Spray
- Walk behind spray bar
- Truck or trailer mounted spray bar

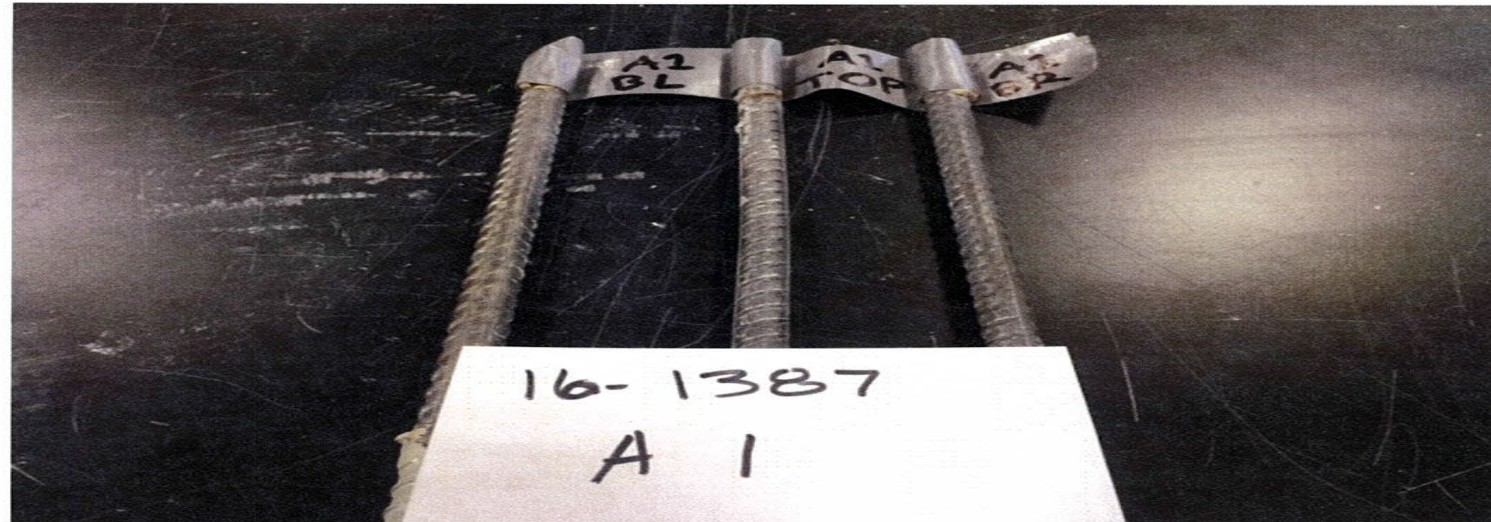
Pictures – FHWA-HRT-07-043 – After Testing – Sil-Act CI (A1)

SIL-ACT SIL-COR (A1)	<1% corrosion visible on top bar after 12 month testing
SIL-ACT SIL-COR (A2)	<1% corrosion visible on top bar after 12 month testing
SIL-ACT SIL-COR (A3)	<1% corrosion visible on top bar after 12 month testing
Uncoated Control (X1)	50% corrosion visible on top bar after 12 month testing
Uncoated Control (X2)	60% corrosion visible on top bar after 12 month testing
Uncoated Control (X3)	90% corrosion visible on top bar after 12 month testing

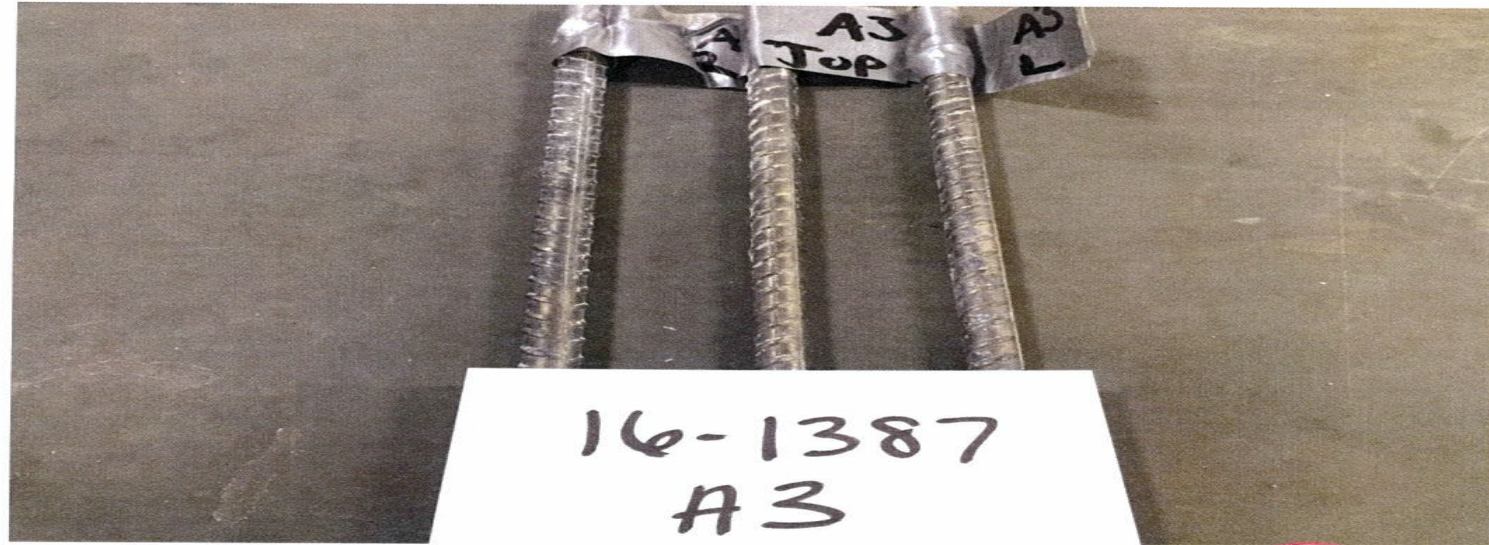
Pictures – FHWA-HRT-07-043 – After Testing – Sil-Act CI (A3)
