Bridge Deck Preservation Program

**Washington State
Department of Transportation**

Washington State's Concrete Bridge Deck Program

**Preserve WSDOT's reinforced concrete bridge decks,
with cost effective repairs and protective overlays.**

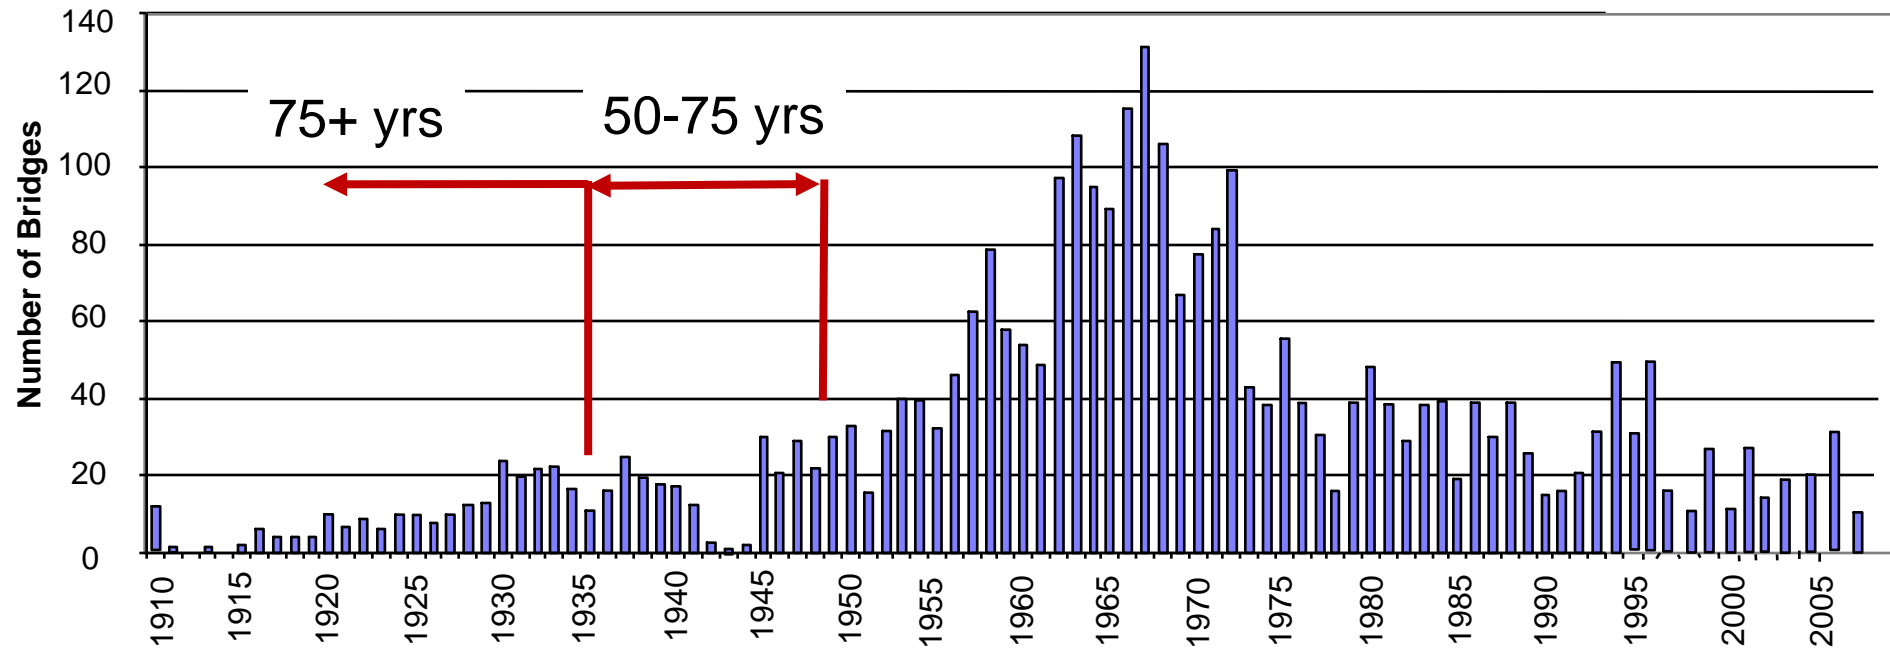
WSDOT Bridges Built-per-Year

3,039 Bridges (45 million sq ft)

Average Age = 43 yrs

1937 or older – 232 bridges (1.6 million sq ft)

1936 to 1951 – 672 bridges (7.7 million sq ft)

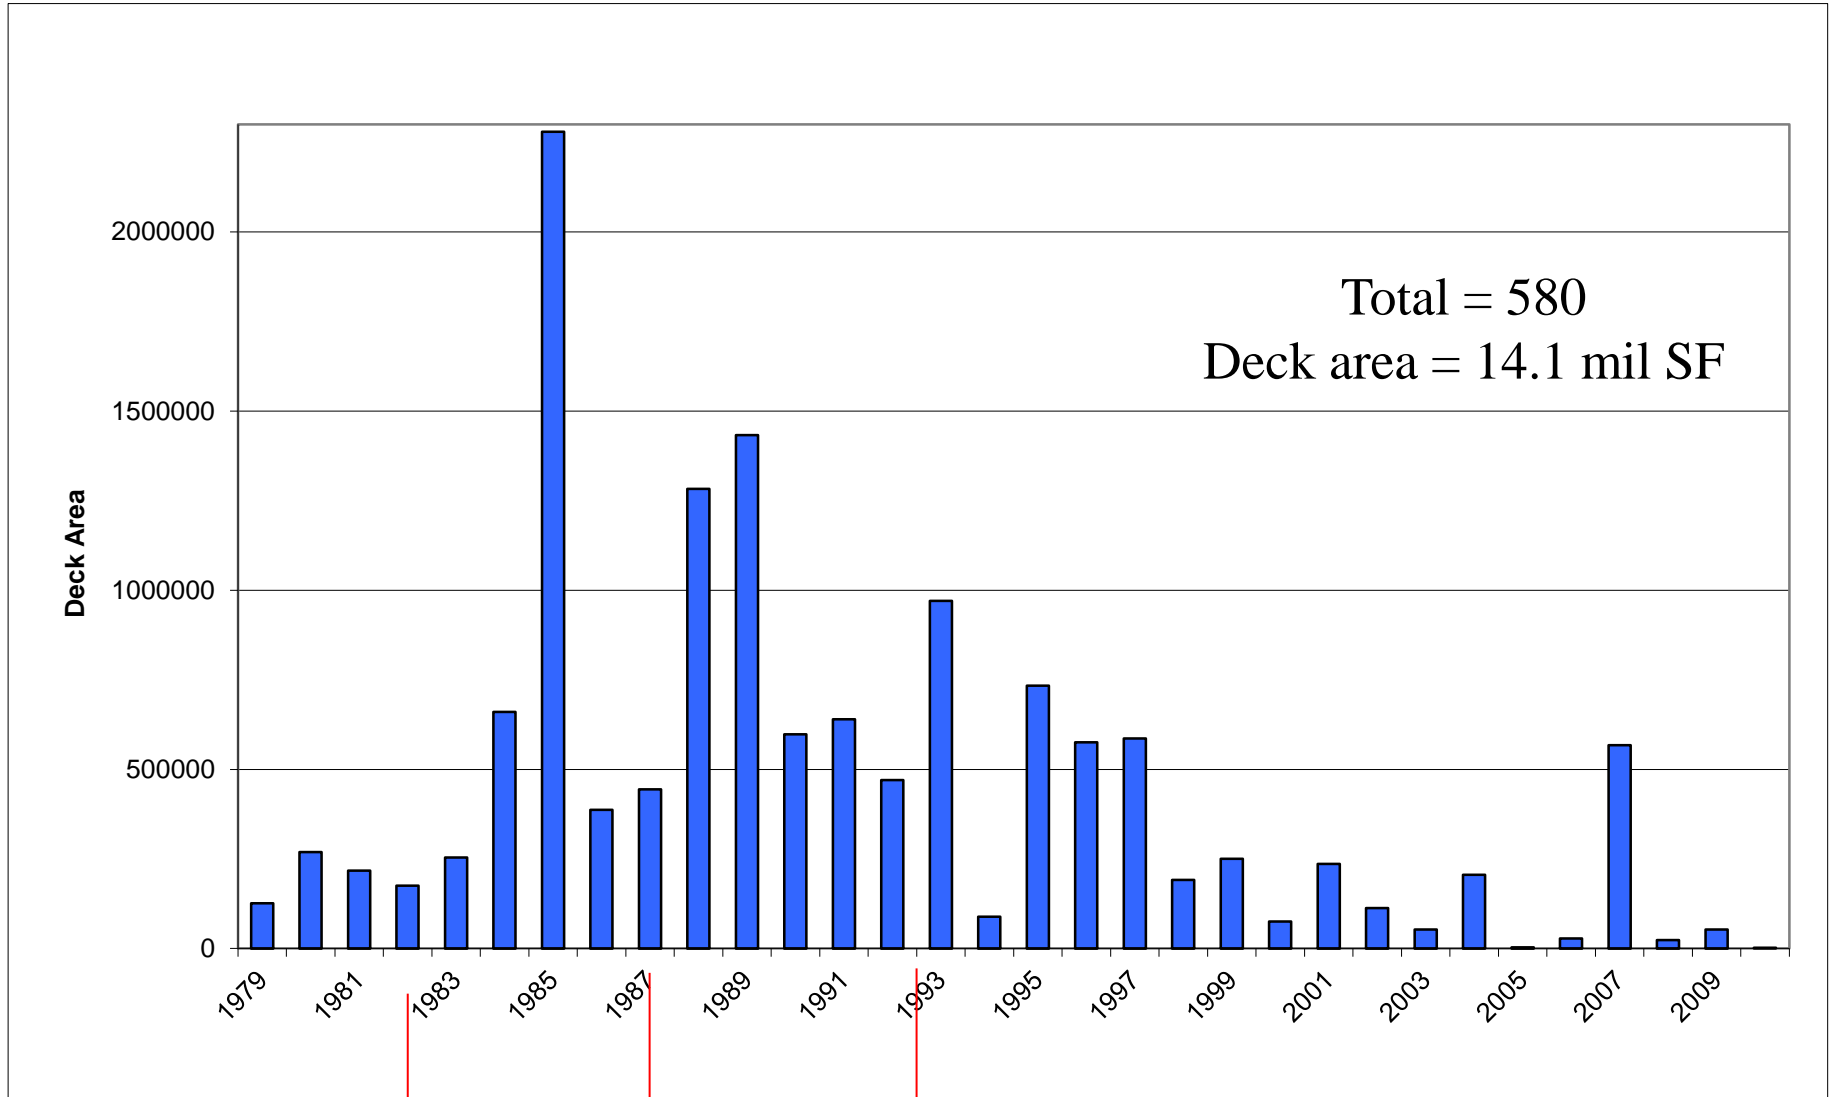
WSDOT Bridges with a Modified Concrete Overlay

30+ yrs

25–30 yrs

20 – 25 yrs

25br - \$0.6M

140br - \$375M

189br - \$440M

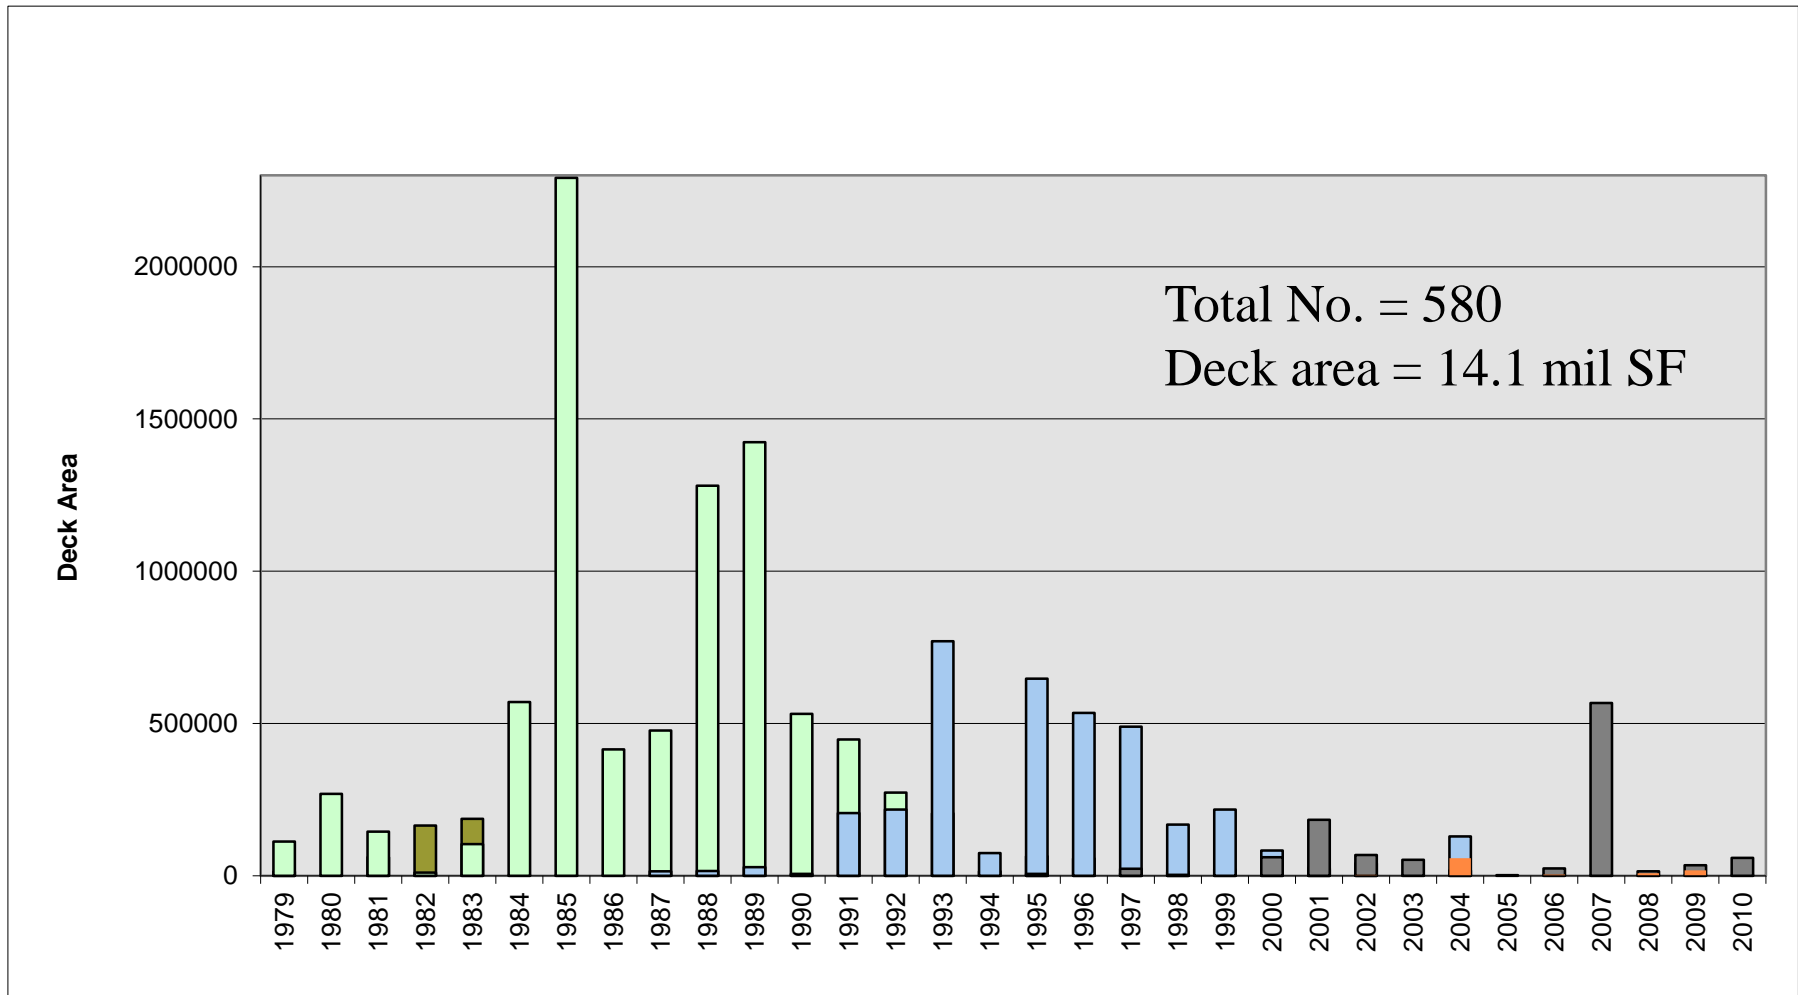
Bridges with a Modified Concrete Overlay

Latex

Low Slump

Rapid Set
LMC

Microsilica

Fly-Ash

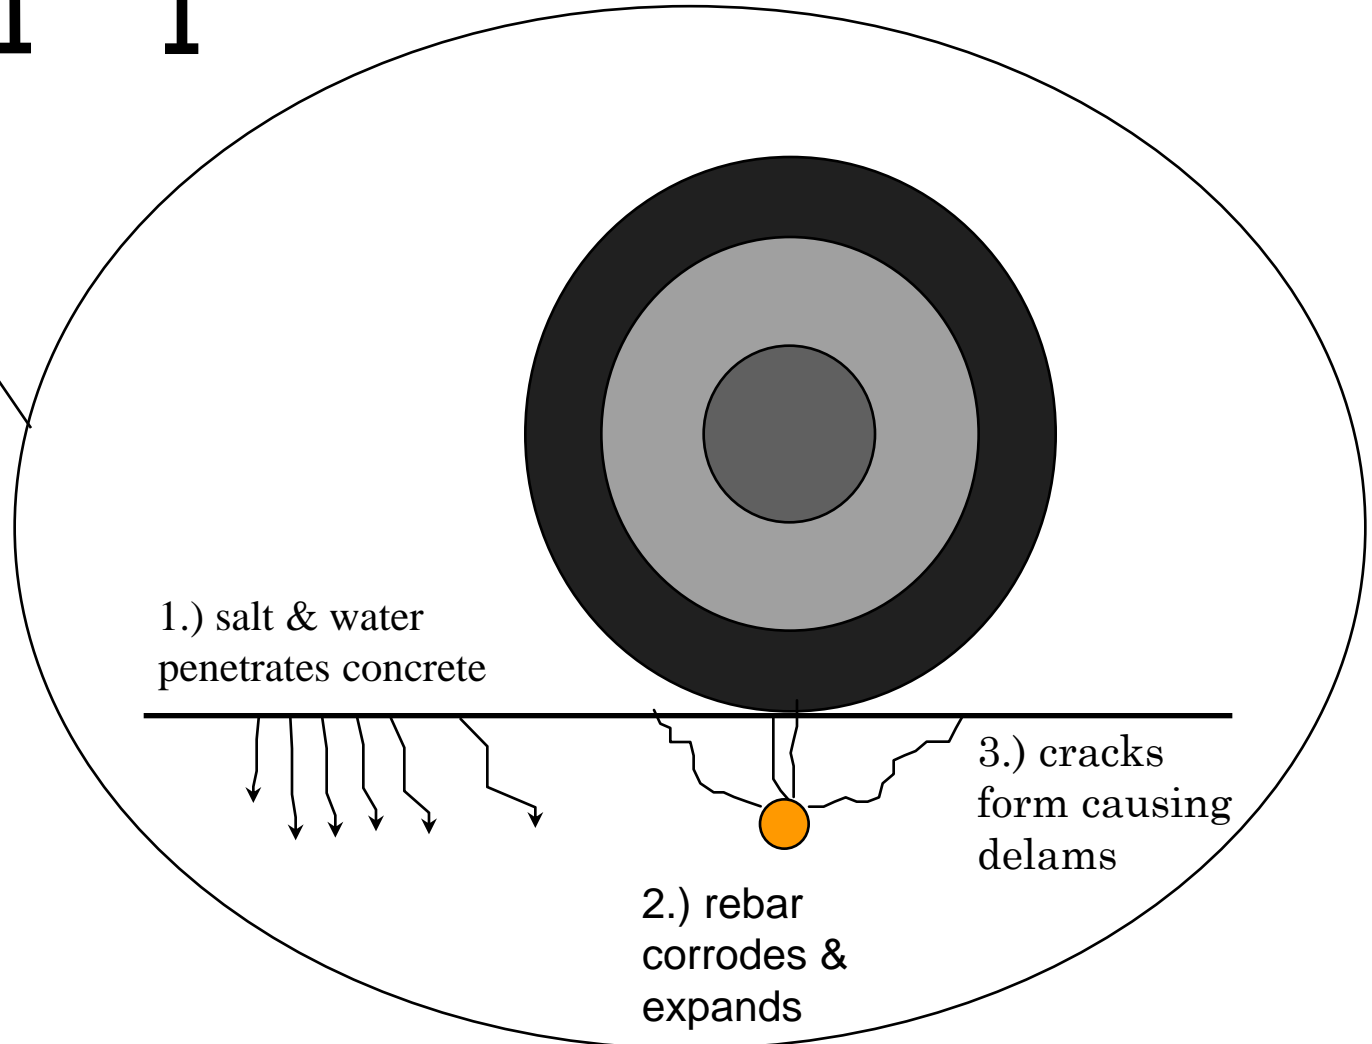
Corrosion of the Reinforcing steel

1.) salt & water penetrates concrete

2.) rebar corrodes & expands

3.) cracks form causing delams

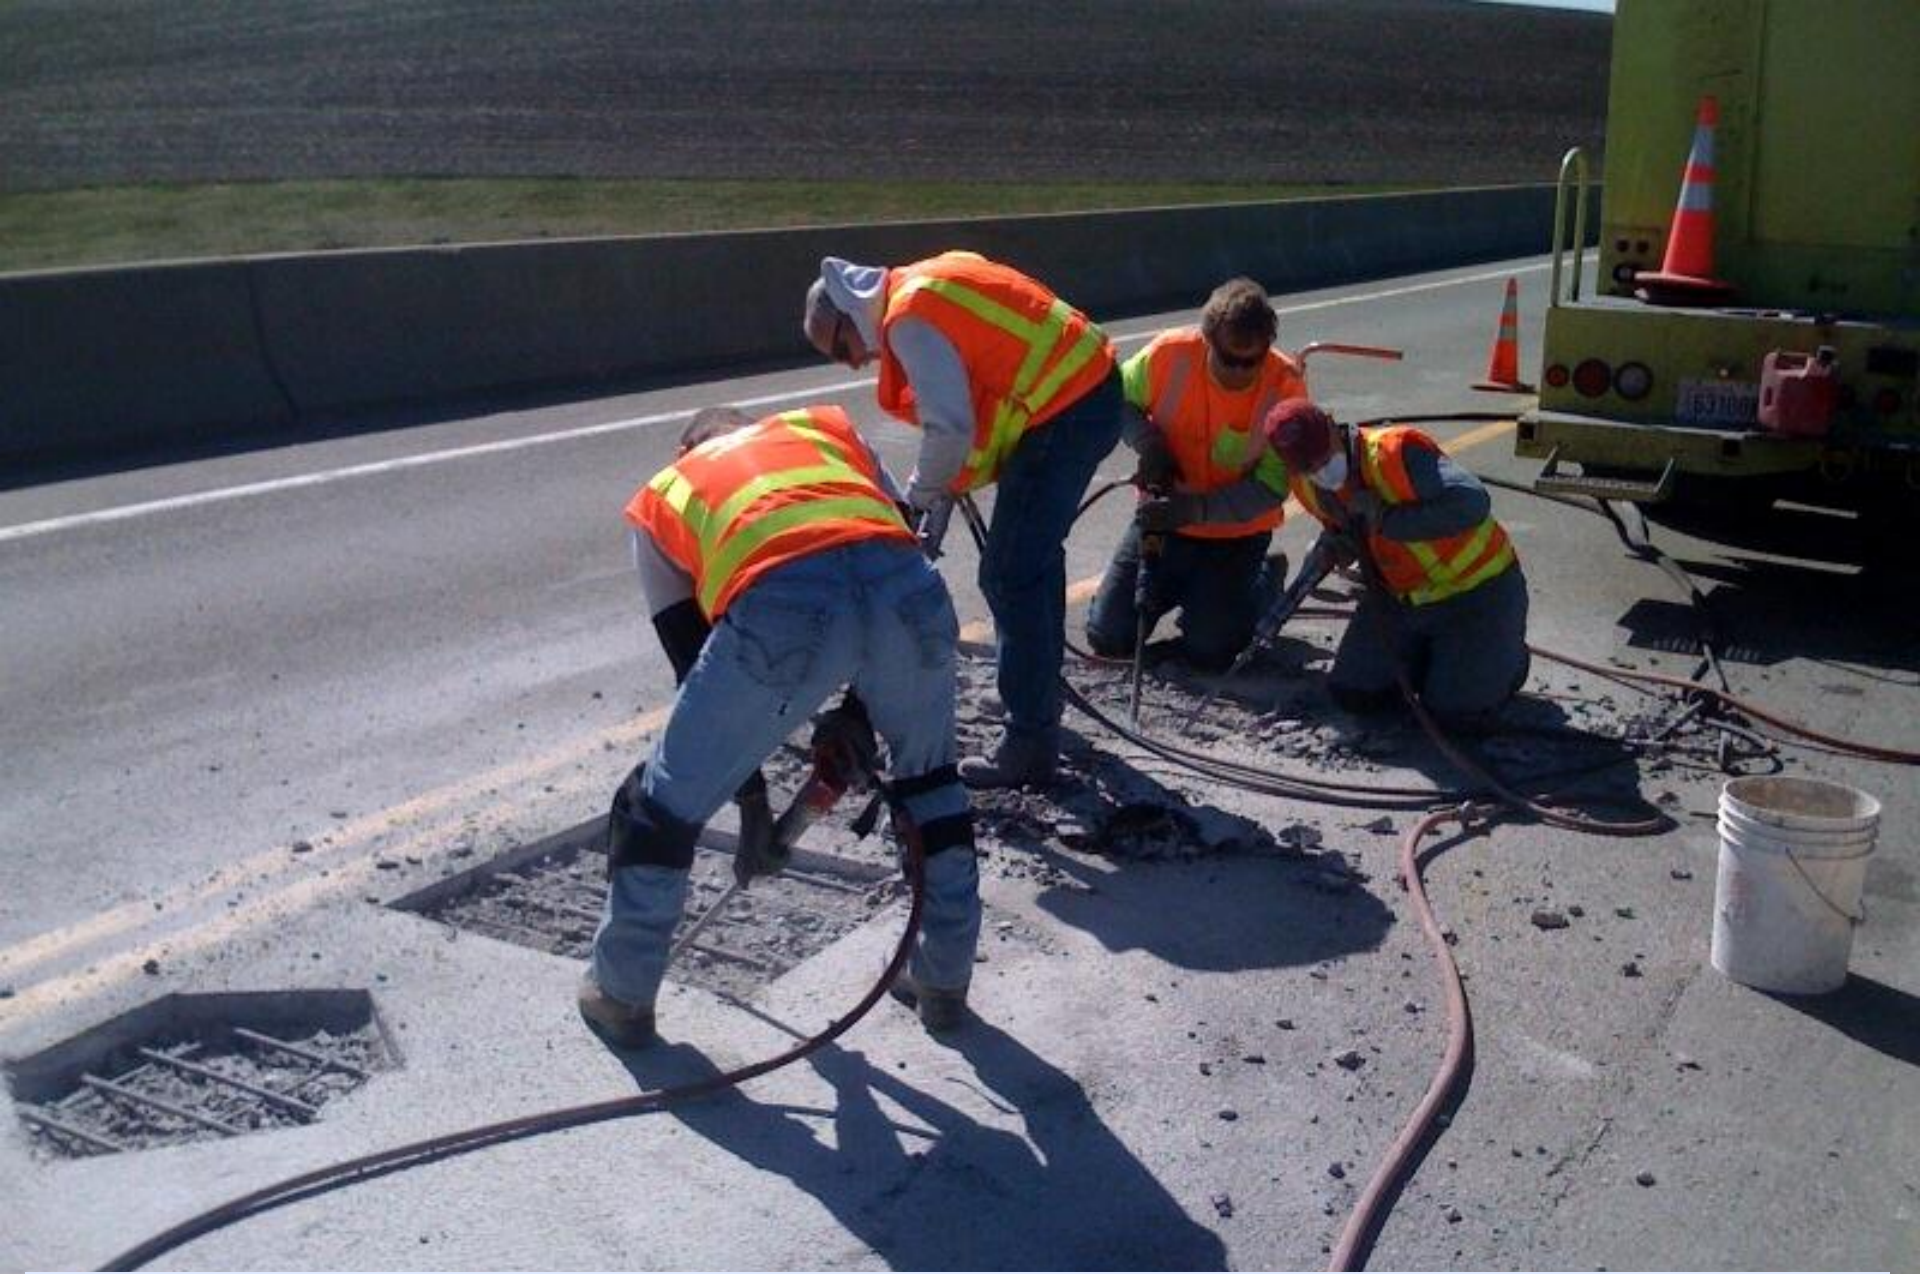
Bridge Deck Repair by WSDOT Maintenance Forces

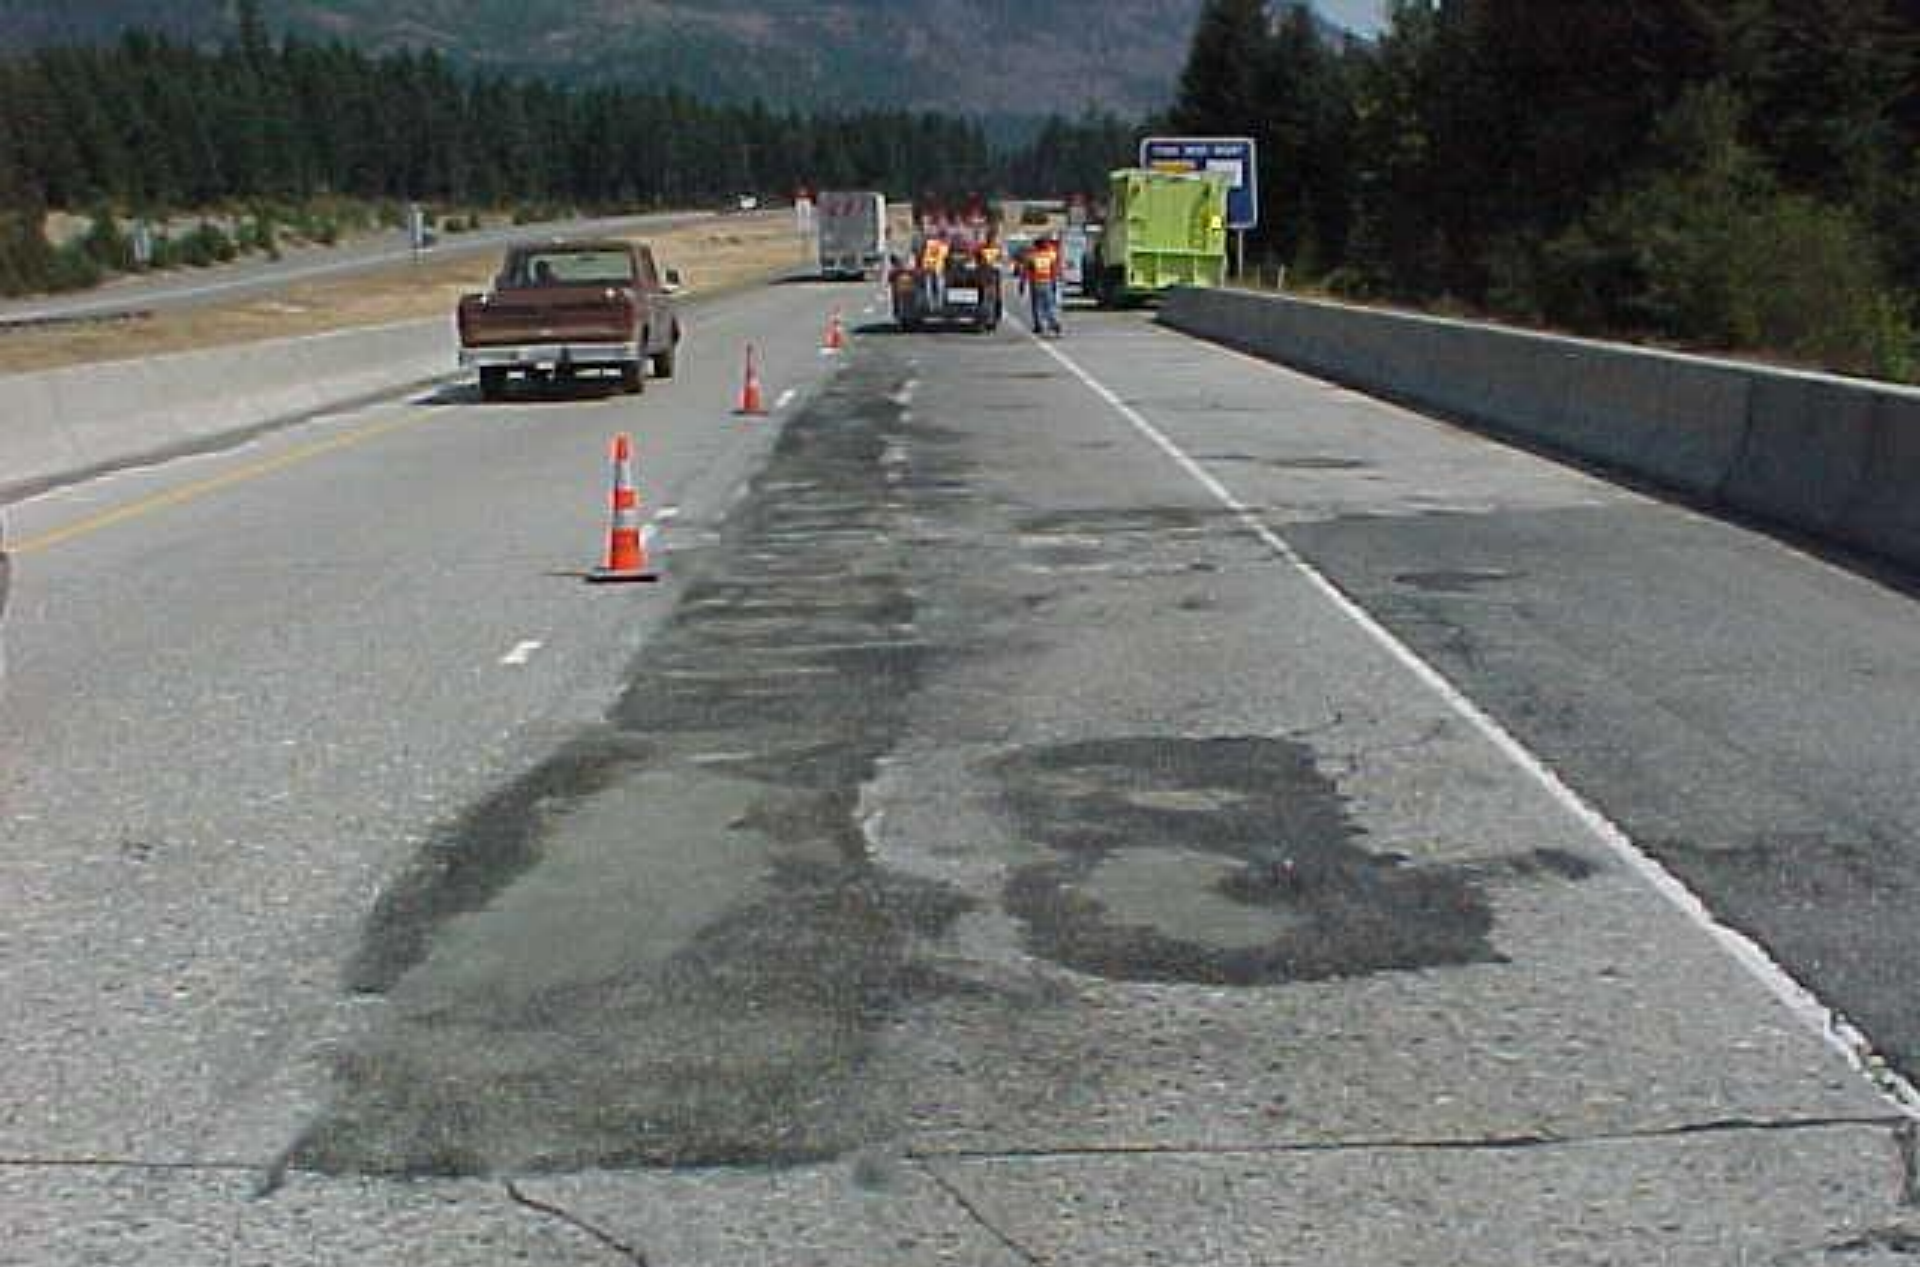
Bridge Deck Repair by WSDOT Maintenance Forces

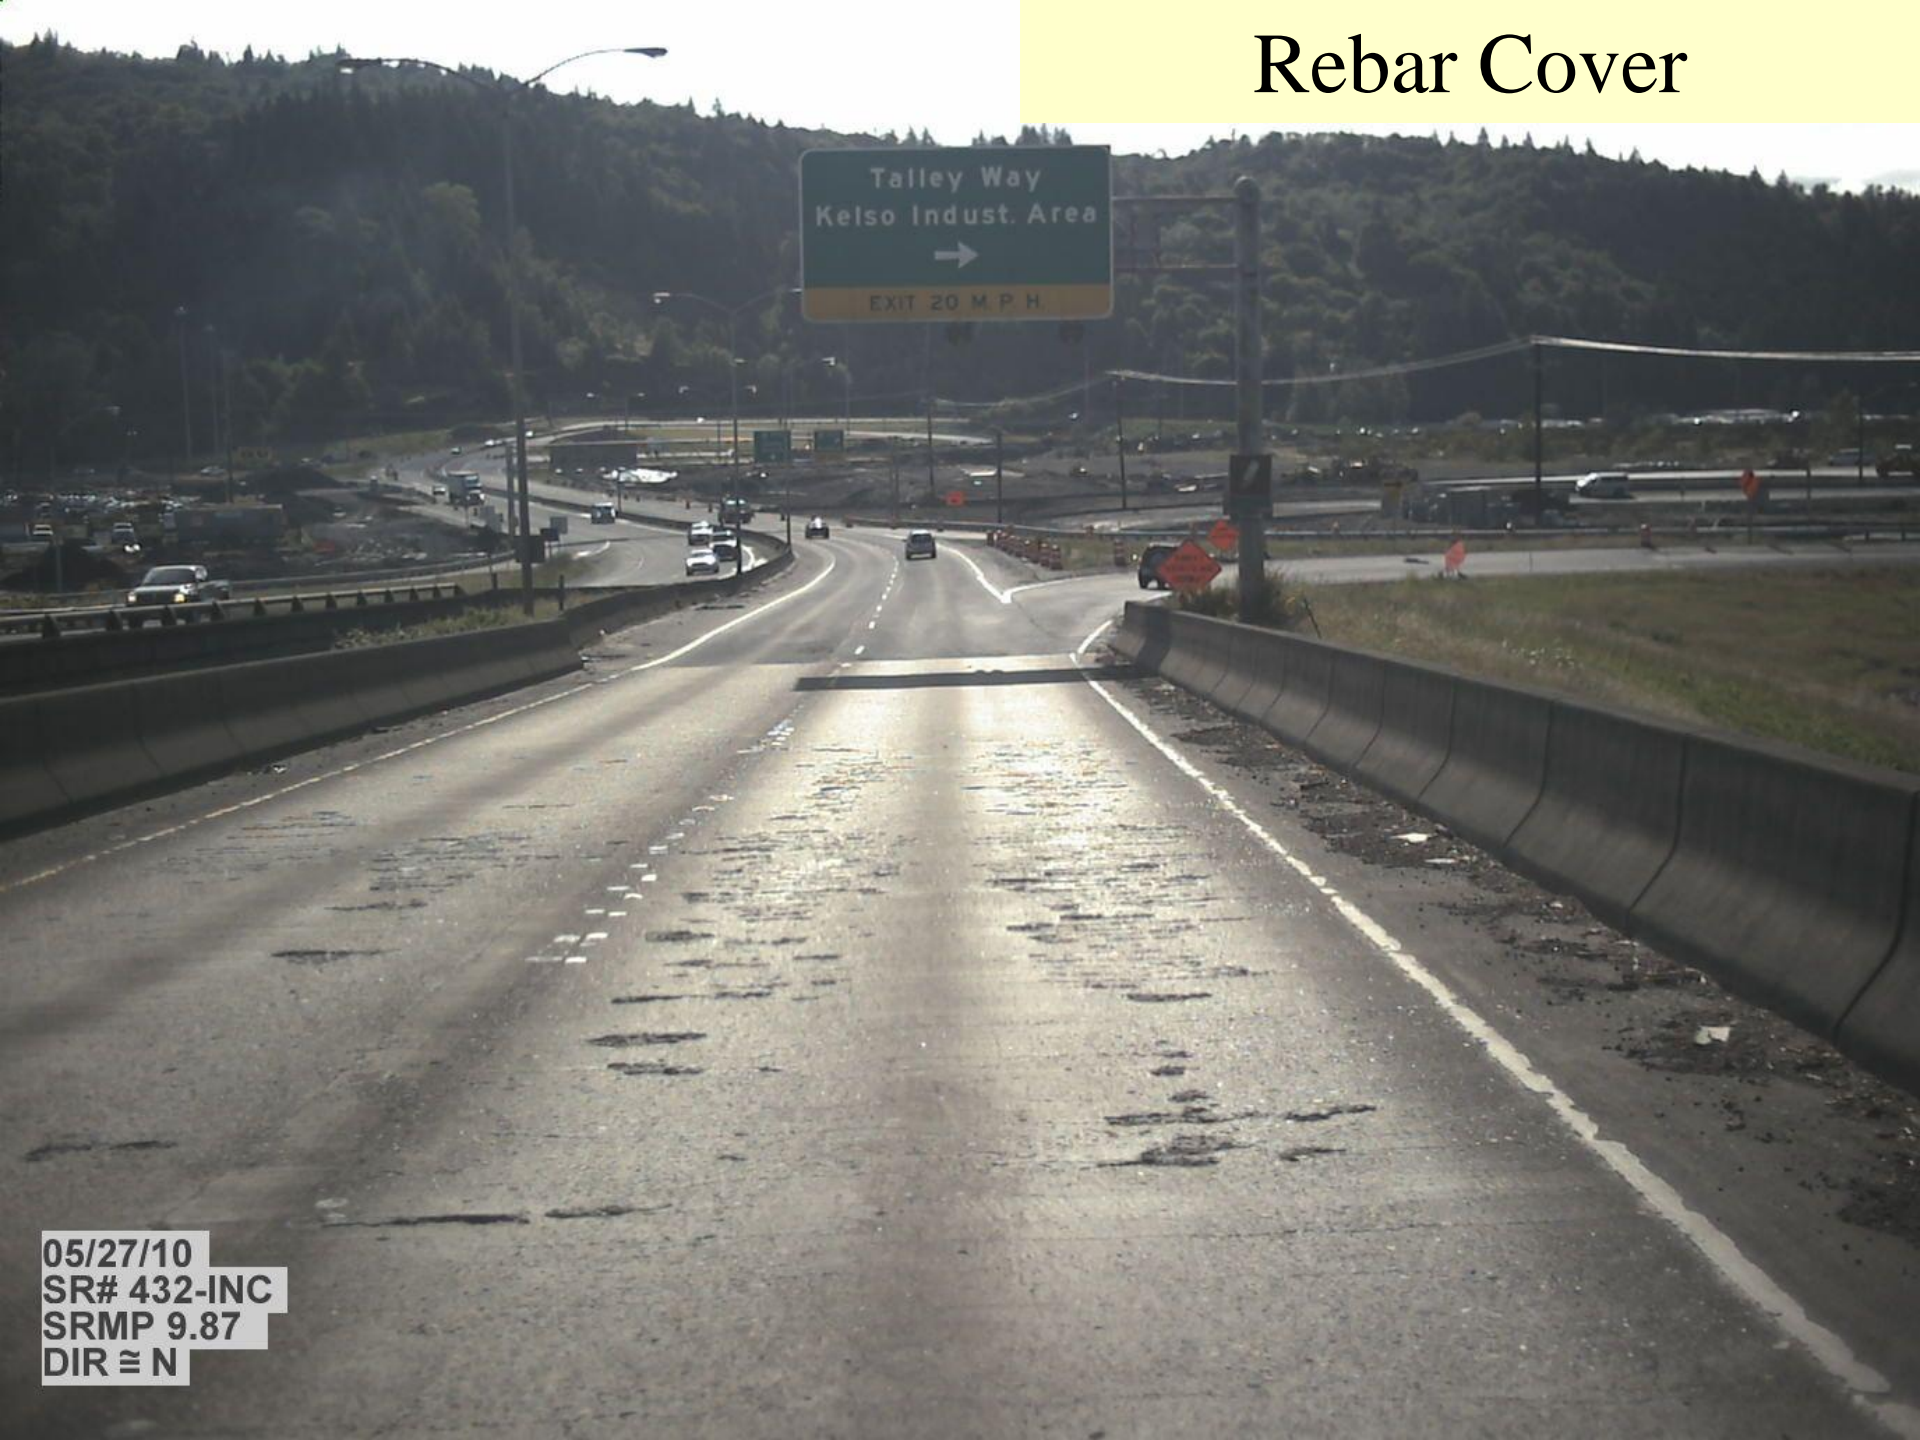
05/27/10
SR# 432-INC
SRMP 9.87
DIR ≅ N

Rebar Cover

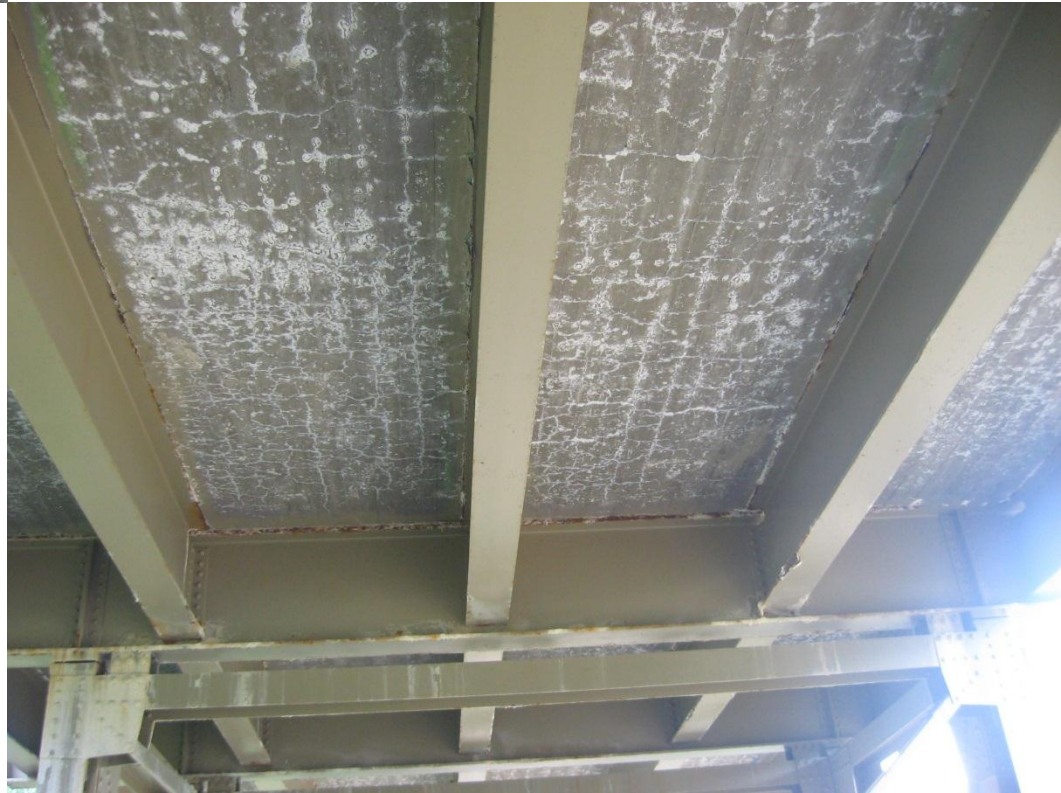
Poor Concrete

SR10 Bristol Fill

Near Cle Elum / Ellensburg

Built in 1937 (75 yrs old)

DESIGN ASSUMPTIONS.

CONCRETE IN ROADWAY SLAB:

Class "A" mix - Vibrated.

$f_c = 1200$ #per sq. inch.

$f_s = 18,000$ #per " "

$n = 10$

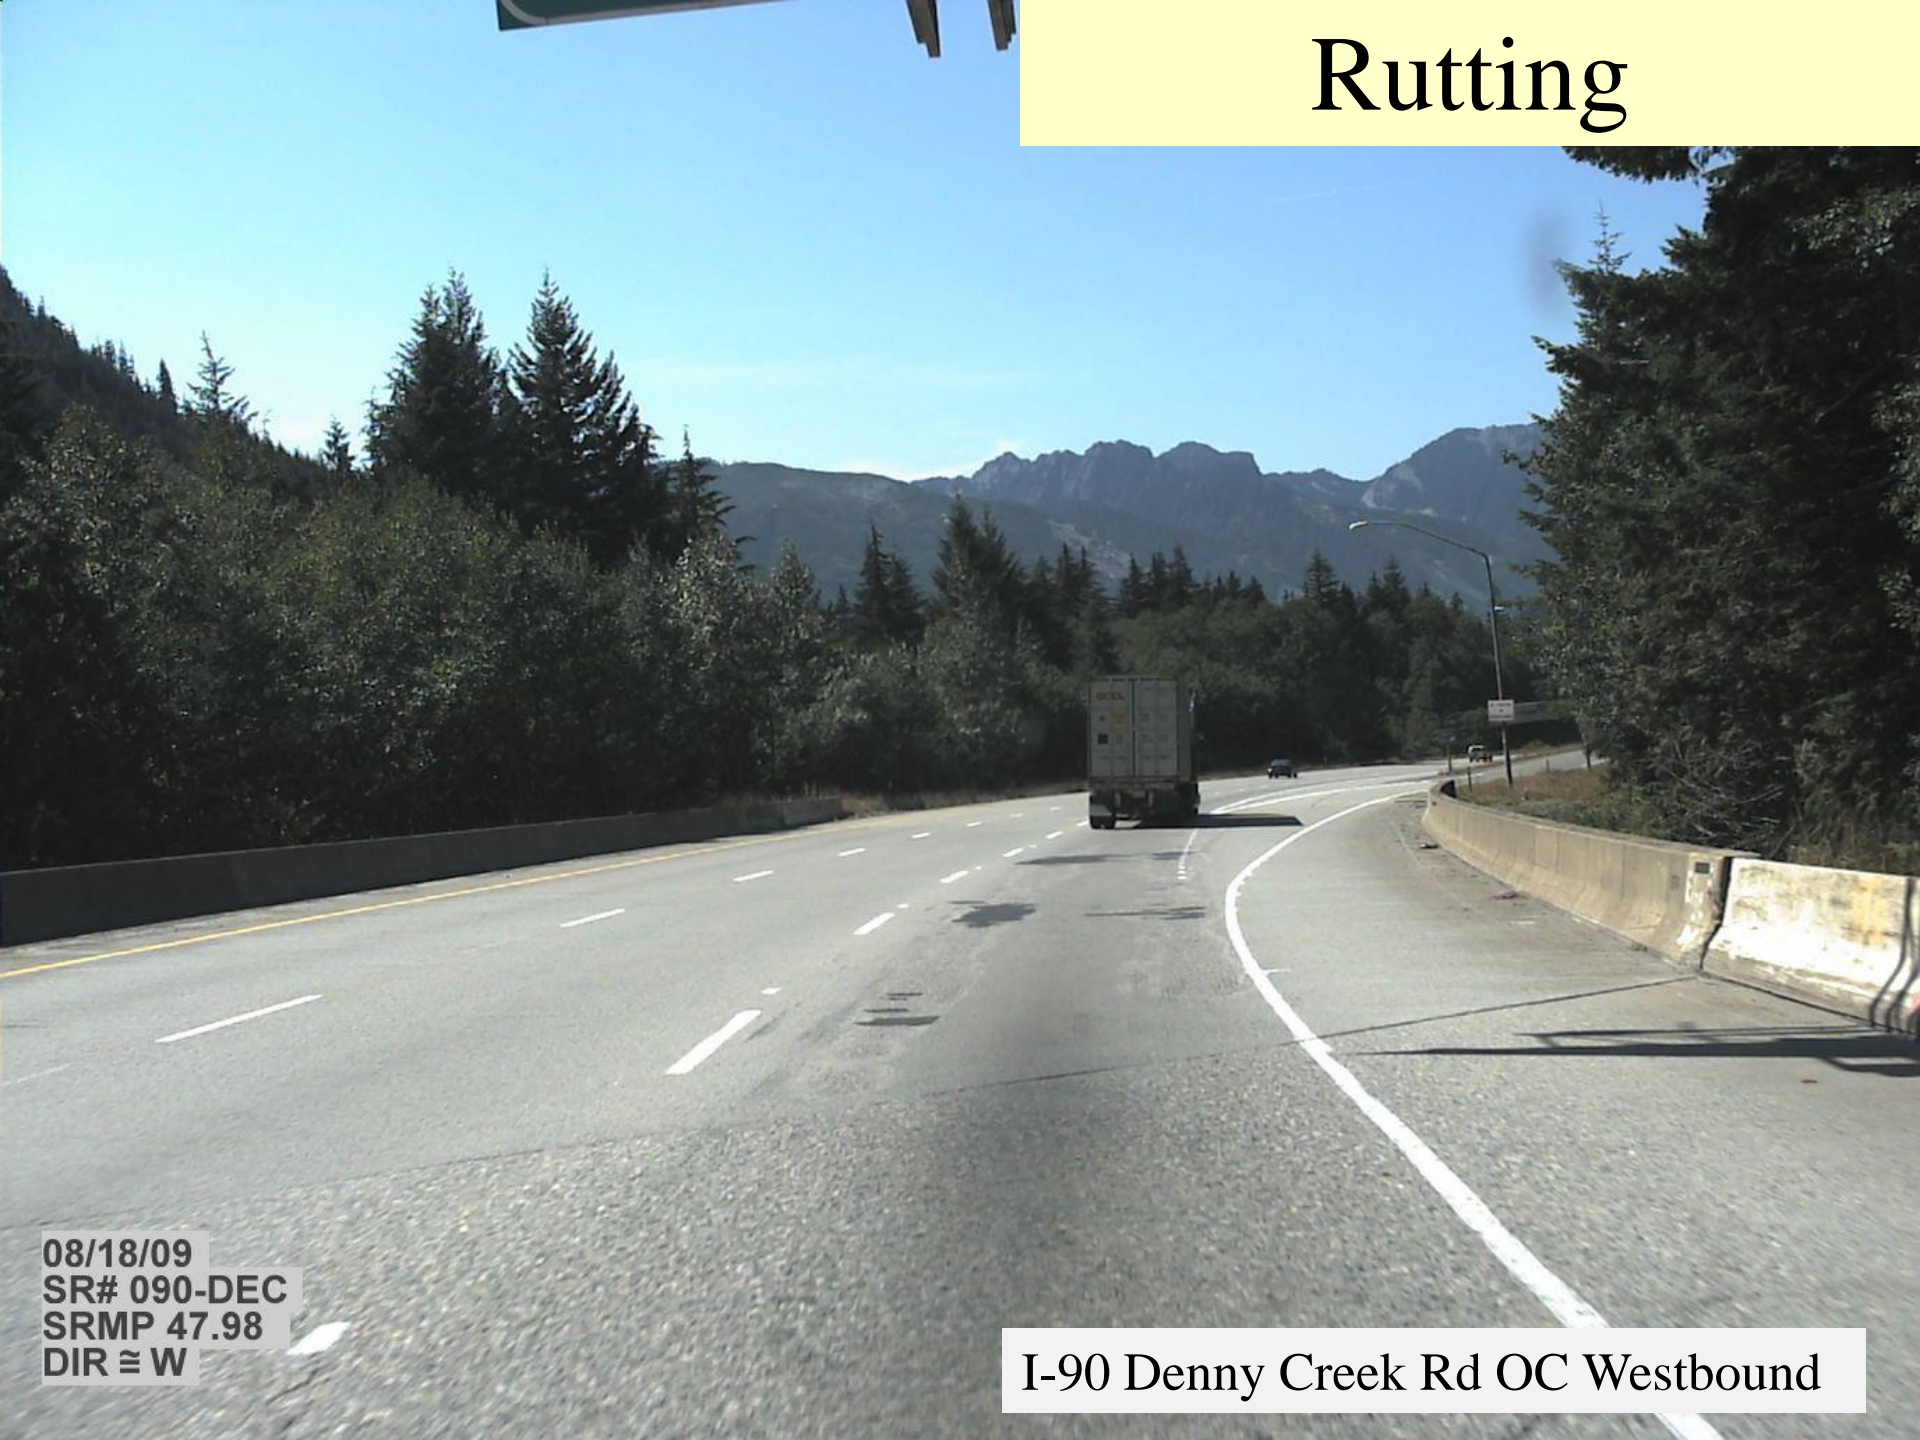
08/18/09
SR# 090-DEC
SRMP 47.98
DIR ≅ W

Rutting

I-90 Denny Creek Rd OC Westbound

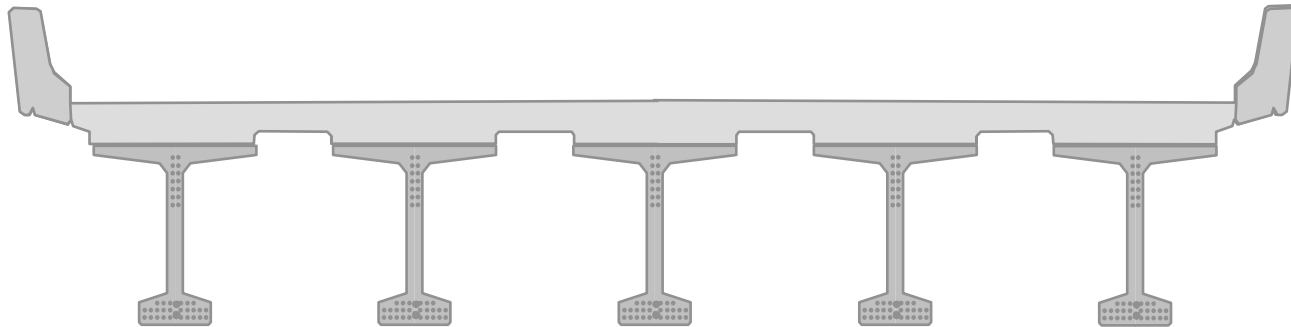
Typical Concrete Bridge Deck

WSDOT BMS Deck Elements

Element # 12 – Concrete Deck

Element # 20 – Concrete Deck with lightweight aggregate

Element # 26 – Concrete Deck with coated bars

Element # 35 – Deck Soffit

Element # 36 – Deck Rebar Cover Flag

Element # 376 – Concrete Deck Delamination

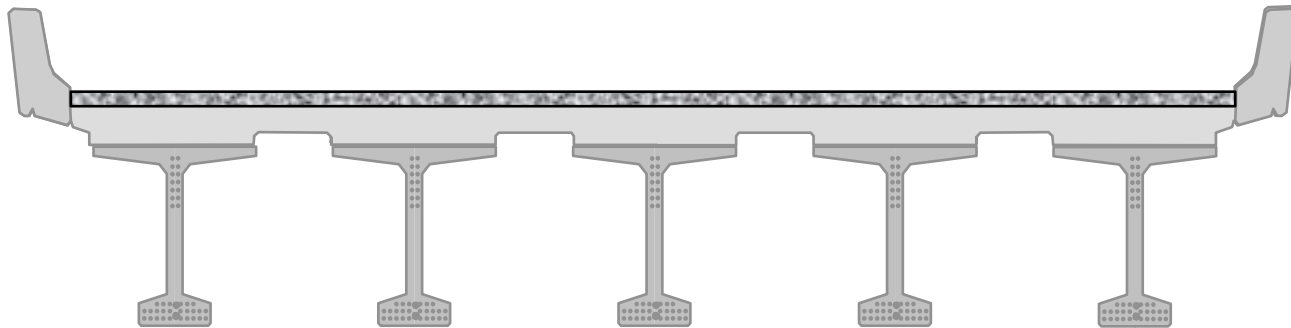
Typical Concrete Bridge Deck (with Overlay)

WSDOT BMS Overlay Elements

Element # 800 – Asphalt Overlay

Element # 801 – Asphalt with membrane overlay

Element # 802 – Thin Polymer Overlay

Element # 803 – Concrete Overlay

Element # 804 – Polyester Concrete Overlay

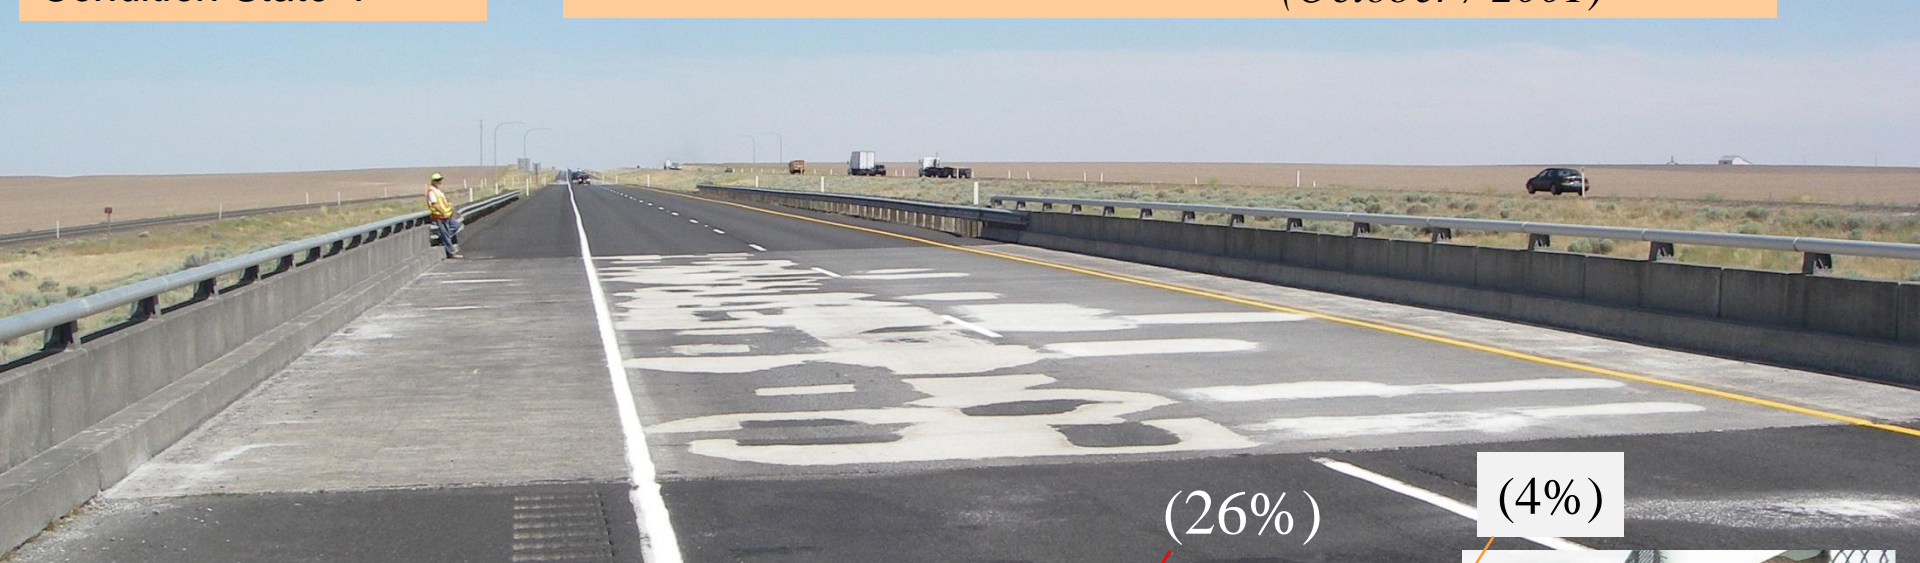
Delamination Test Results. (October / 2001)

(26%)

(4%)

Elem	Description	Total	Unit	State1	State2	State3	State4
12	Conc. Deck	3,990	SF	2,774	1,053	0	163
35	Soffit	3,990	SF	3,990	0	0	0
376	Delam Testing	3,990	SF	3,827	0	0	163

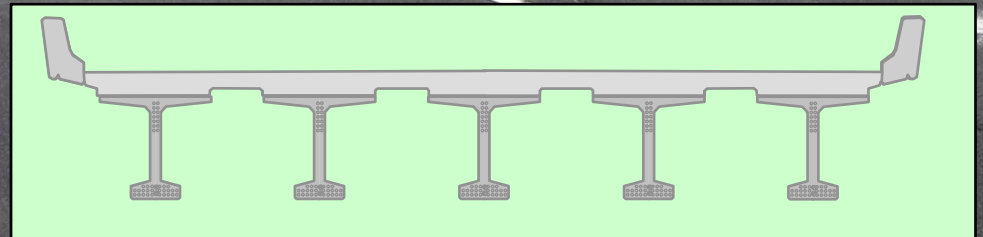
Interstate 90

Length: 105ft

Width: 38ft

Year Built: 1972

Deck Thickness: 7”

Top Conc. Cover: 2”

Deck Repair/Overlay in 2013

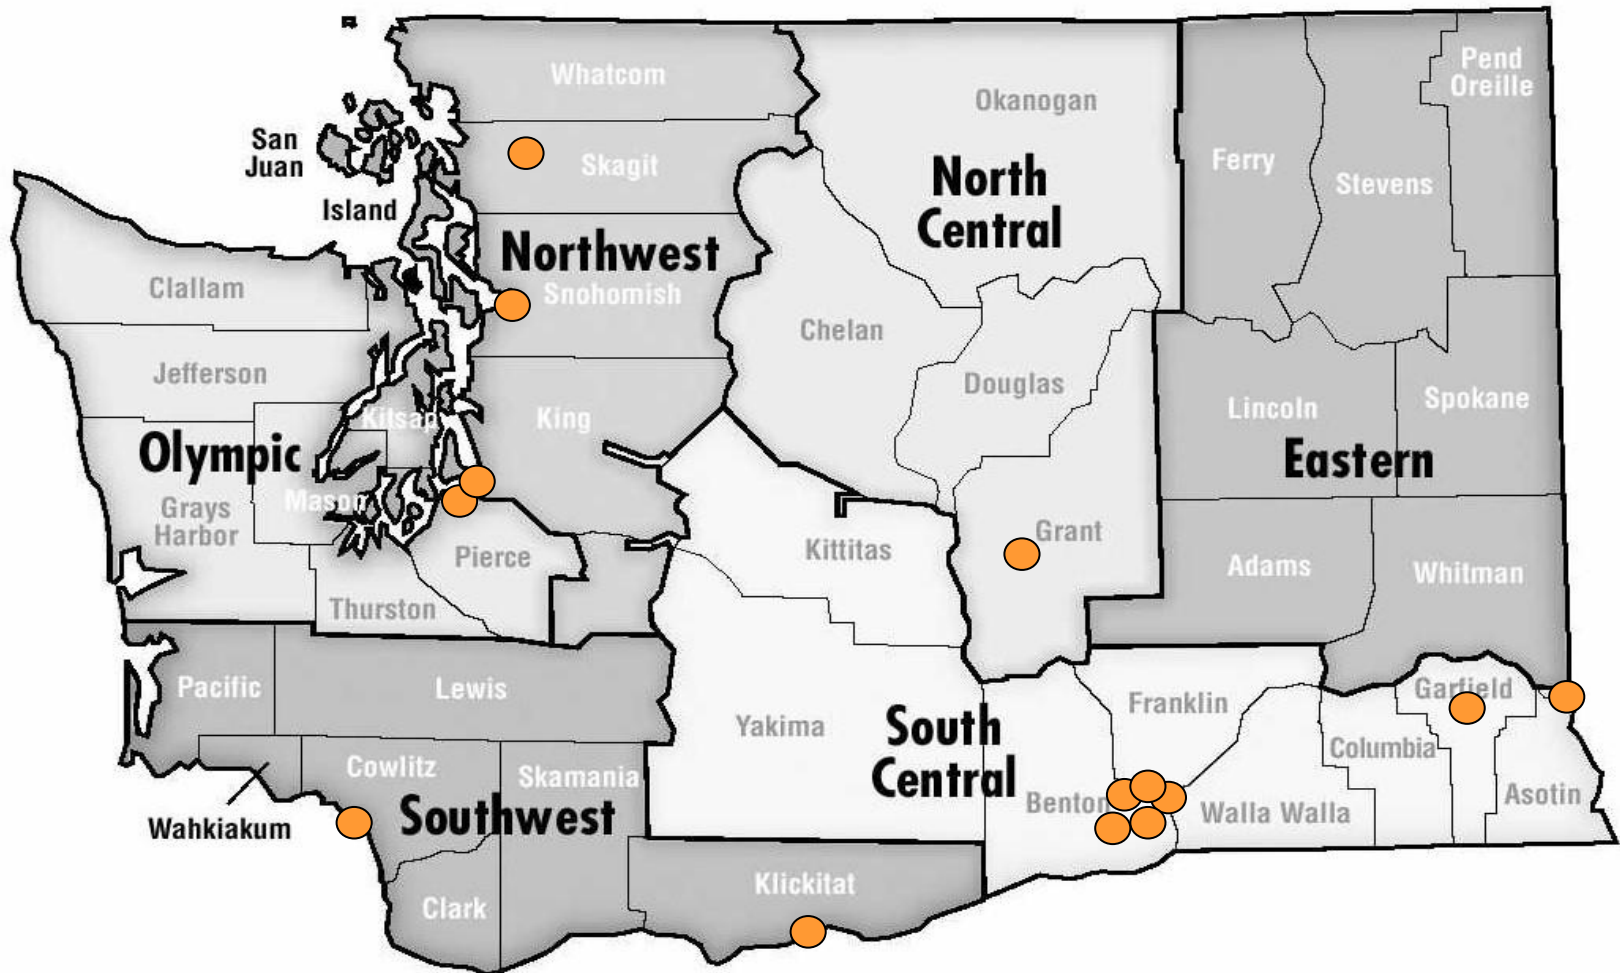
Past Bridge Deck Replacements

14 bridges (588,536 sq. ft.)

1986 thru 2009

1.3% of total Statewide Deck Area
