Bridge Deck Preservation Program

**Washington State
Department of Transportation**

Washington State's Concrete Bridge Deck Program

**Preserve WSDOT's reinforced concrete bridge decks,
with cost effective repairs and protective overlays.**

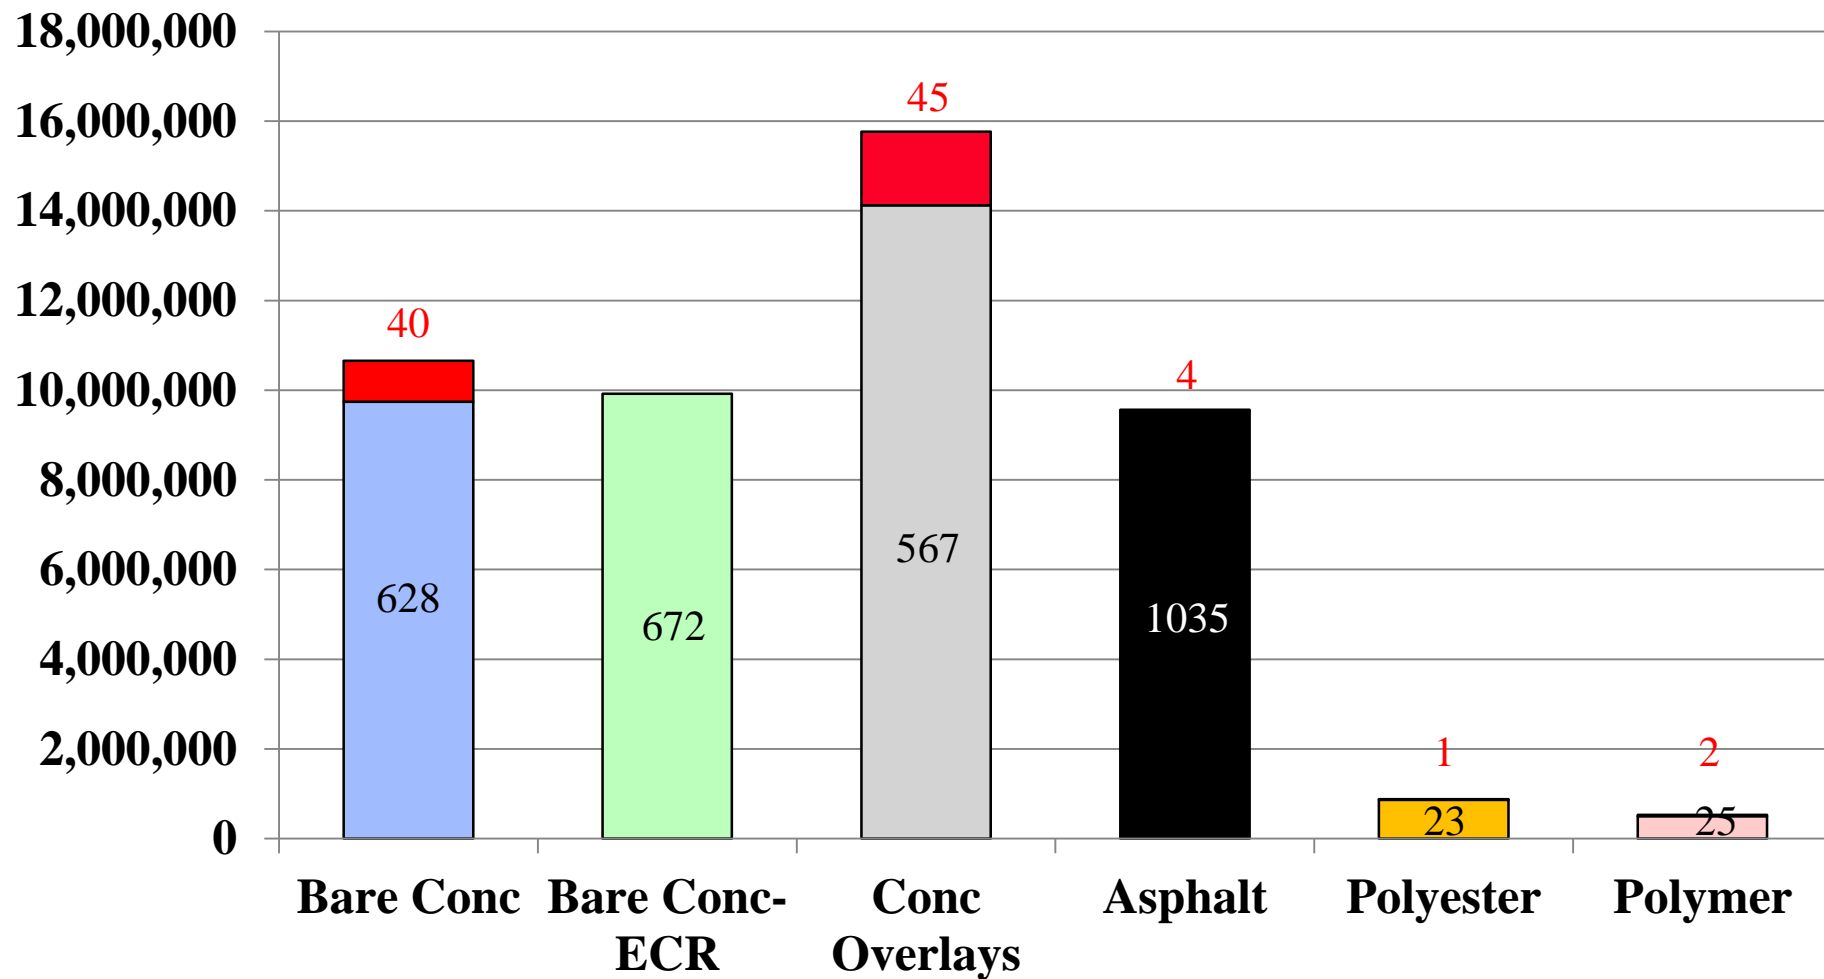
Washington State's Bridge Deck Preservation Needs

\$50.5M

\$101.1M

\$0.9M

\$152.5M

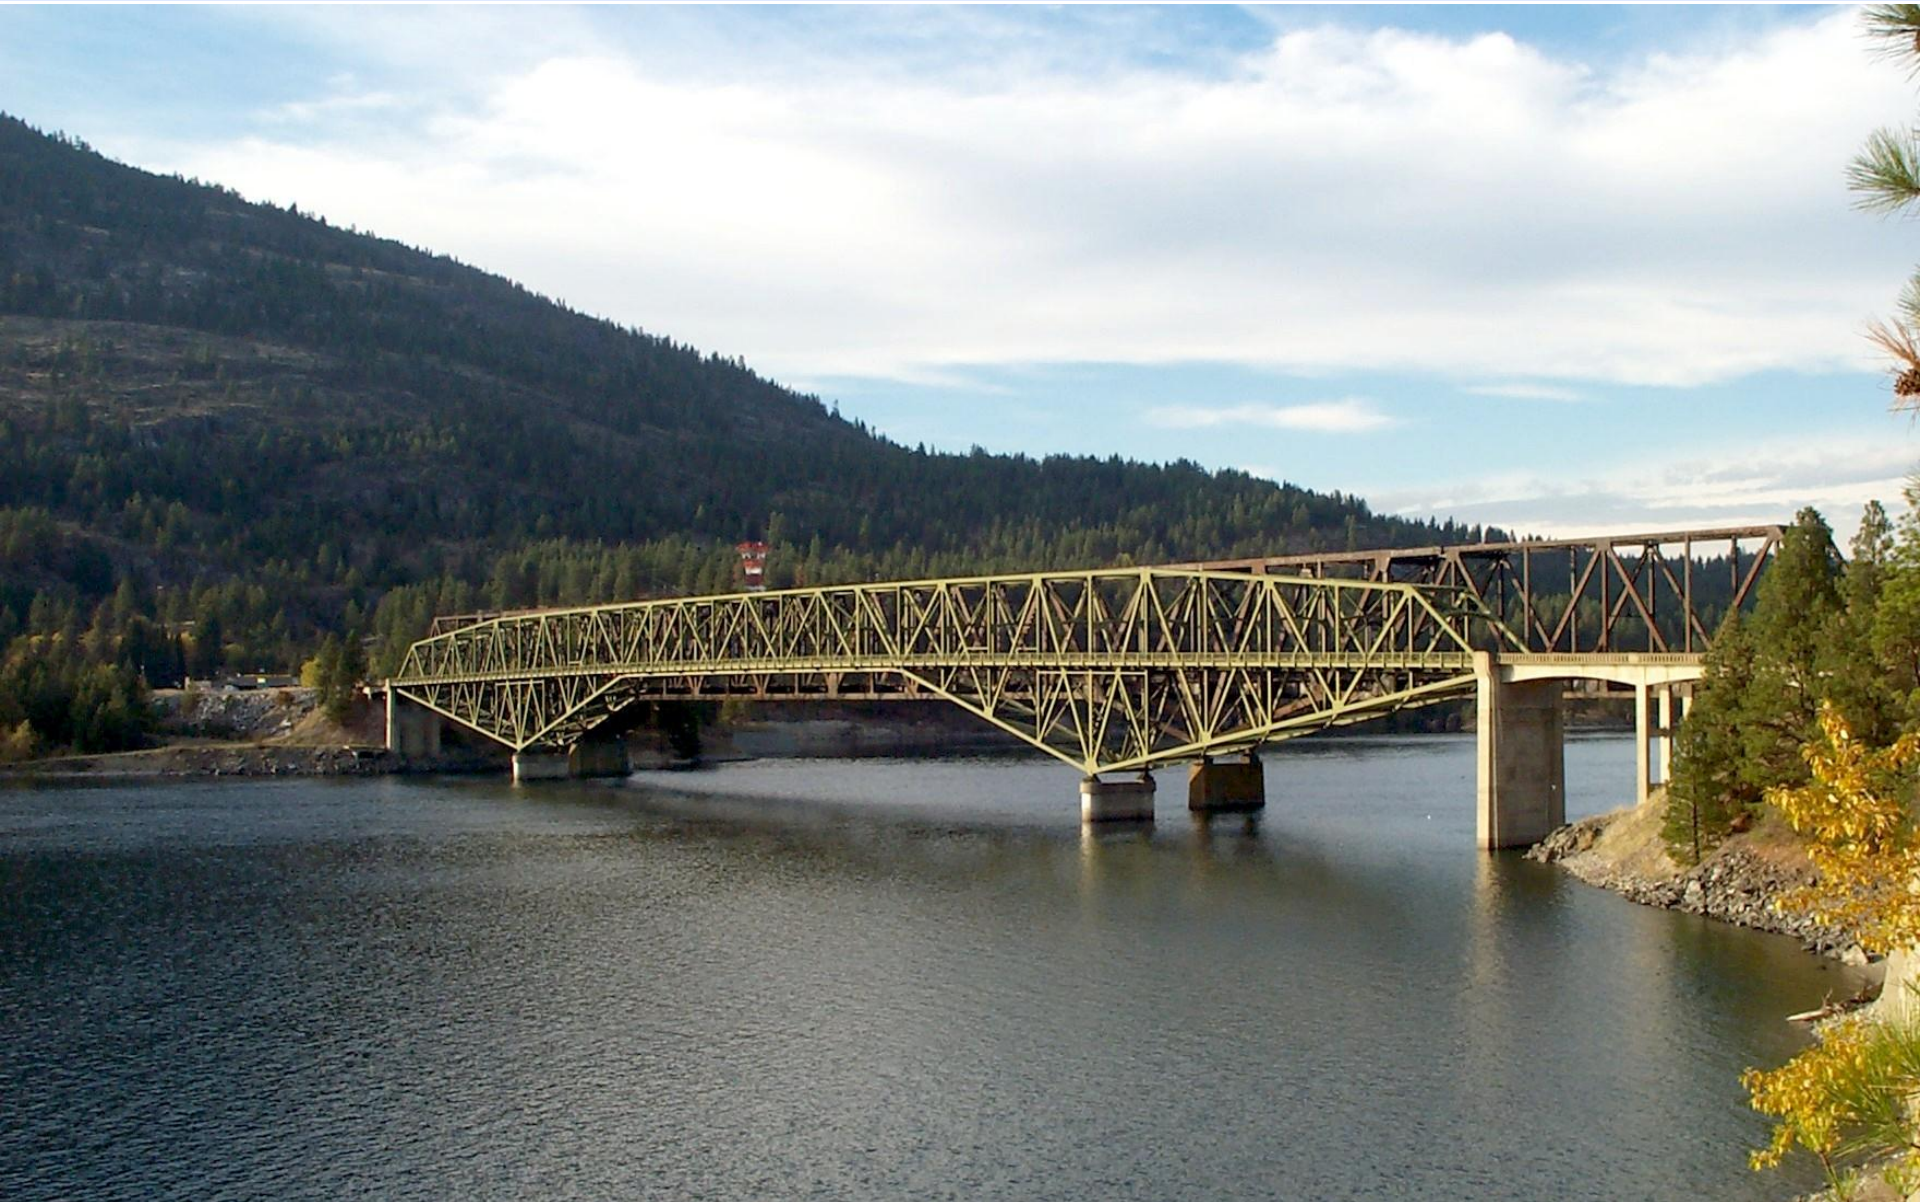
US395 Columbia River @ Kettle Falls

Year Built – 1941

Length = 1,267ft

Width = 24ft

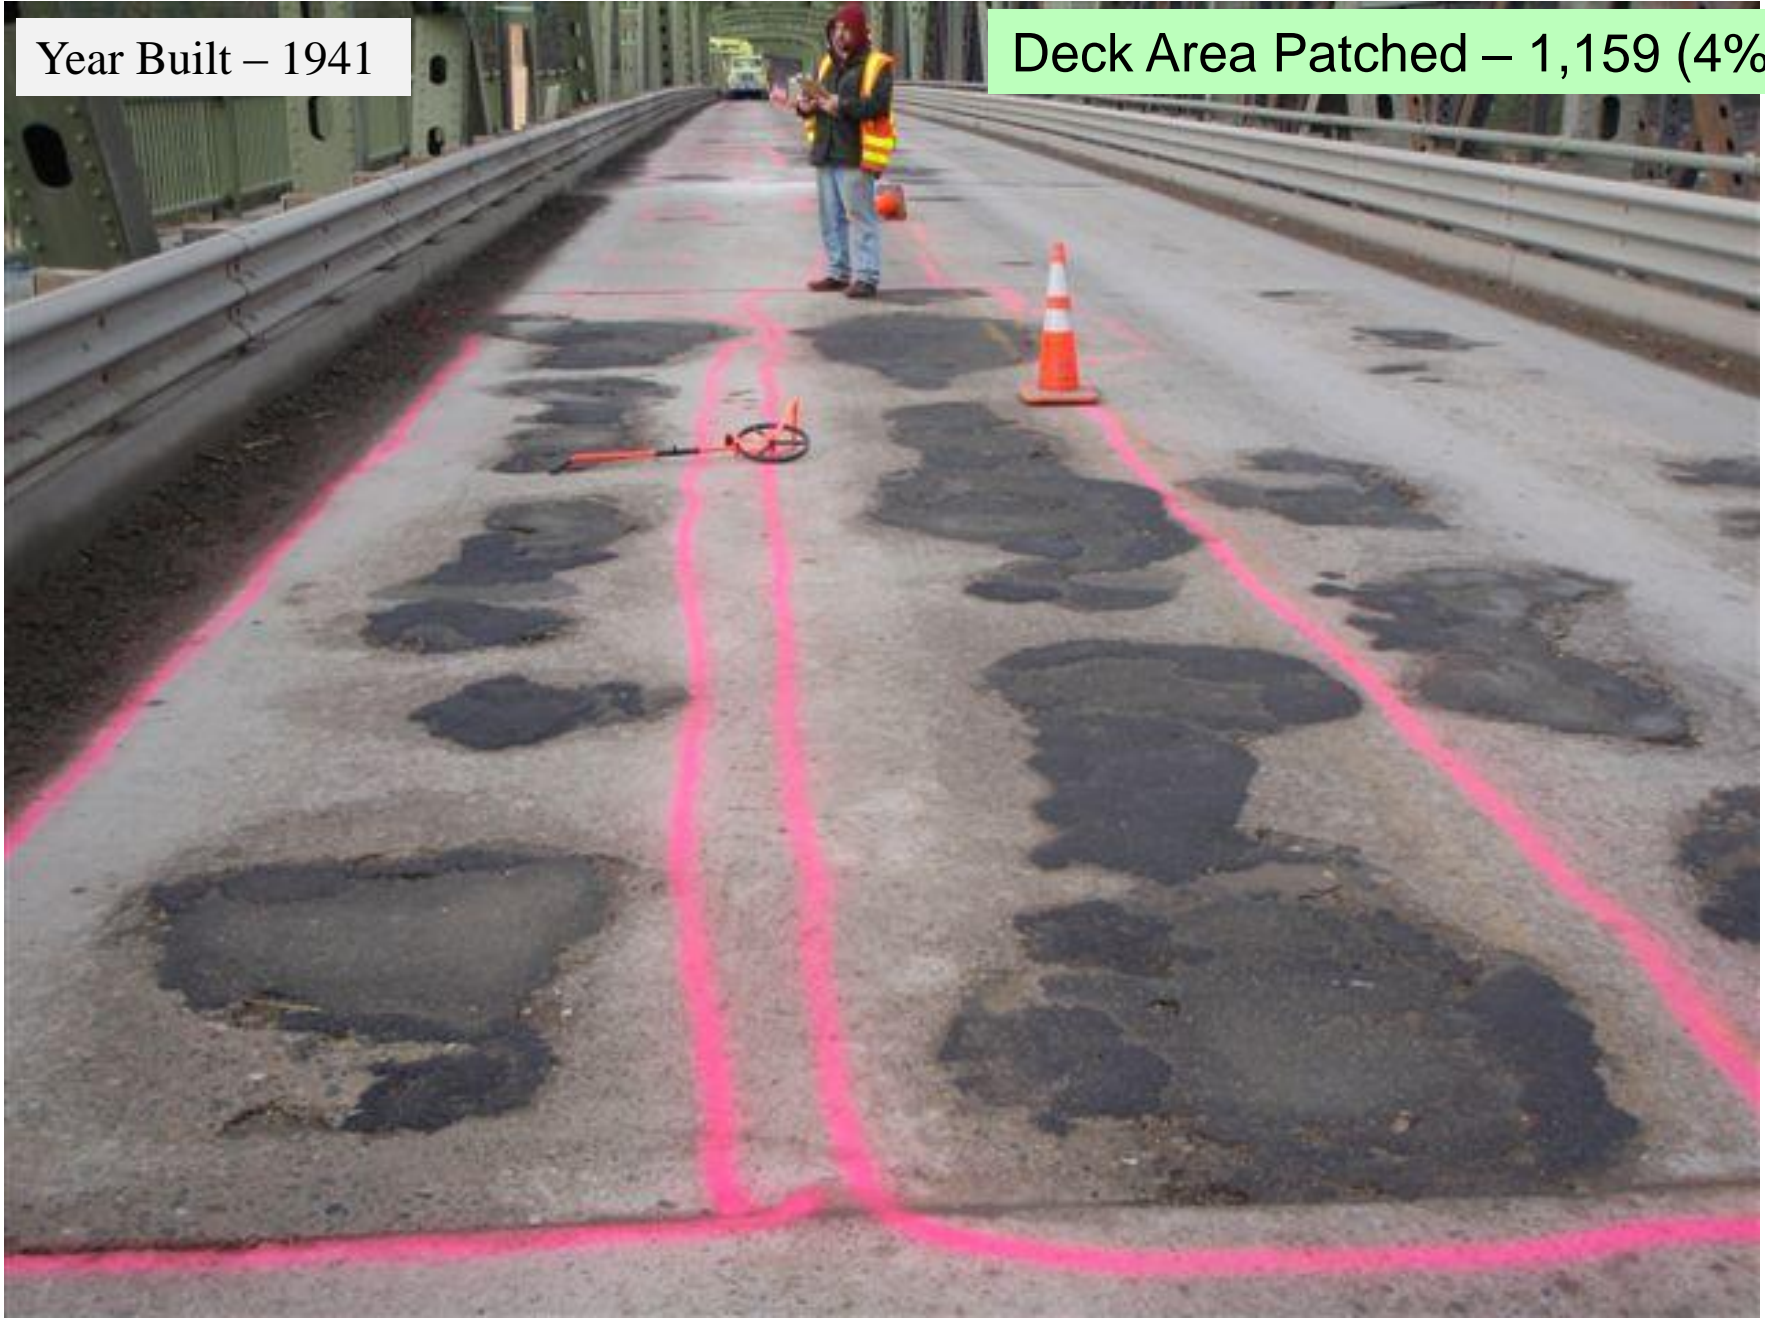
US395 Columbia River @ Kettle Falls

Year Built – 1941

Deck Area Patched – 1,159 (4%)

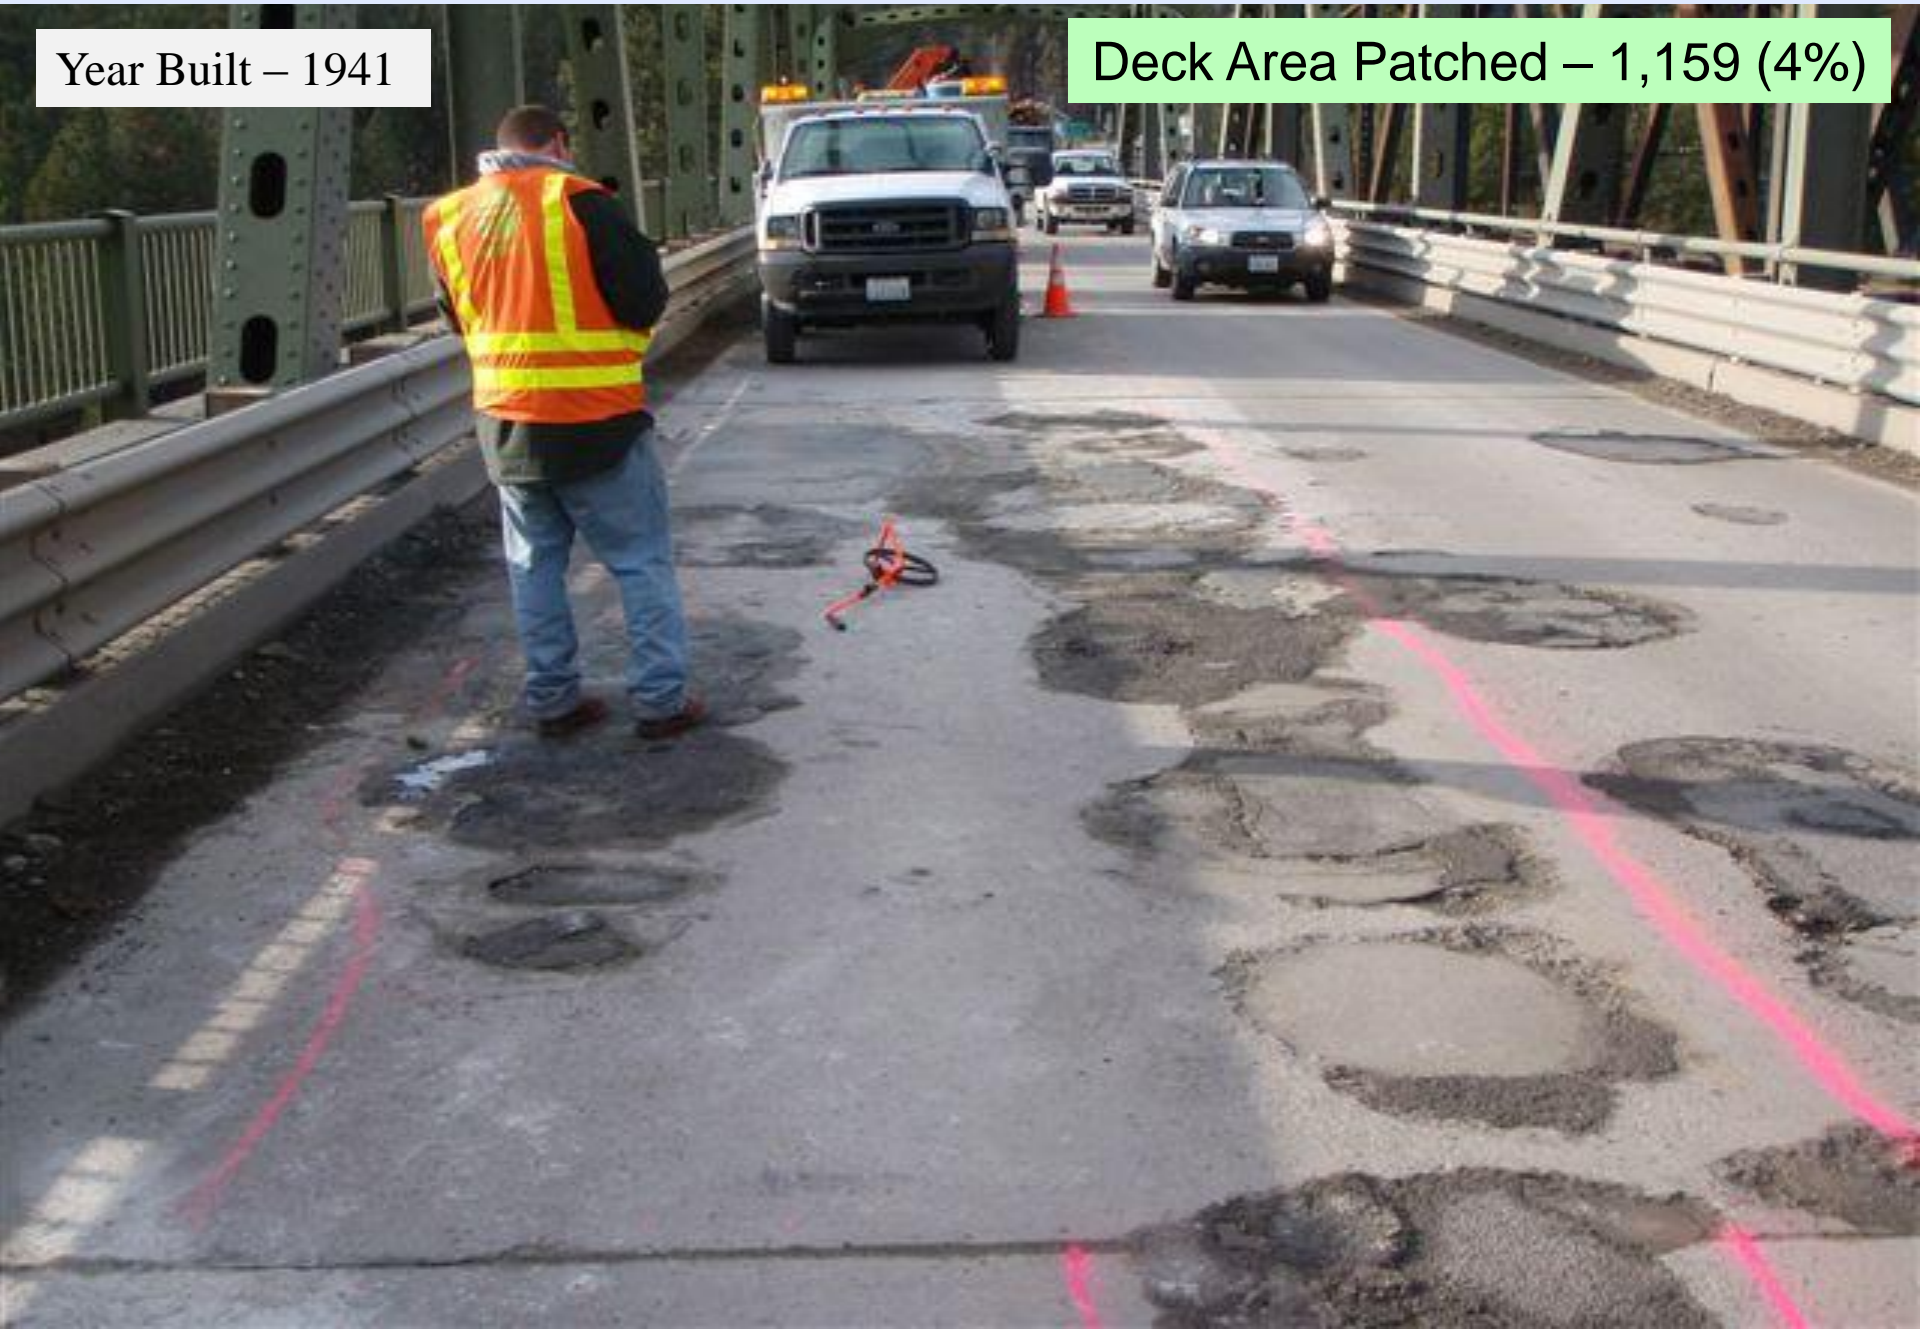
US395 Columbia River @ Kettle Falls

Year Built – 1941

Deck Area Patched – 1,159 (4%)
