# AZZ Galvanizing Services

# The Corrosion Problem

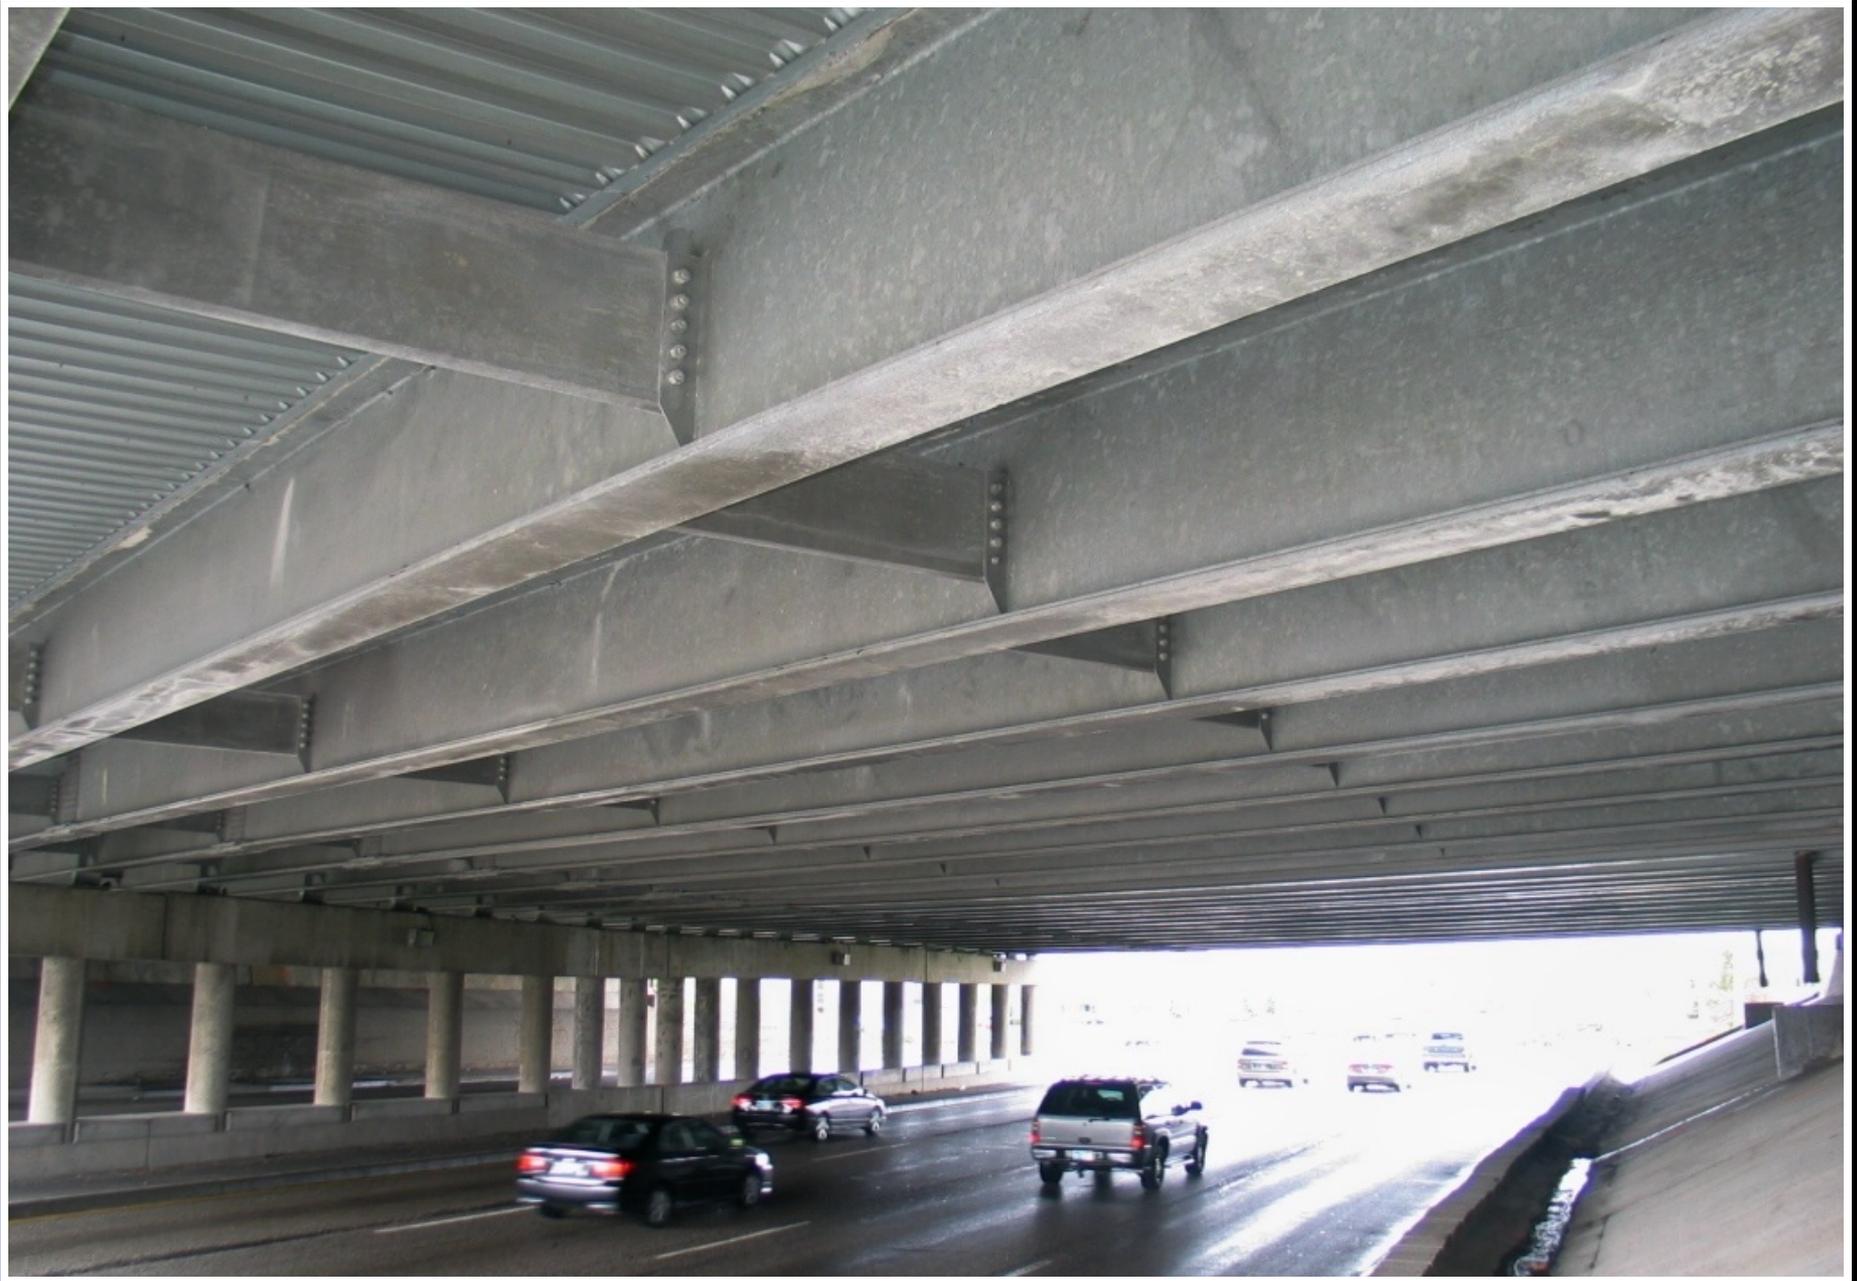
Beam 1

6.20 6.10 7.60  
8.90 7.70

7.60 8.00 5.70  
5.50 7.40

$\bar{X}=6.82$

7.60 7.70 6.70  
5.80 5.60

7.50 7.50 6.60  
7.30 5.60

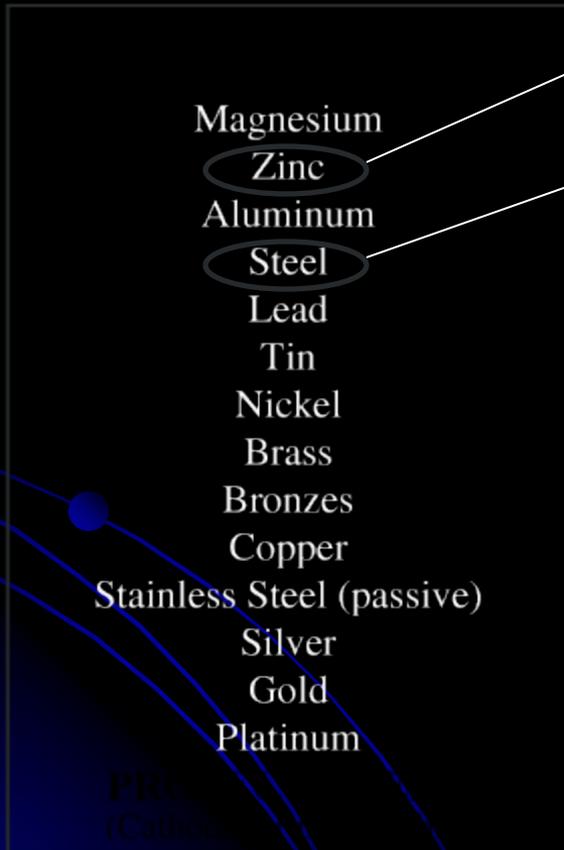
# Galvanic Series of Metals

**ZINC = ANODE**

**STEEL = CATHODE**

**This arrangement of metals determines what metal will be the anode and cathode when the two are put in a electrolytic cell (arrangement dependent on salt water as electrolyte).**

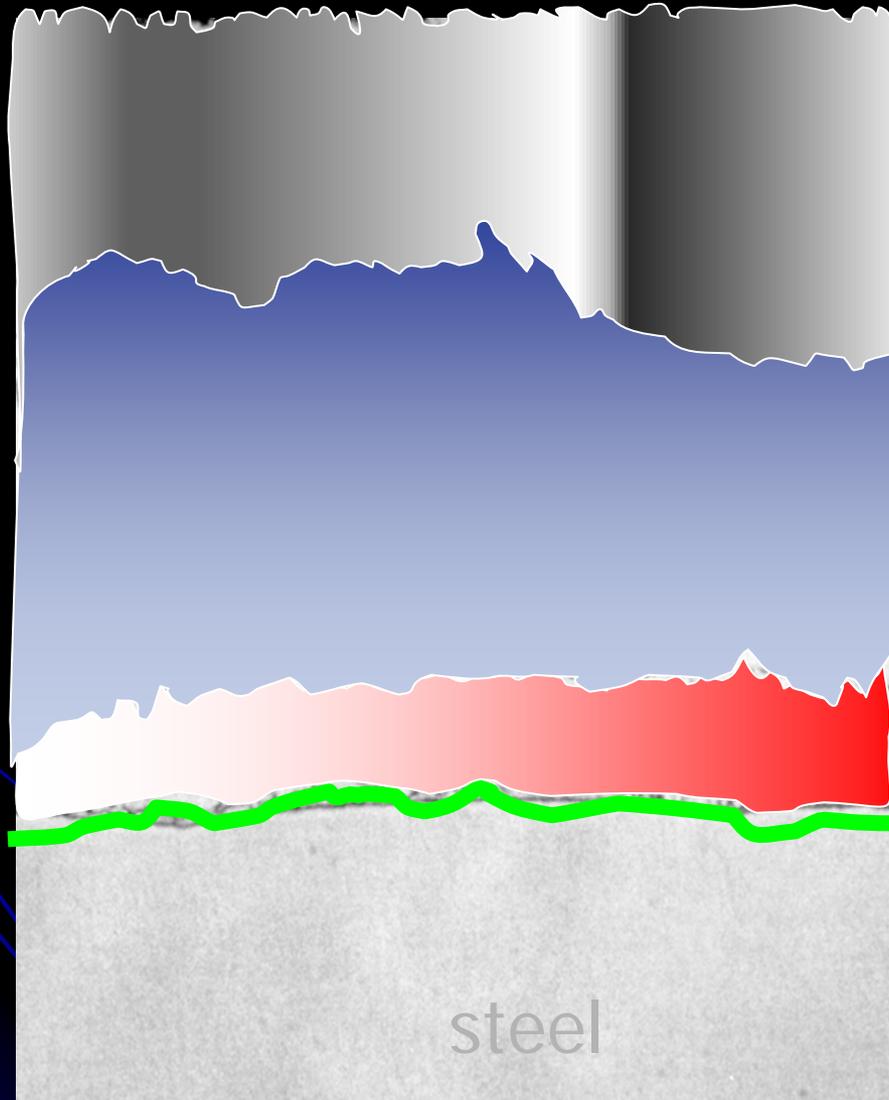
# Metallurgical Bond

**Eta**  
**Zeta**  
**Delta**  
**Gamma**

100%

Zinc

94% Zinc

6% Iron

90% Zinc

10% Iron

75% Zinc

25% Iron

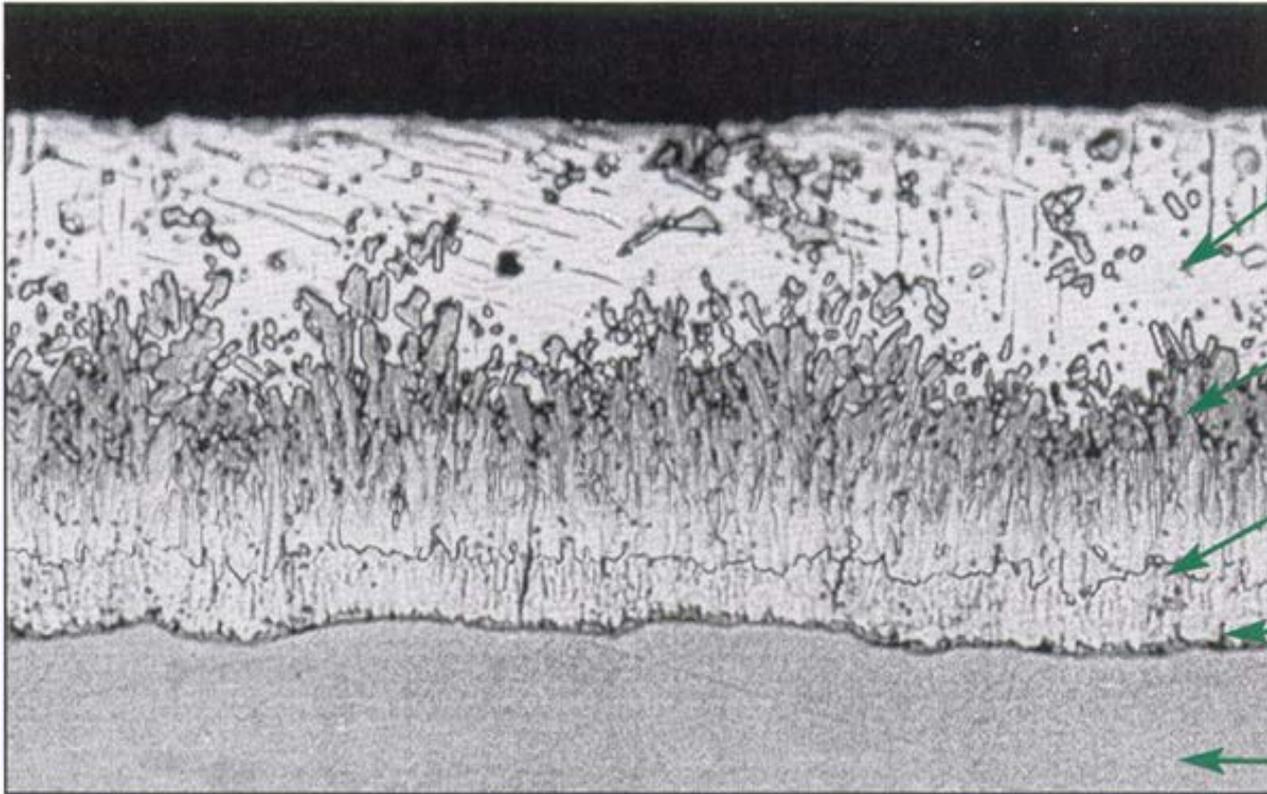
**Eta**

(100% Zn)

70 DPN Hardness

**Zeta**

(94% Zn 6% Fe)

179 DPN Hardness

**Delta**

(90% Zn 10% Fe)

244 DPN Hardness

**Gamma**

(75% Zn 25% Fe)

250 DPN Hardness

**Base Steel**

159 DPN Hardness

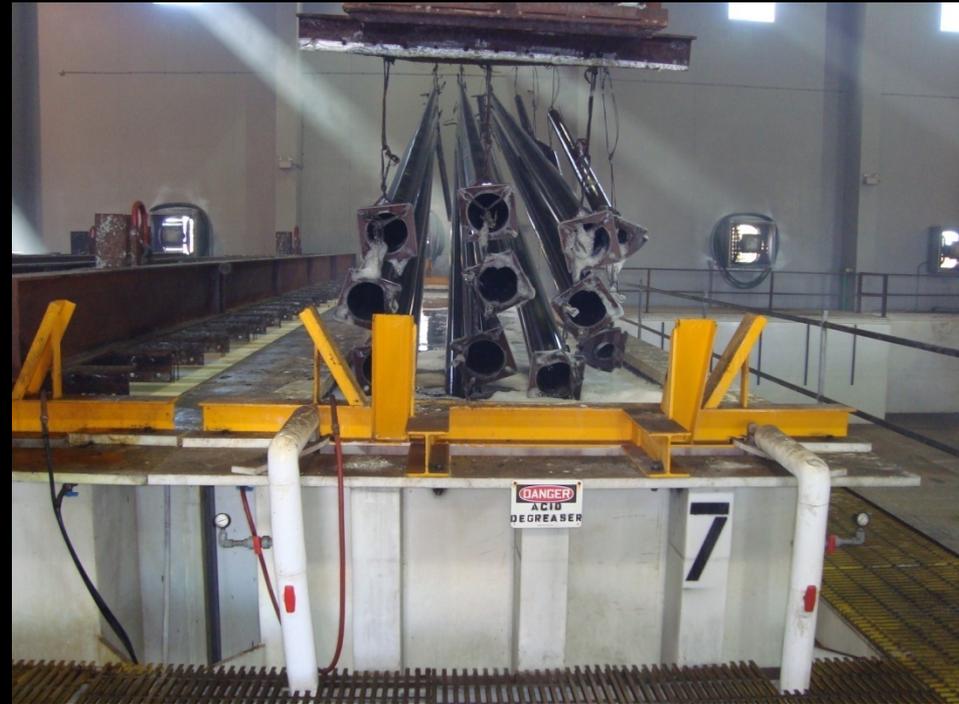
**Degreasing  
Tank**

- Thorough cleaning is necessary as zinc will only adhere to clean steel
  - **Degreasing** – removes dirt, oils, organic residue

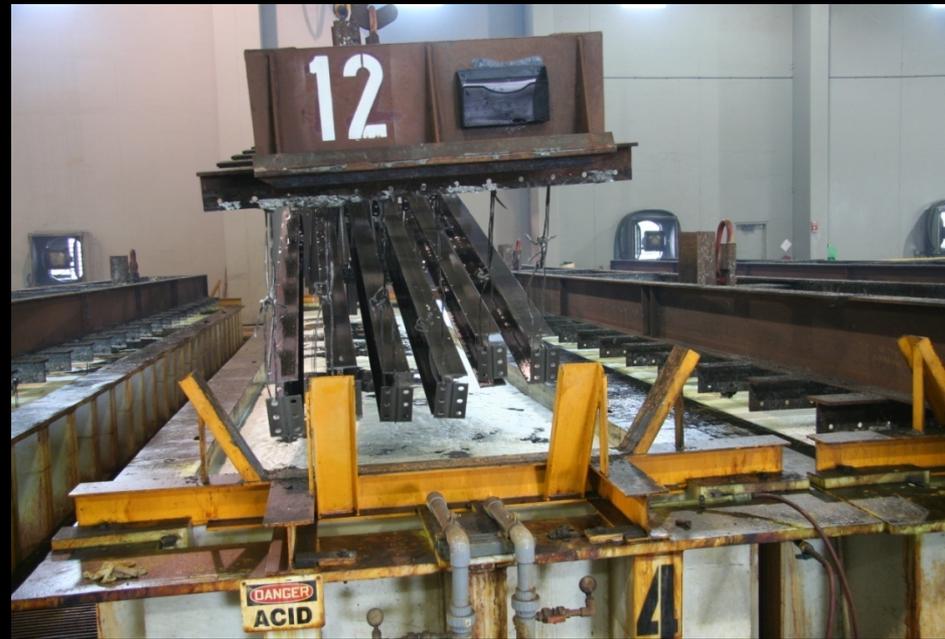
**Pickling Tank**

- Thorough cleaning is necessary as zinc will only adhere to clean steel
  - **Degreasing** – removes dirt, oils, organic residue
  - **Pickling** – Removes mill scale and oxides

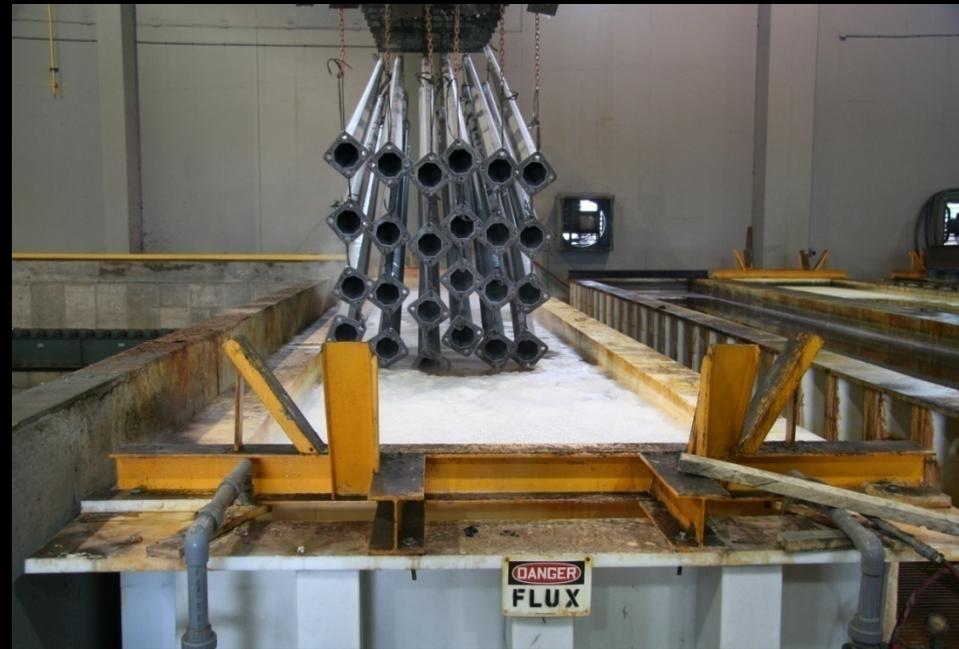
## Flux Tank

- Thorough cleaning is necessary as zinc will only adhere to clean steel
  - **Degreasing** – removes dirt, oils, organic residue
  - **Pickling** – Removes mill scale and oxides
  - **Fluxing** – Mild cleaning, provides protective layer

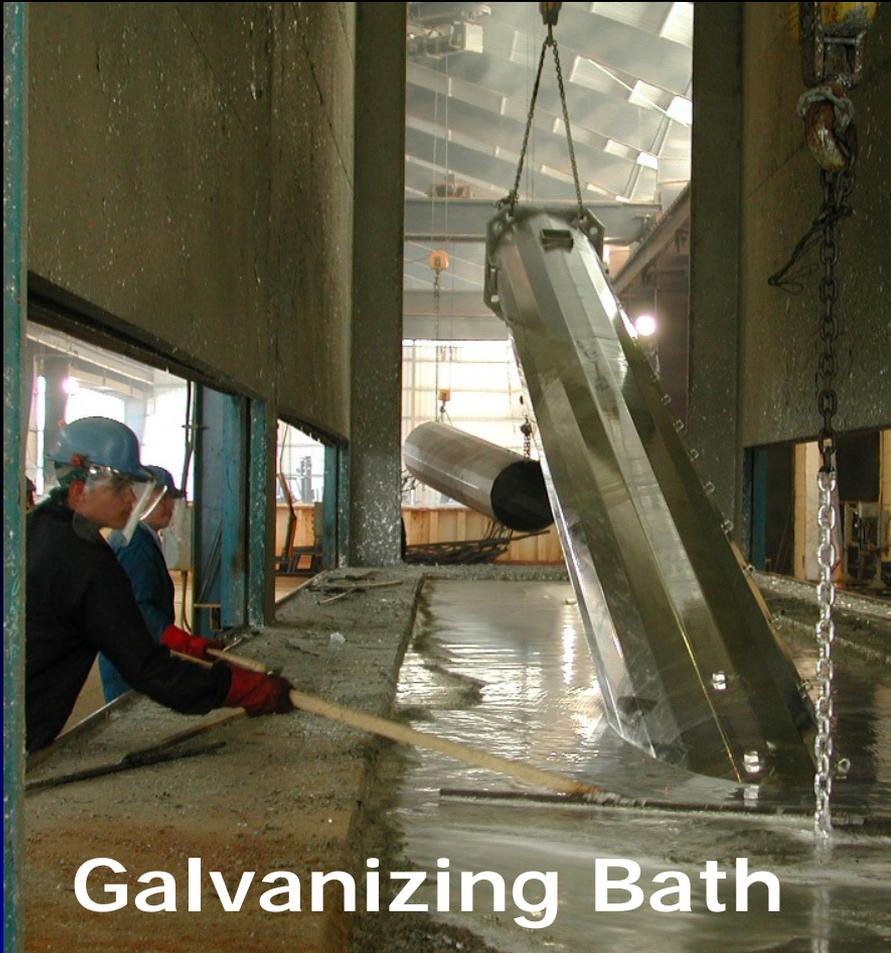
**Galvanizing Bath**

- Steel immersed in bath of molten zinc (~830 F)
- > 98% pure zinc, up to 2% additives (Al, Bi, Ni)
- Zinc reacts with iron in steel to form coating
- Reaction is complete when steel reaches bath temperature

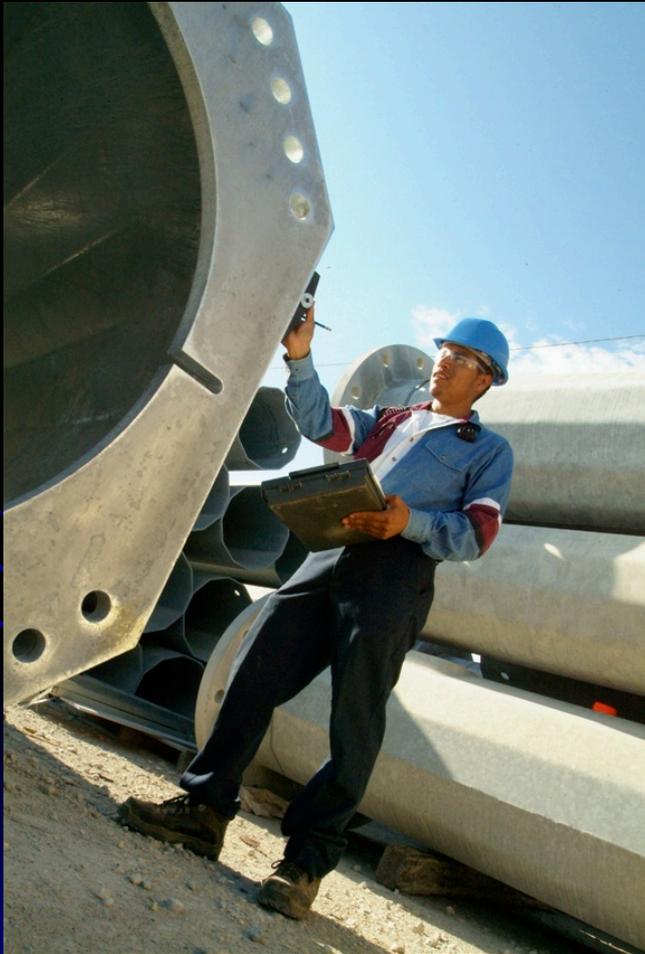
# HDG Process: Inspection

- Steel is inspected after galvanizing to verify conformance to specs
- Visual inspection to identify any surface defects
- Magnetic thickness gauge to check coating thickness

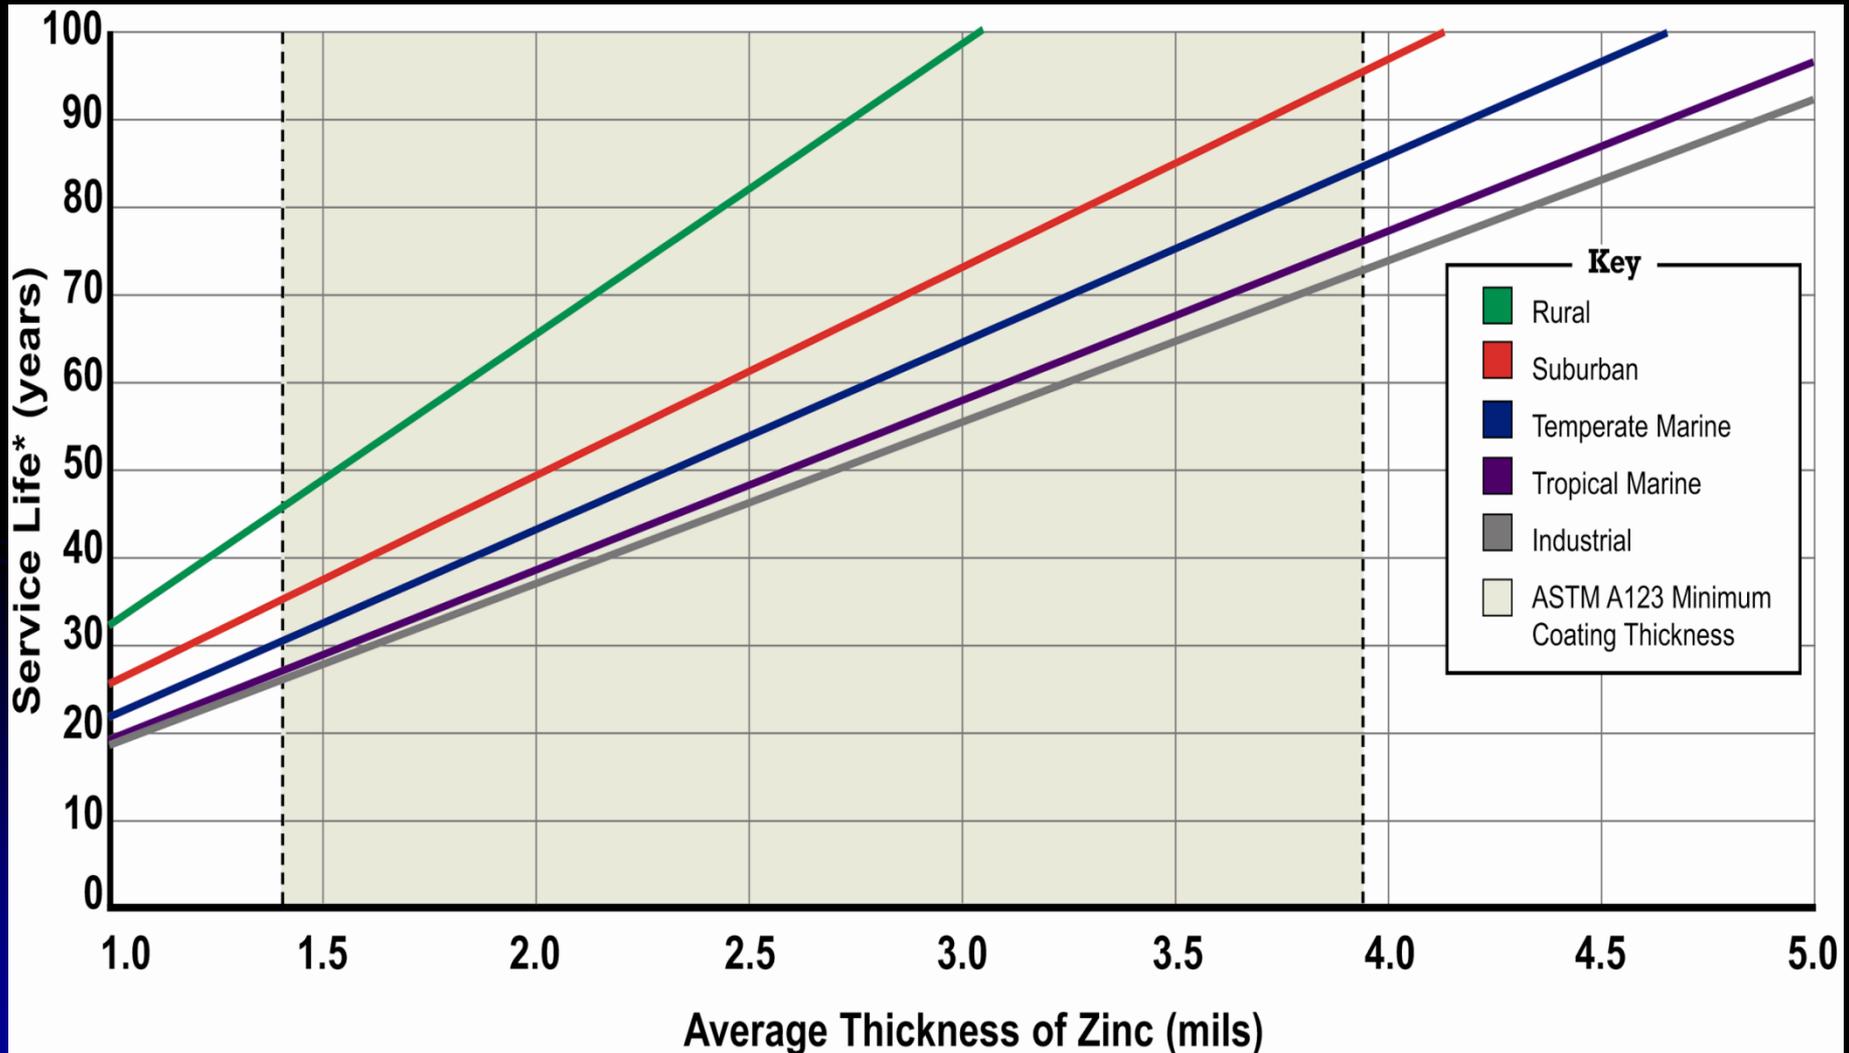
# Estimated Service Life of HDG

\*Service life is defined as the time to 5% rusting of the steel surface. 1 mil = 25.4 $\mu$ m = 0.56oz/ft<sup>2</sup>

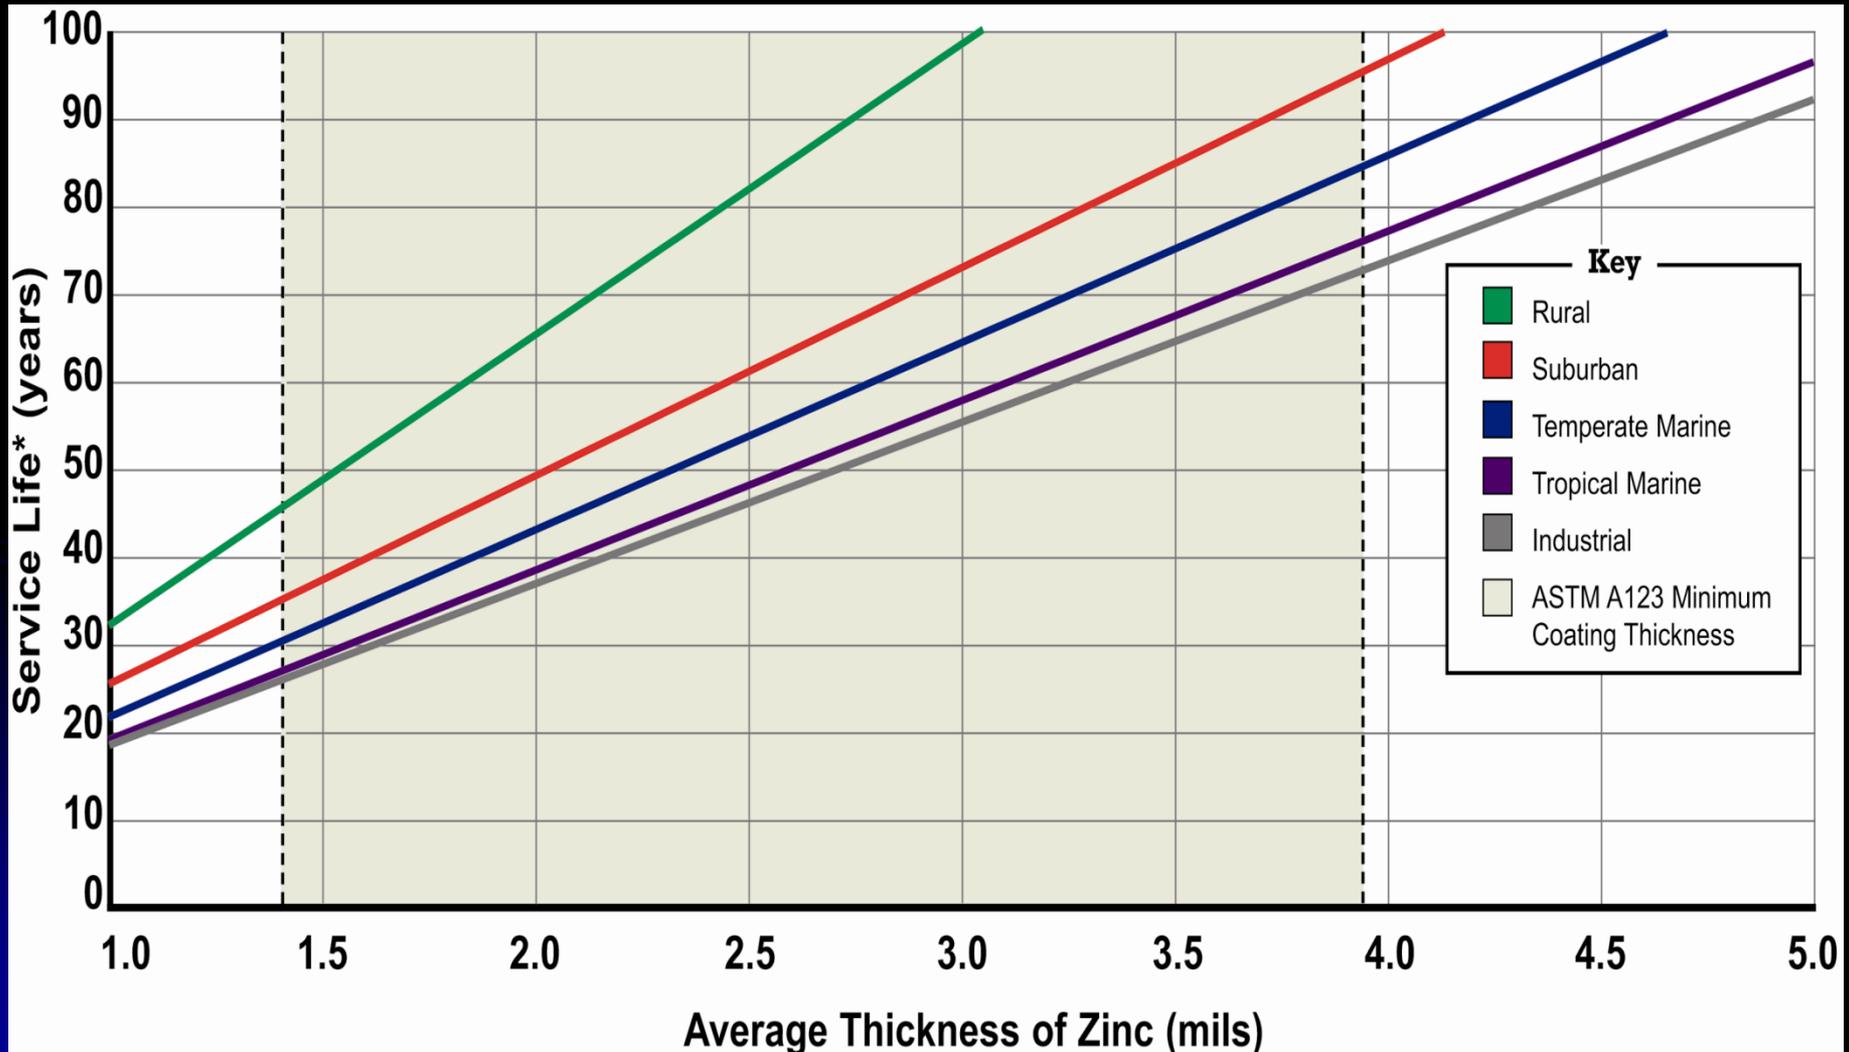
# Estimated Service Life of HDG

\*Service life is defined as the time to 5% rusting of the steel surface. 1 mil = 25.4 $\mu$ m = 0.56oz/ft<sup>2</sup>

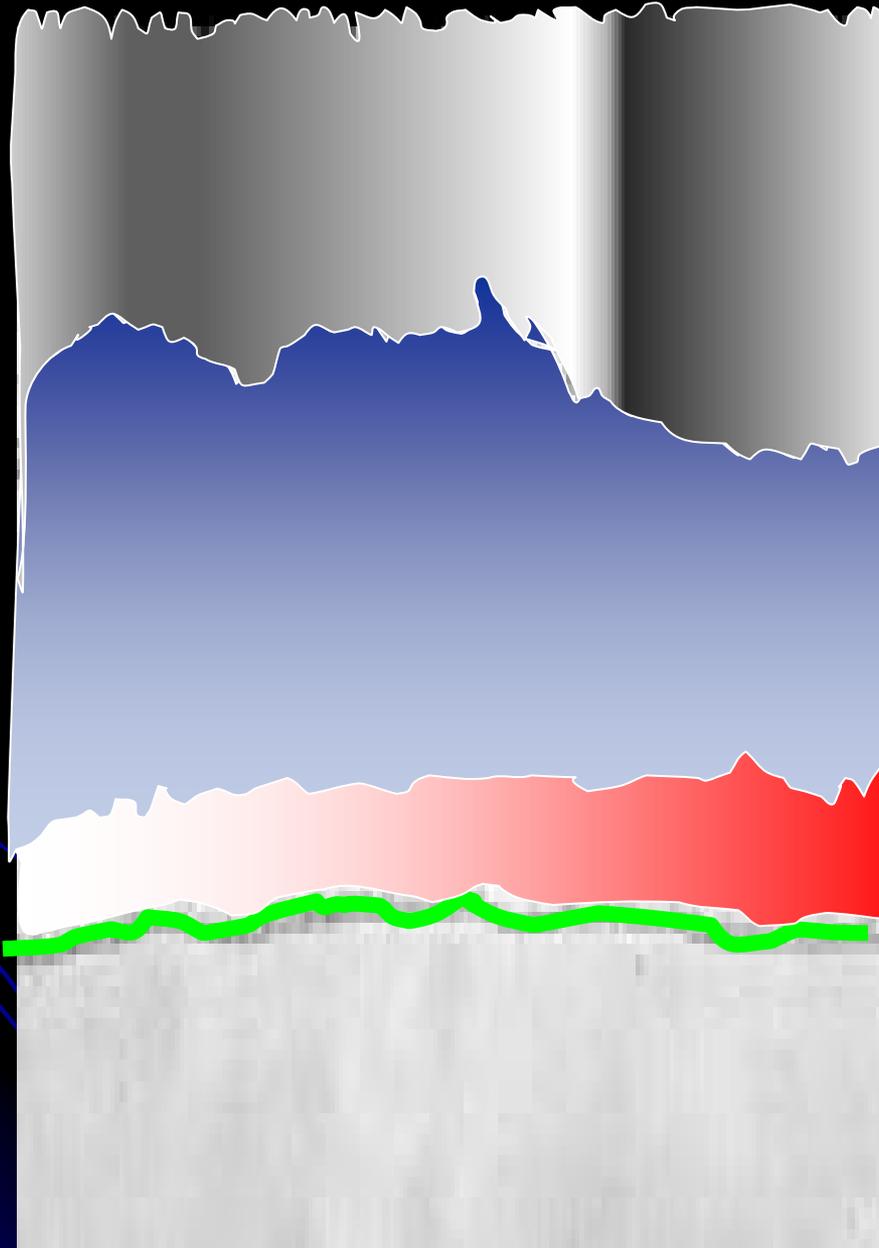
# Metallurgical Bond

Eta

100% Zinc

Zeta

94% Zinc  
6% Iron

Delta

90% Zinc  
10% Iron

Gamma

75% Zinc  
25% Iron

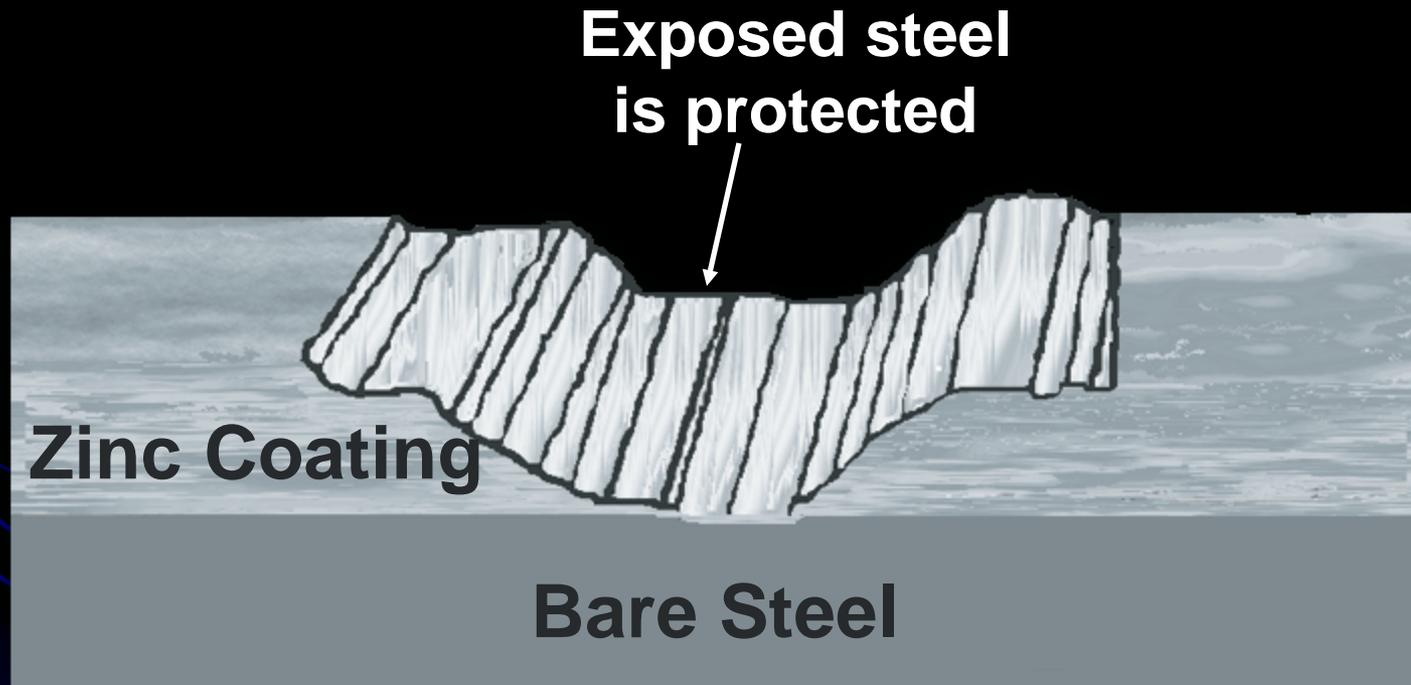
# Cathodic Protection: Sacrificial Zinc

**Even damaged areas of the coating will be  
cathodically protected by surrounding zinc**

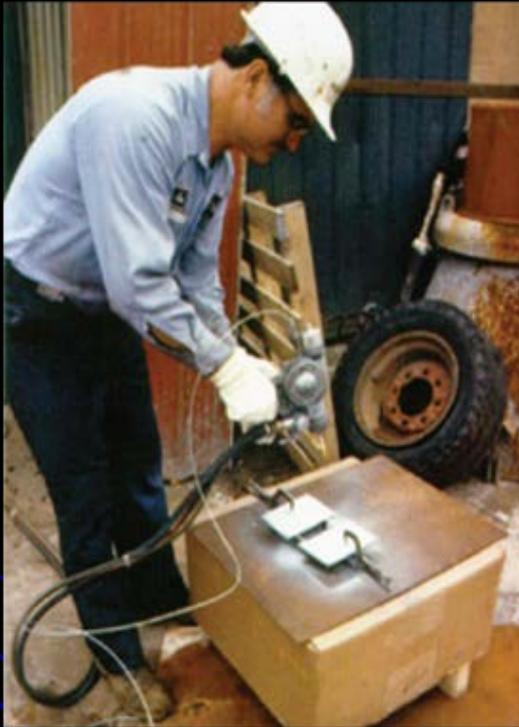
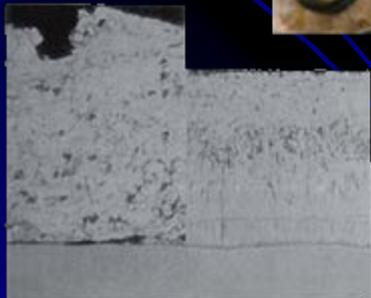
# Metallizing

- Zinc wire or powder melted and sprayed onto the surface
- Shop or field application
- 85% as dense as HDG
- Mechanical bond and no alloy layers

Metallized

Hot Dip Galvanized

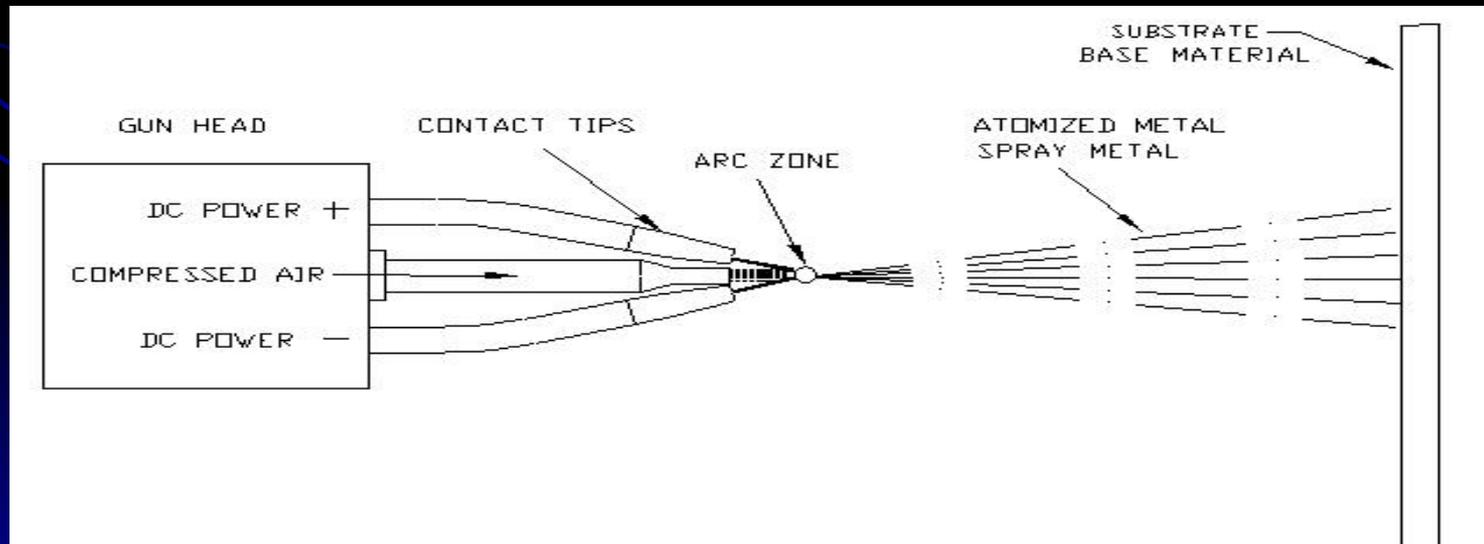
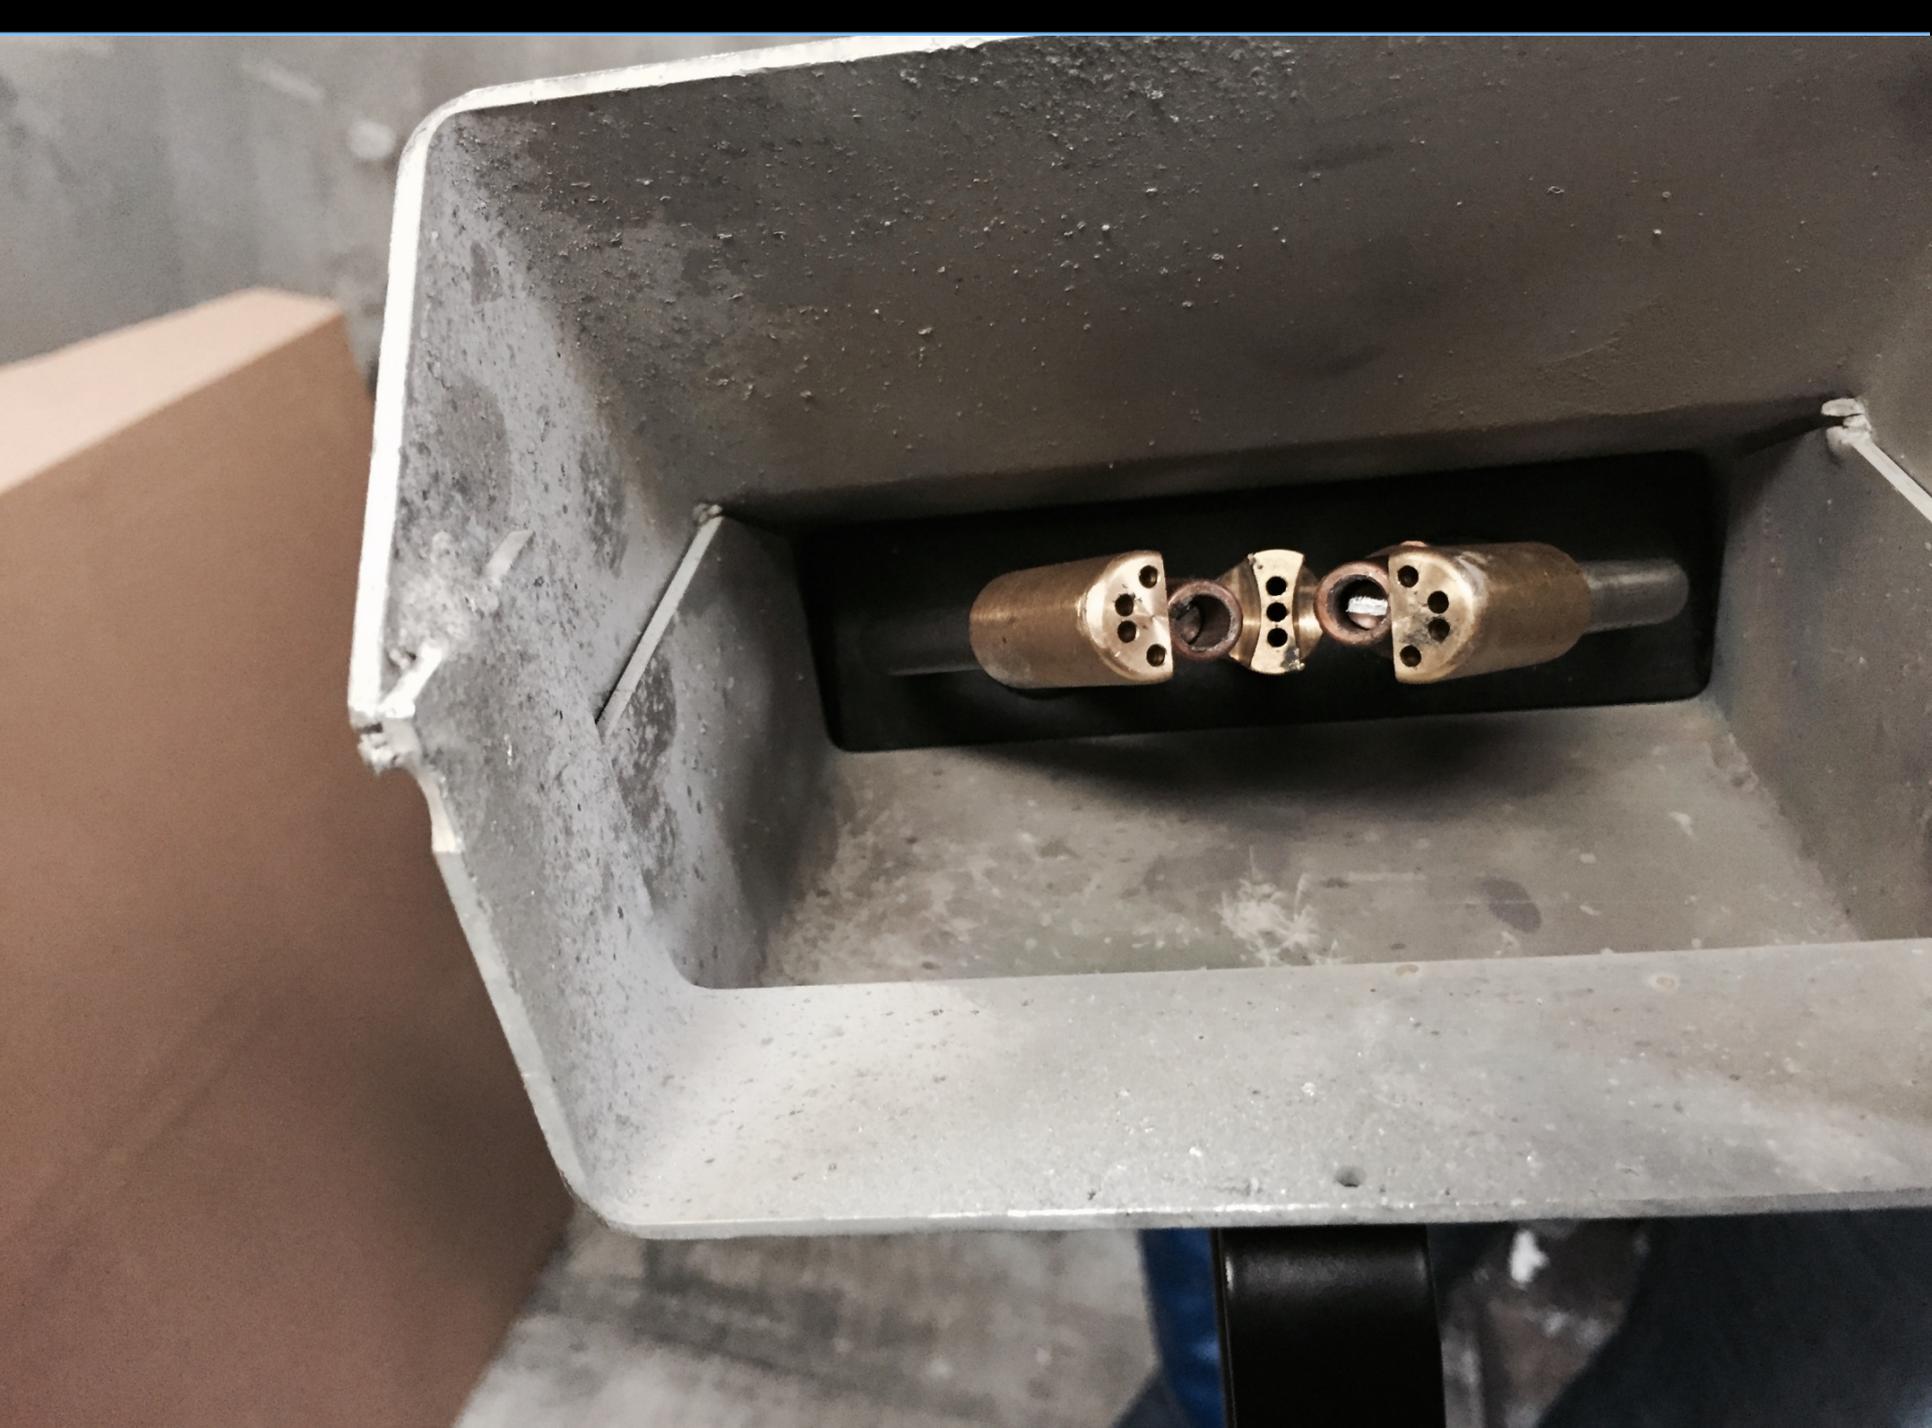
# Twin Wire Arc Process Description

Electrically Charged Wires, one Positive and the other Negative

**Charged Wires Meet at the Gun Head and Create an Arc**

**Molten Metal Propelled to Substrate with Compressed Air**

**Molten Metal Solidifies in flight /Rapidly Cools on Contact with Substrate to Form Protective Sacrificial Coating**

**Substrate Heating Minimal (Thin Coating, Thick Substrate)**

**No Cooling or Curing of Coating Required (Ready for Immediate Service)**

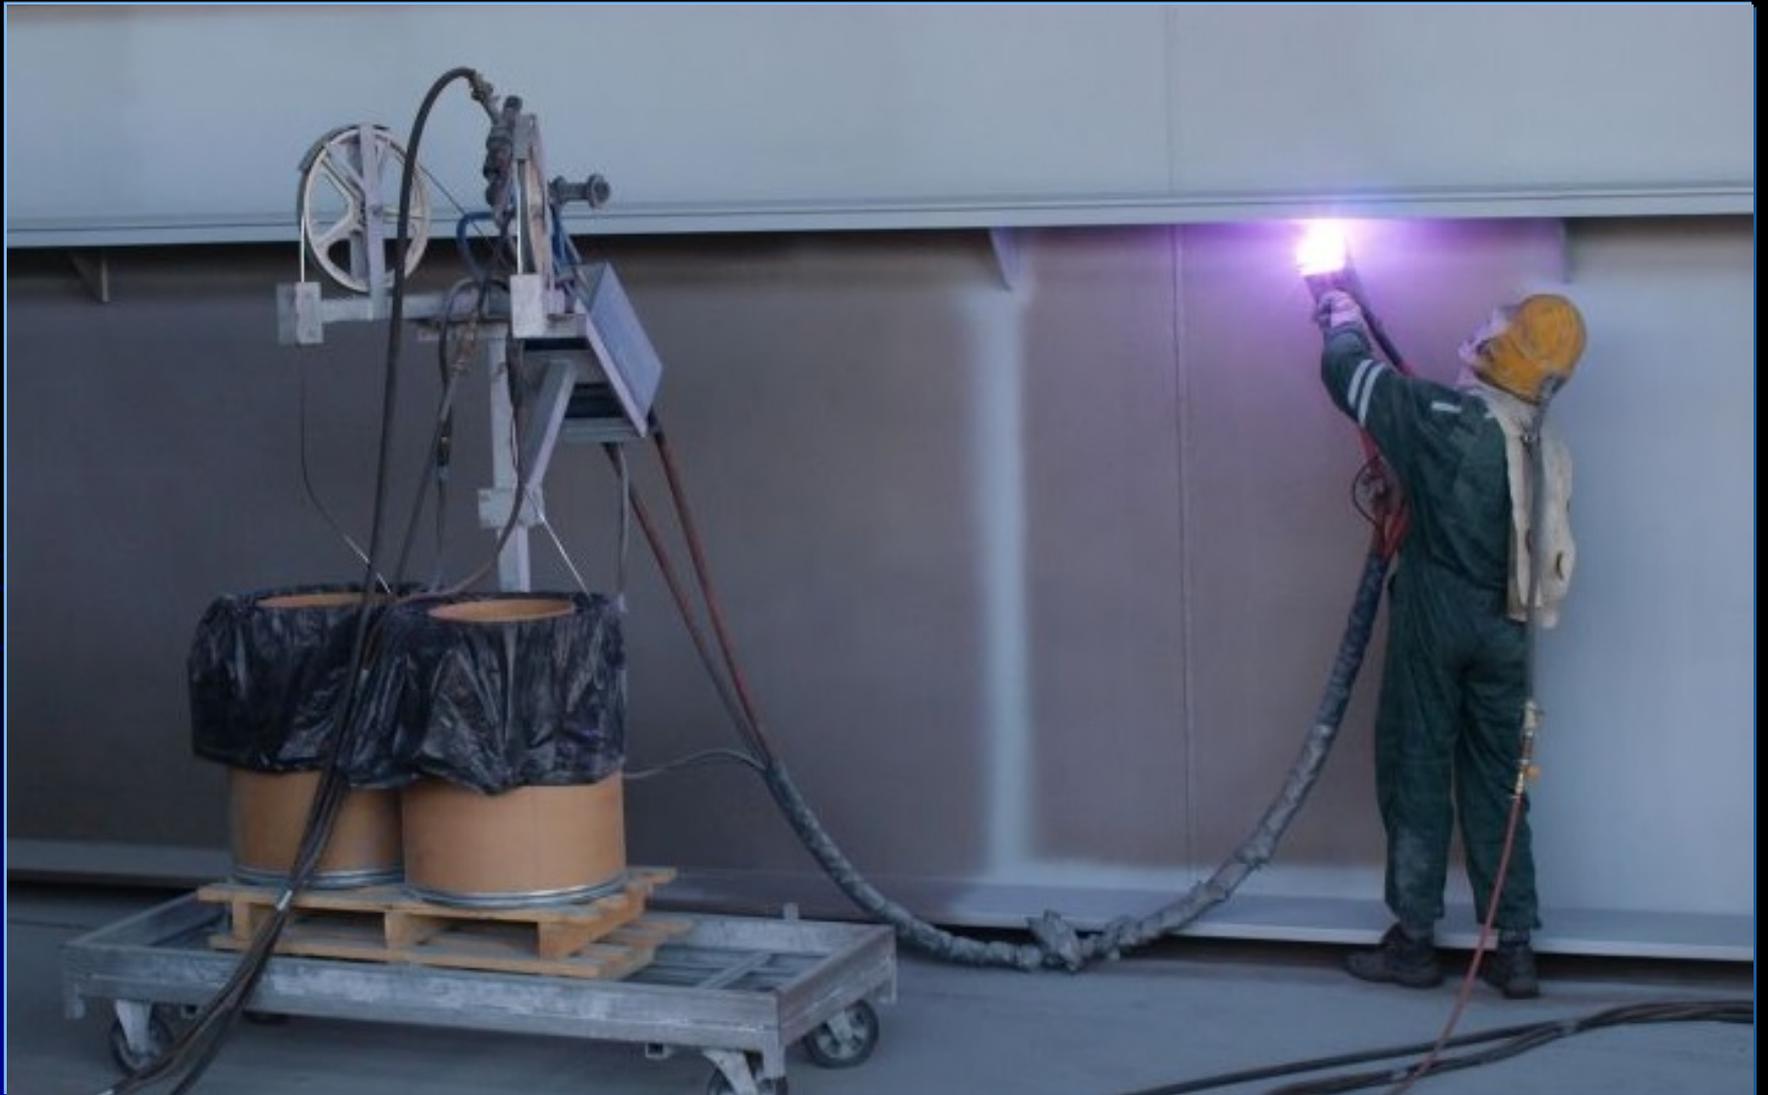
# Surface Prep

(Coating Adheres thru a Pure Mechanical Nature)

- SP 5/ SP 10, White Metal or Near White Metal Blast
- Anchor Profile is needed –Min. 3mils
- No Contaminants Present
- Sharp Angular Grit, No Round Shot
- Garnet, Kleen Blast, Green Diamond, Aluminum Oxide to name a few

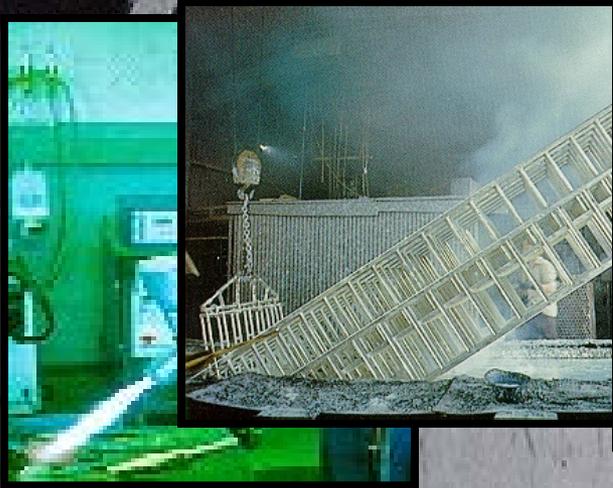
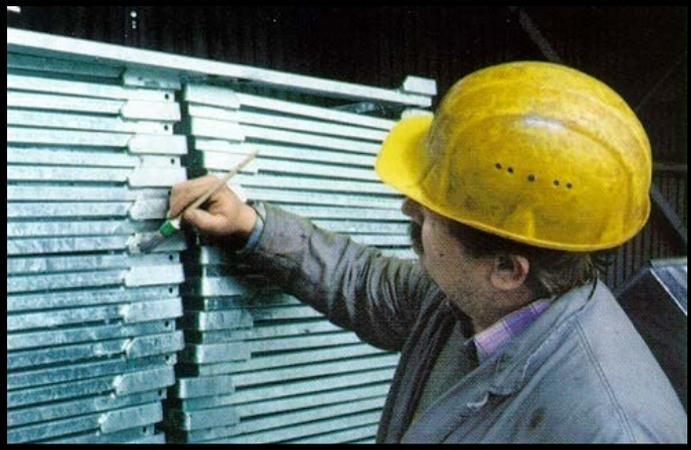
# Other Zinc Coatings

Metallized  
Hot-Dip  
Galvanized

ized  
Electroplated

1 mil

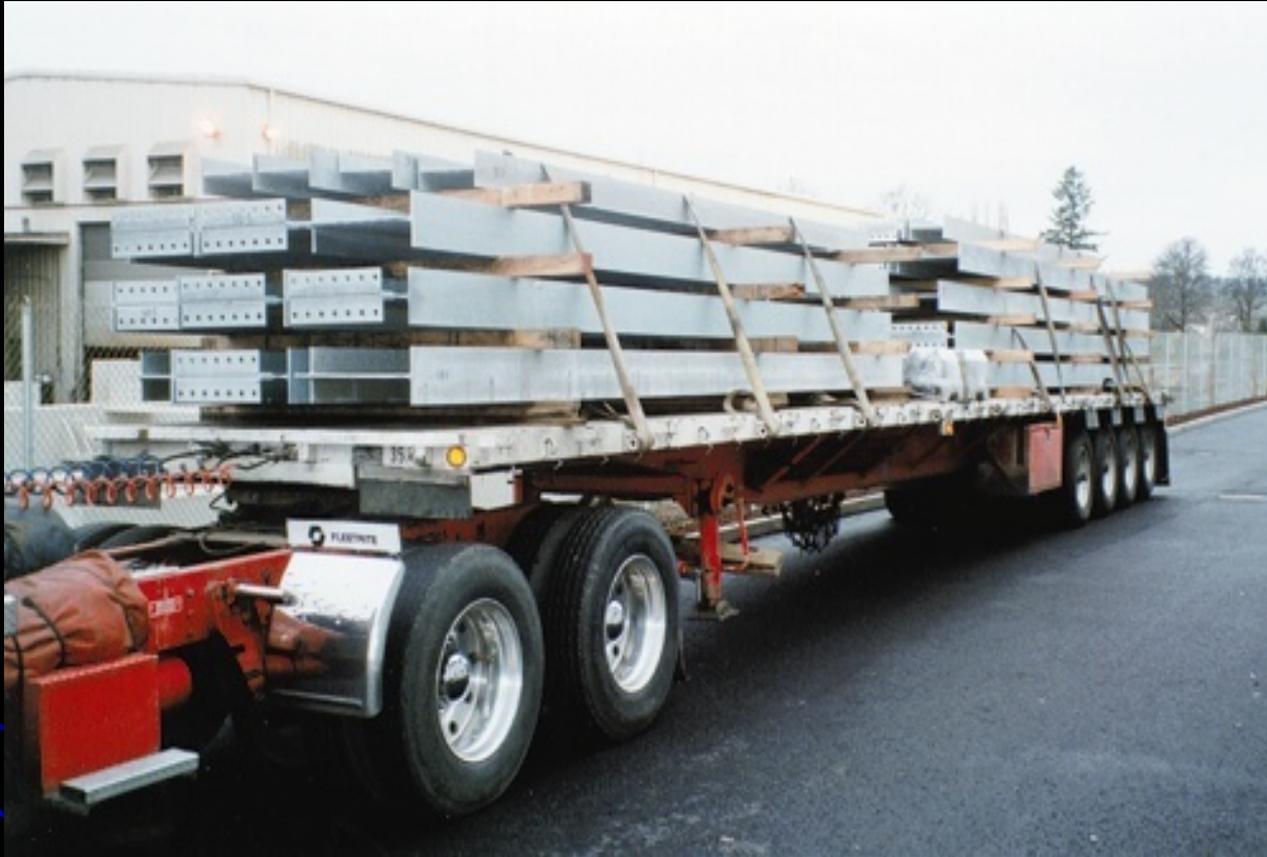
# ASTM A 123

**Coatings on Iron &  
Steel Products**
