# AZZ Galvanizing Services

# The Corrosion Problem

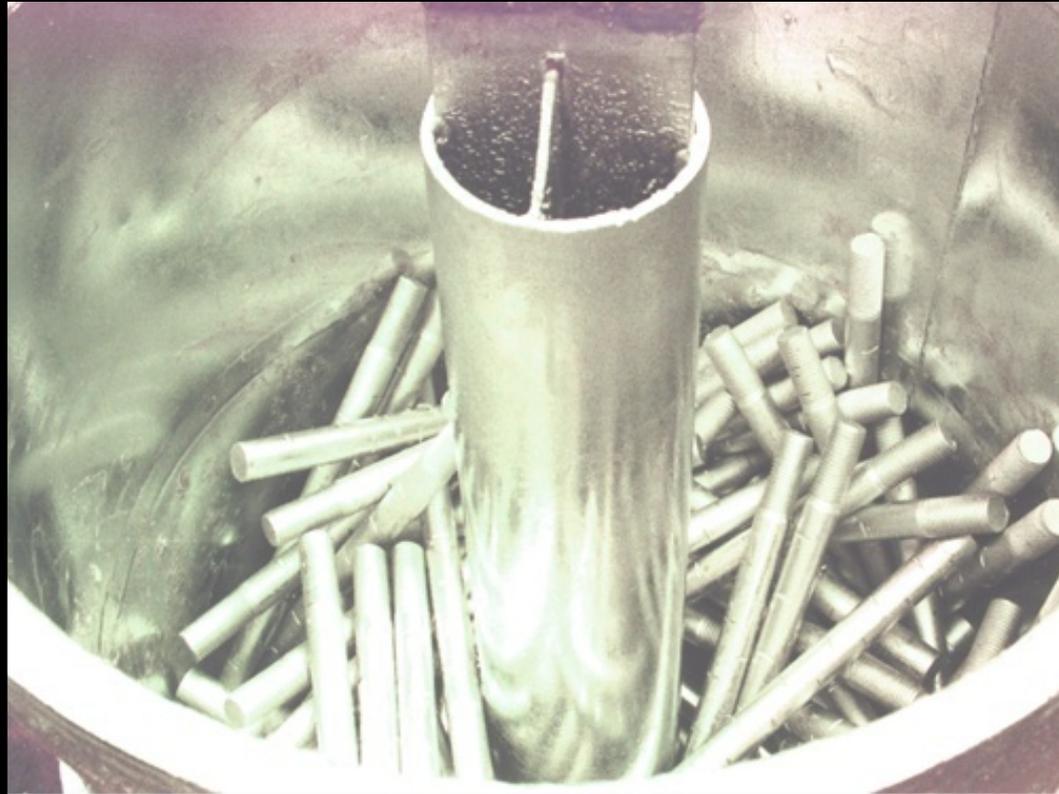
# *ASTM A 153*

**Coatings on Iron &  
Steel Hardware**

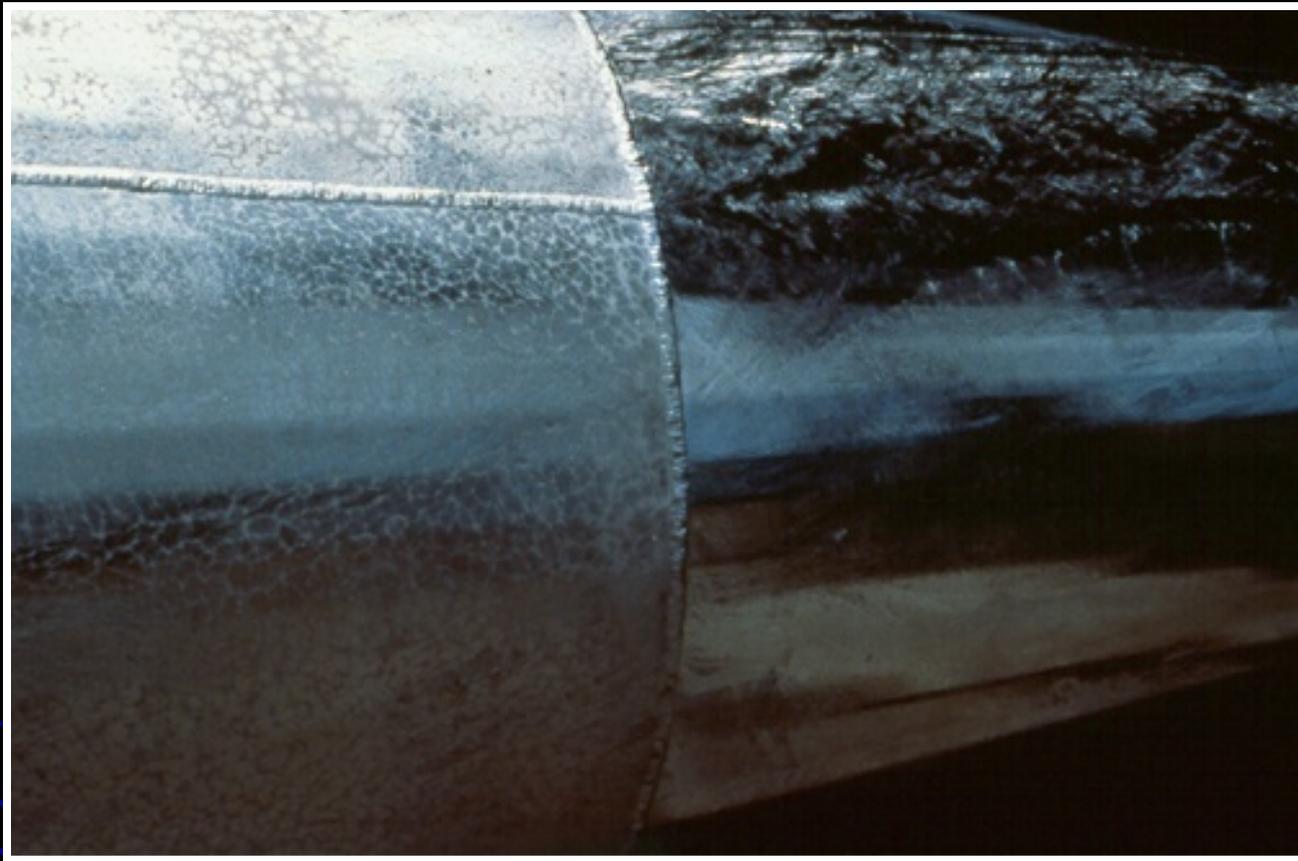
# *ASTM A 385*

**Providing High-Quality  
Zinc Coatings**

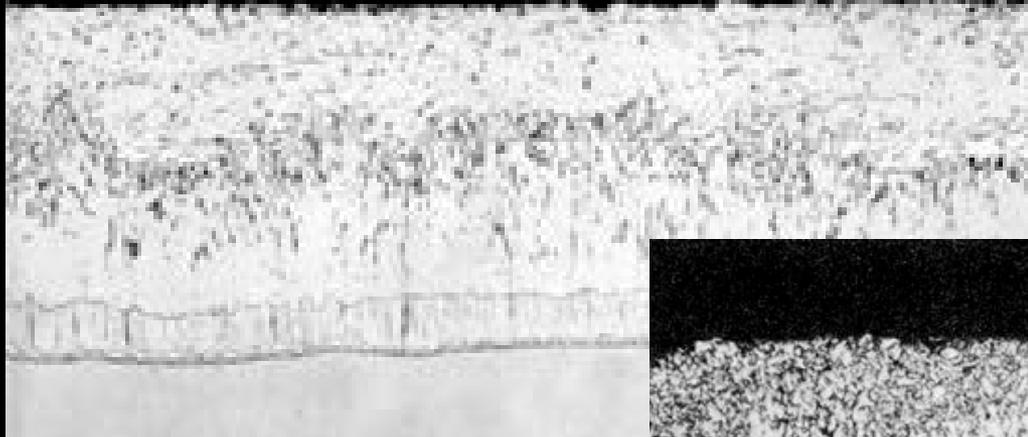
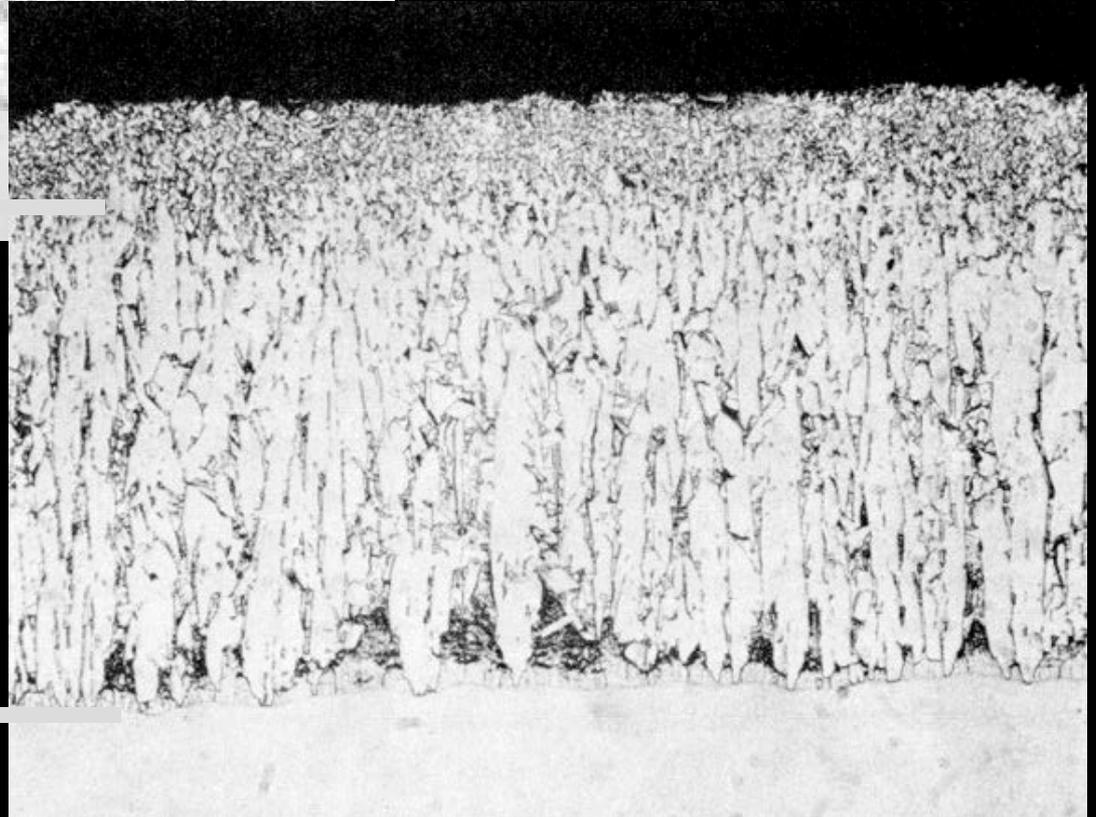
# Typical Zinc-Iron Alloy Layers

Irregular  
Zinc-Iron  
Alloy Layers

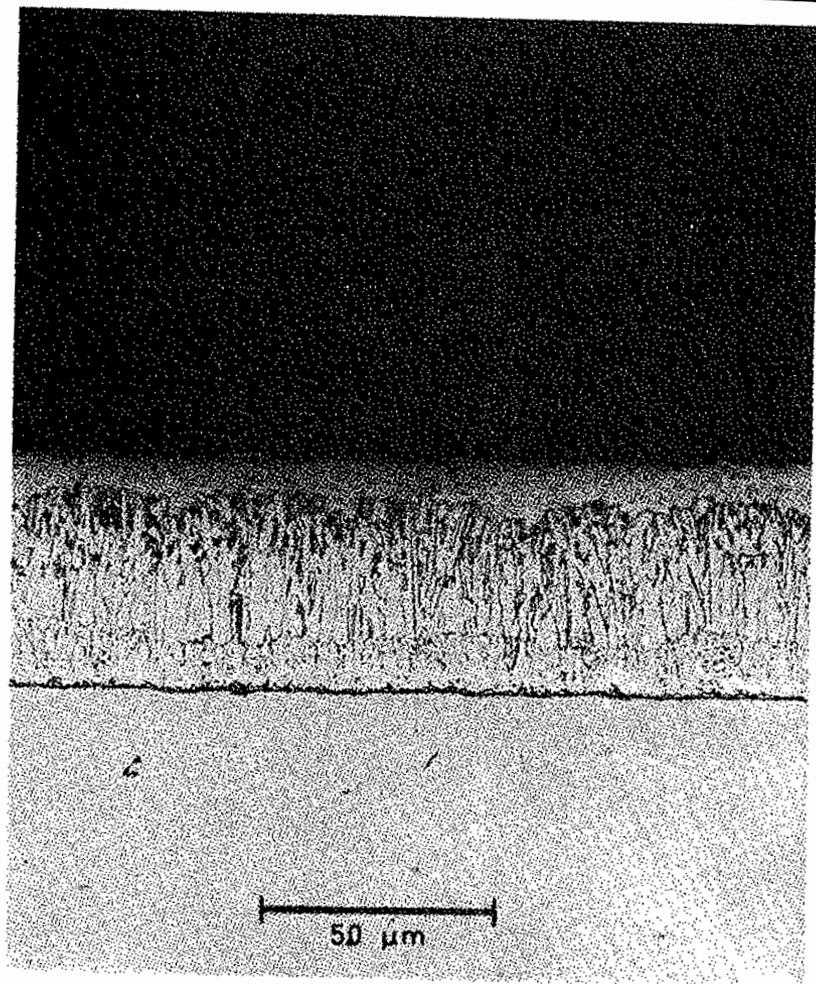
0.3% Si

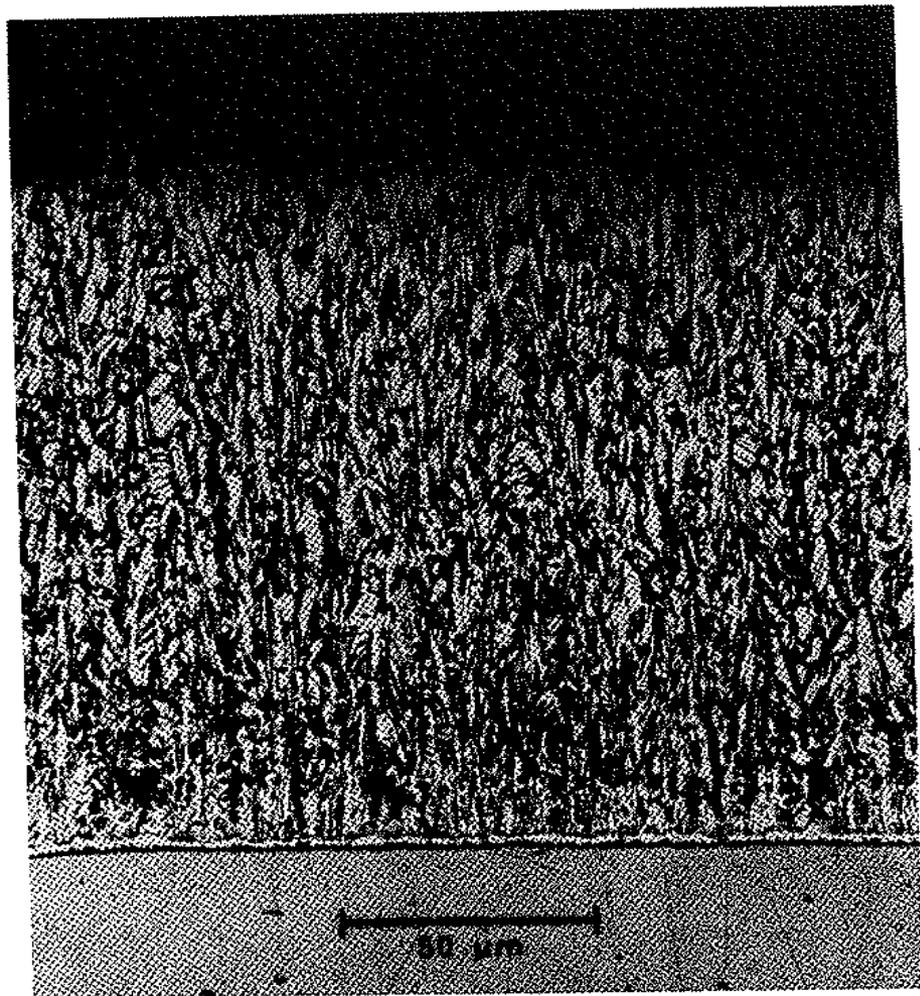
10% Si

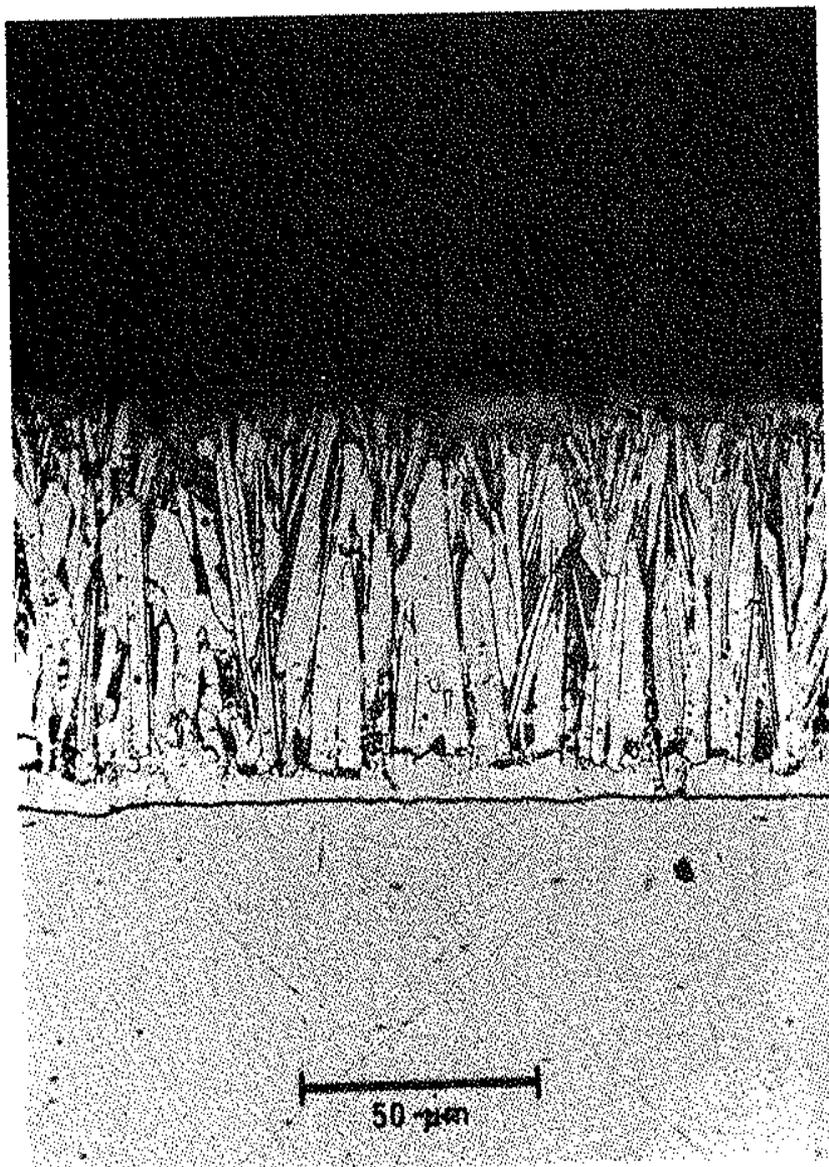
.24% Si

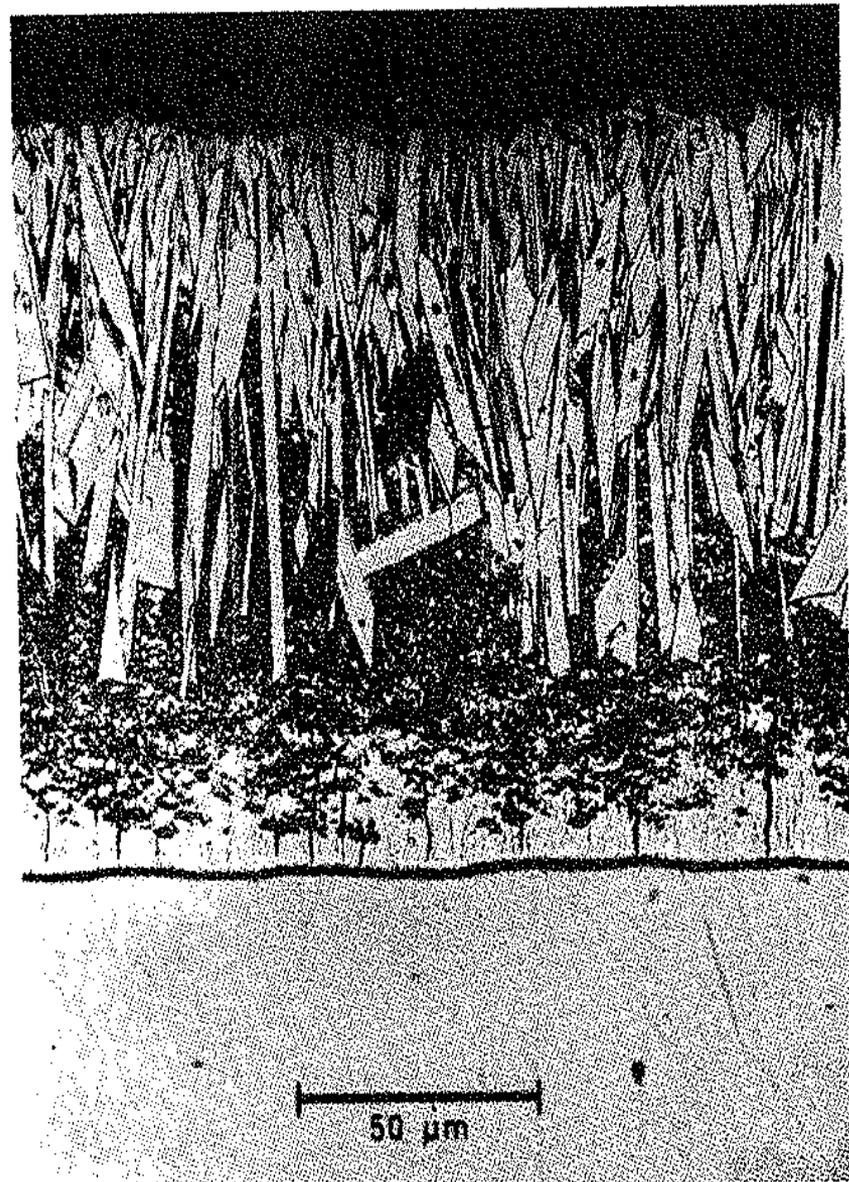
.44% Si

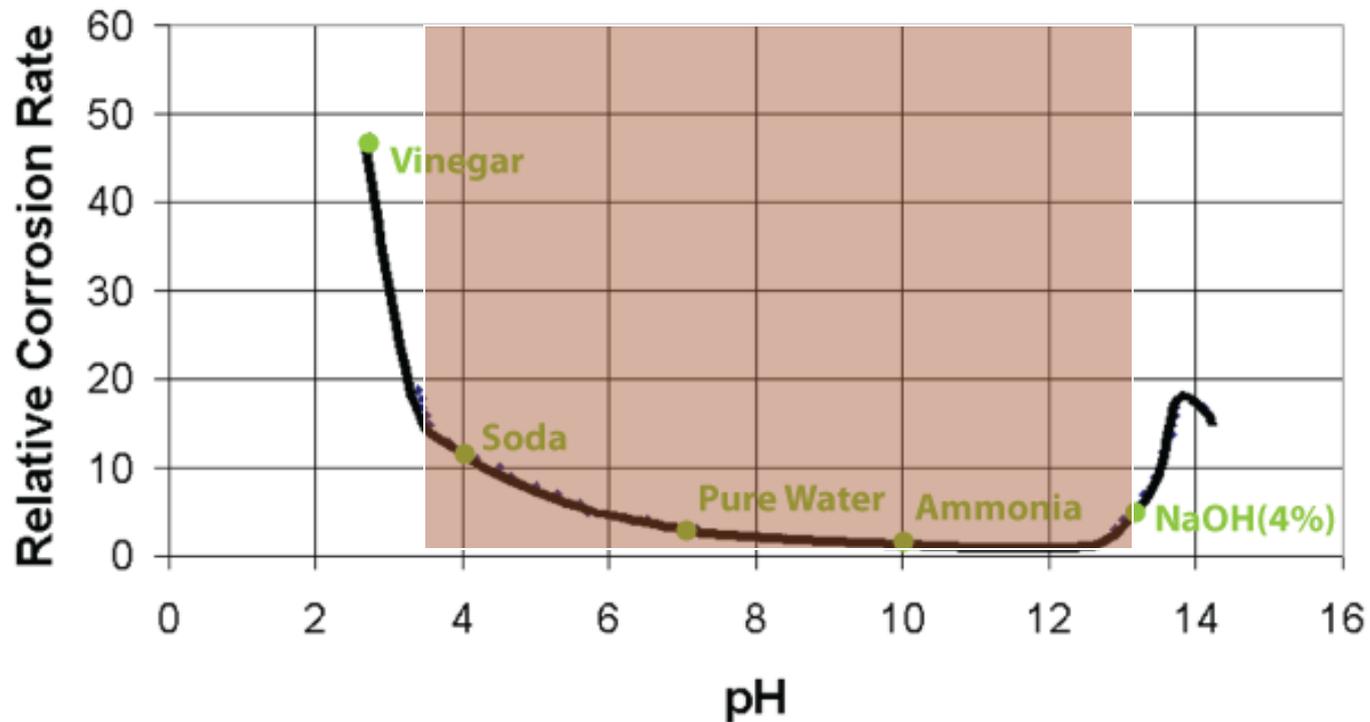
## Corrosion Rate of Zinc vs. pH

# Electrochemical Corrosion Zone

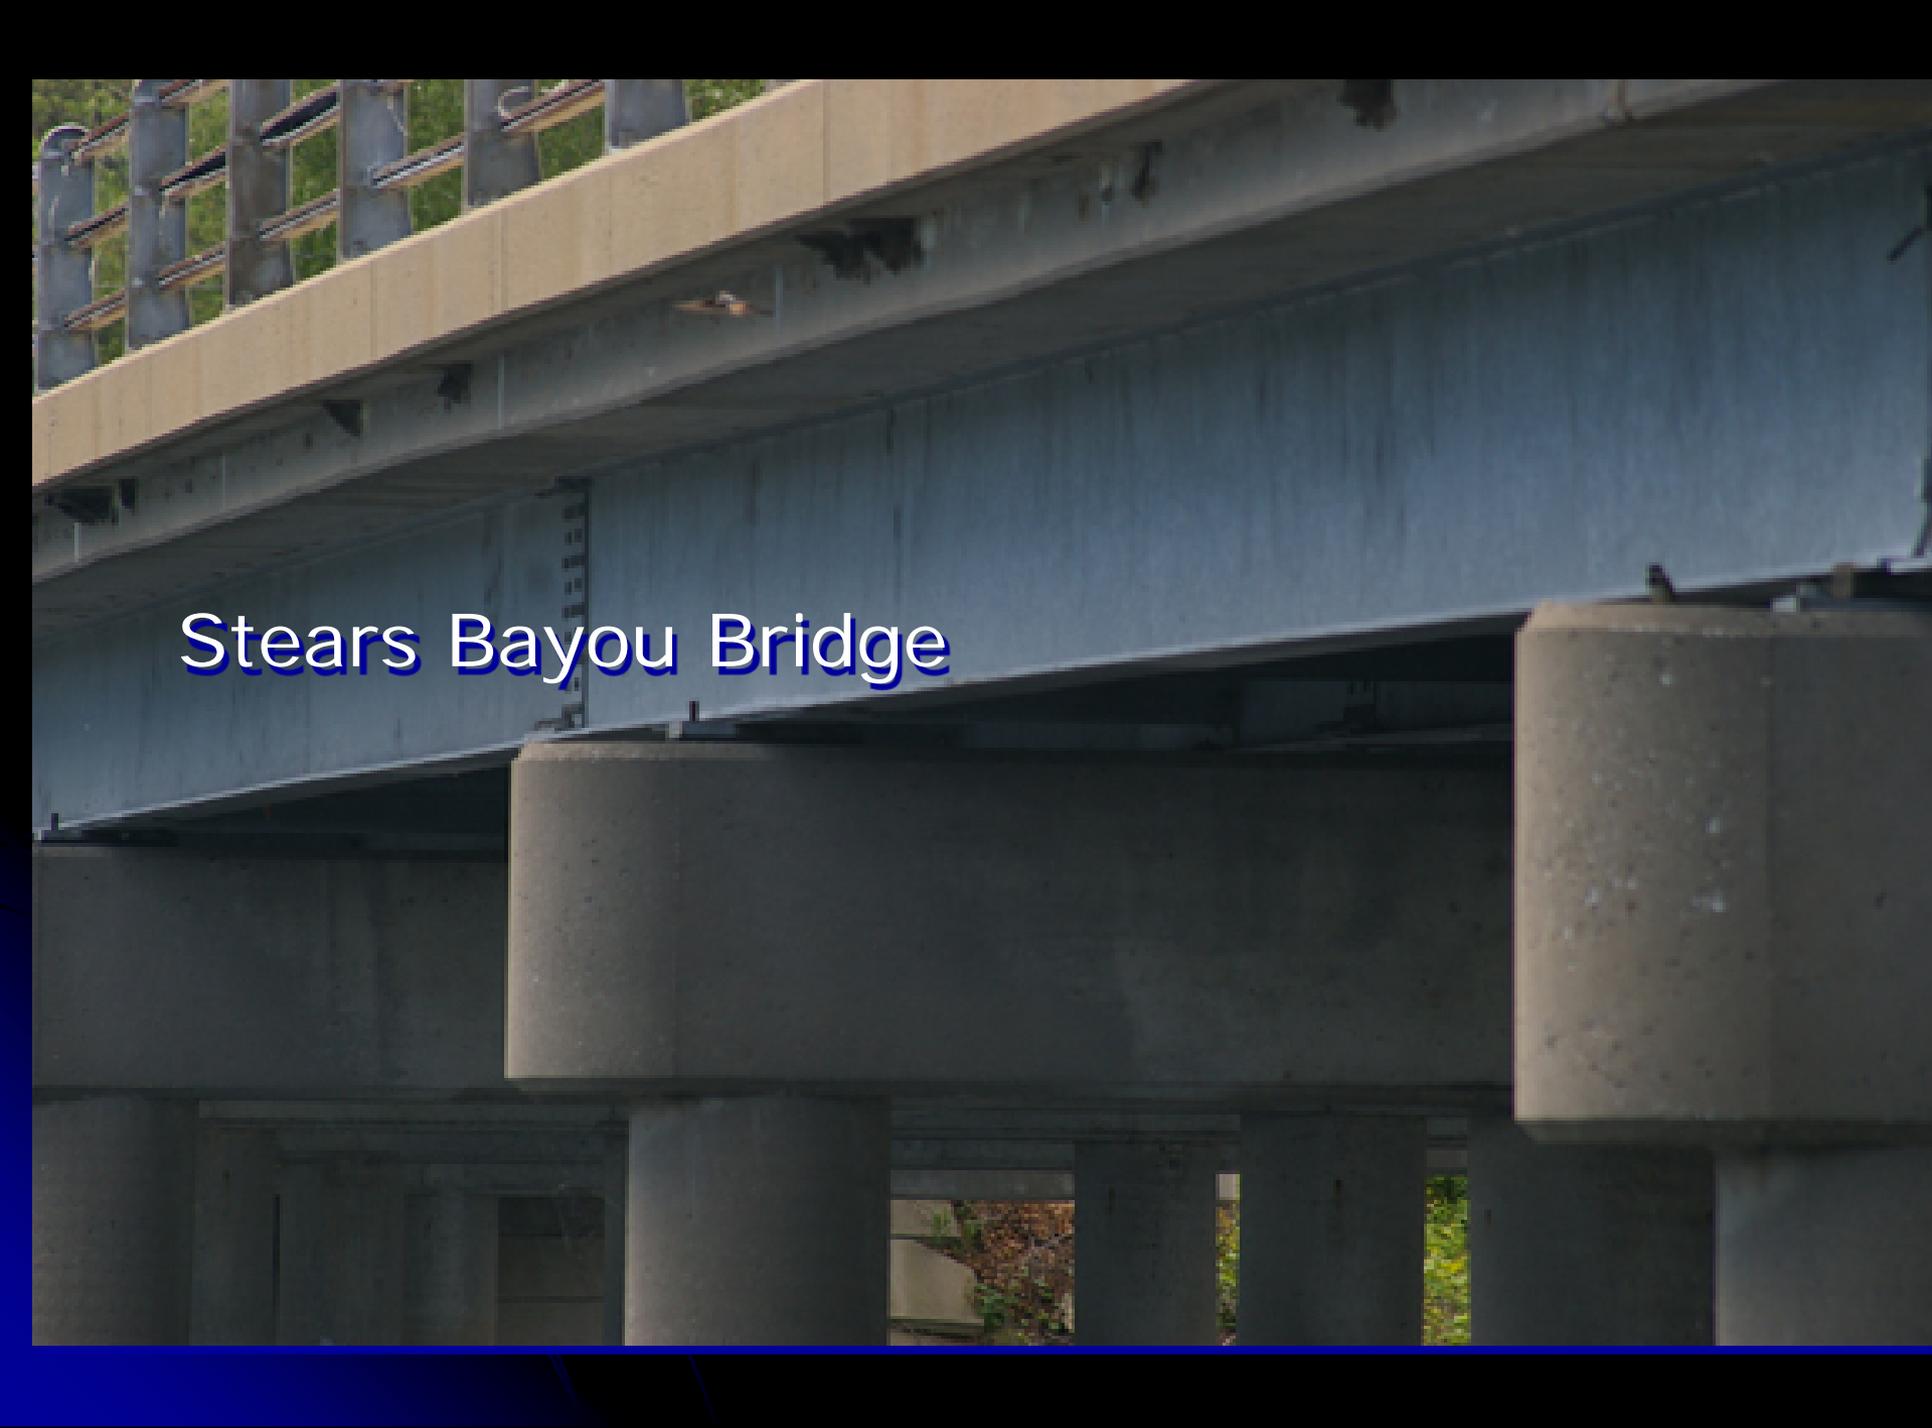
# Stears Bayou Bridge

A photograph of the Stears Bayou Bridge, showing its concrete structure and support pillars. The bridge is a multi-level concrete structure with a prominent horizontal beam and several vertical support pillars. The image is taken from a low angle, looking up at the bridge. The text "Stears Bayou Bridge" is overlaid in the center-left of the image.

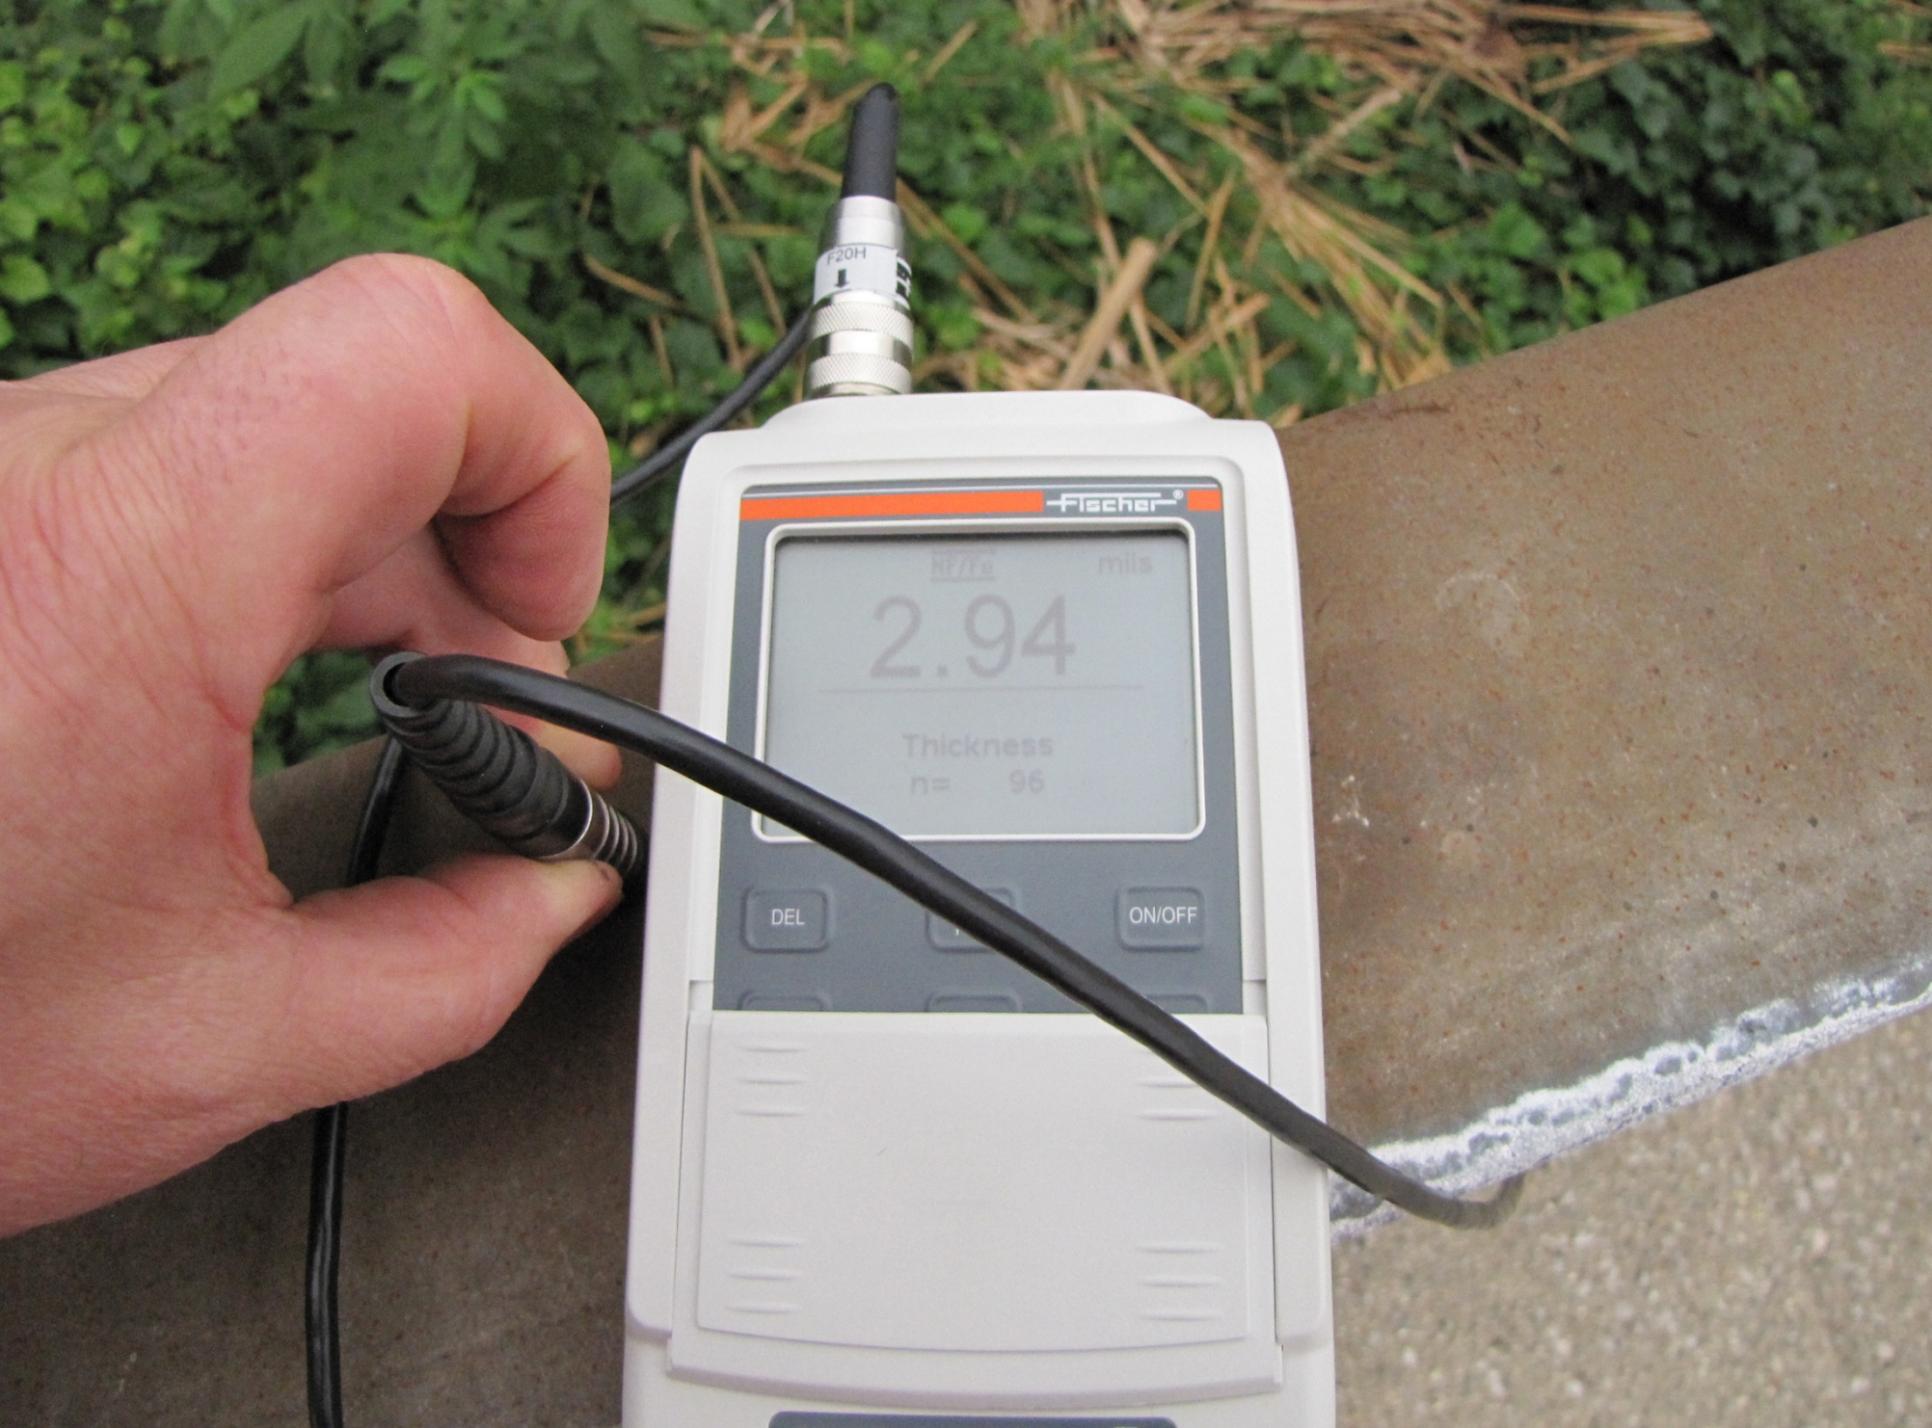
Fischer®

HV/1a mils

2.94

Thickness  
n= 96

- Steel is inspected after galvanizing to verify conformance to specs
- Visual inspection to identify any surface defects
- Magnetic thickness gauge to check coating thickness

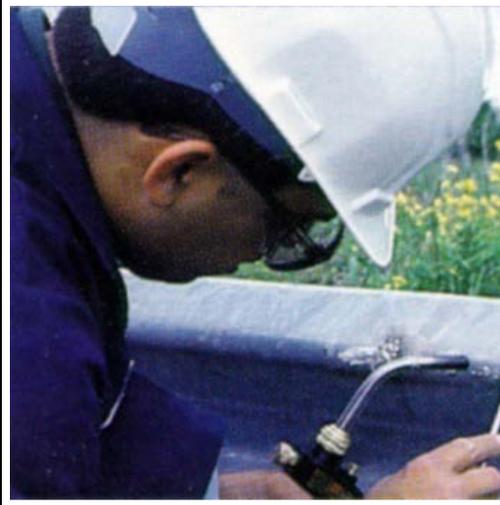
Zinc-Based Alloys

**Repair of Damaged & Uncoated  
Areas of Hot-Dip  
Galvanized Coatings**

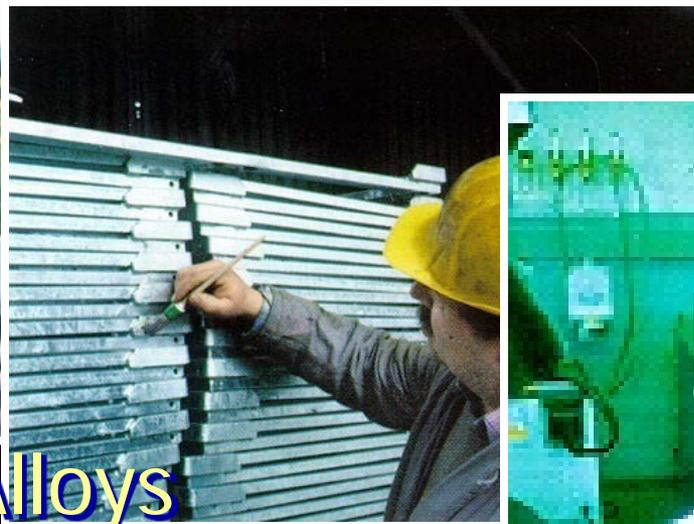
Zinc Dust Paint

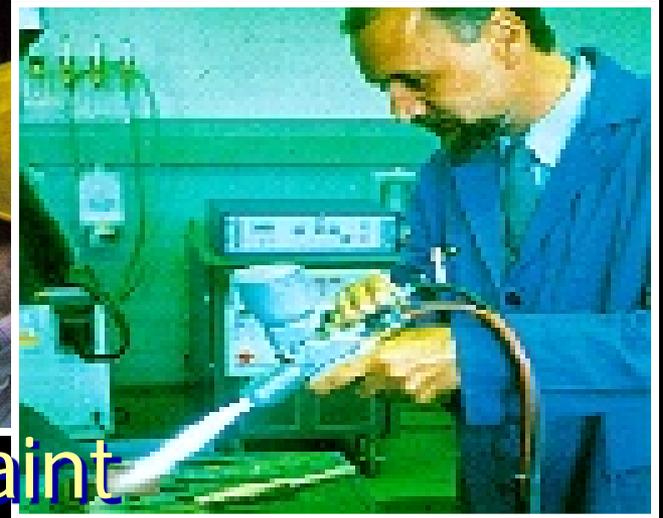
Metallizing

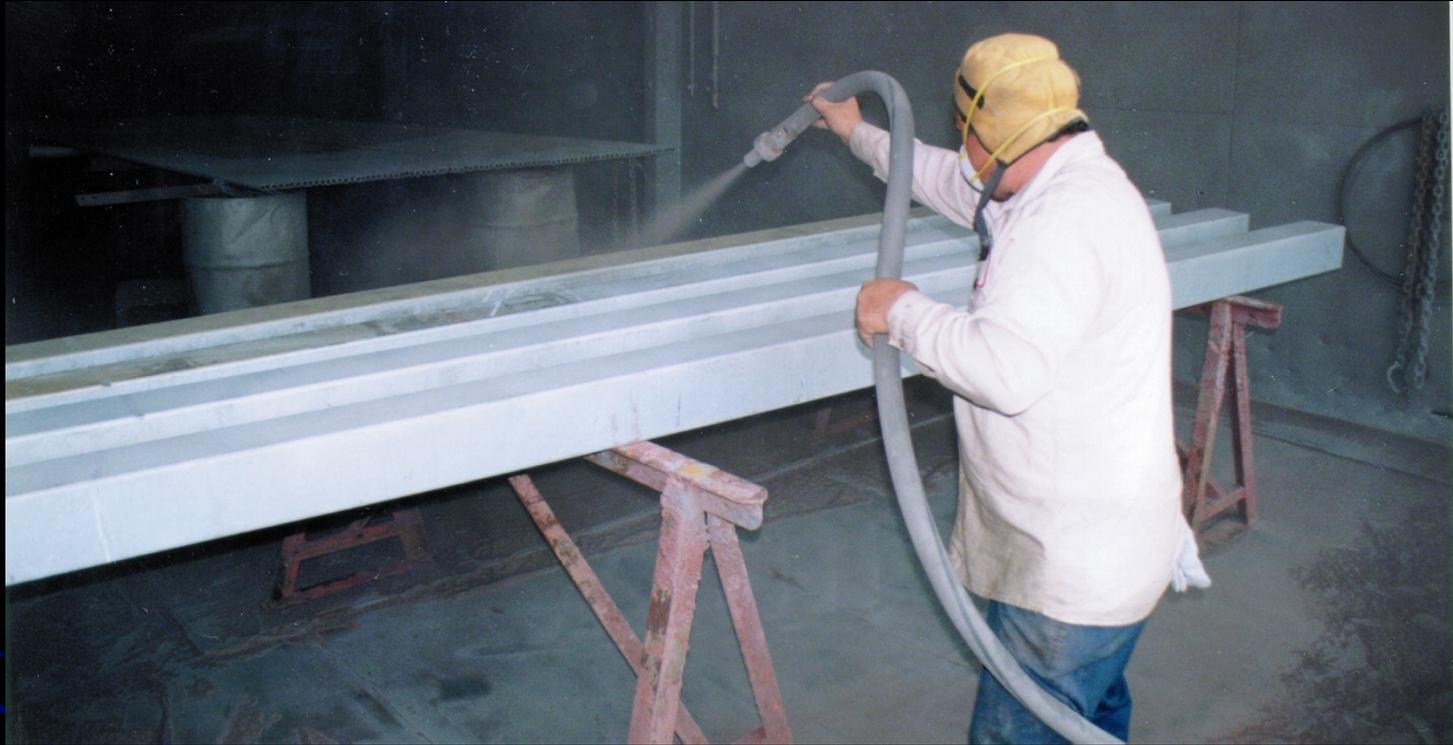
# ***ASTM D 6386***

**Standard Practice for Preparation of Zinc  
(Hot-Dip) Galvanized Coated Iron &  
Steel Product & Hardware Surfaces  
for Painting**

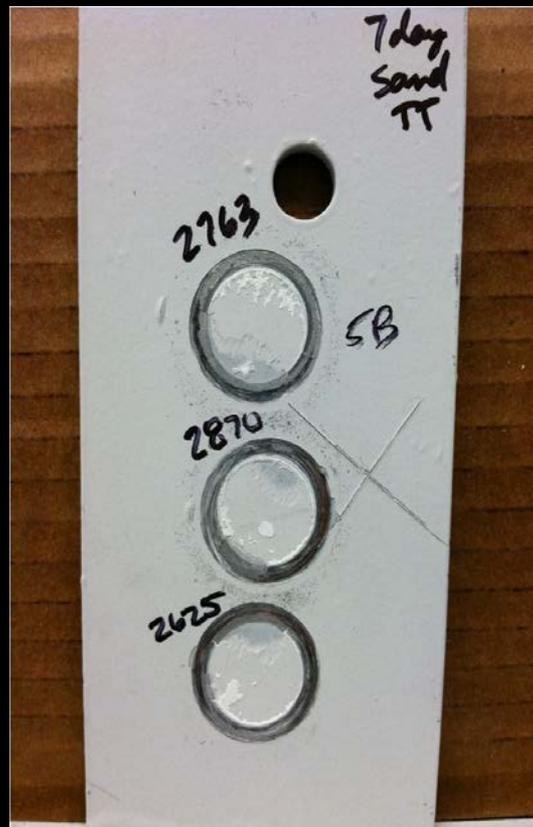
# Adhesion of Coatings to Galvanizing
