Framework for Concrete Bridge Deck Management Practices in Utah

W. Spencer Guthrie, Ph.D., M.ASCE Professor Department of Civil and Environmental Engineering Brigham Young University

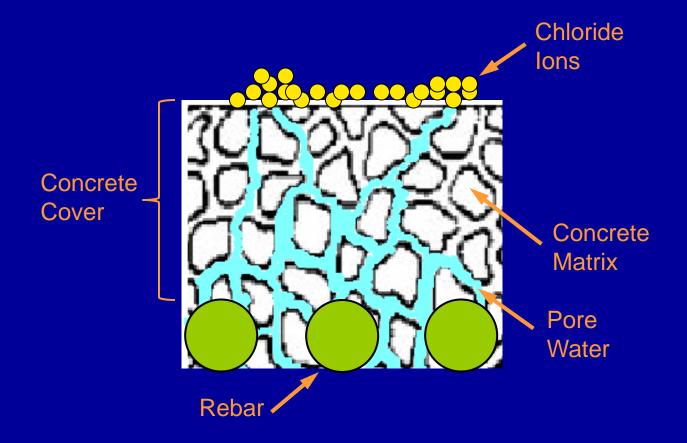
Chloride Diffusion

Corrosion threshold for black bar = $2.0 \text{ lb } \text{Cl}^{-}/\text{yd}^{3}$ of concrete

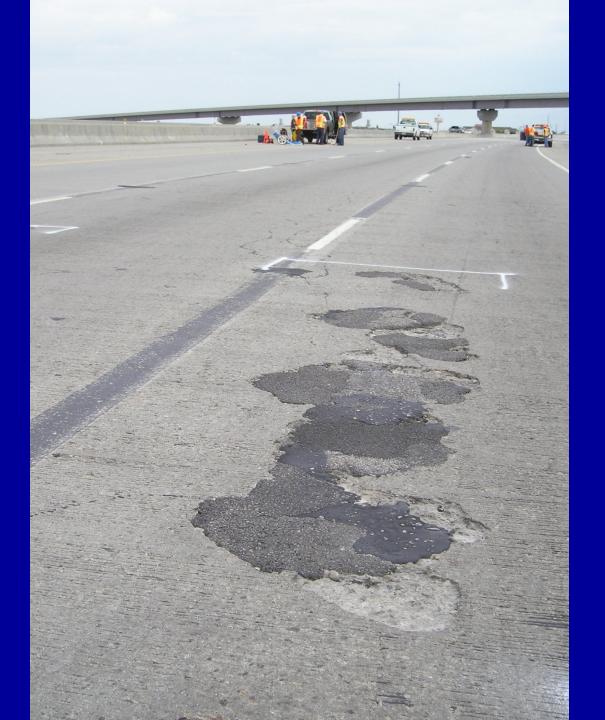
Stay-in-Place Metal Forms (SIPMFs)

Typical Chloride Concentration Profiles for Utah Bridge Decks

Depth	Chloride Concentration			
(in.)	(lbs Cl ⁻ /yd ³ Concrete)			
	With SIPMFs	Without SIPMFs		
1	21.9	16.6		
2	13.2	7.0		
3	6.9	2.4		
4	3.0	1.1		
5	1.1	0.2		
6	0.4	0.1		
7	0.2	0.1		
8	0.1	-

Corrosion threshold for black bar = 2.0 lb Cl⁻/yd³ of concrete

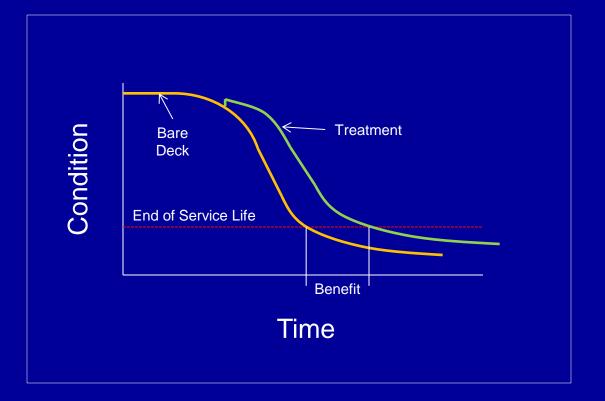
Preservation Strategy

Bridge Deck Deterioration

Some initial settlement and/or shrinkage cracking may occur, but chloride ingress and carbonation are primarily diffusioncontrolled. Preventive maintenance treatments should be applied to retard the onset of deterioration. Conditions suitable for corrosion are attained by the end of this period.

Chlorideand/or carbonationinduced corrosion of the reinforcing steel begins, and the formation of rust causes deck damage. Maintenance and/or rehabilitation is required to provide satisfactory ride quality.

Accelerated chloride ingress occurs through preferential pathways within damaged areas. The deck must be replaced, as failure is imminent.

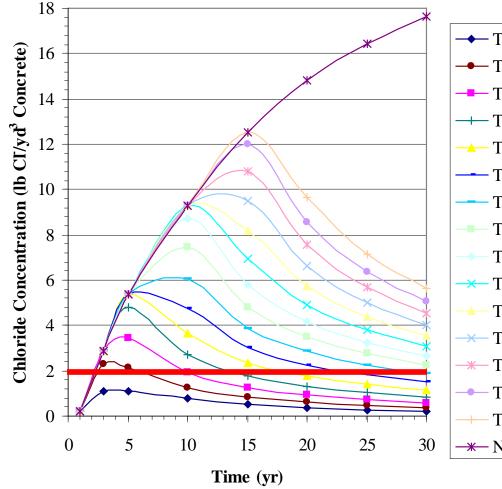
Effect of Surface Treatment Timing

Chloride concentrations through time at a depth of 2 in. on a deck with SIPMFs for different surface treatment timings

(Compilation of 128 simulations)

Recommended Surface Treatment Timing for Utah Bridge Decks

Cover	Deck Age for Surface Treatment				
Depth	Application (yr)				
(in.)	With SIPMFs	Without SIPMFs			
2.0	1	5			
2.5	3	9			
3.0	5	15

Each additional 0.5 in. of cover beyond 2.0 in. allows an extra 2 years for decks with SIPMFs and 5 years for decks without SIPMFs before a surface treatment must be placed to prevent future accumulation of chlorides in concentrations above the threshold value

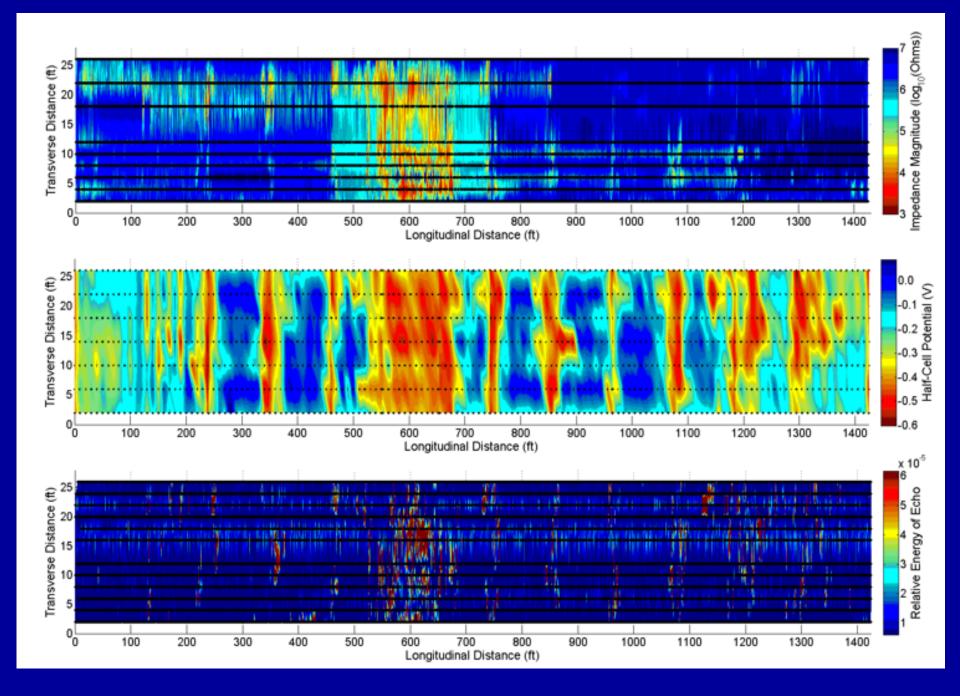
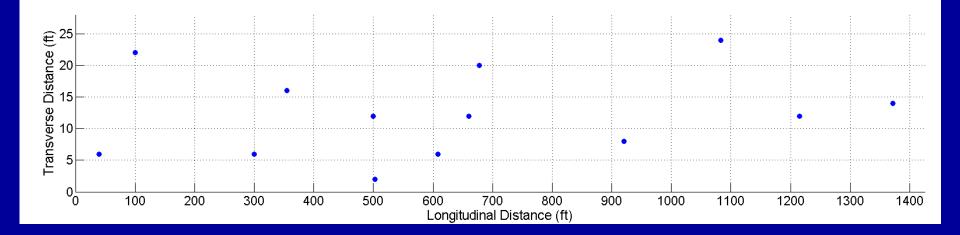
Case Study

11 spans
1425 ft long
28.5 ft wide
1972 construction
1973 concrete overlay
2003 epoxy overlay

Percentage of Deck Area (%) in Indicated Condition		Test	Cover Depth	Delamination	Chloride Concentration (lb/yd ³)				Occurrence of
Delaminated/	Actively	Section	(in.)	Depth (in.)	Top Surface Intact		Top Surface Delaminated		Efflorescence at Bottom of Deck
Patched	Corroding				Top Mat	Bottom Mat	Top Mat	Bottom Mat	Bottom of Deck
0-10	0-10	A, J	3.1, 4.3	-	0.7	0.4	-	-	At End, along Side
	10-30	B, C, D, H, I, K, M	2.9, 3.2, 3.4, 3.4, 3.5	1.125, 1.5, 3.5	0.2, 0.4	0.2, 0.6	2.1, 2.3, 8.6	1.2, 7.0	At Both Ends
	>30	G, L	3.3, 3.4, 3.6	1.5, 4.25	0.3	3.2	3.0, 3.5	2.4, 2.8	At End
10-30	10-30	Е	3.4, 3.6	1.125	0.2	0.2	0.6	0.3	Along Side
	>30	-	-	-	-	-	-	-	-
>30	>30	F	2.9	Asphalt Patch	-	-	3.1	3.5	At Both Ends, along Both Sides, in Middle

Overall	Percentage	Deck				
Condition	ofDeck	Area	Description			
Index	Area (%)	(ff^2)				
1	45.2	18371	Intact with inactive corrosion; conditions suitable for corrosion have probably not yet developed, and no delamination has			
			occurred			
2	26.8	10903	Intact with uncertain corrosion activity; conditions suitable for corrosion may or may not be developing, but no delamination has occurred			
3	19.5	7925	Intact with active corrosion; conditions suitable for corrosion			
			have probably developed, but no delamination has yet			
			occurred			
4	0.1	46	Delaminated with inactive corrosion; delamination probably			
			does not extend beyond the polymer surface treatment or			
			concrete overlay into the original deck surface			
5	1.9	775	Delaminated with uncertain corrosion; delamination may or			
			may not extend beyond the polymer surface treatment and			
			concrete overlay into the original deck surface

6		2592	Delaminated with active corrosion; delamination probably			
	6.4		extends beyond the polymer surface treatment and concrete			
			overlay into the original deck surface
