Consideration for Preservation: FDOT District 5 Bridge Preservation Practices – *A Context Sensitive Approach*

Jonathan Jastremsky, PE Matthew Hodges, PE

NATIONAL BRIDGE PRESERVATION PARTNERSHIP CONFERENCE 2018

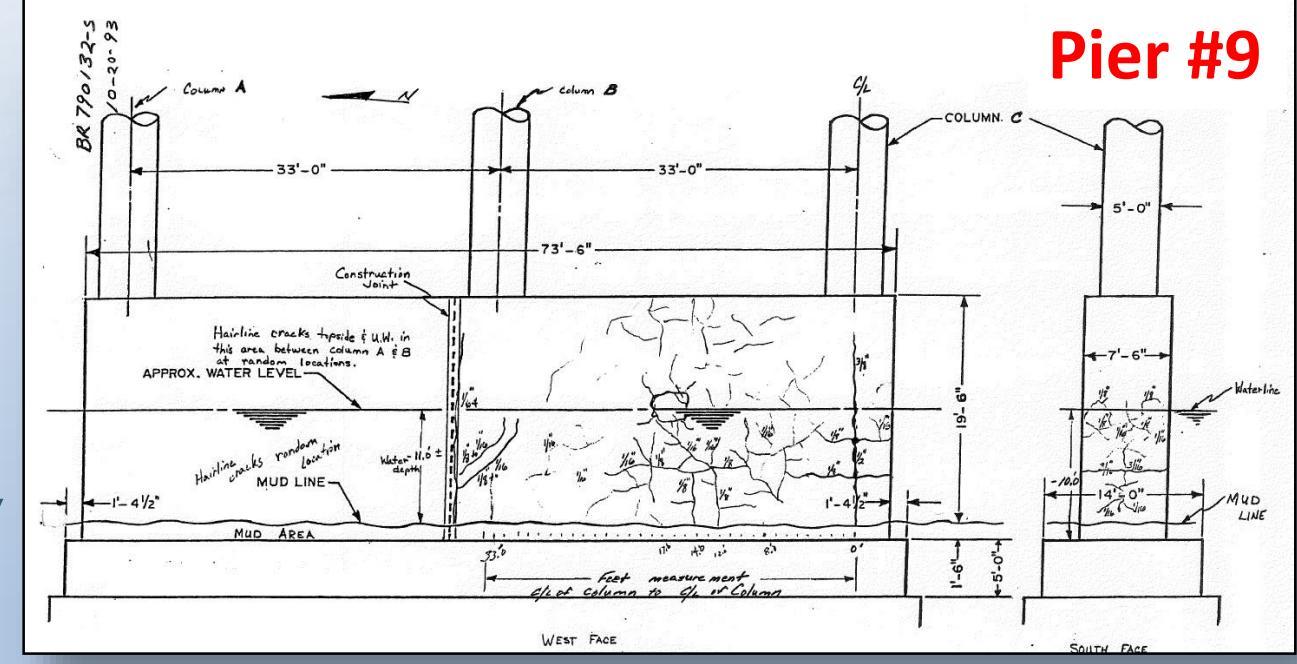
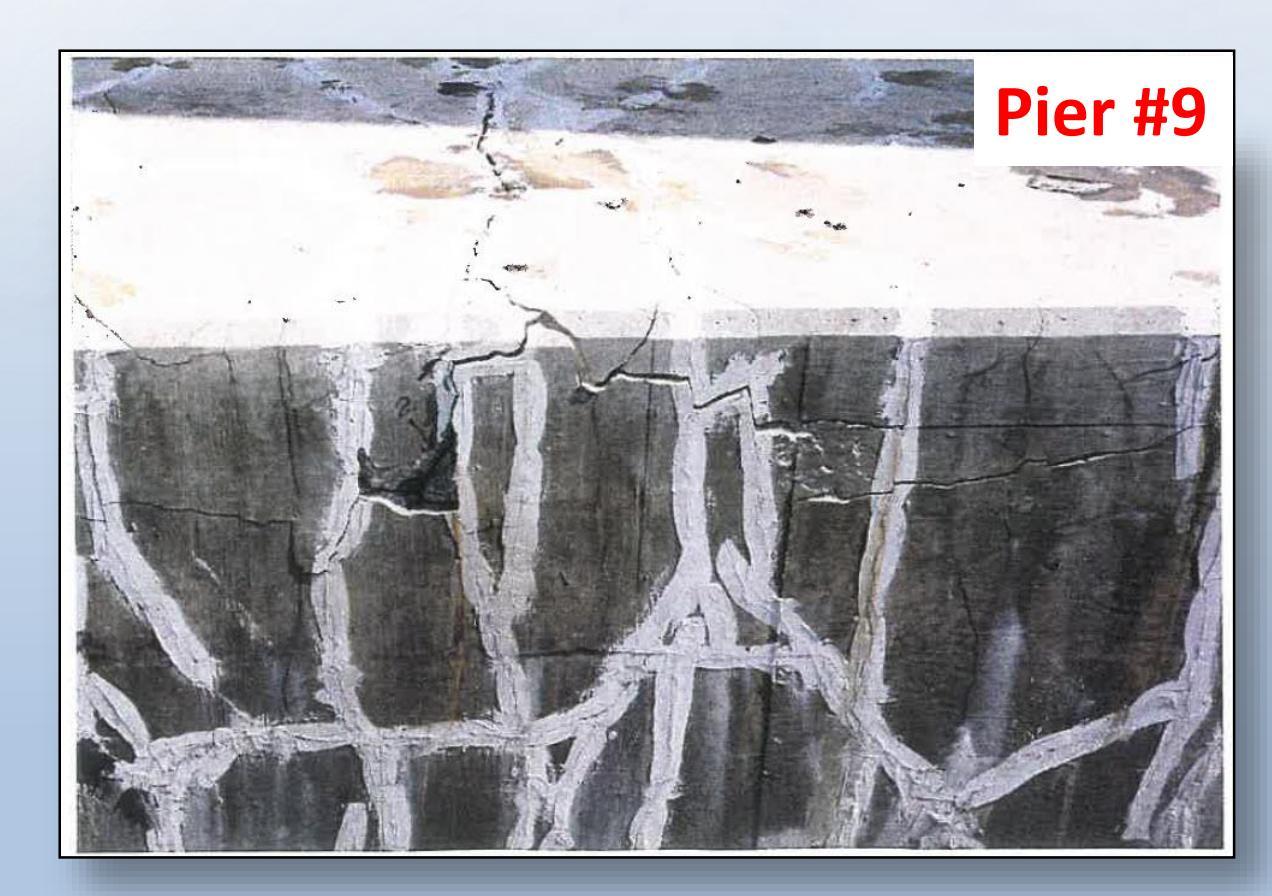
- Bridge constructed between 1981- 1983 in two phases
- Substructure distress and deterioration observed shortly after construction completion

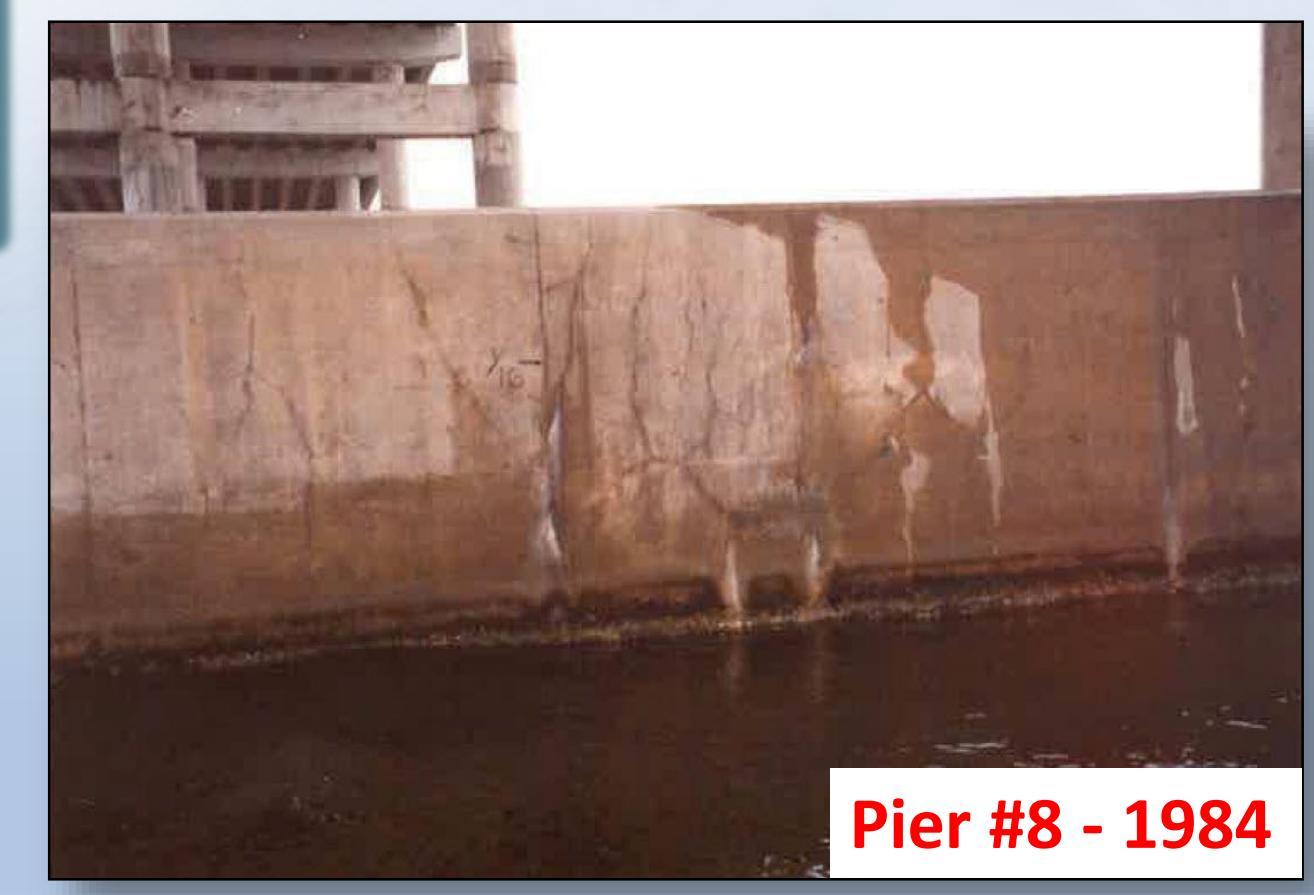
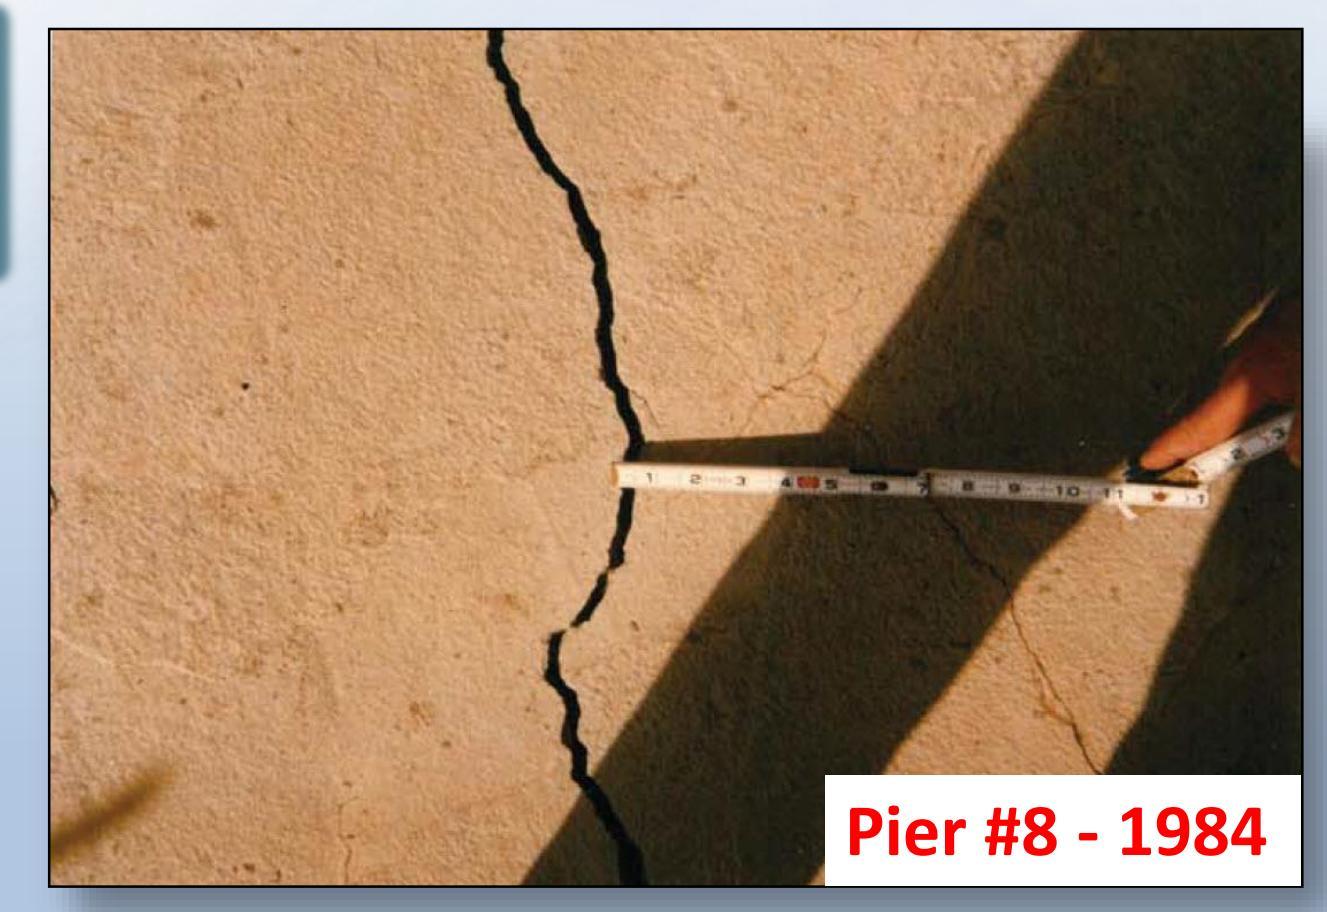
- Pier #9 in worse condition & repaired in 1995
- Pier #8 not as severe –
 State crews carbon-wrapped the crashwall in 1995 with goal to delay in-depth repairs

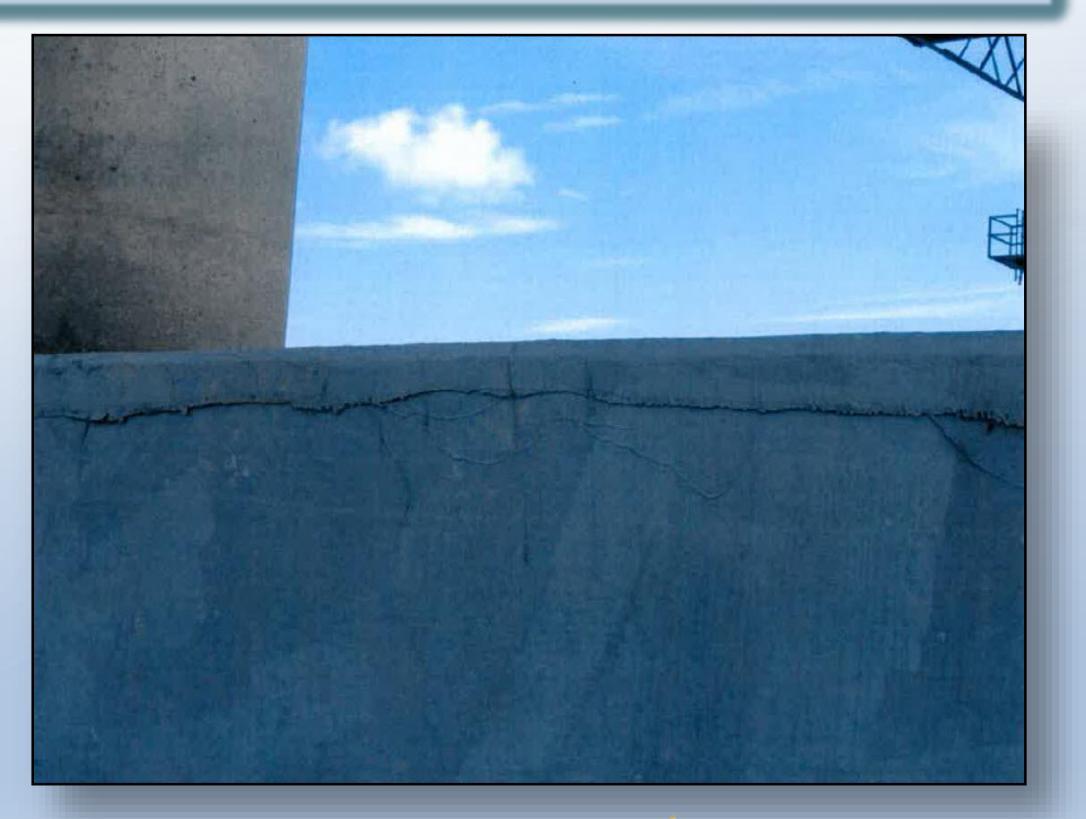
- Atypical Failure Mode for Intracoastal Bridges
 Investigations propose differing theories: 1994 Report – Mass Concrete Pour Failure 2014 Report – Differential Settlement
- Yearly surveys = pier is stabilized
- Carbon repair had gone past its intended service life (20+ years)

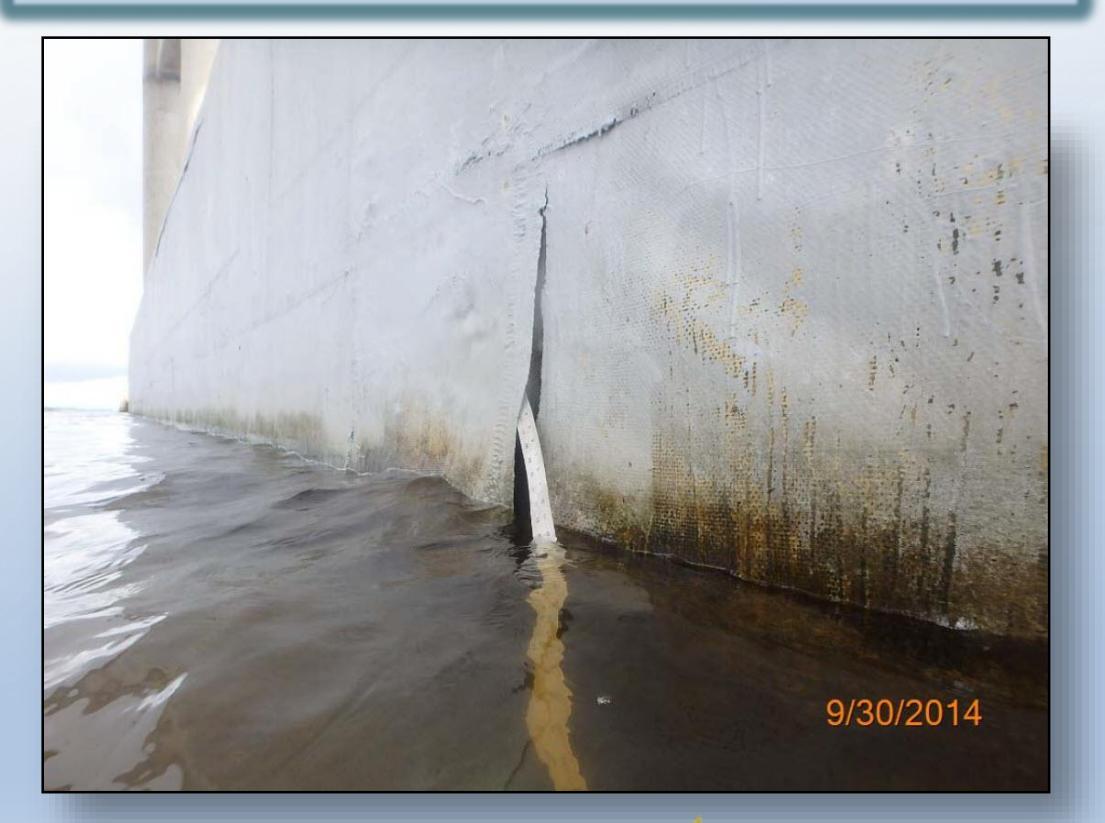
- Aggressive brackish environment
- Structure built in 1983 –
 40+ year service life remaining
- Time for a <u>permanent</u> repair

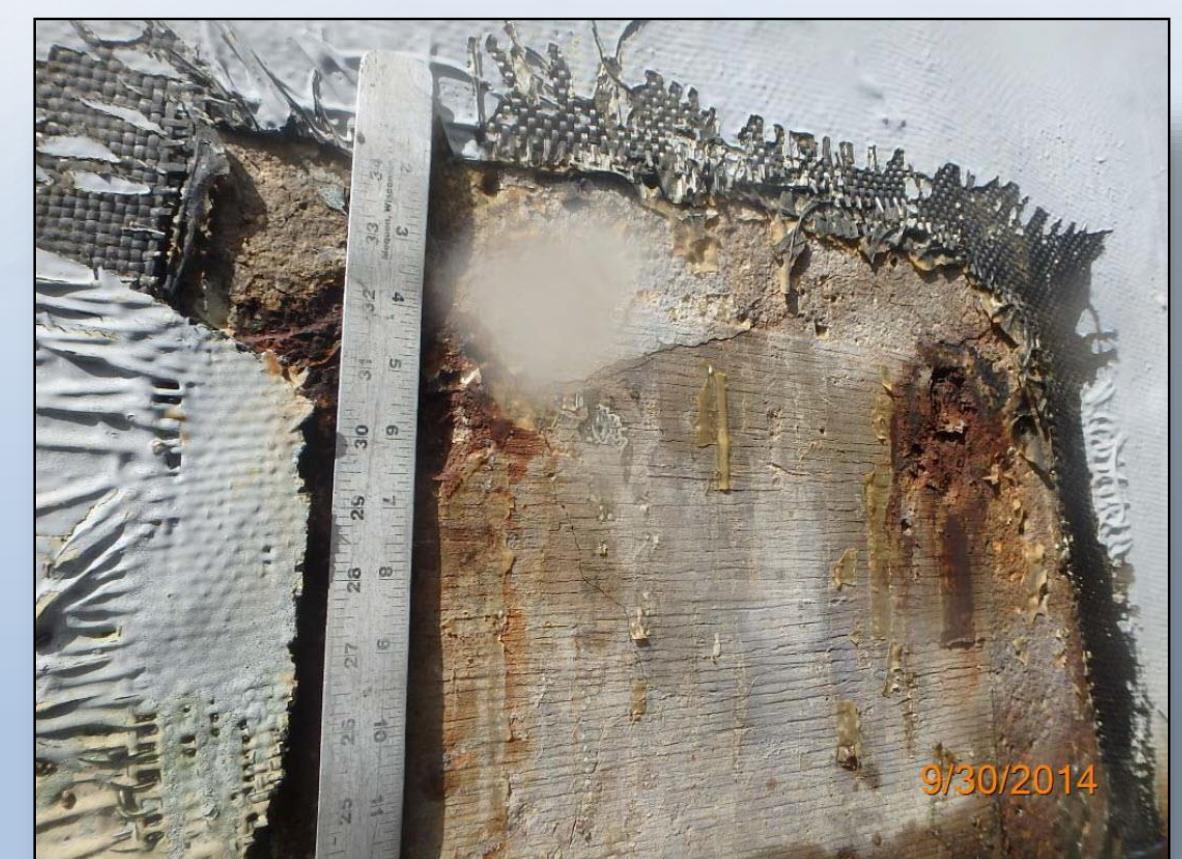
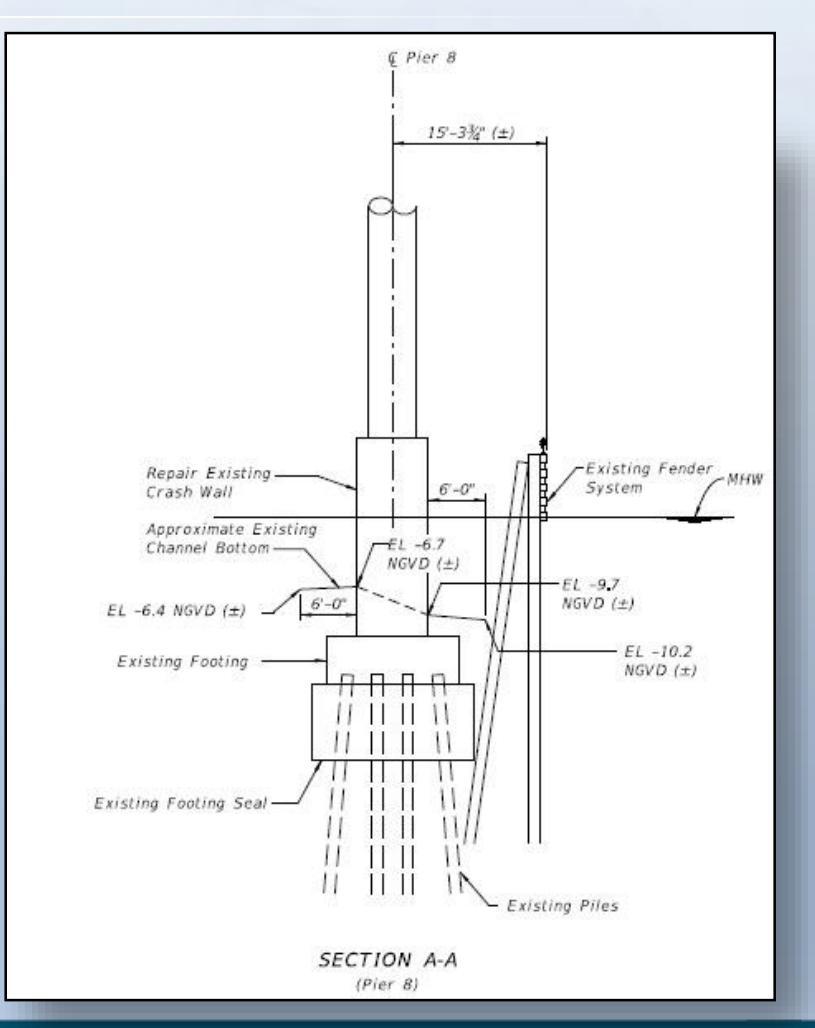
- Unknown condition of concrete under the carbon-fiber wrap
- Proximity of the fender system & battered piles
- Coordination with Army Corp of Engineers, Water Management District, and Coast Guard

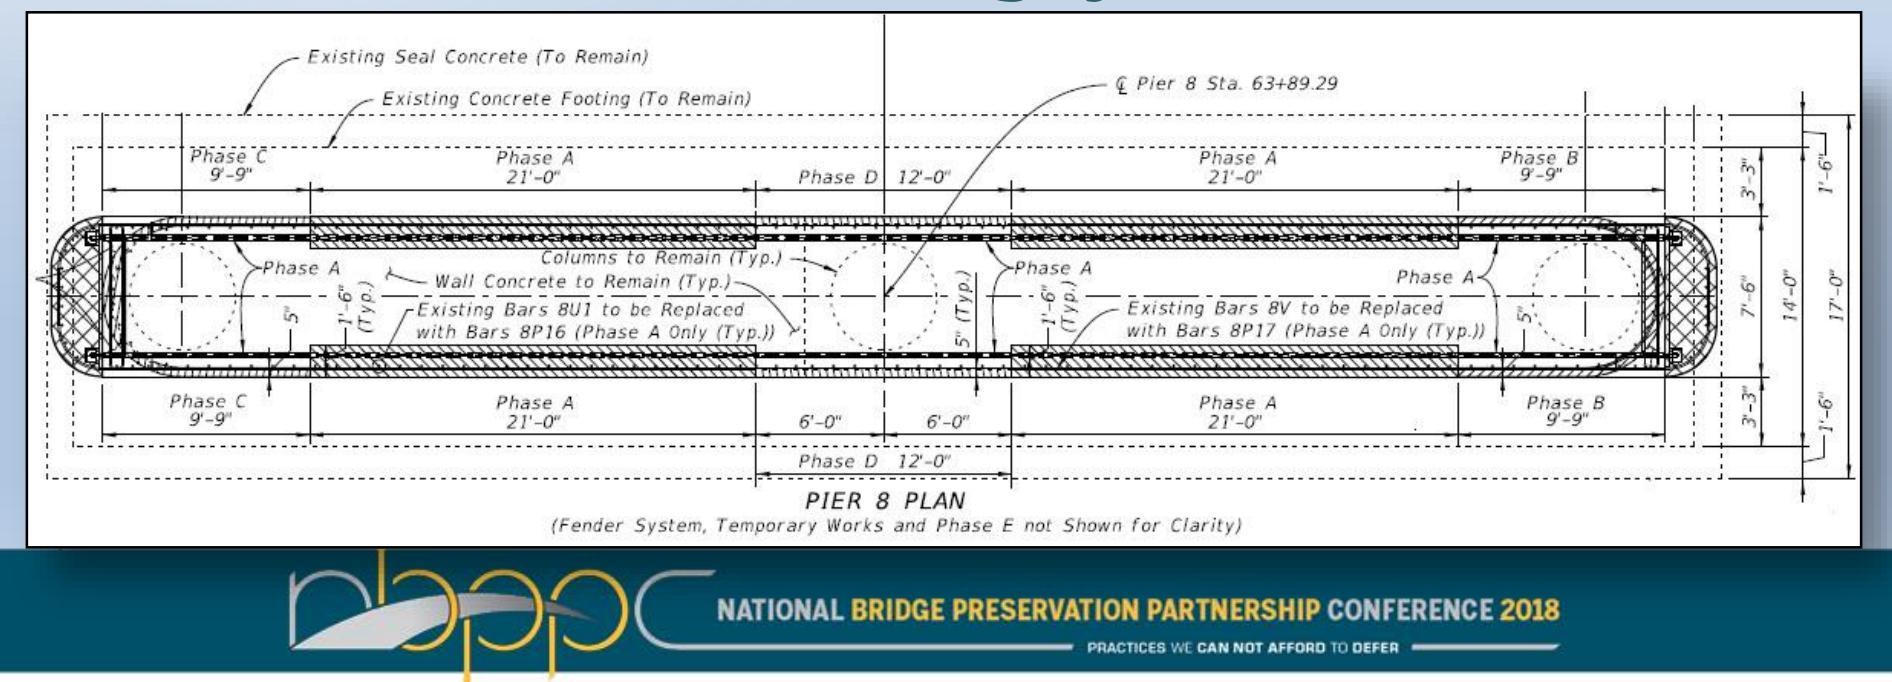
- Design Consultant: AECOM
- Phased removal of existing deteriorated concrete
- Installation of new Post-Tensioning system

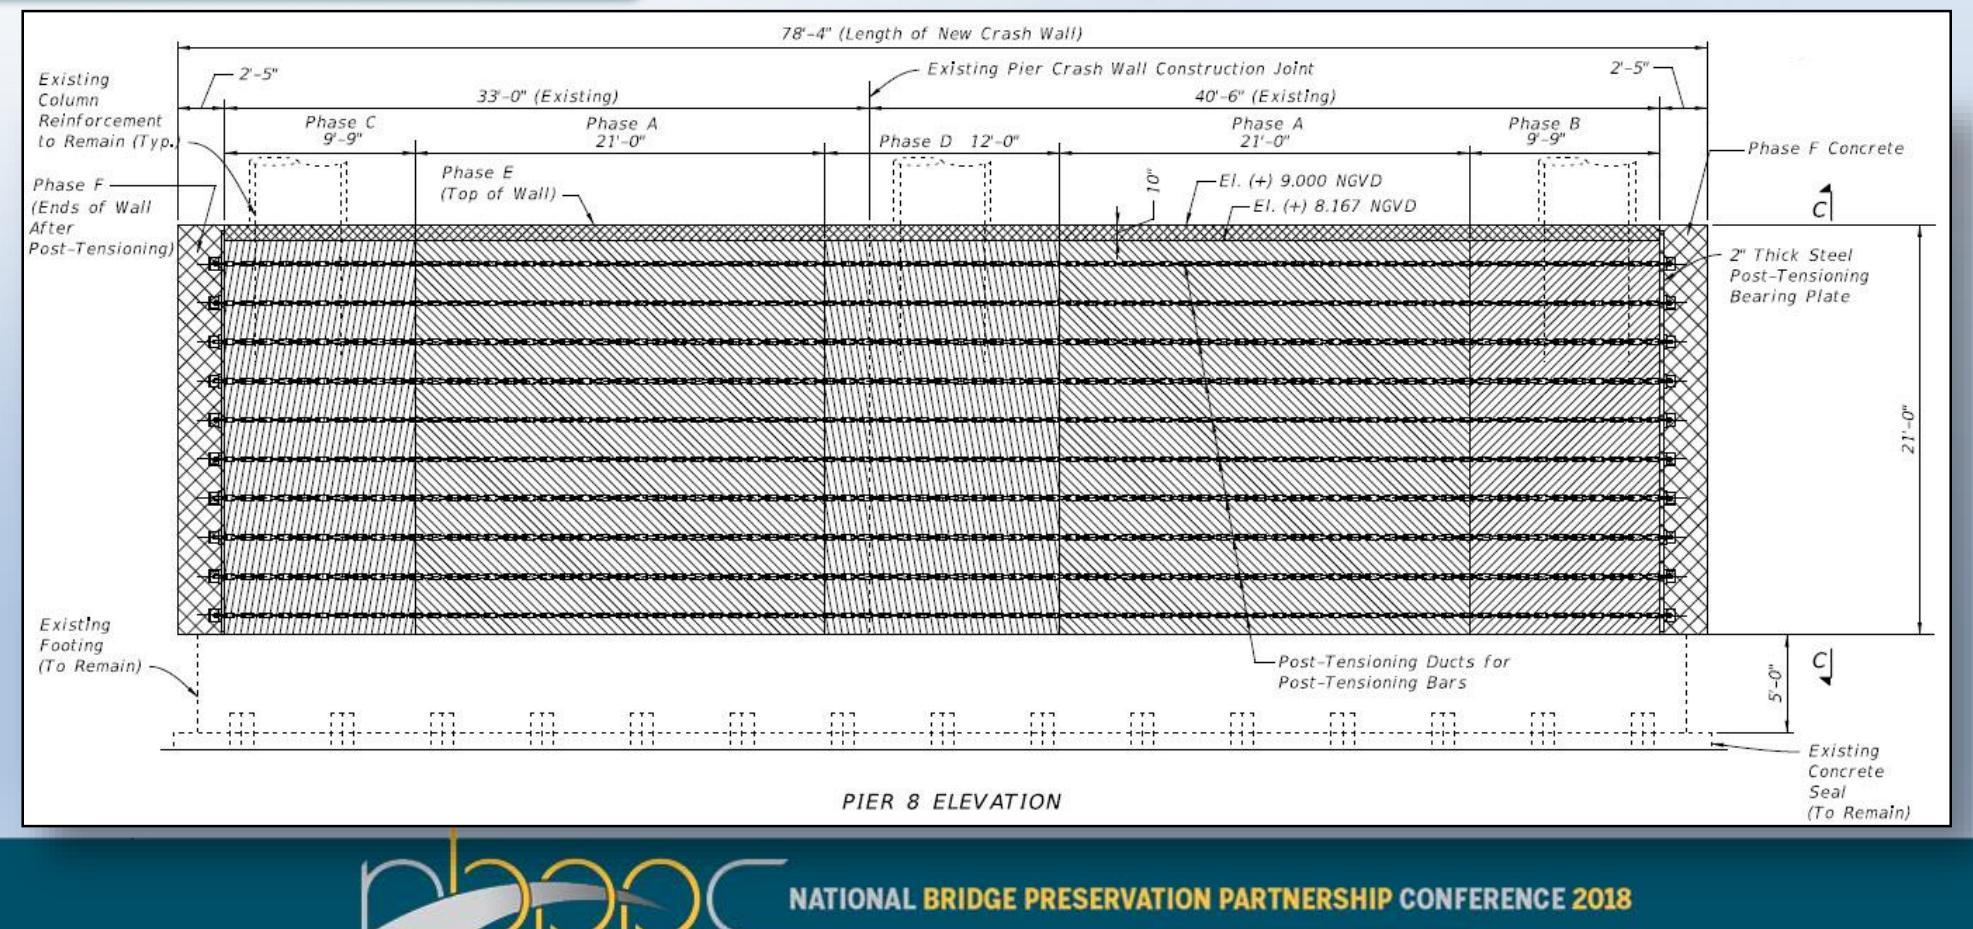
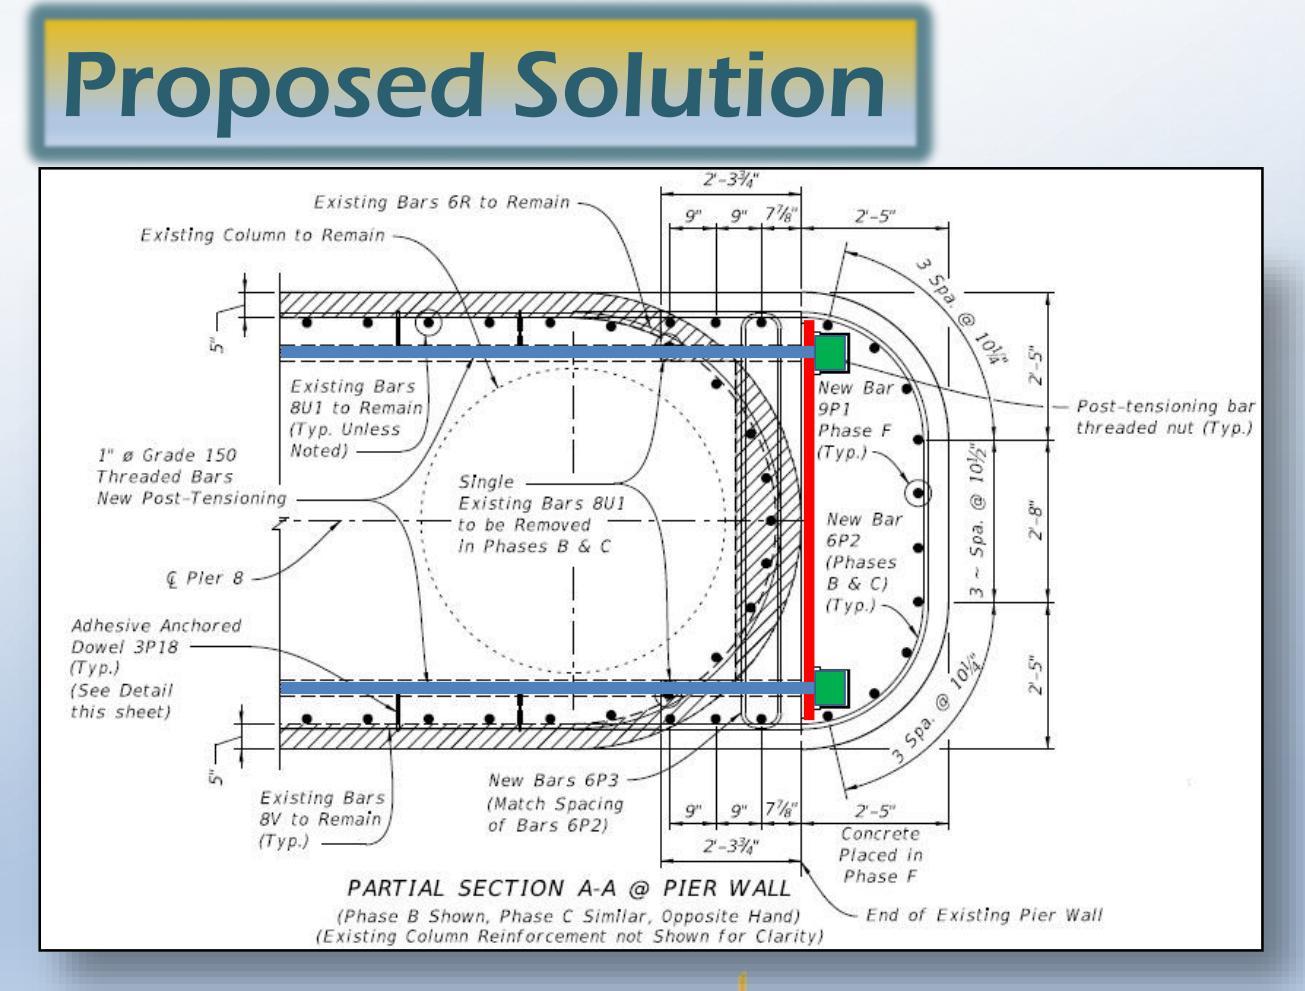
Post-Tensioning system using
 2" thick steel bearing plates

Reconstructed larger crashwall to encapsulate the PT system

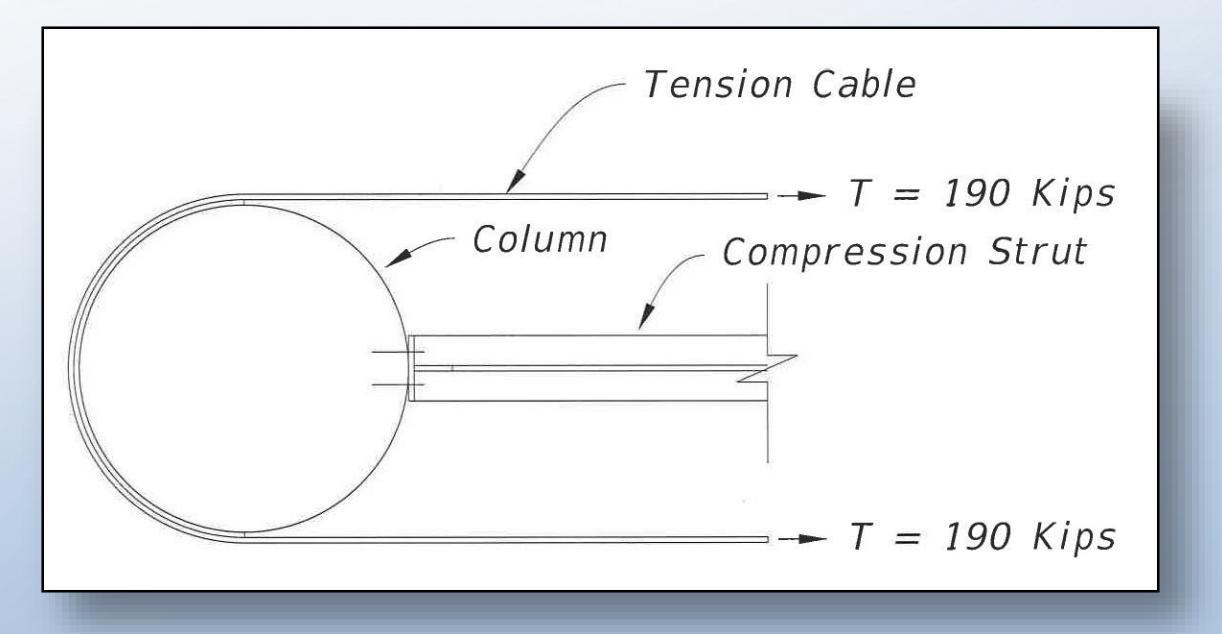
- Phased repairs for substructure integrity
- At least two columns fully bonded to the crash wall at any one time during construction
- Temporary column bracing concept added for additional confinement & stability (think hurricane season)

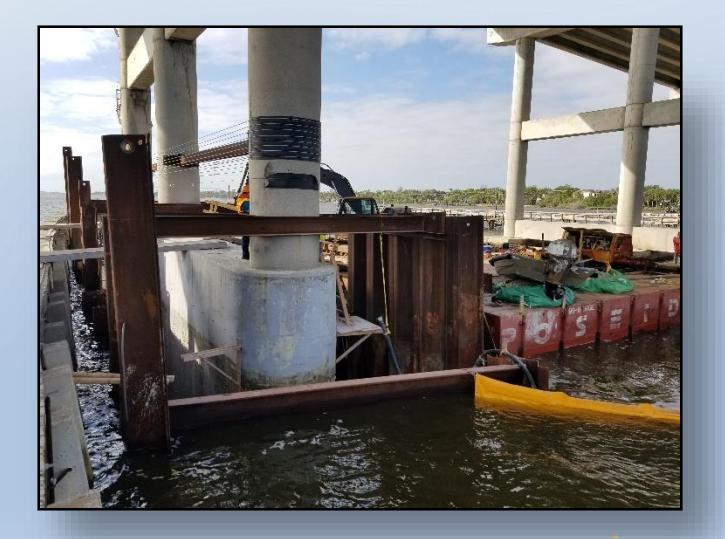
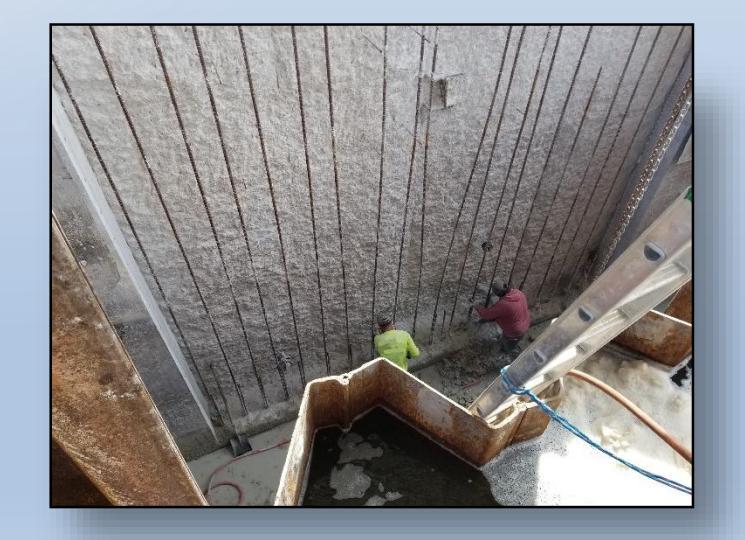
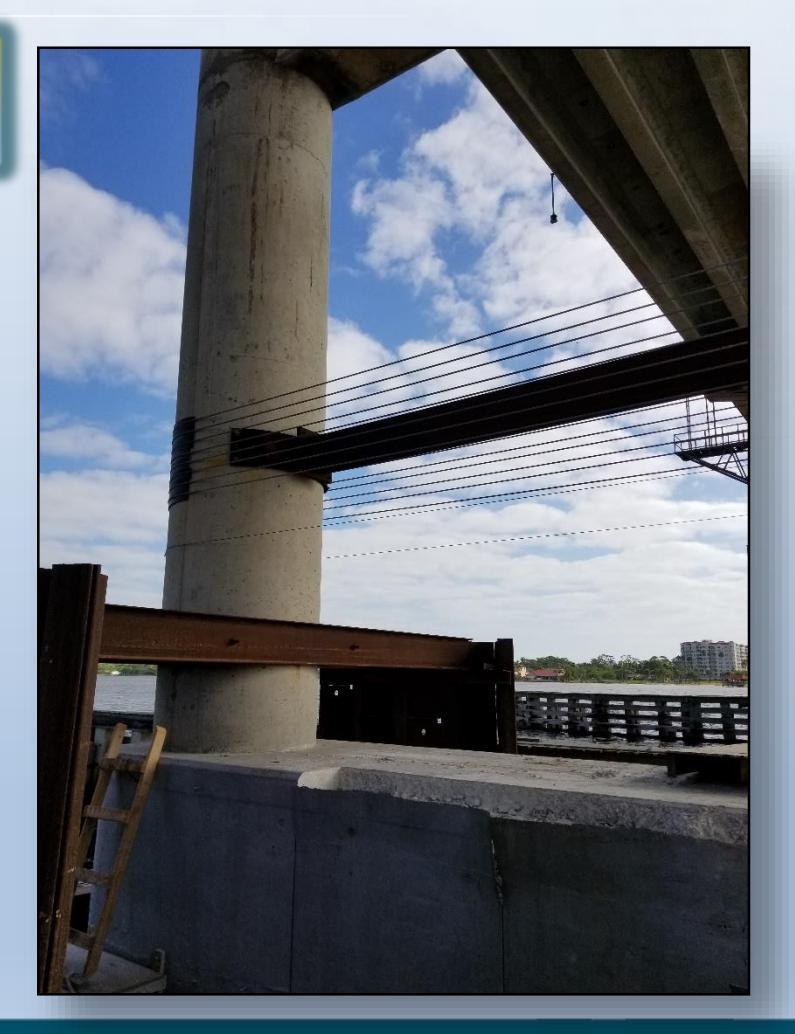
- Cofferdam is complete & dry
- Contractor currently wrapping-up Phase A (first of six phases)

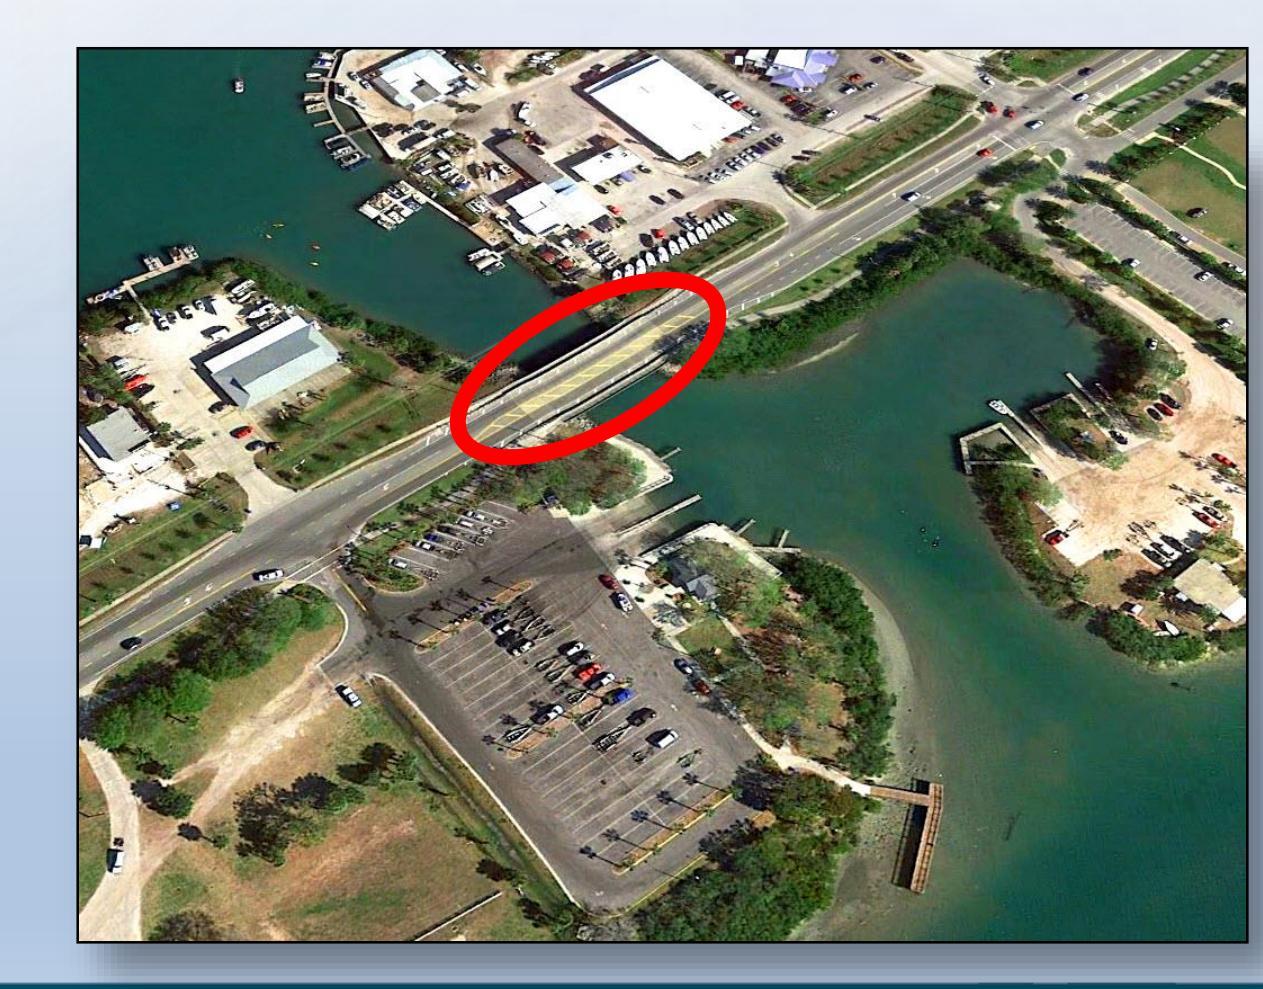
- Both bridges built in 1994 flat slab bridges with 14" decks
- Delaminations, spalls, and popouts developing at a quick rate
- Bridges serve beach access and county's busiest boat ramp (salt water)

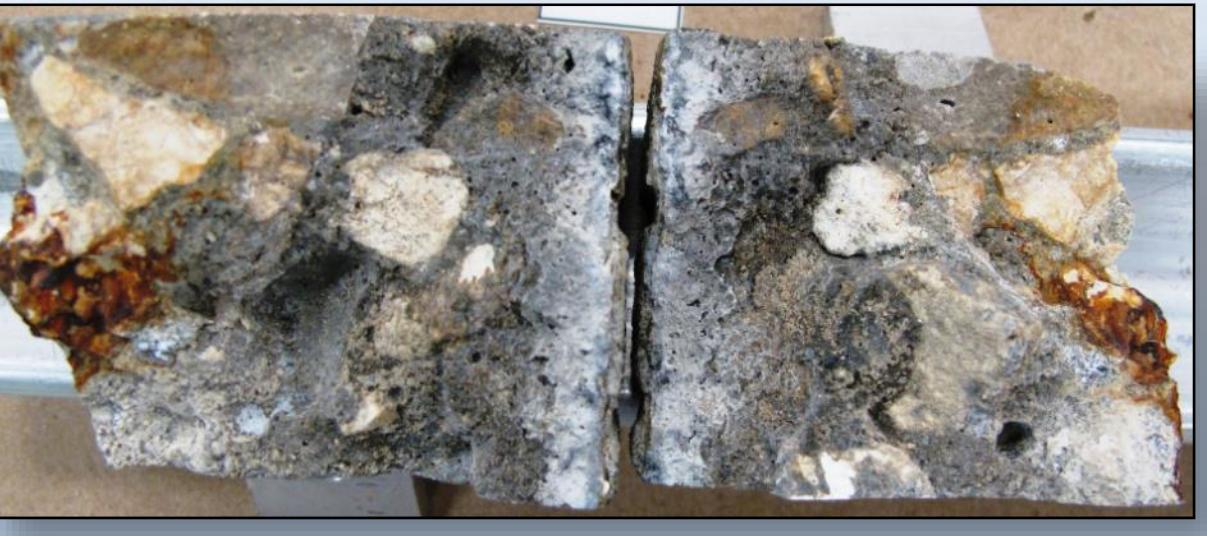
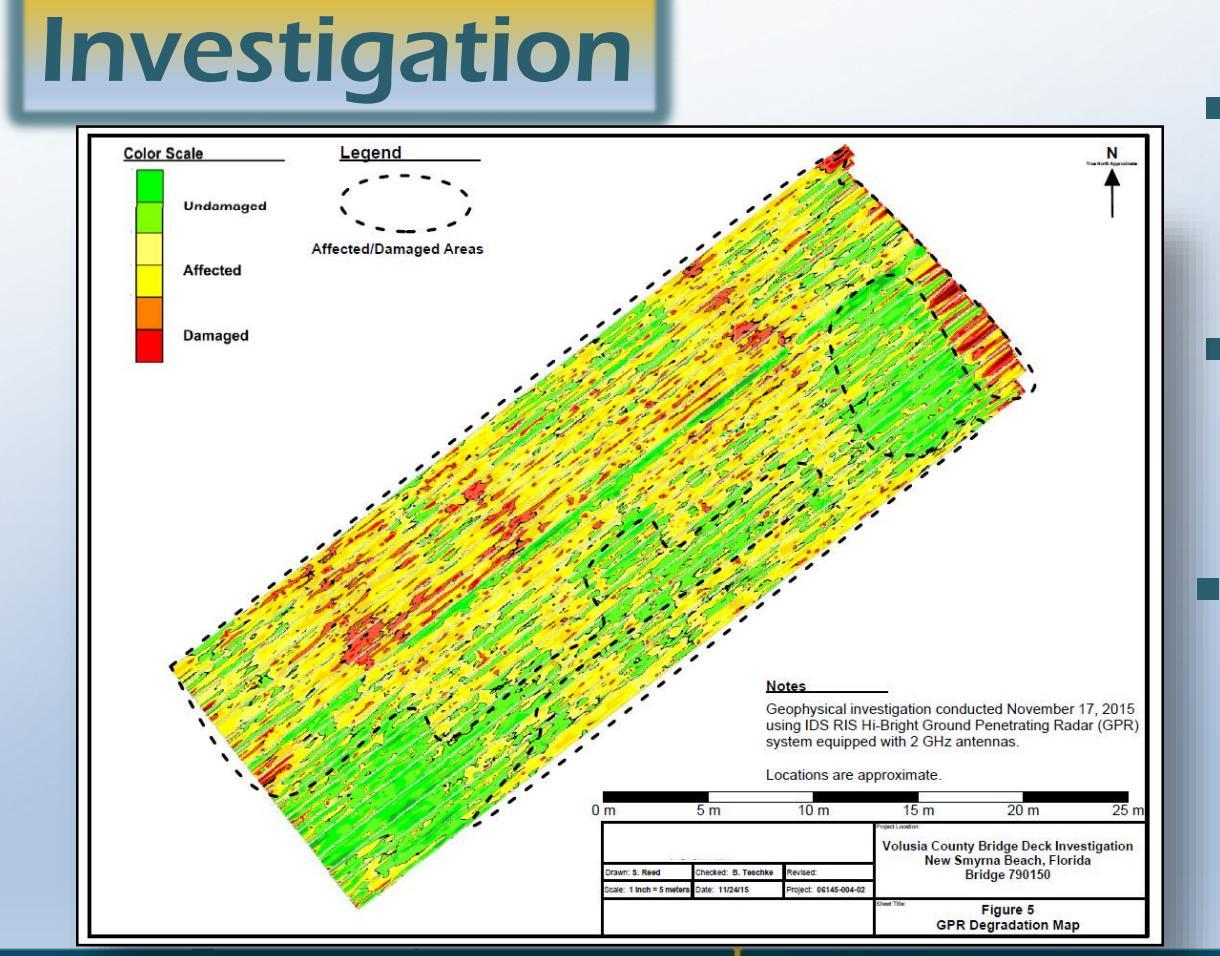
- Cores taken by FDOT Corrosion Research Laboratory
- Berrys Canal 3.40 lb/yd³
- Connors Canal 1.90 lb/yd³
- Chloride concentration of
 1.2 lb/yd³ considered threshold for corrosion
- Active corrosion identified on both structures

- GPR scan commissioned by D5 Structures Maintenance
- Goal to delineate damaged and undamaged areas
- Data analysis and interpretation: entire deck area needs attention

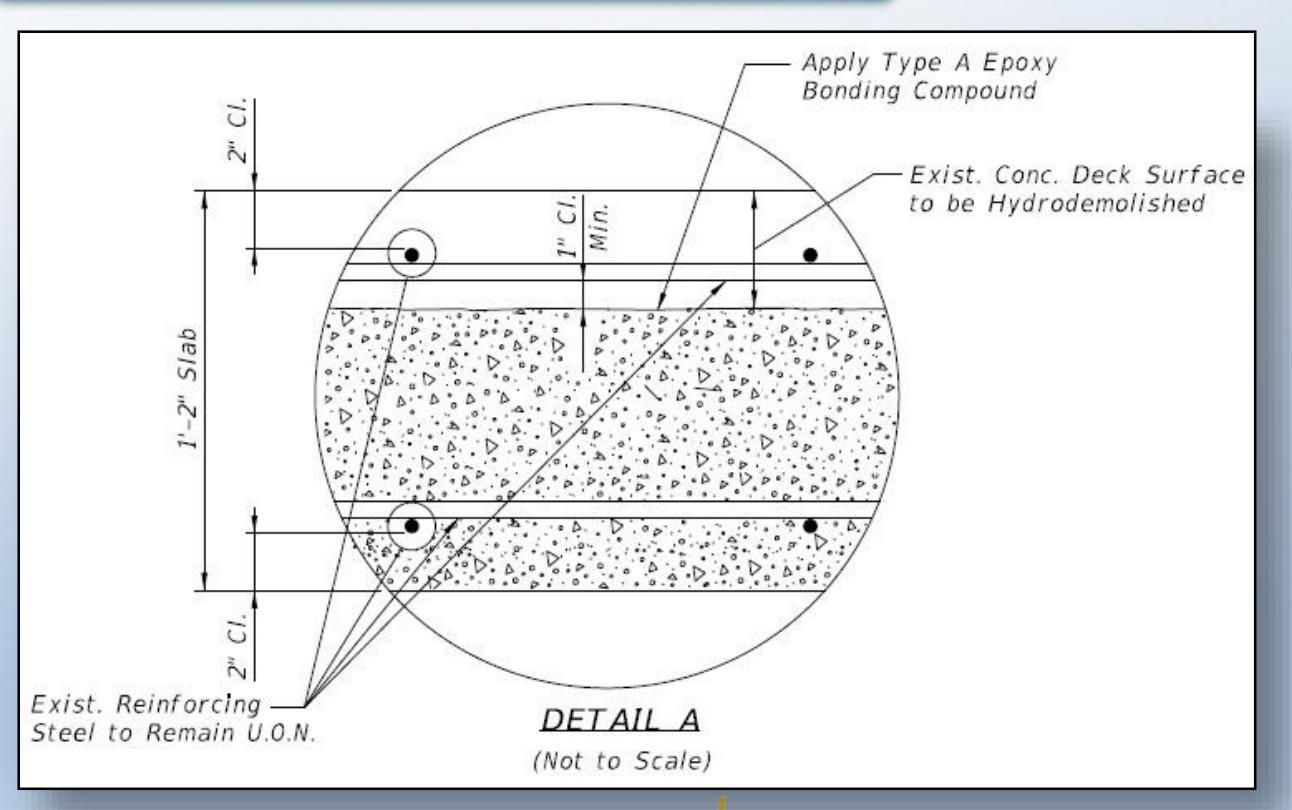
- Design Consultant: AECOM
- Partial-depth hydrodemolition
- Approximately 5" depth concrete removal
- Hydrodemolition avoids introducing microfractures

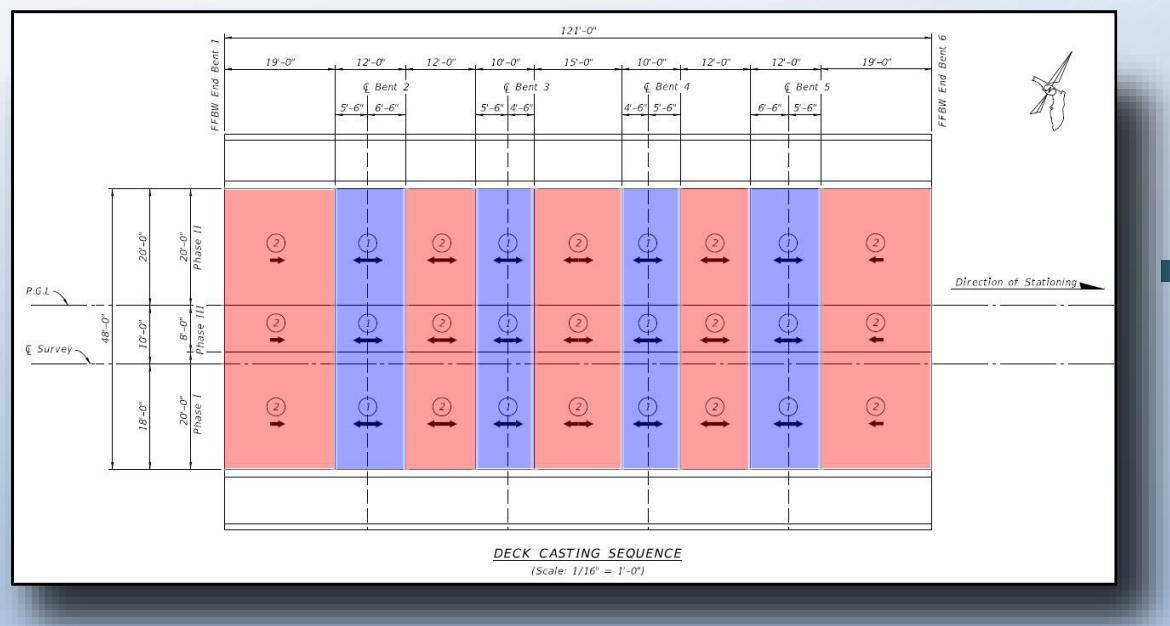
Top-mat exposed after hydrodemo

limited reinforcing remaining in
 negative moment region

Pour sequence developed so that negative moment regions be placed first

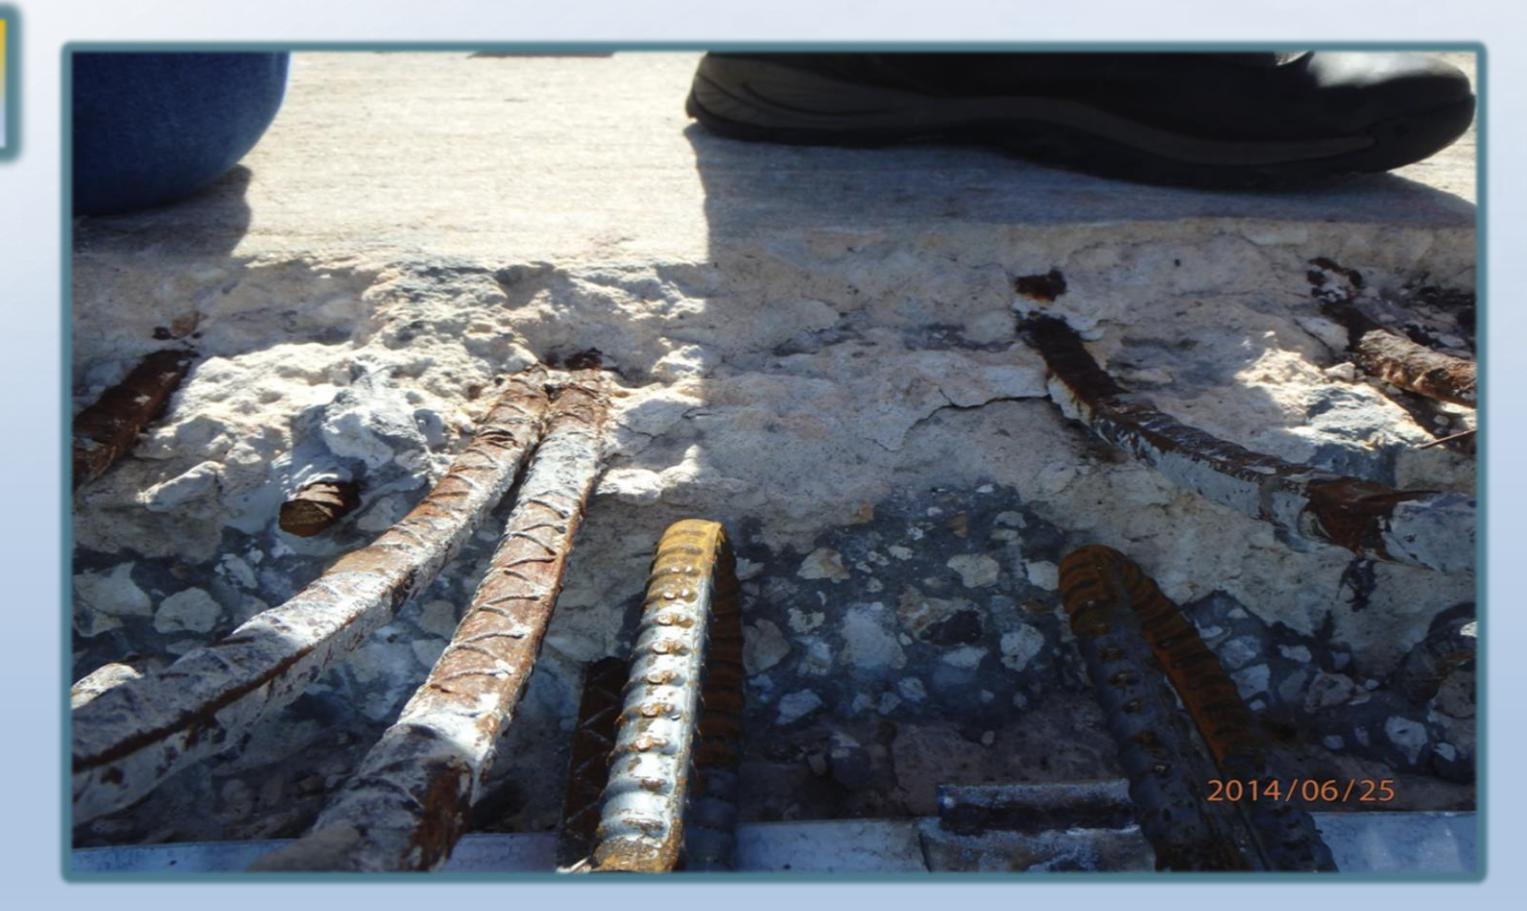
2014: Irregular/brittle concrete layer found in 2 bays of Span 3 Bridge Deck section during I-95 widening project

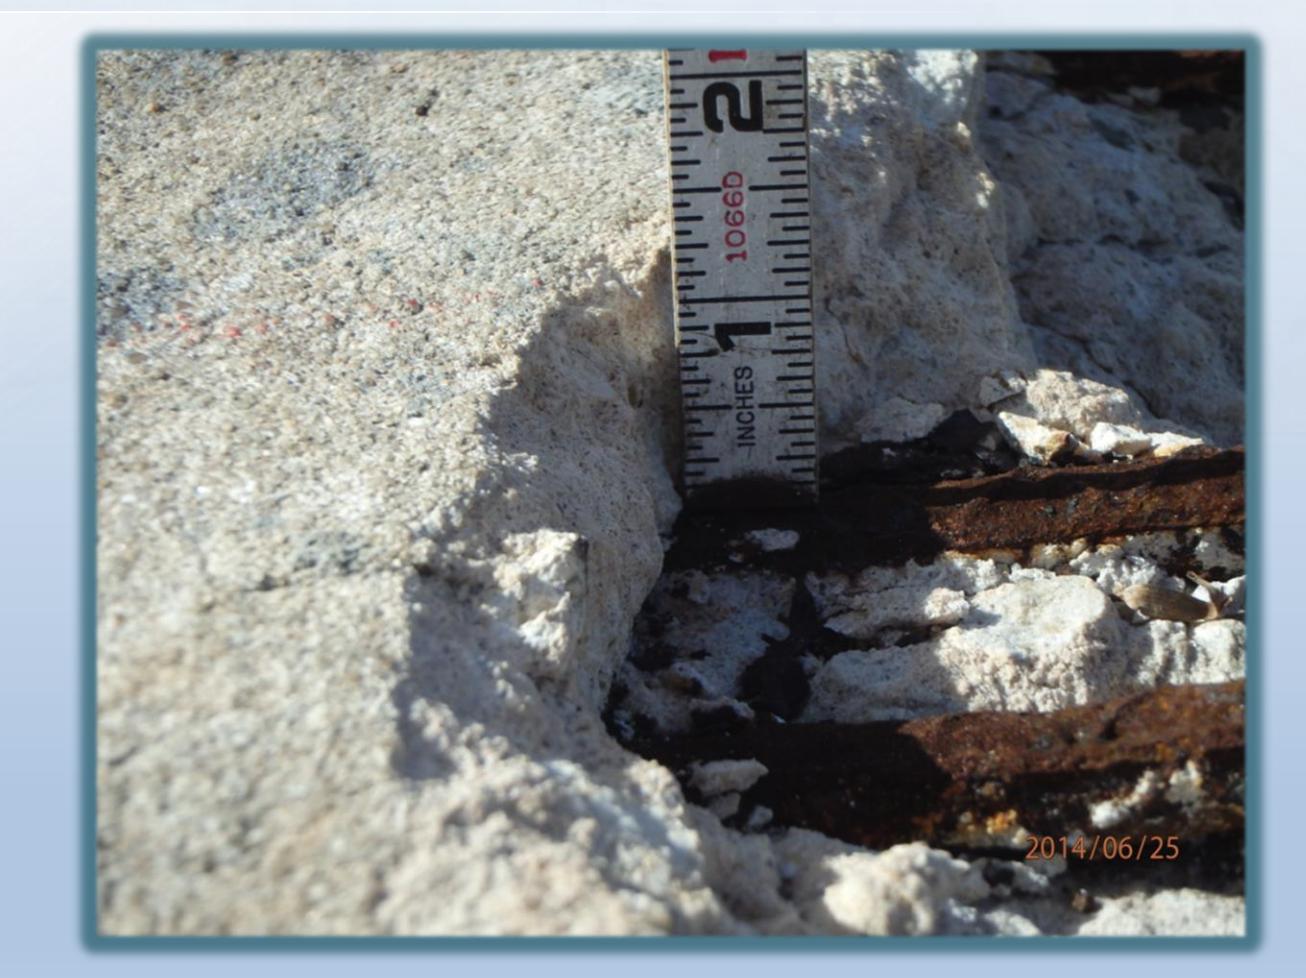
2015: Coring Results at the affected section indicated high chloride content and low compressive strength (avg. 2560 psi)
