Consideration for Preservation: FDOT District 5 Bridge Preservation Practices – *A Context Sensitive Approach*

Jonathan Jastremsky, PE Matthew Hodges, PE

NATIONAL BRIDGE PRESERVATION PARTNERSHIP CONFERENCE 2018

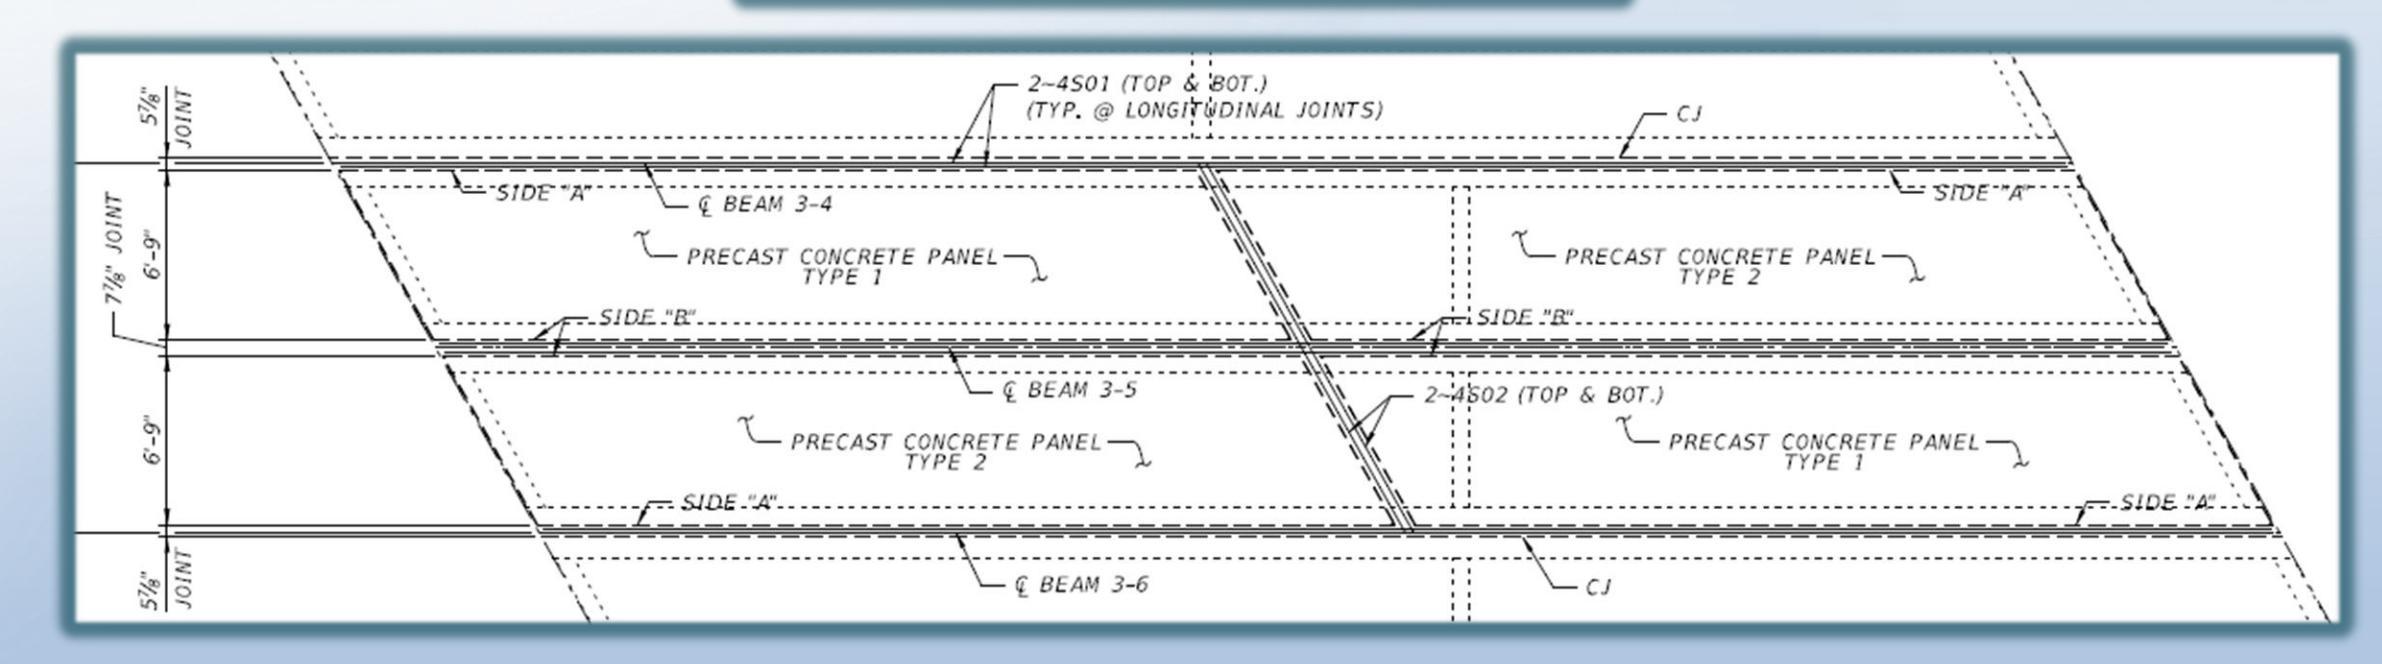
Precast Deck Panels with Ultra High Performance Concrete "UHPC" joints
