# FOLLOWING UP ON BRIDGE INSPECTION FINDINGS

Graham Bettis, P.E. Texas State Bridge Engineer

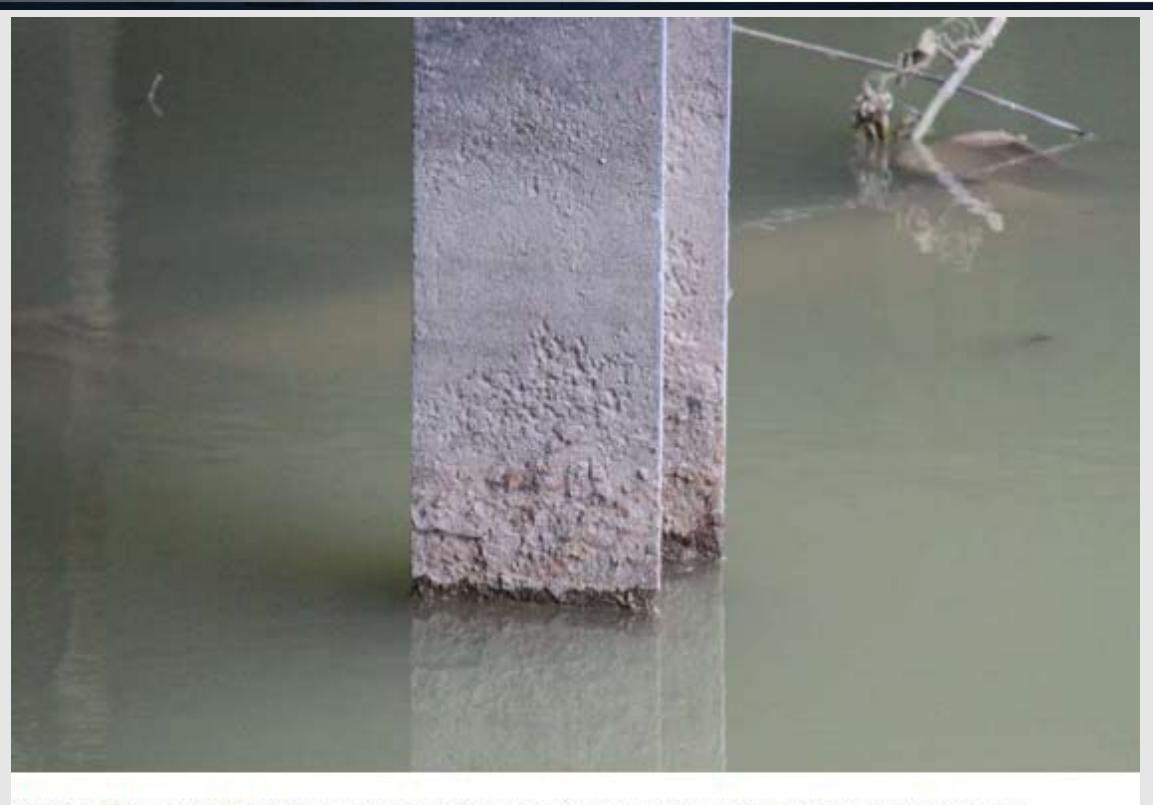
#### **Steel Piling – 2012 Routine Safety Inspection**

NOTE: Heavy rust & flaking with significant pitting along waterline of steel piles in main channel – est. up to 10% section loss. Light rust on remaining steel piles on channel banks – est. 2% section loss.

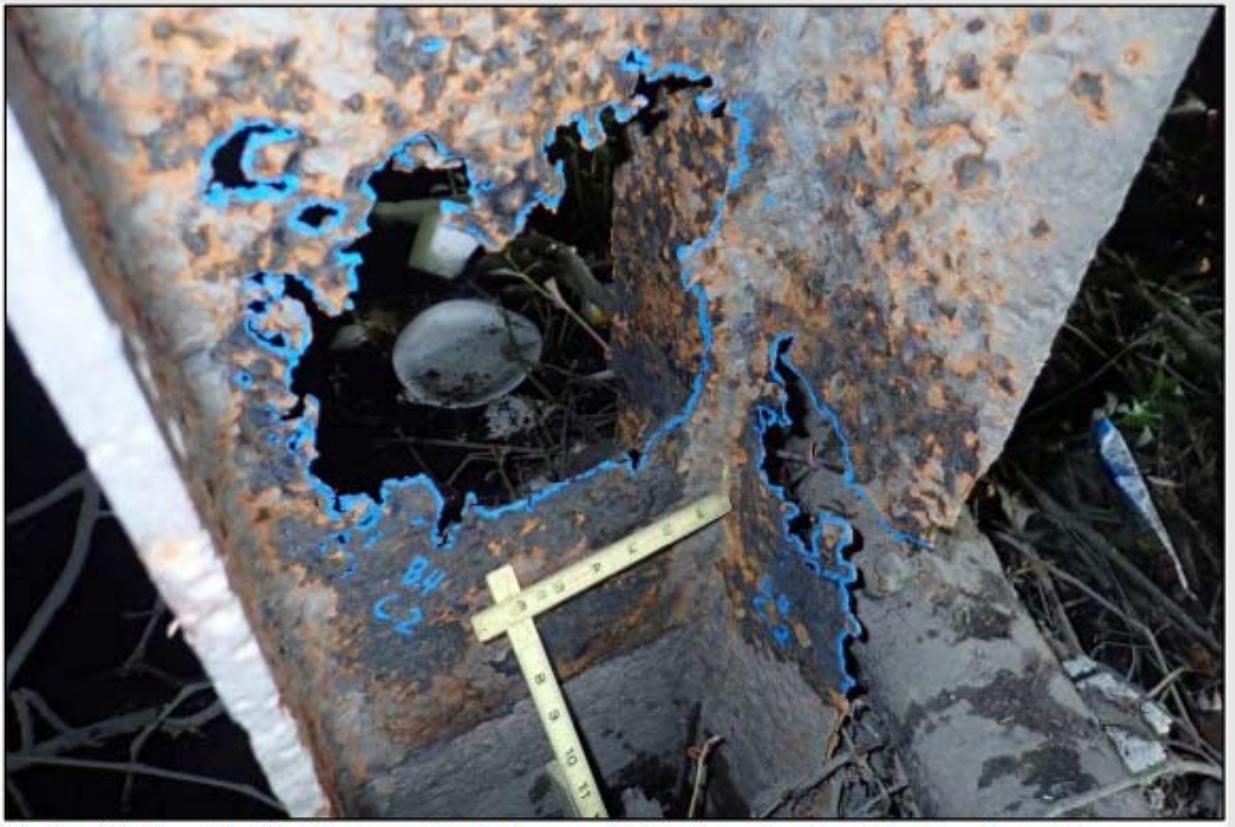
#### **Steel Piling – 2018 Routine Safety Inspection**

Photo 13: Bent 4, Pile 2; corrosion holes up to 9" diameter, looking Southwest

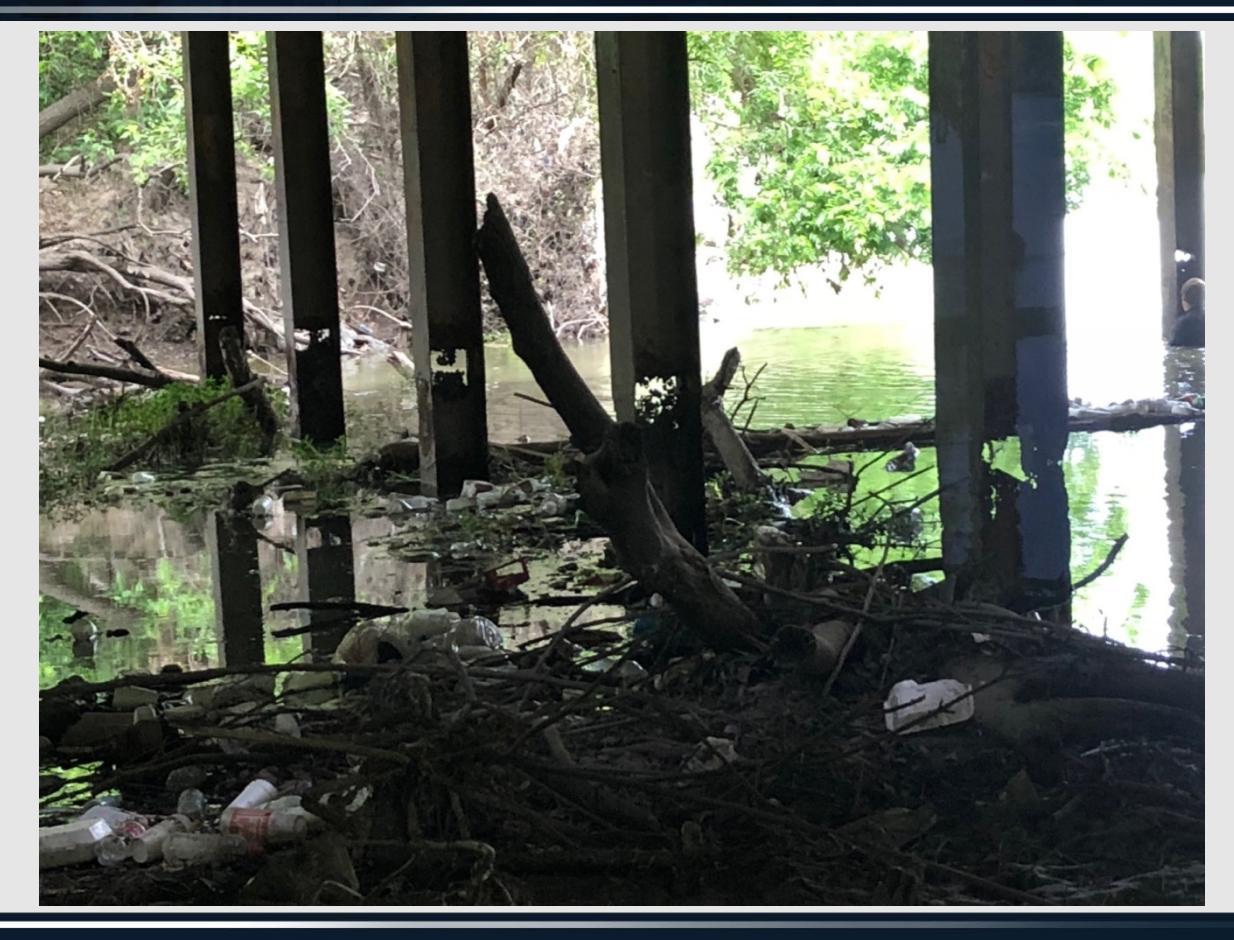
#### **Steel Piling – 2018 Routine Safety Inspection**

Resulted in immediate closure of State Highway in urban area.

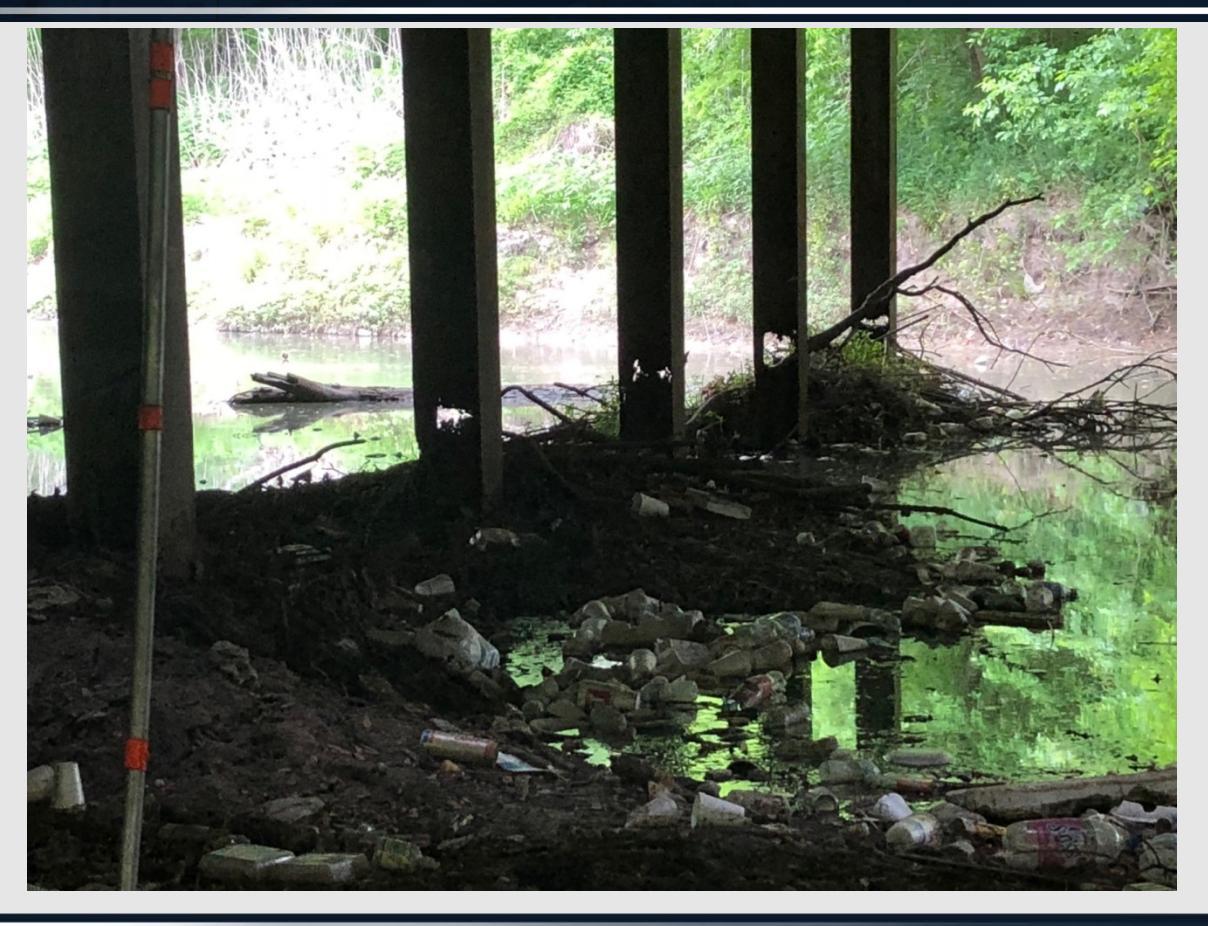
#### **Steel Piling – 2018 Routine Safety Inspection**

Resulted in immediate closure of State Highway in urban area.
