CHEMICAL STABILIZATION LESSONS LEARNED

PROJECT DESCRIPTION

- 1,100,000 square foot warehouse and manufacturing facility for Arm and Hammer
- ¾-mile long existing municipal roadway accessing site to be constructed
- Truck parking lots, including spaces for over 500 trailers
- Over 200 tractor trailers per day
- York County, Pennsylvania

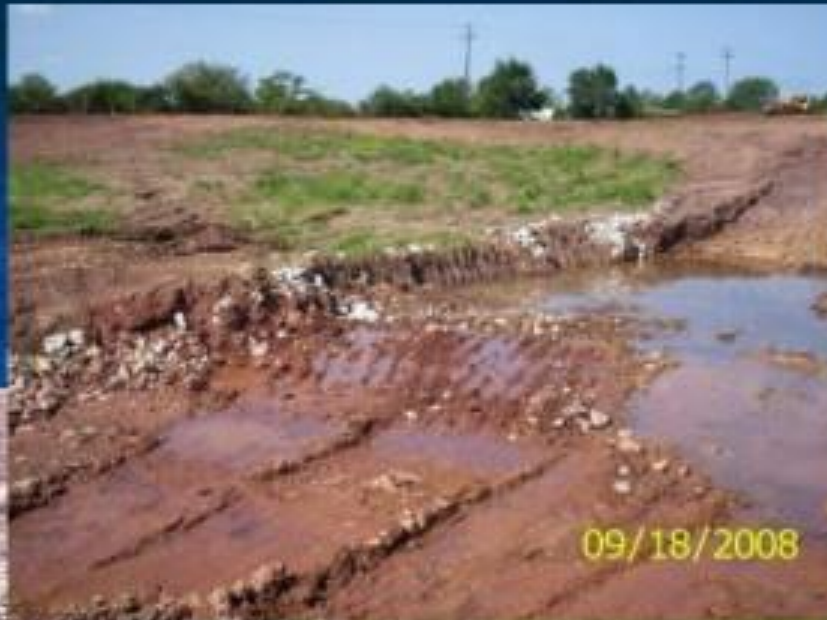
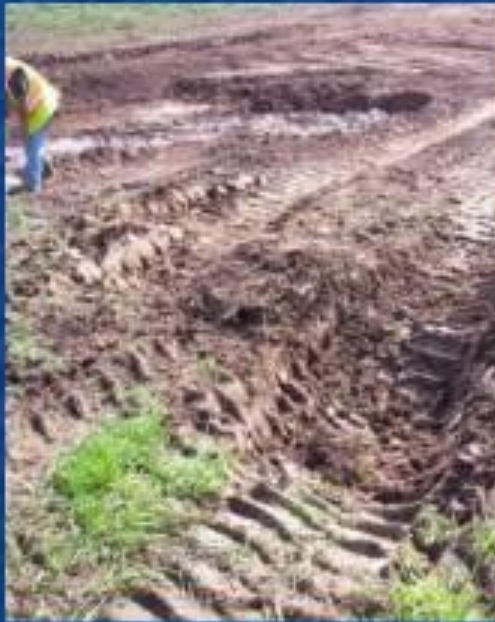
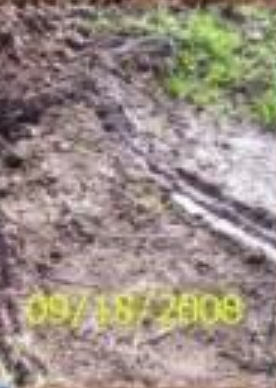
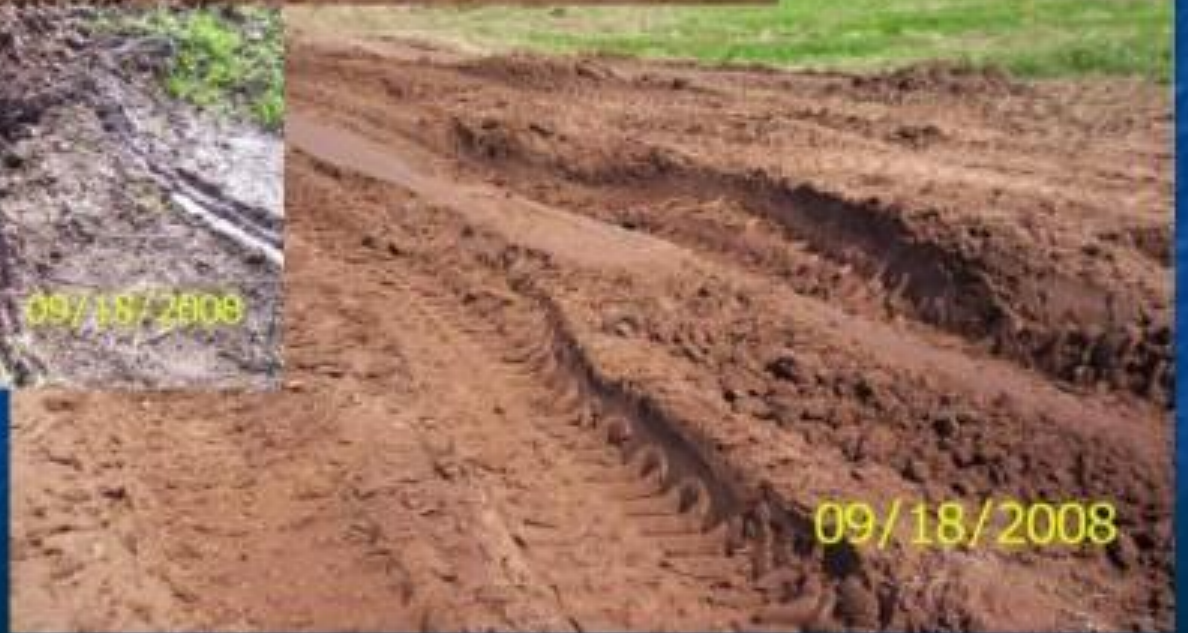
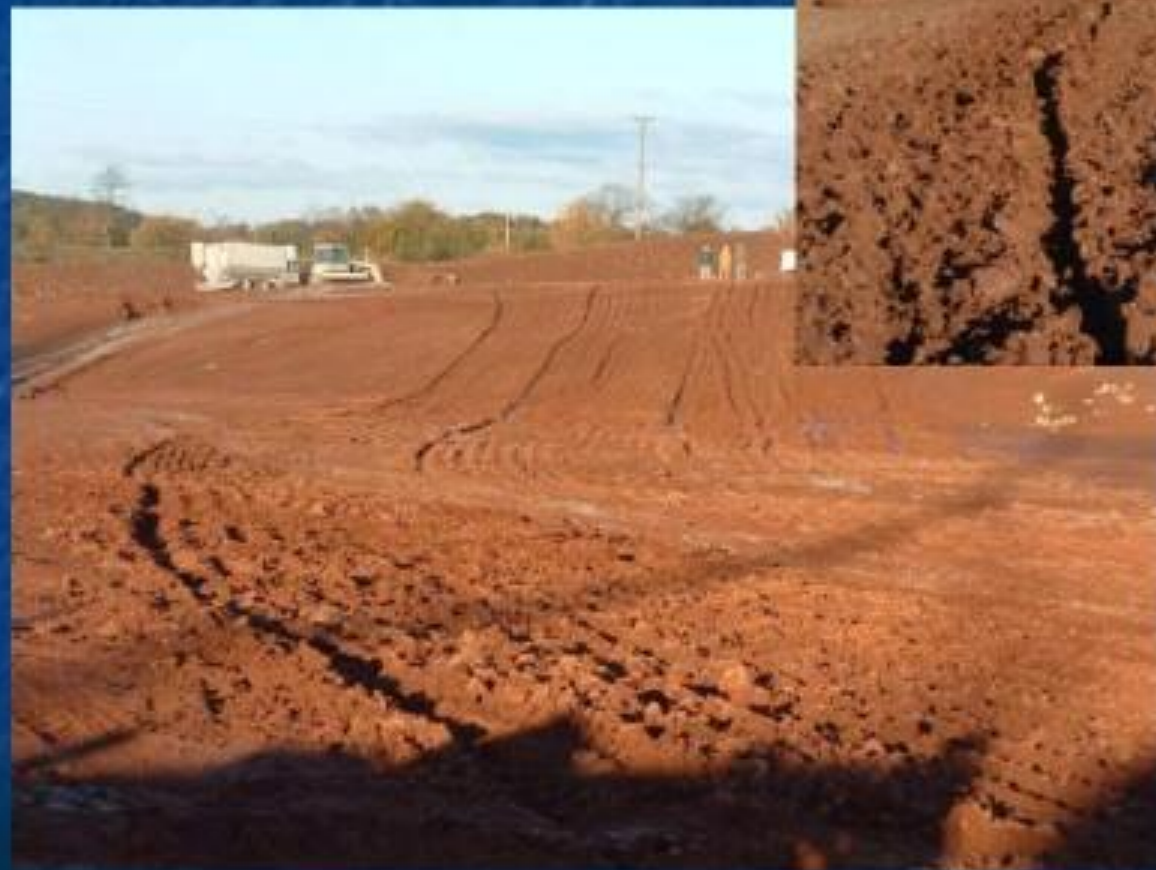
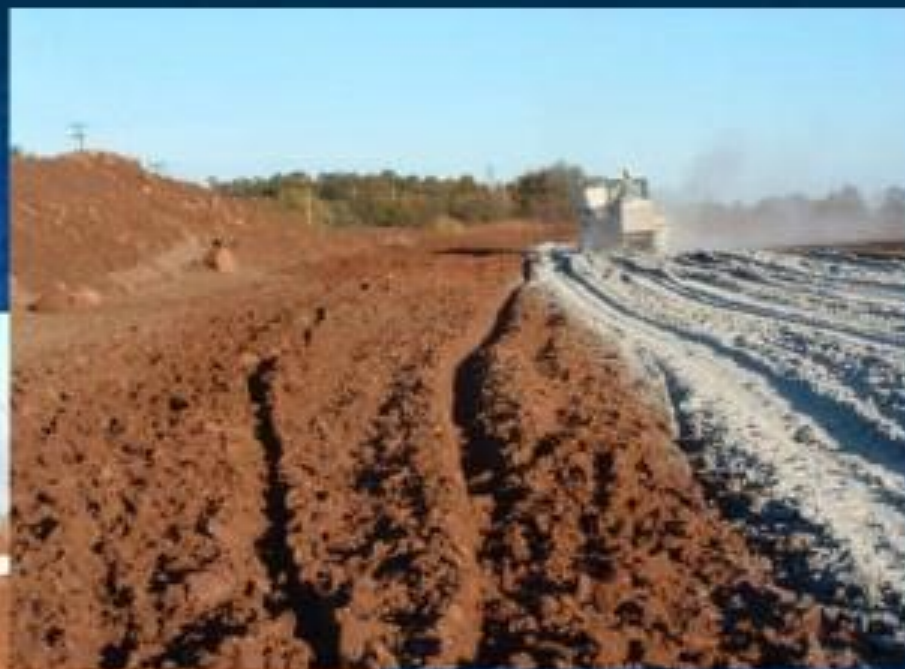
- Soils ranged from 3 to 8 percent above the optimum moisture content; soil dried adequately during warmer weather
- Used 3 percent lime kiln dust to dry the soils and allow placement as structural fill
- Treated areas of unstable subgrade with lime kiln dust to stabilize the subgrade prior to placing fill

- GC and Earthwork contractor knew the soils were moisture sensitive and that drying would likely be necessary
- Allowed a very quick mobilization to treat soils and keep project on schedule
- Manipulated the percentage of chemical to optimize drying of soils with variable moistures

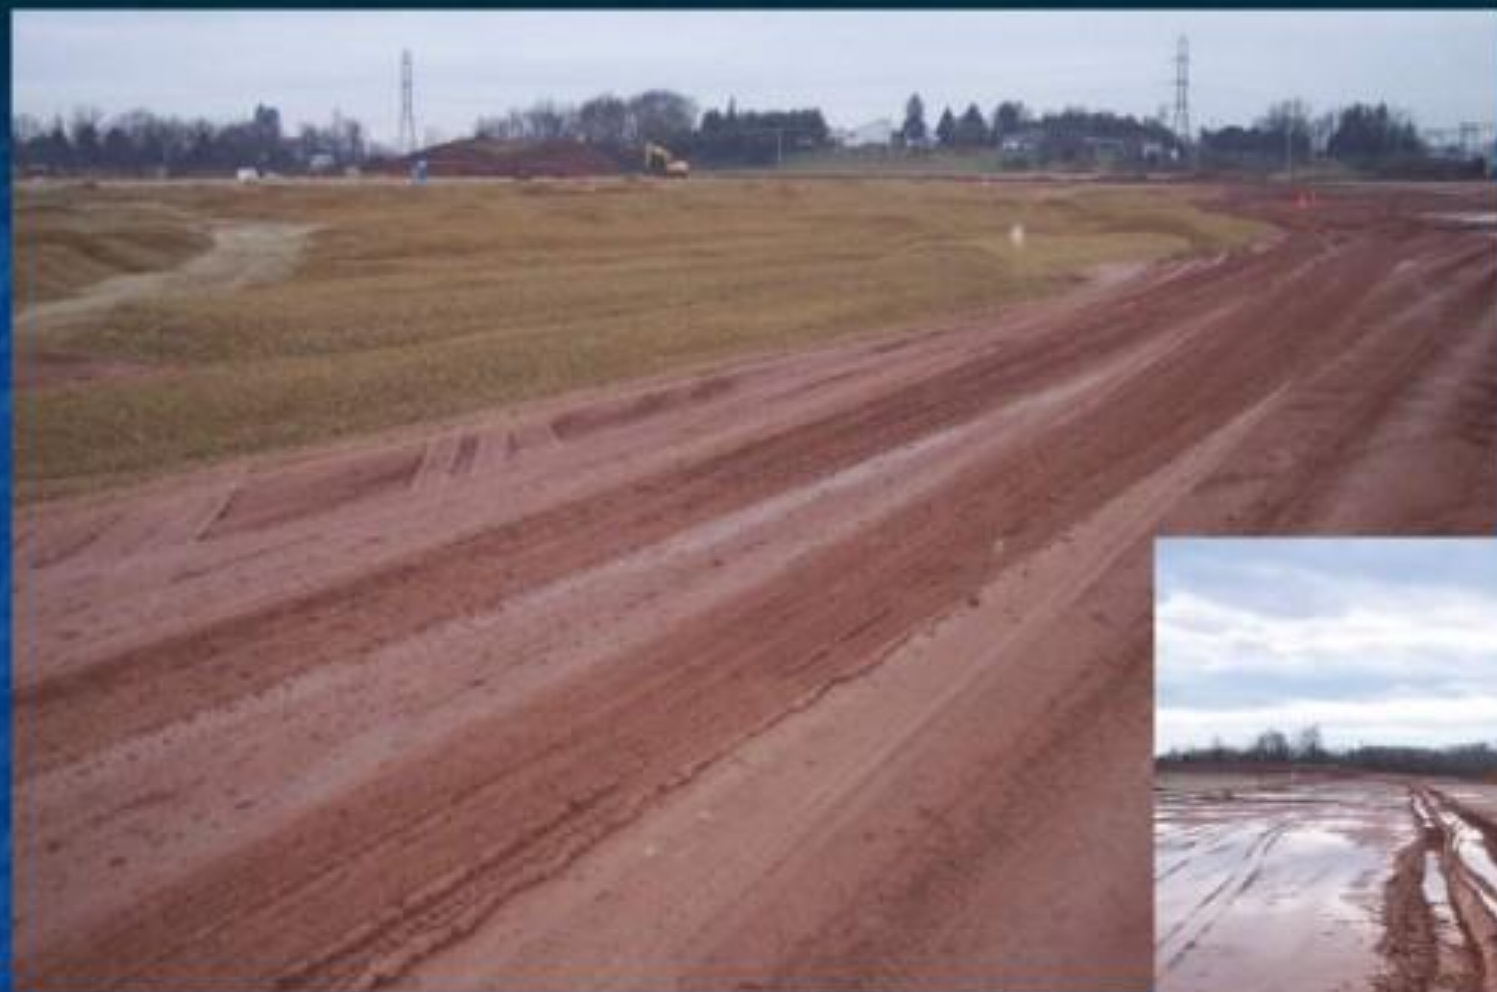
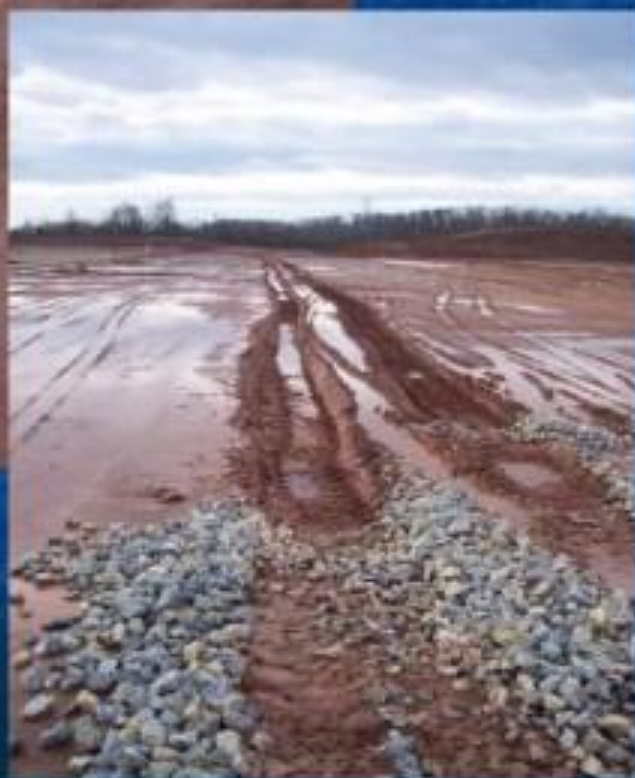
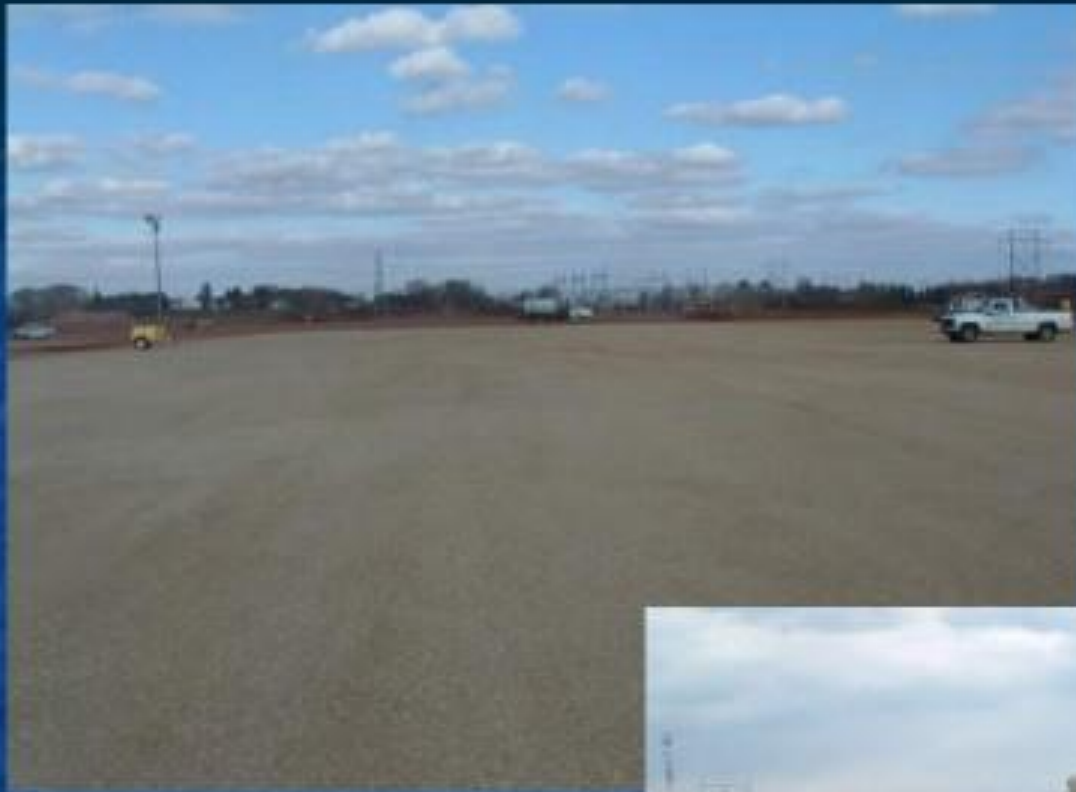
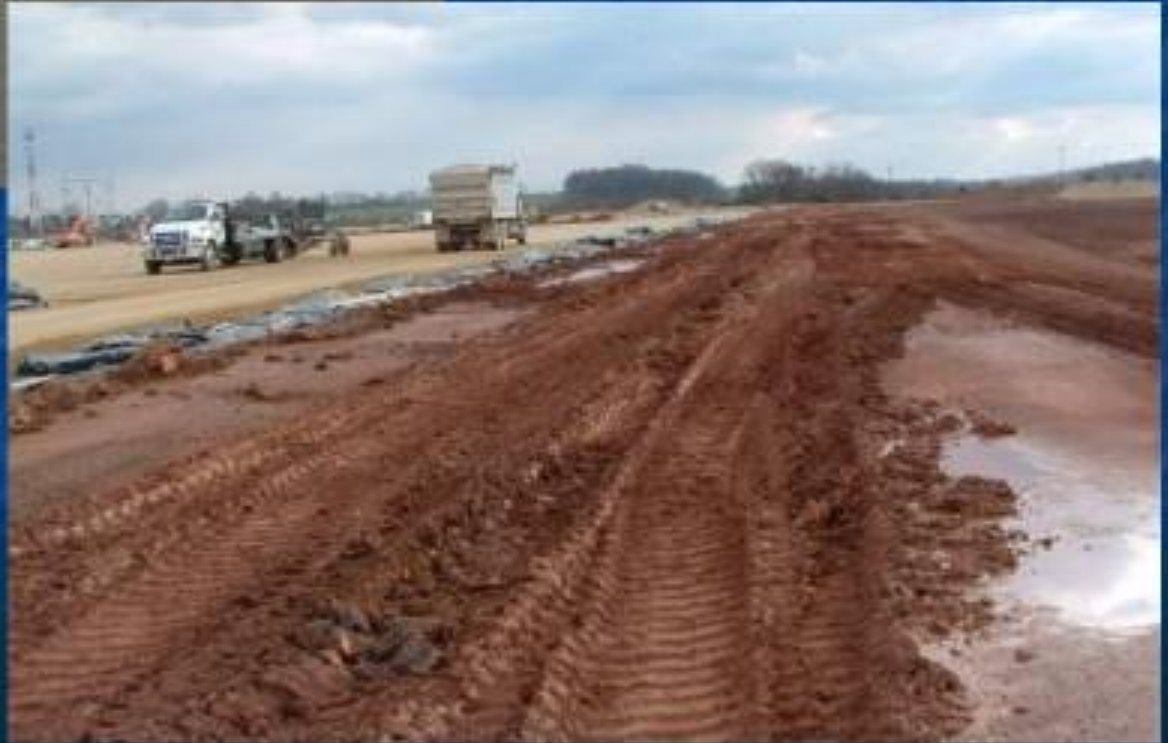
- Contractor decided to use Portland cement to stabilize the upper one foot of the soil subgrade
- Preliminary testing indicated that 5% cement was needed stabilize the soils
- Proceeded with 5% cement on manufacturing side of facility
- Reduced to 3% cement warehouse side of facility

- Stabilized soil allowed traffic for aggregate placement
- Drastically reduced the amount of subgrade stabilization, as evidenced by difference between 3% and 5% areas
- Subgrade experienced reduced degradation from long term saturation and construction traffic; reduced the associated subgrade repair costs
- Theoretically can reduce aggregate and concrete thickness.
 - Problems for buildings are exposure to weather and traffic
 - Grades will change, so need to implement early in design process

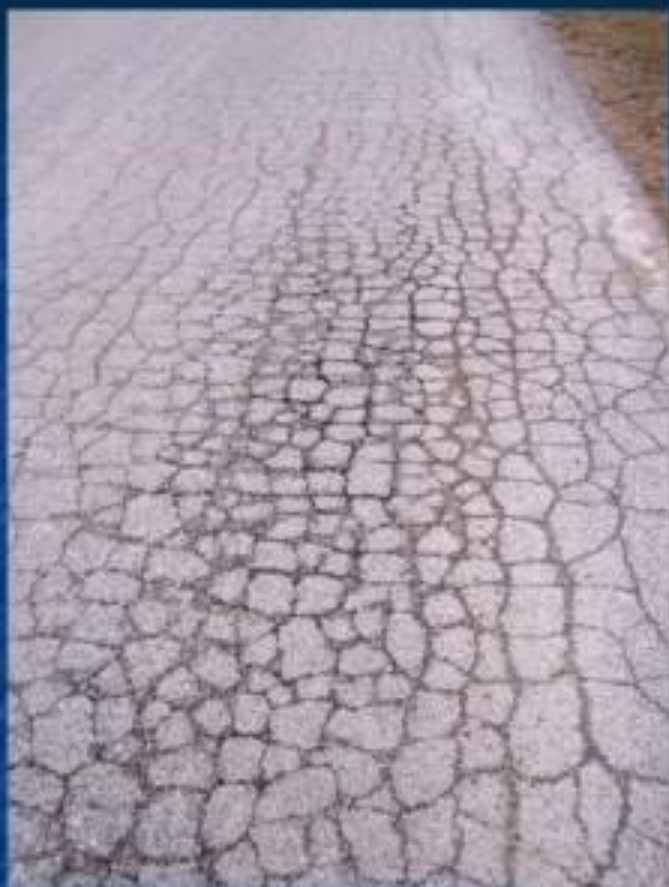
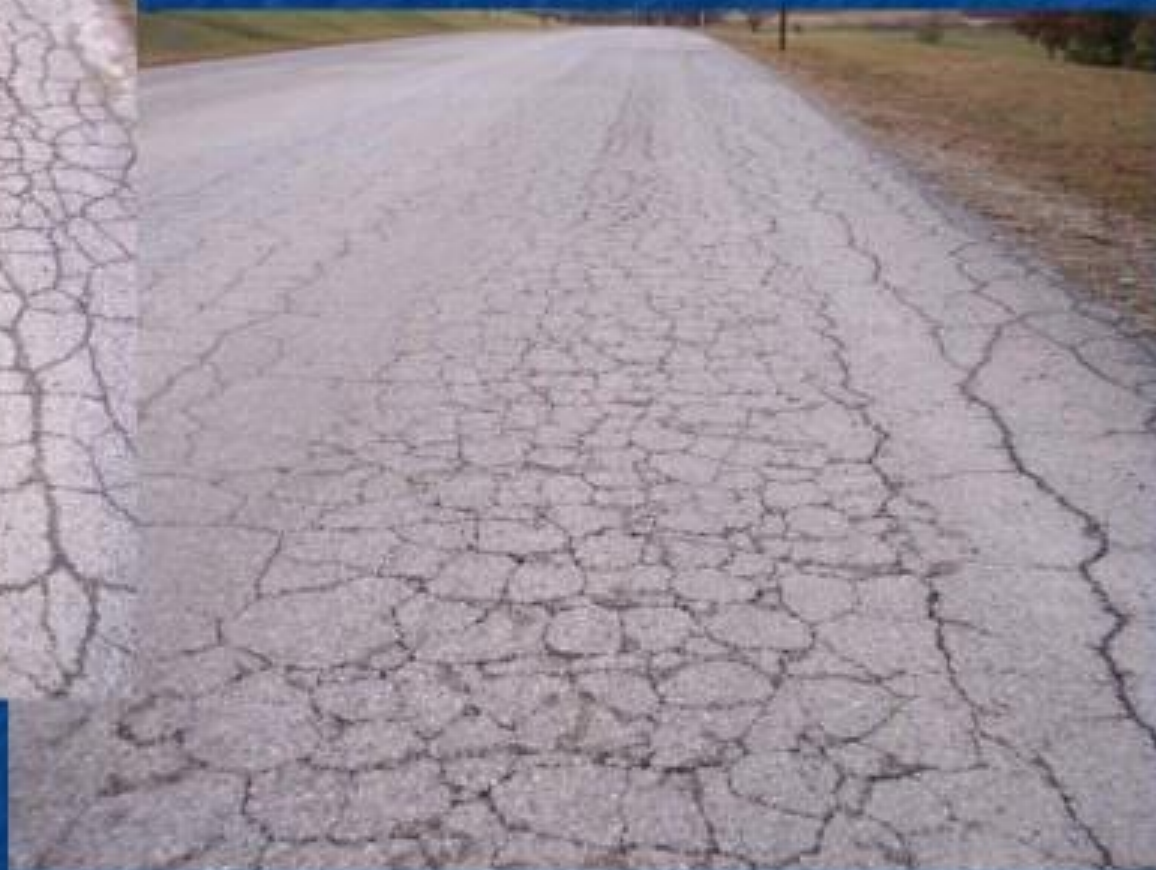
- Commerce Drive is a municipal owned roadway that services a light industrial park, with very little truck traffic
- Roadway required widening and reconstruction due to severe deterioration
- New facility expected 200+ tractor trailers per day

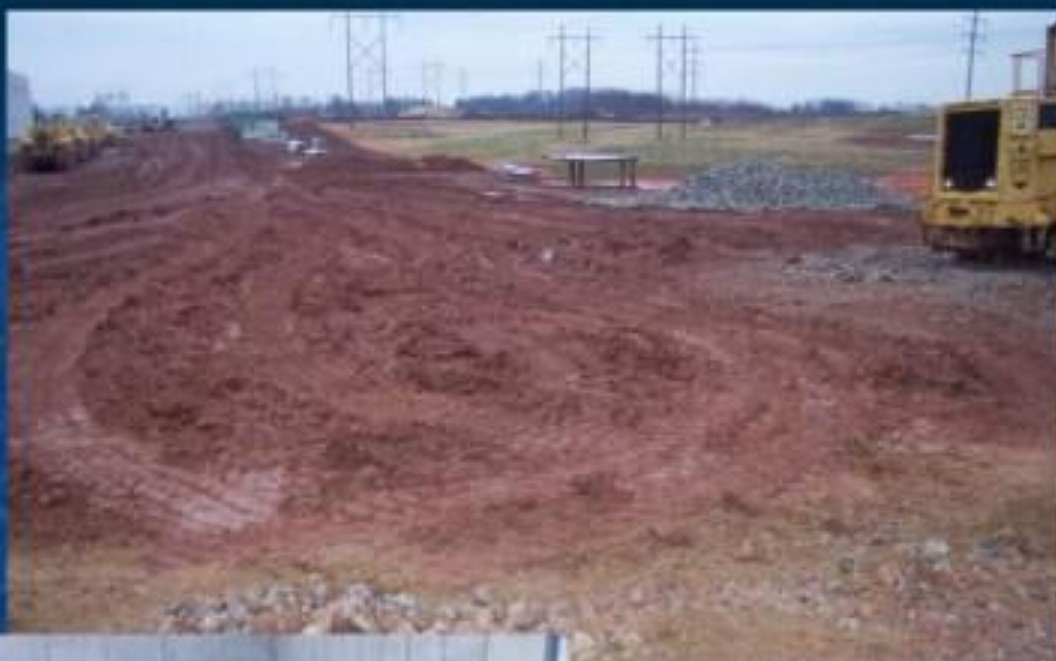
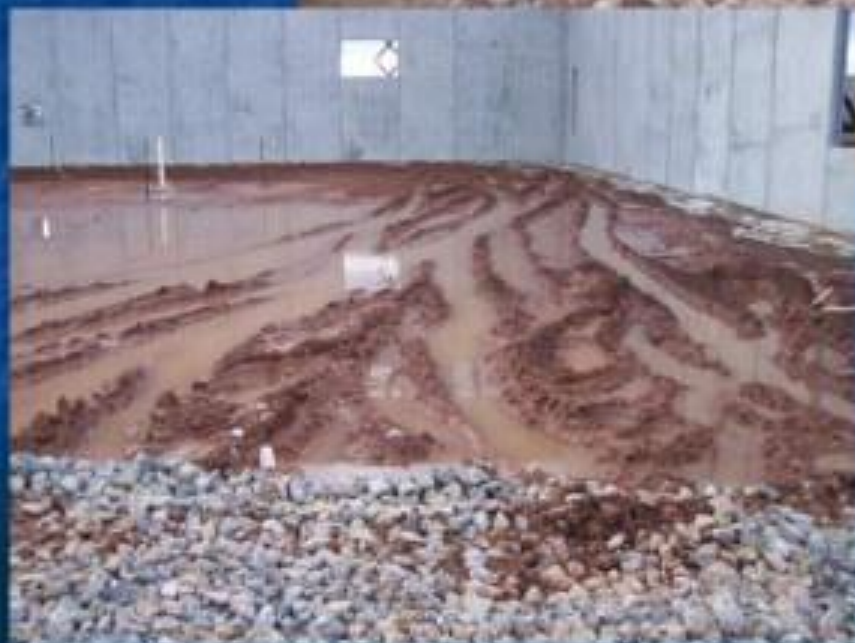
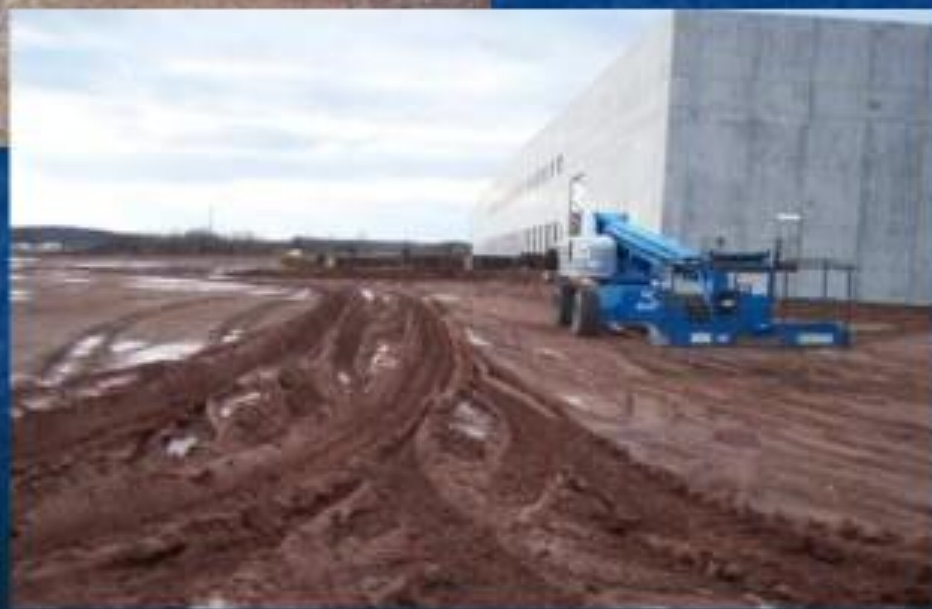
- Contractor asked about using chemical stabilization to enhance the strength of the soil subgrade as a means to reduce the costs of the asphalt pavement for the parking lots

- Proposed asphalt pavement consisted of:
 - 6 inches of asphalt
 - 8 inches of aggregate
- Structural number = 3.28
- Value engineered asphalt pavement on FDR consisted of:
 - 4 inches of asphalt
 - 0 inches of aggregate
 - 12 inches of cement stabilized soils
- Structural number = 3.28
