BRIDGE PRESERVATION

**Silane Penetrating Sealers
the first Defense in Bridge
Protection**

NATIONAL BRIDGE PRESERVATION PARTNERSHIP CONFERENCE 2014

Determining the Effective Service Life of Silane Treatments in Concrete Bridge Decks

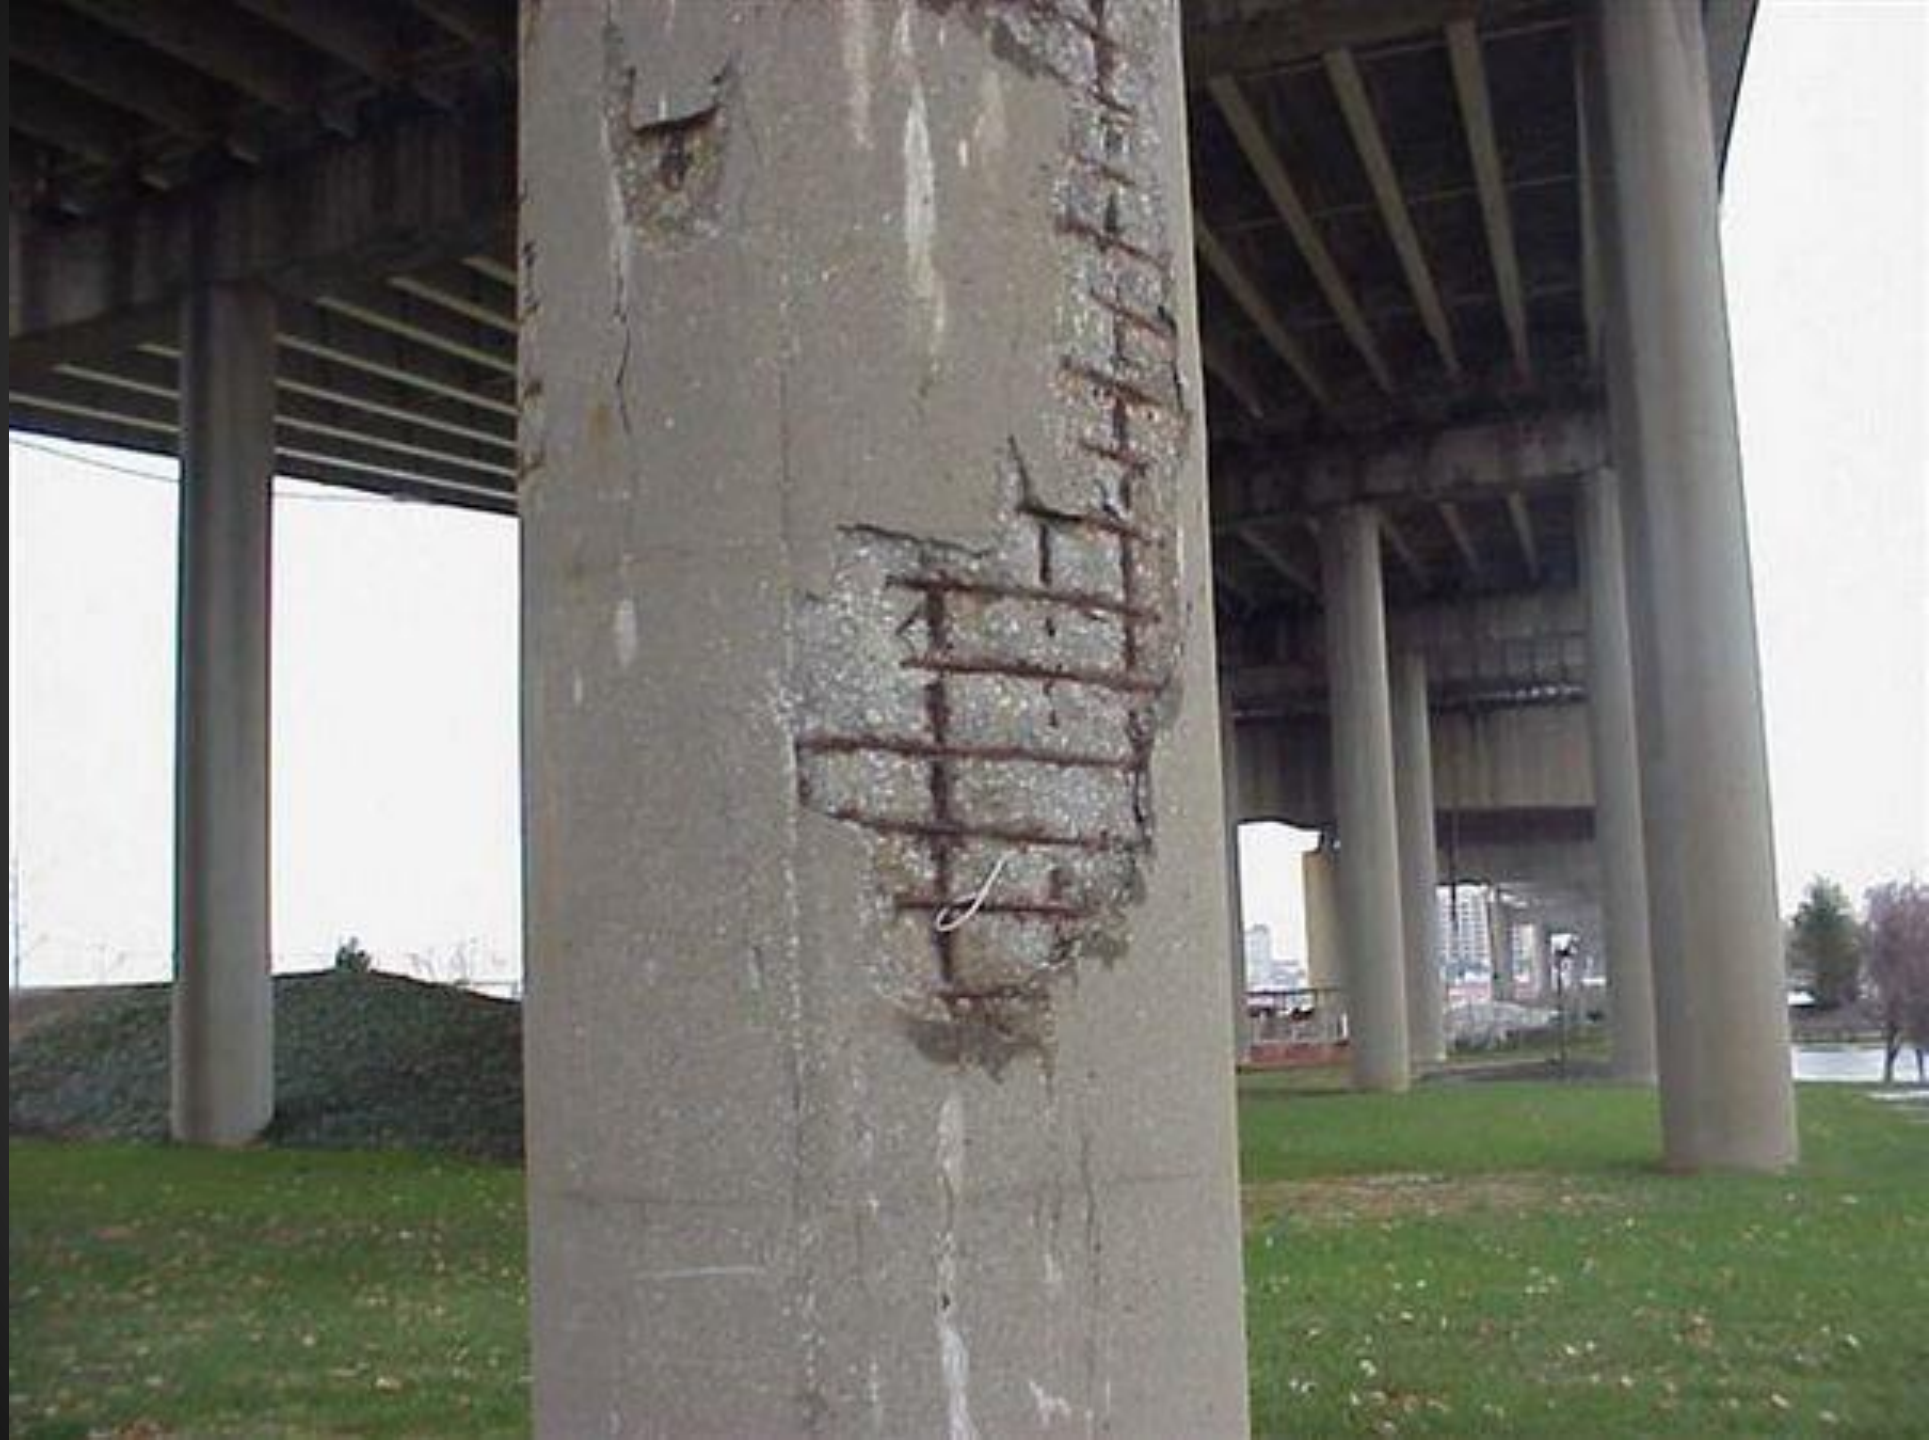
REBAR CORROSION

**Salts dissolve in Water
causing rebar corrosion**

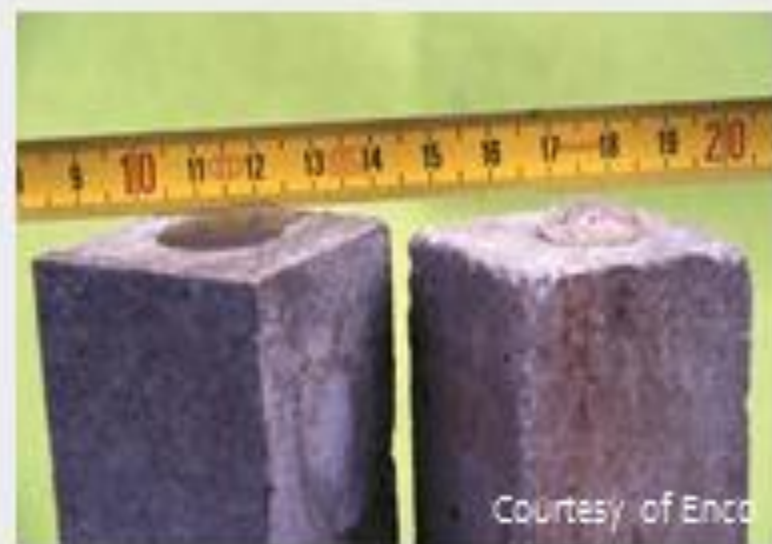
Reduction of concrete surface tension:
inter-molecular attraction of water molecules is much higher than the attraction of water into concrete

From hydrophilic (water-loving) to hydrophobic (water-hating) surface

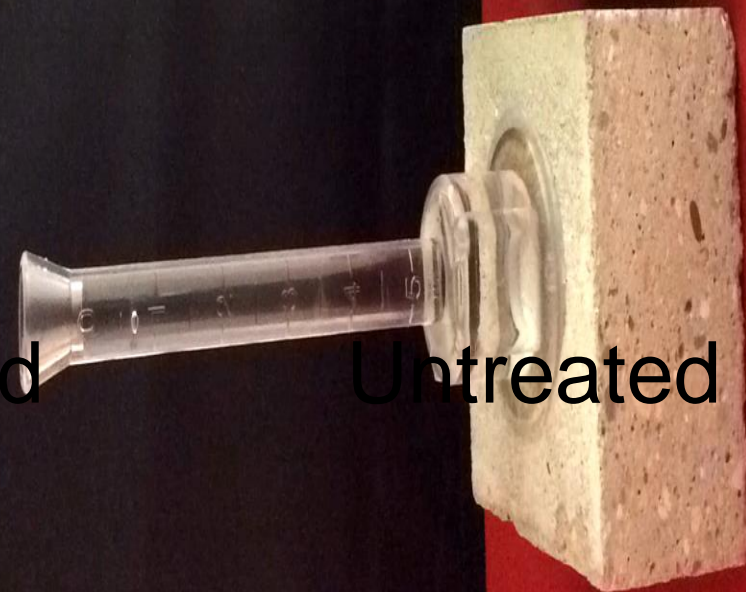
Treated Block

- 100% Silane
- 250sq ft. per gallon
- 3 hour time lapse
- **Zero water absorption.**

Untreated Block

- 3 hour time lapse
- **5 mL of water absorbed.**

OVERALL RESULT

91% reduction in water absorption.

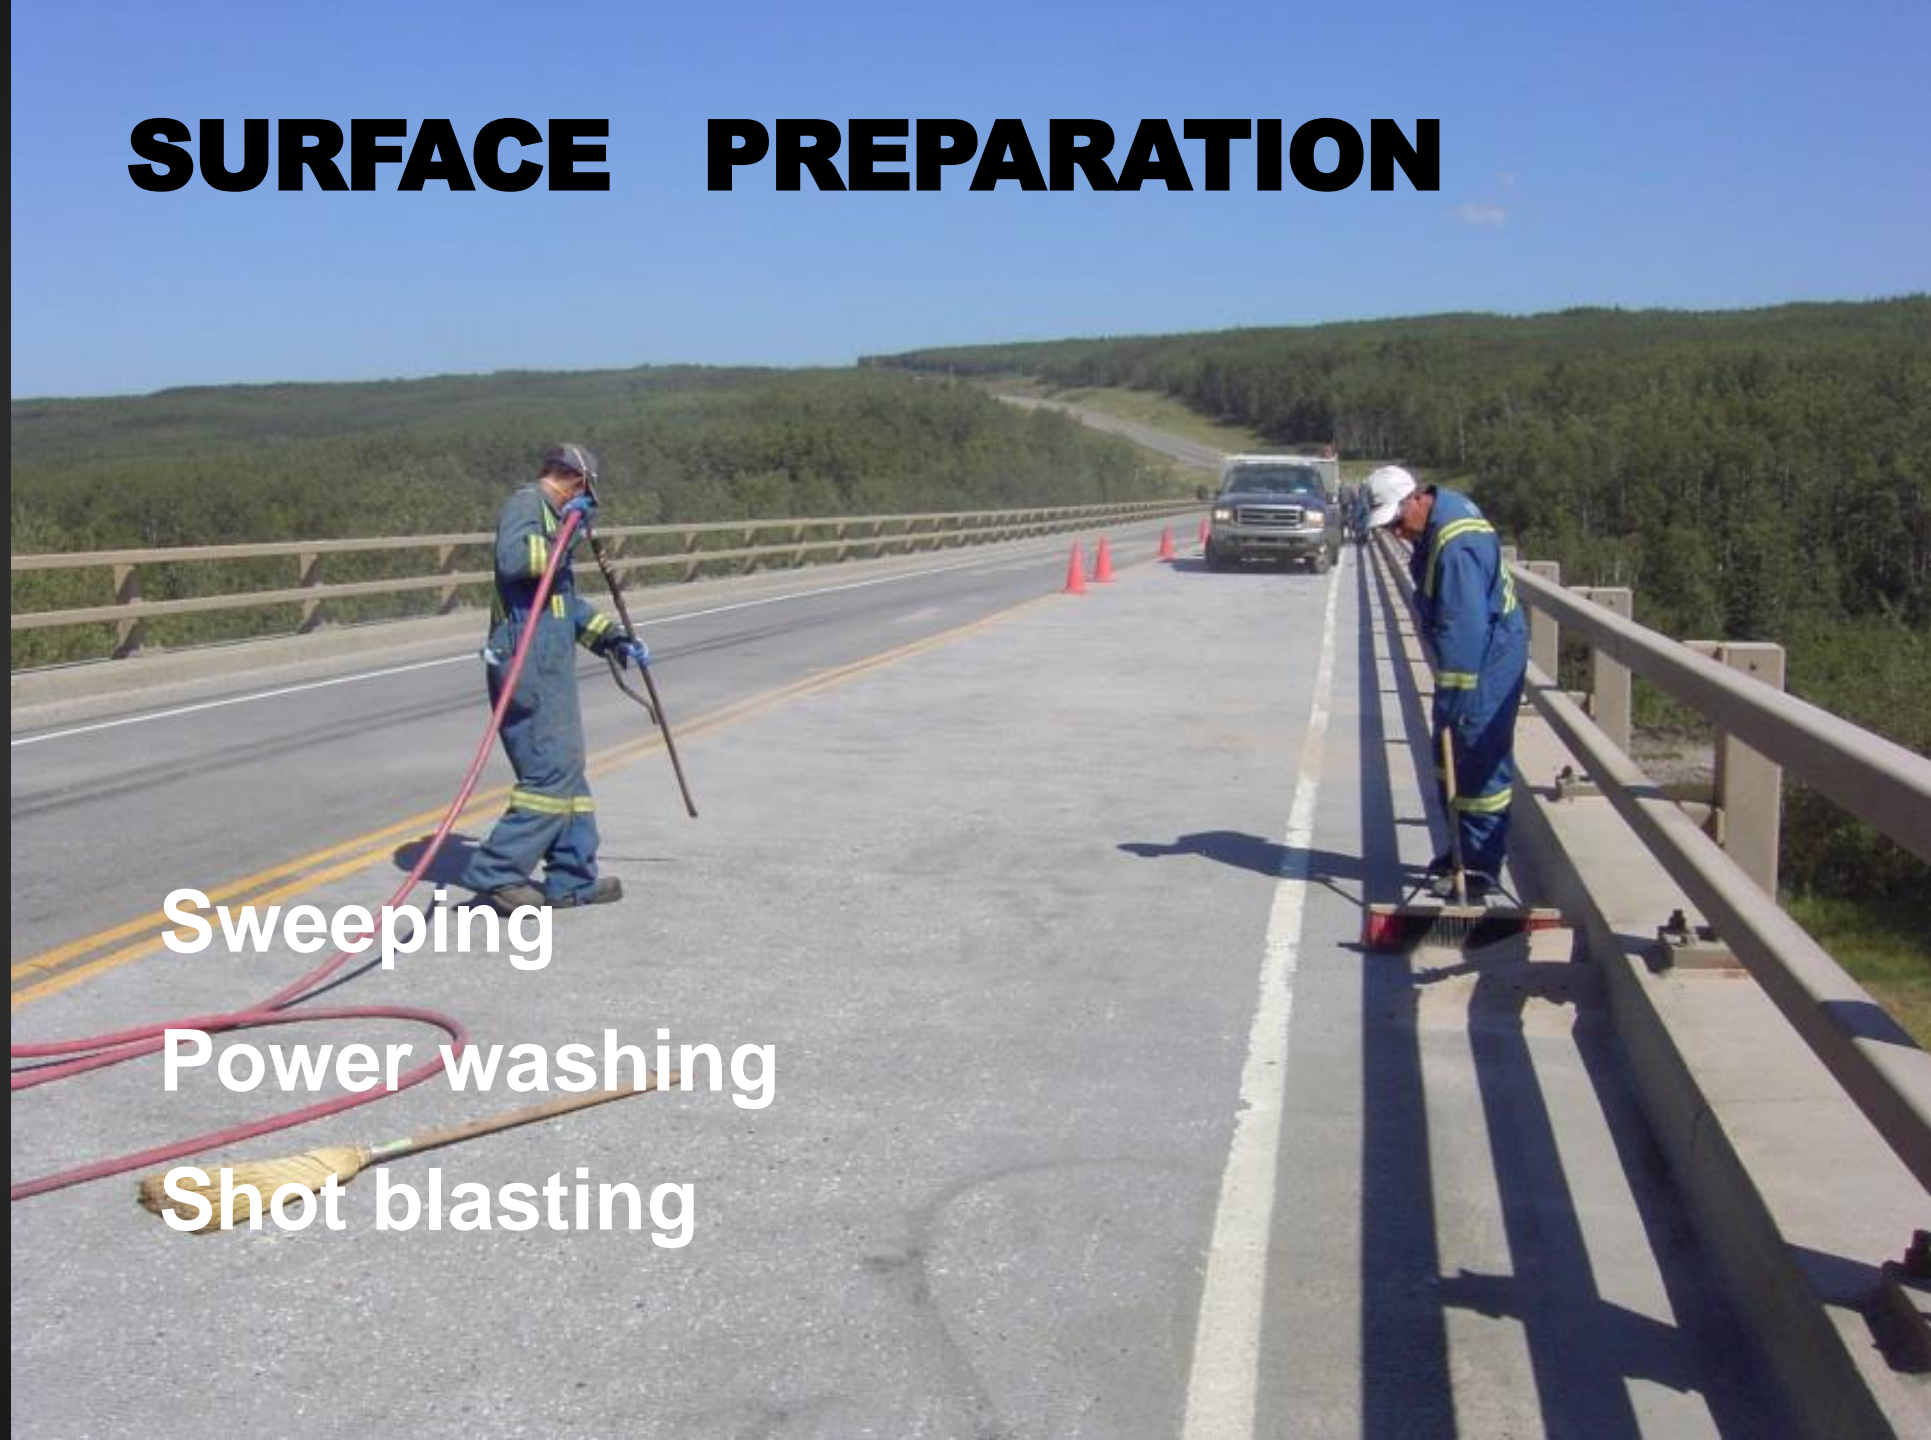
SURFACE PREPARATION

Sweeping

Power washing

Shot blasting

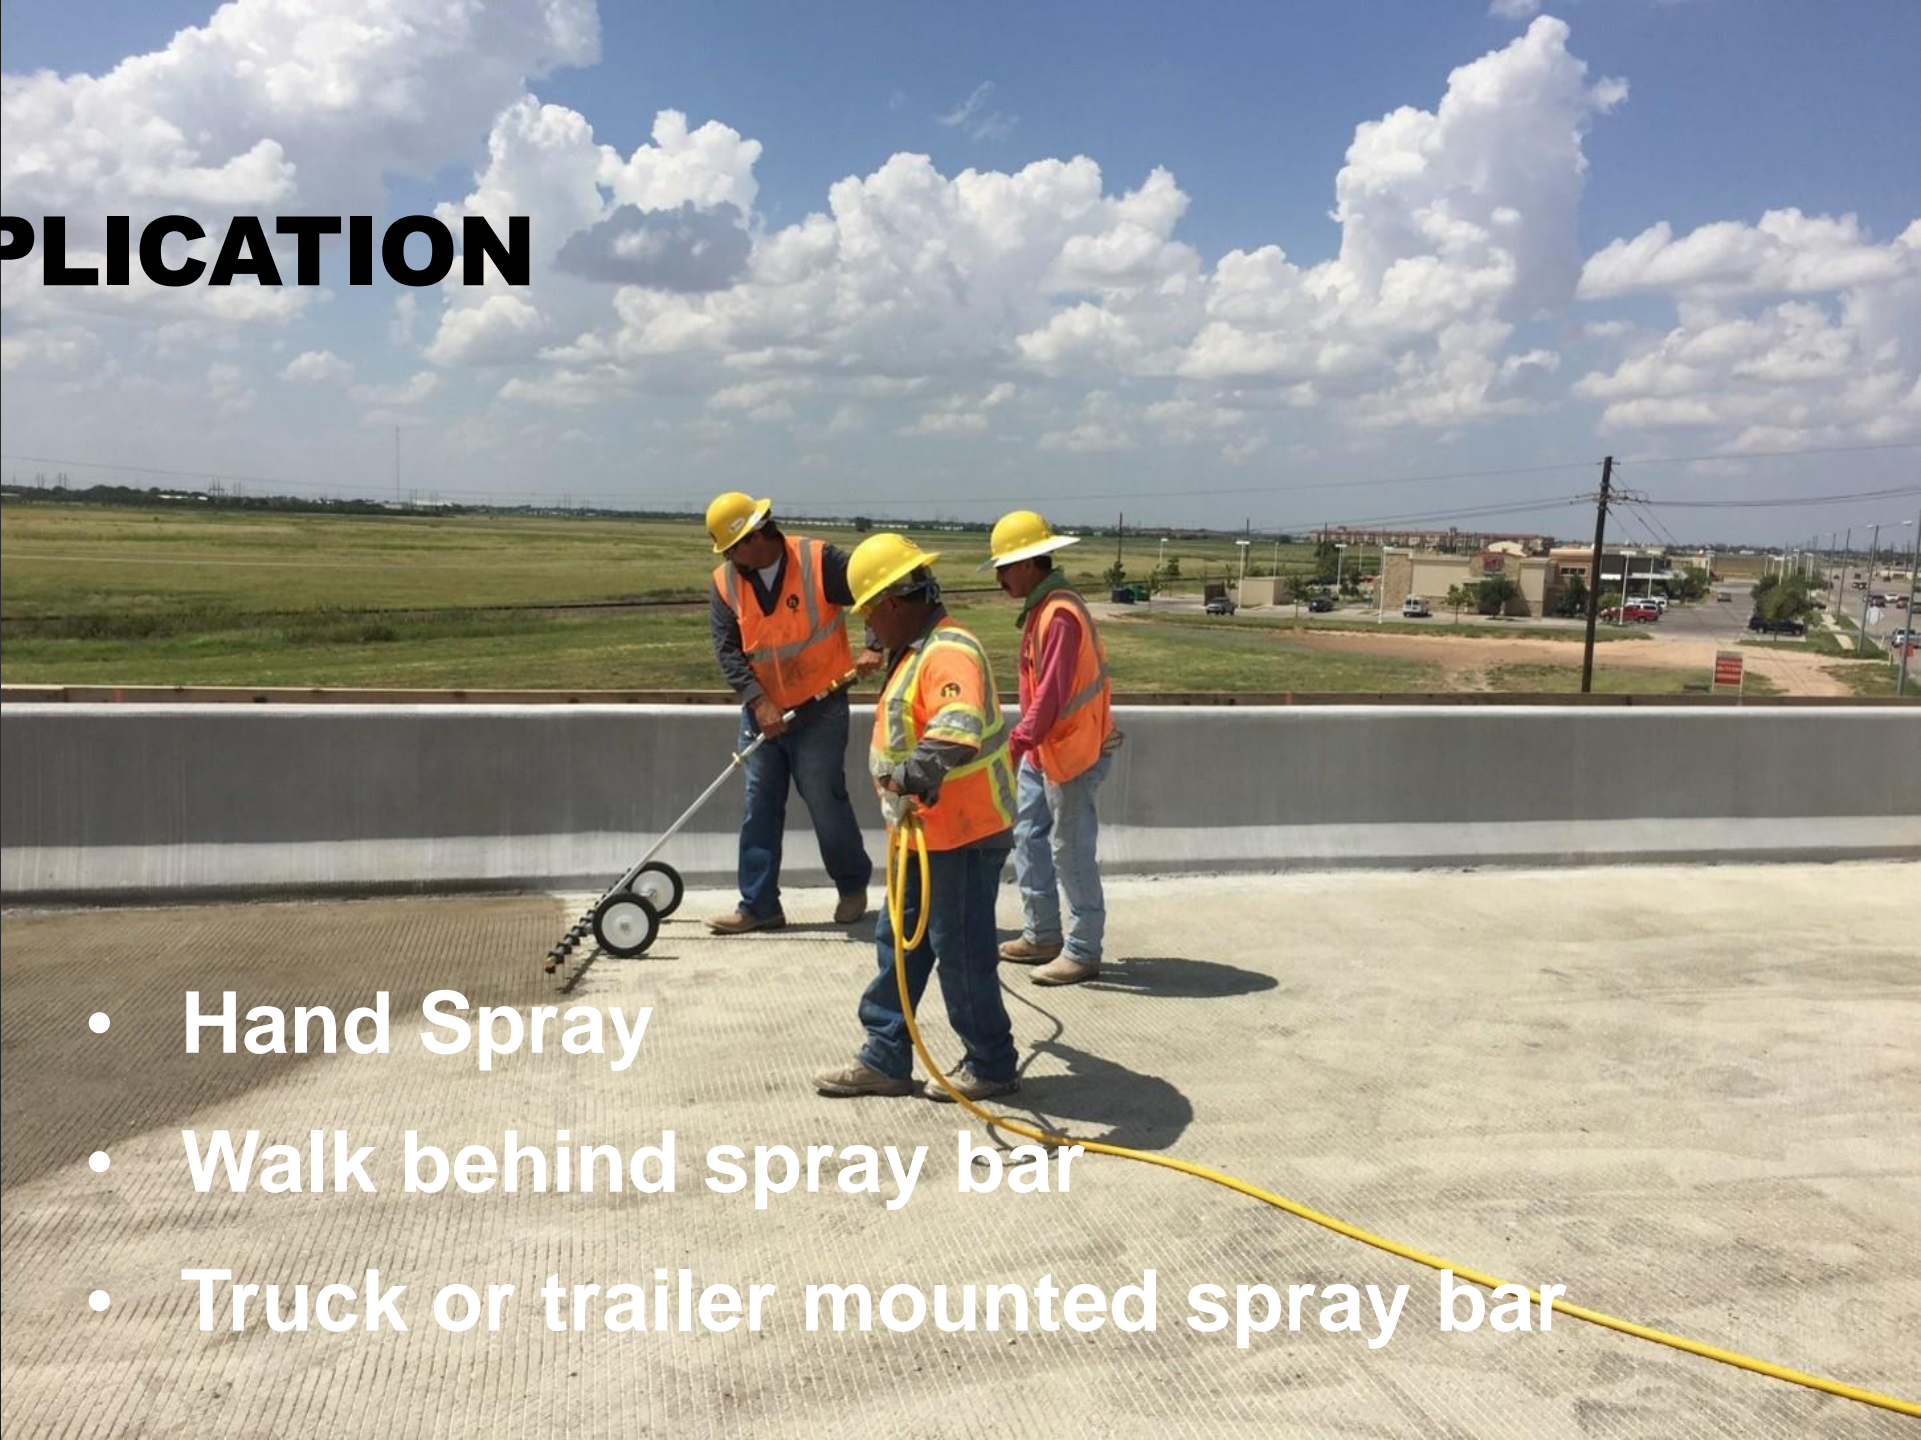
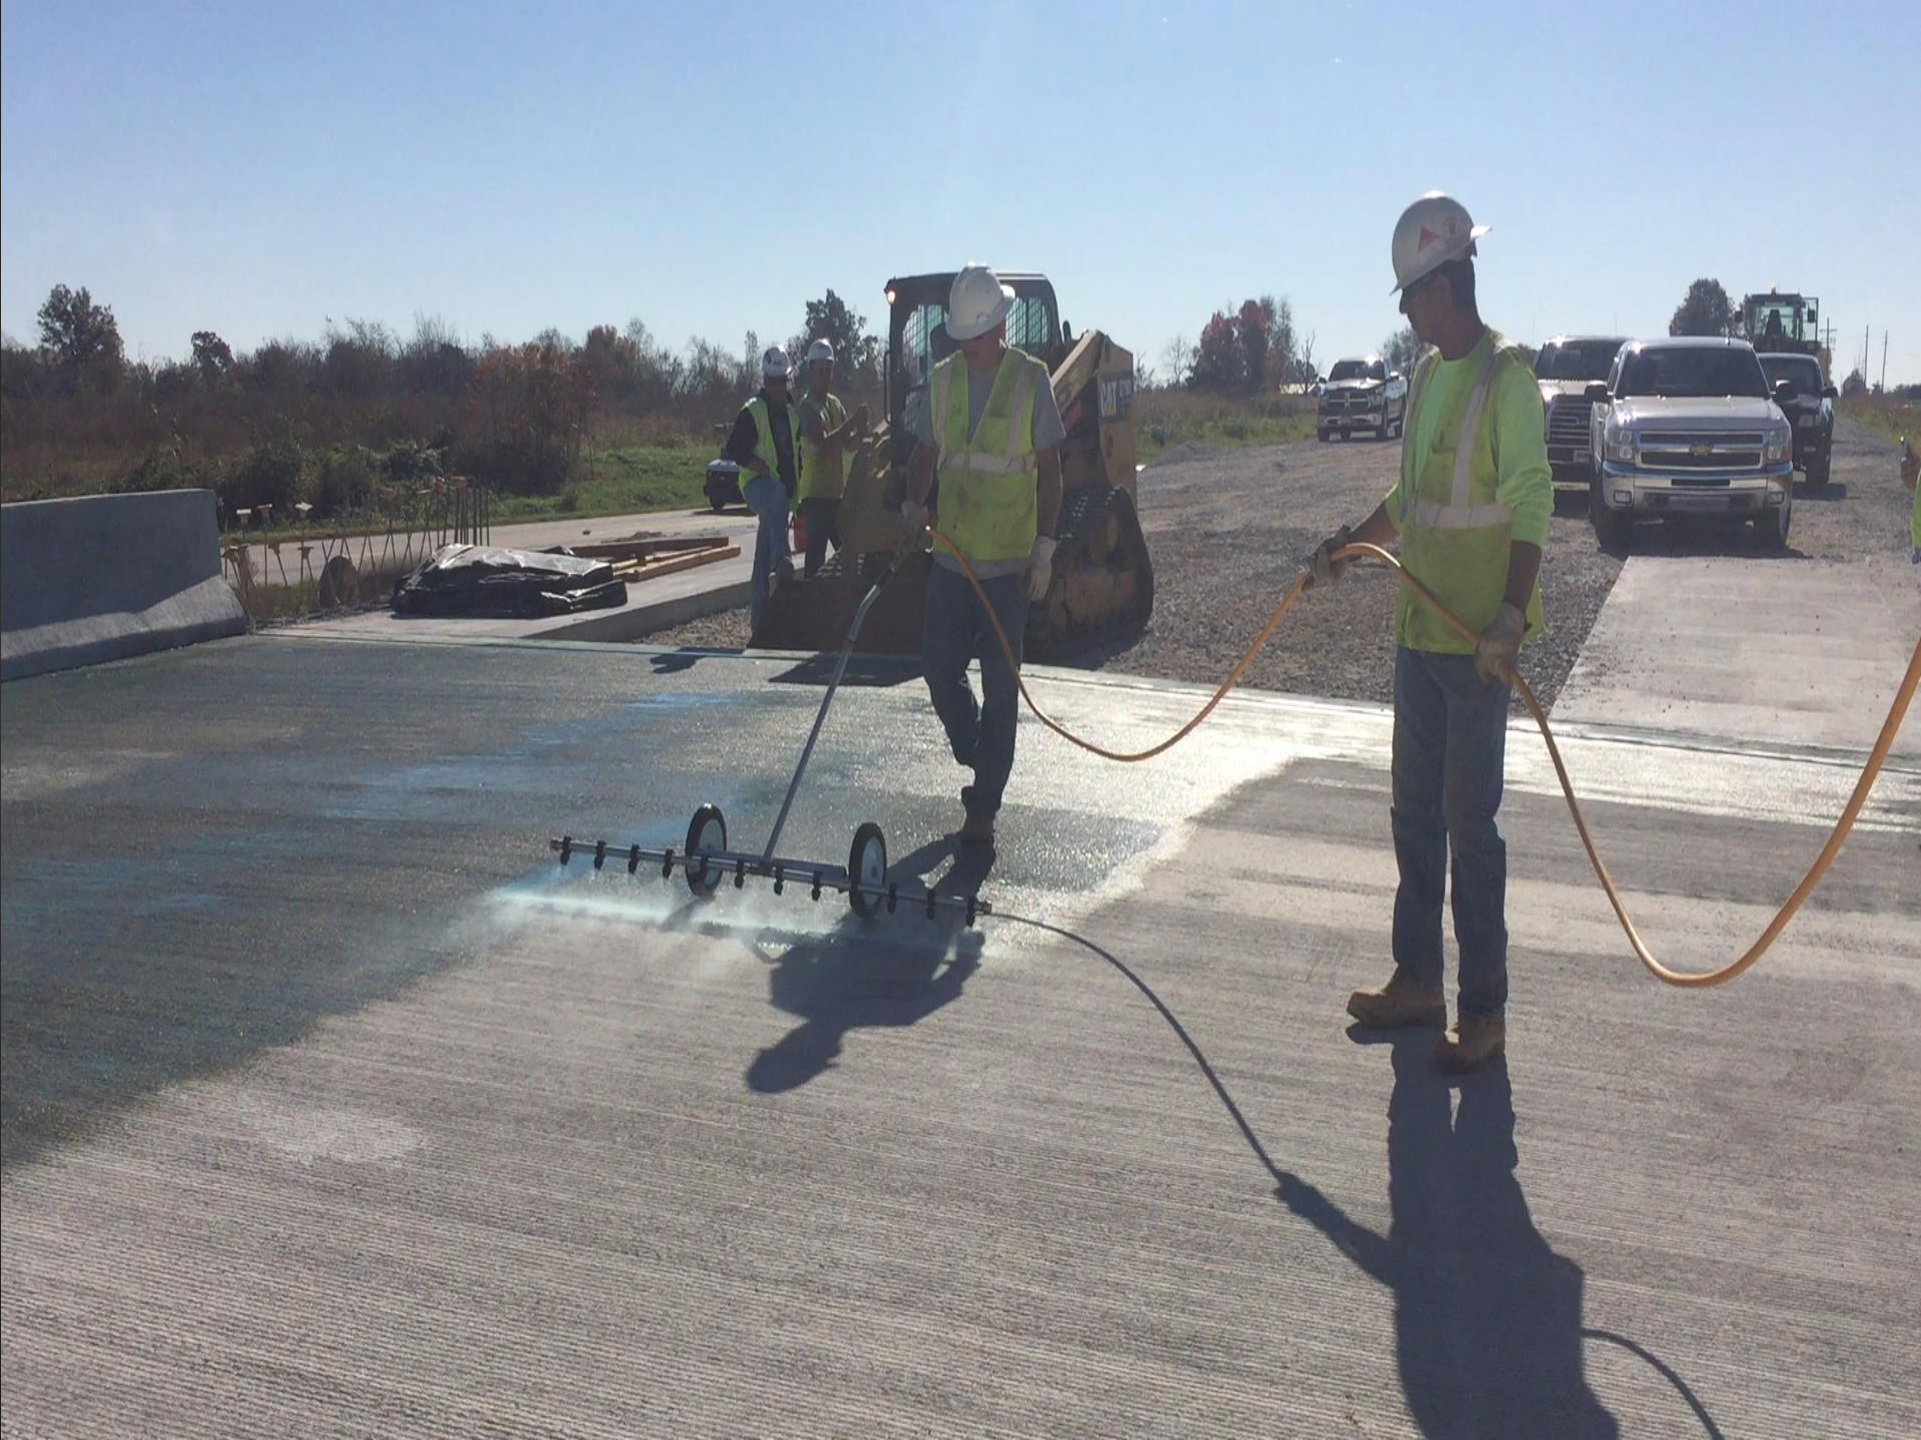
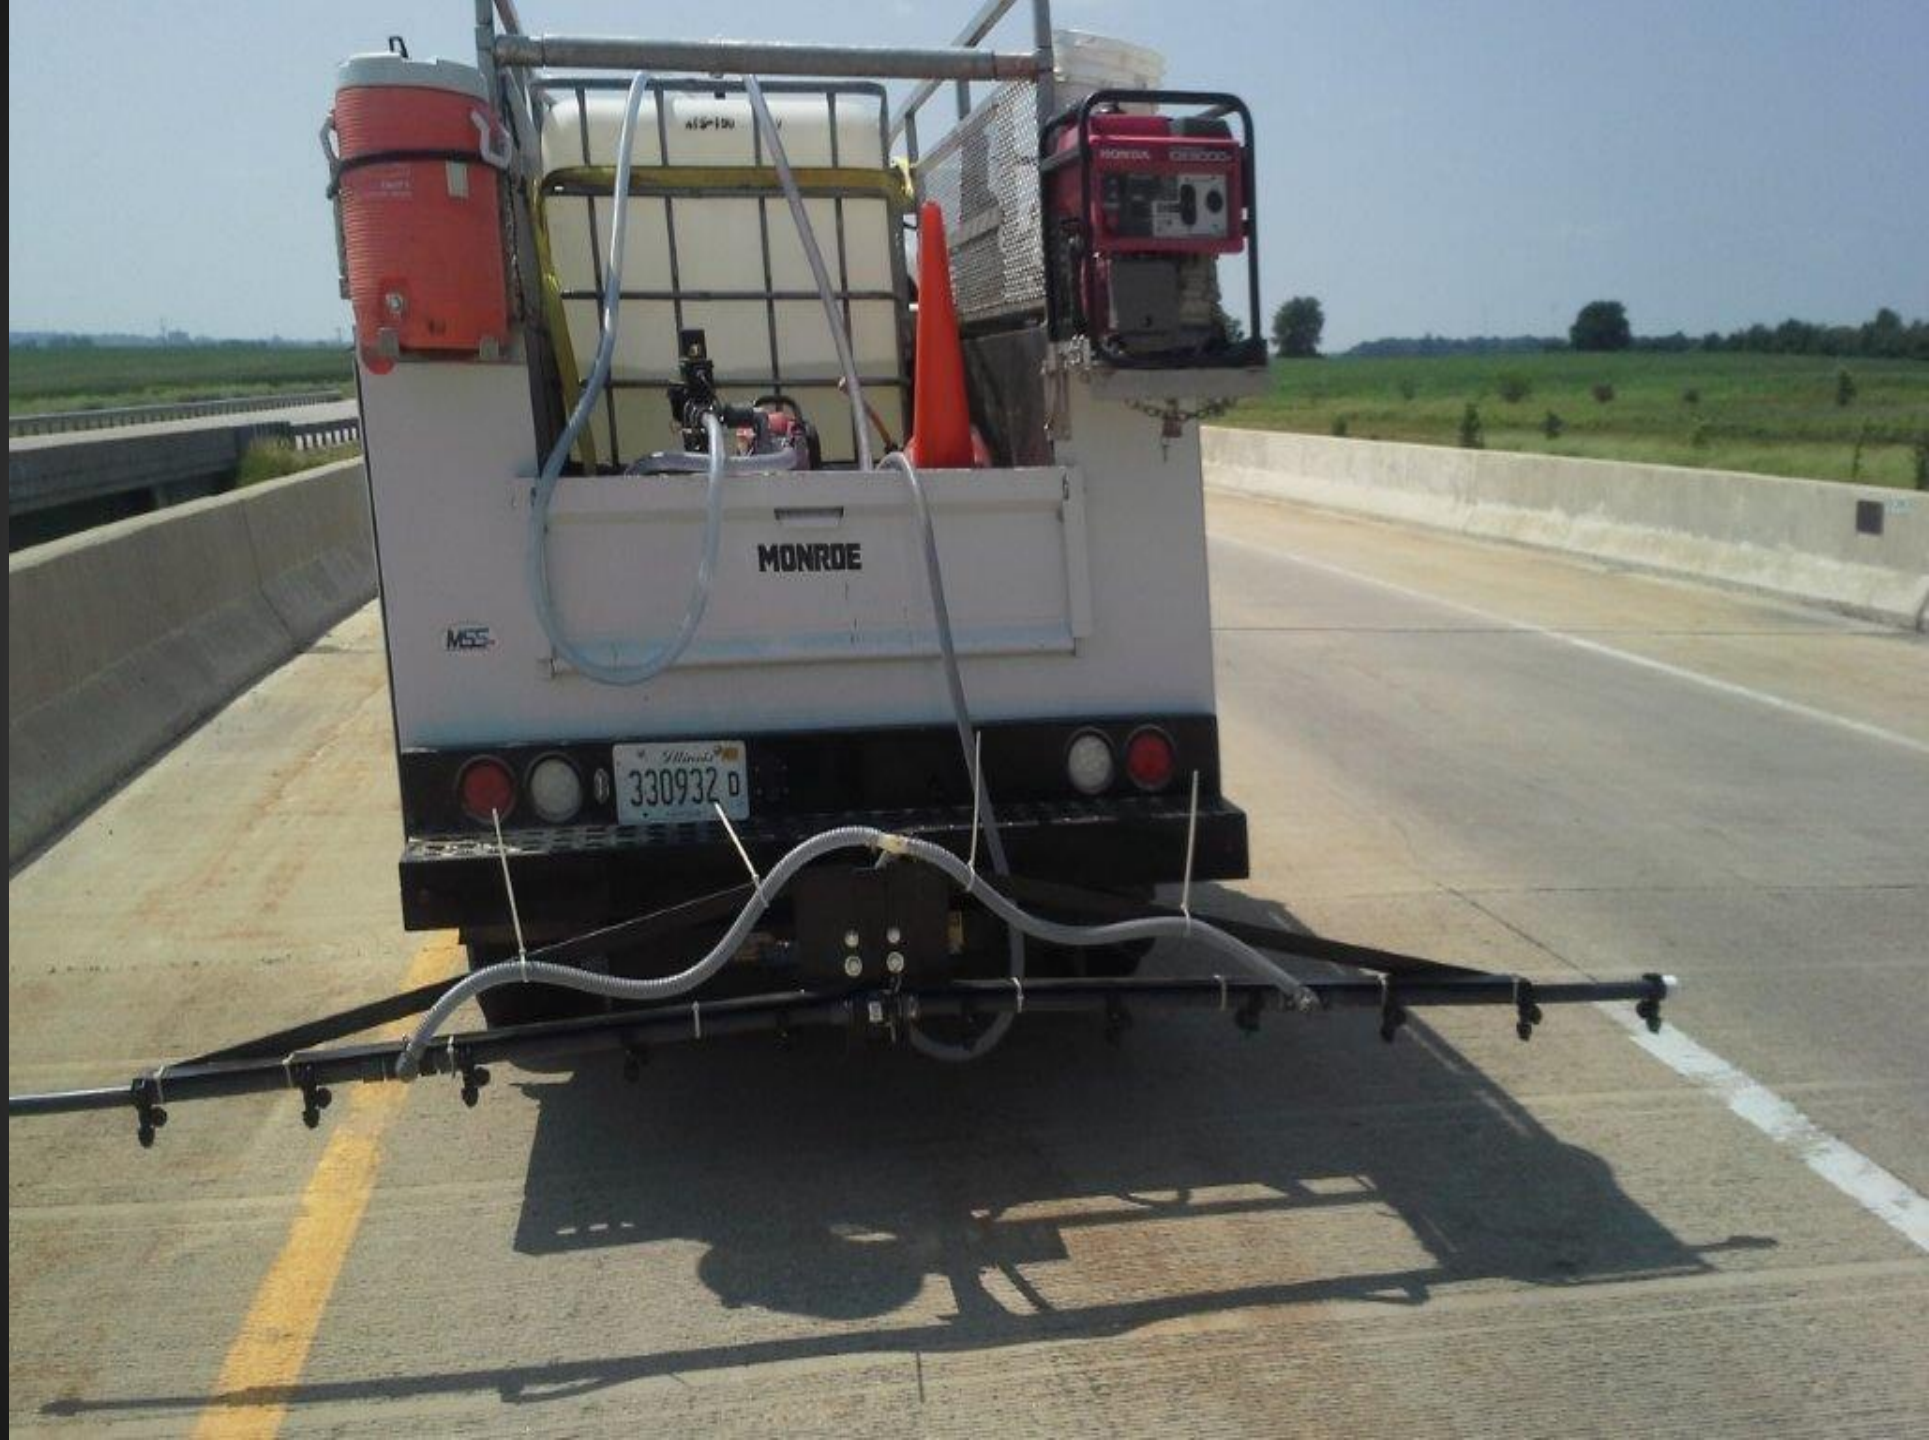
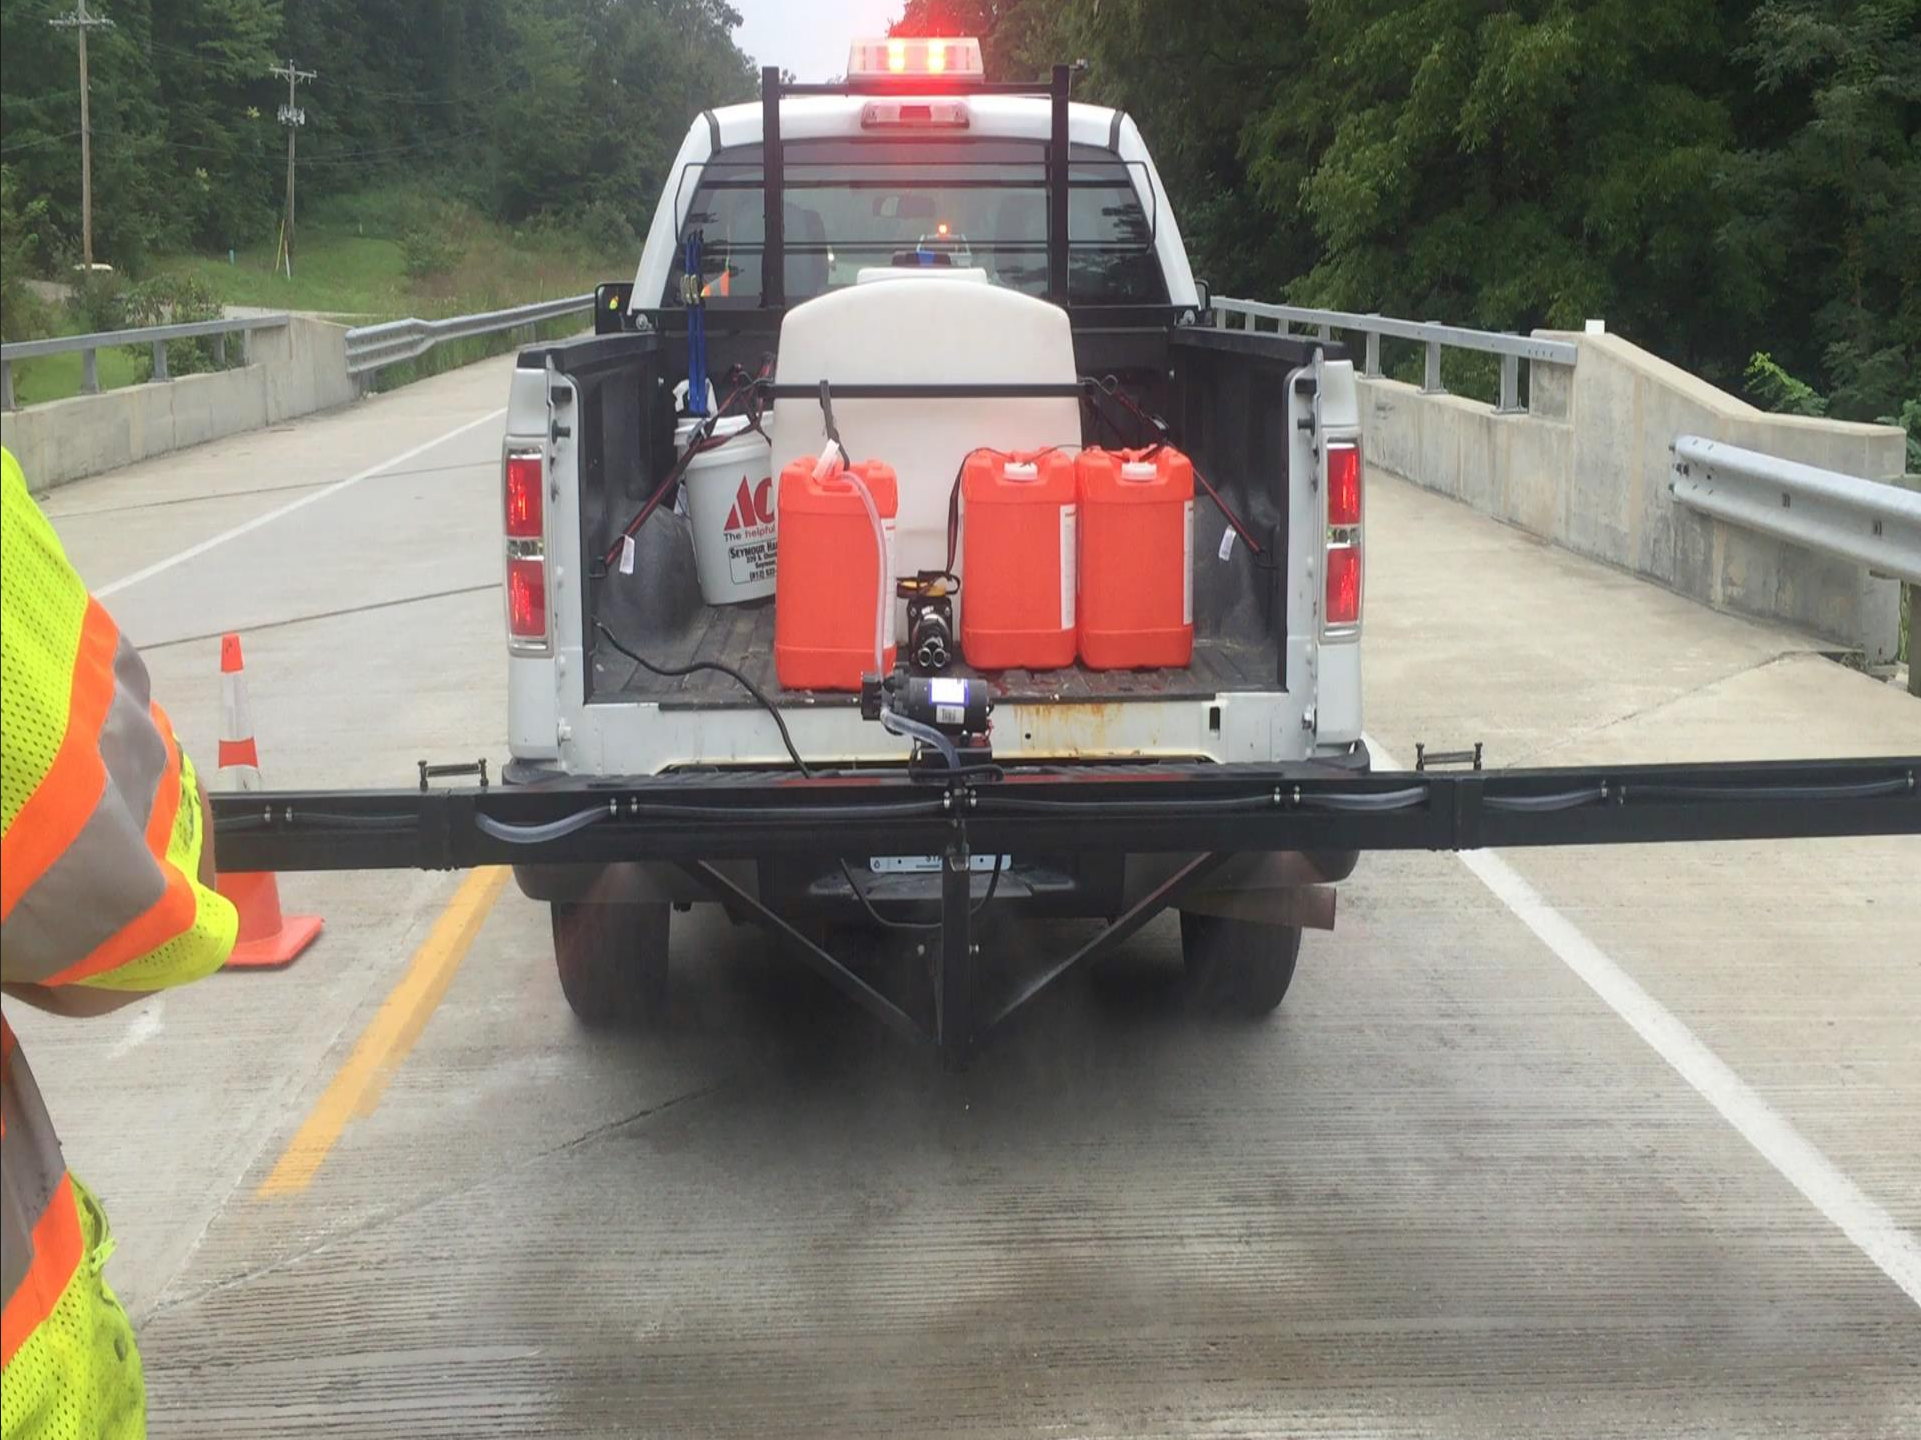
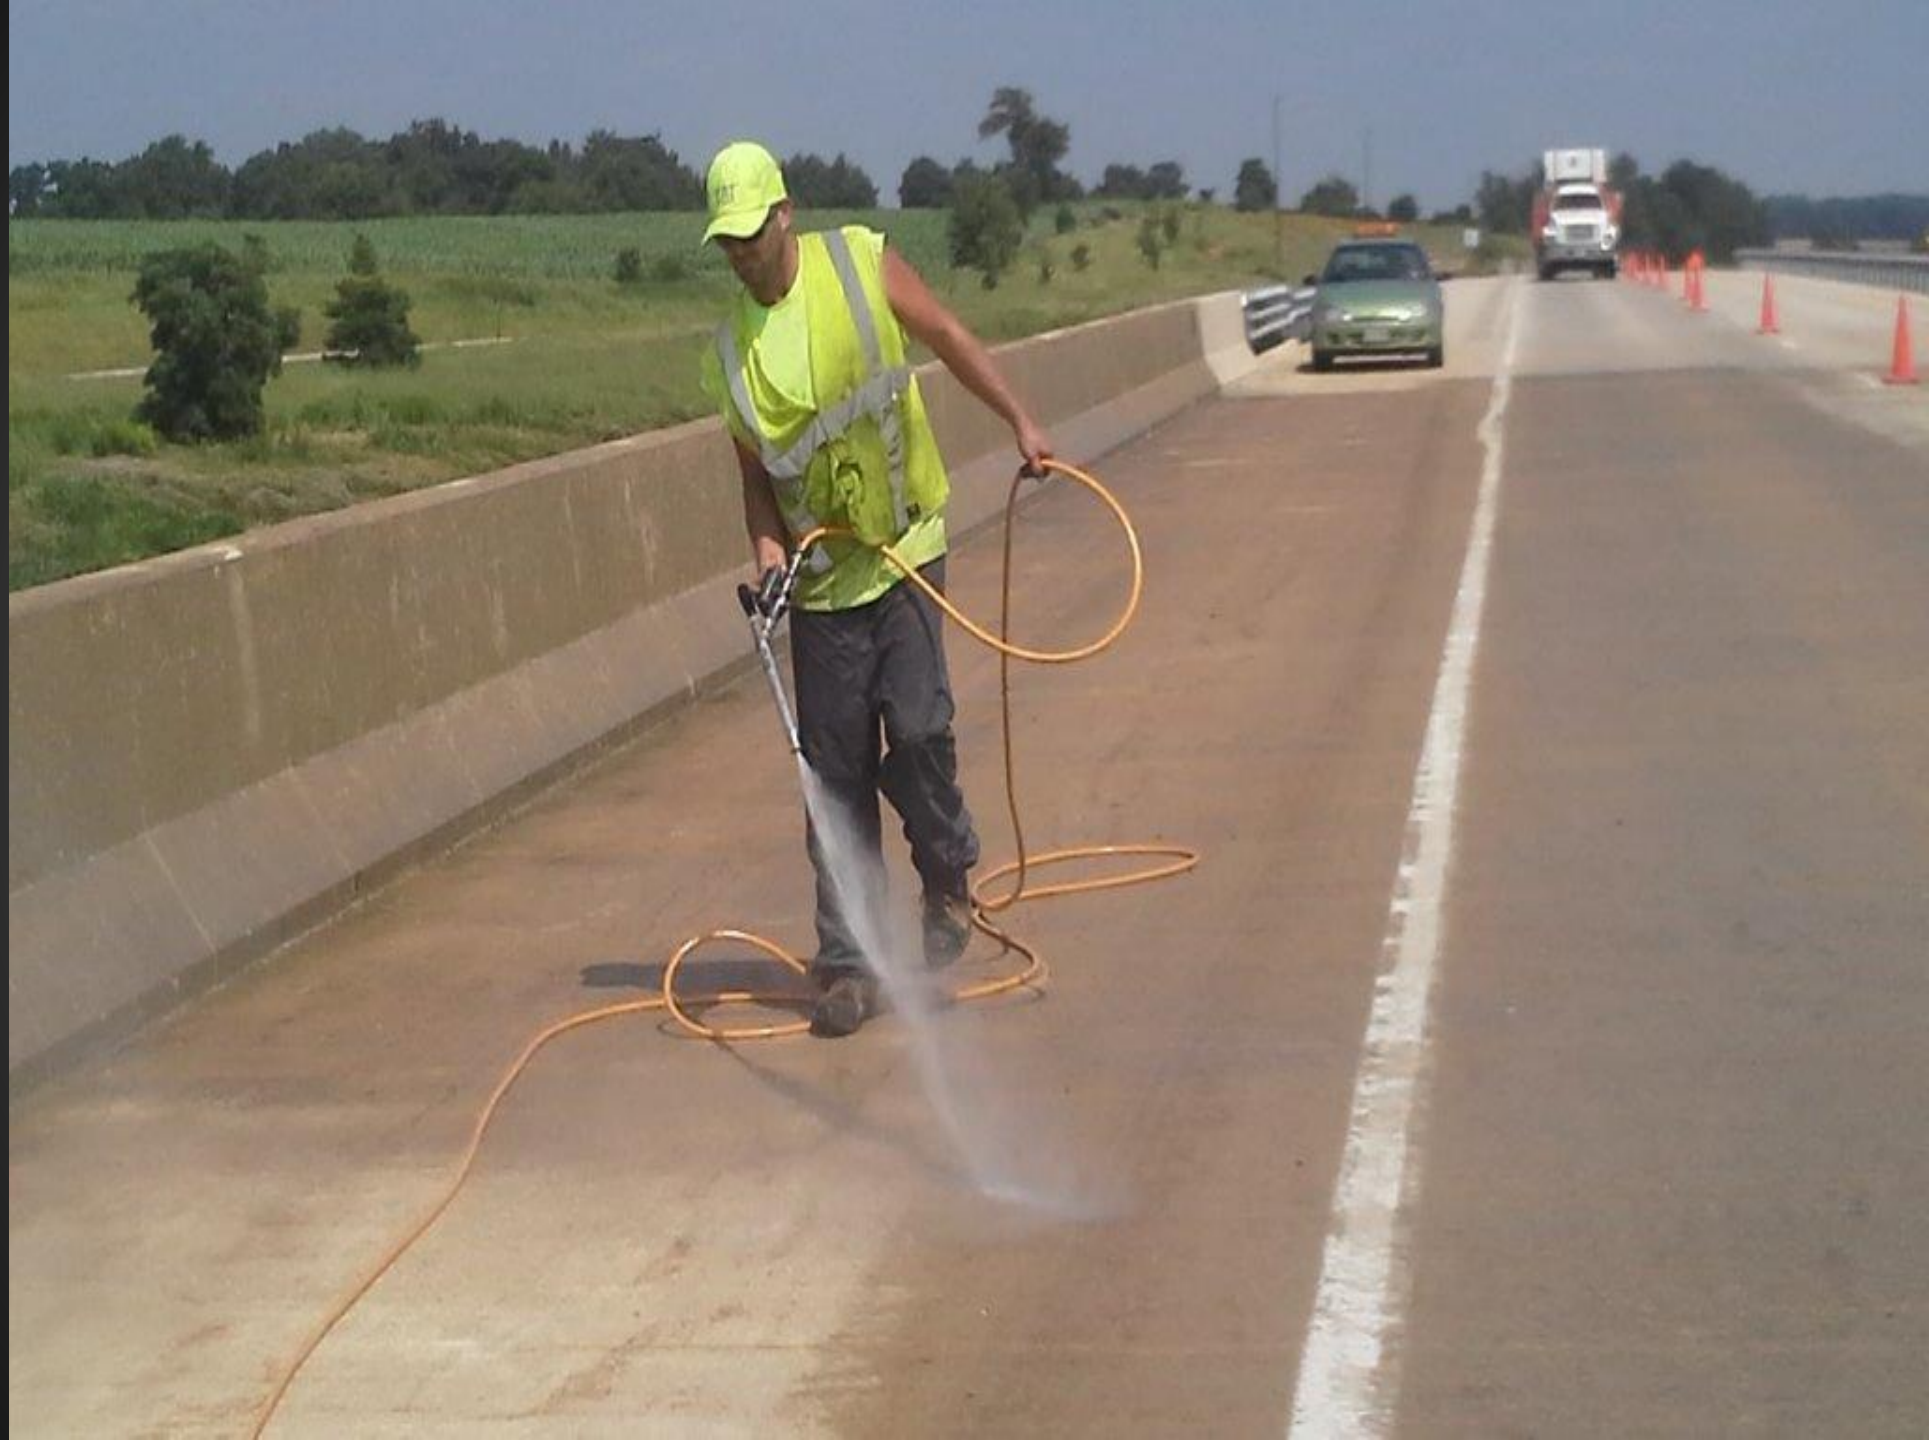
APPLICATION

- Hand Spray
- Walk behind spray bar
- Truck or trailer mounted spray bar
