NDOT Research Report

Exploring Alternative Strategies for the Rehabilitation of Low-Volume Roads in Nevada

Final Management Report

January 2008

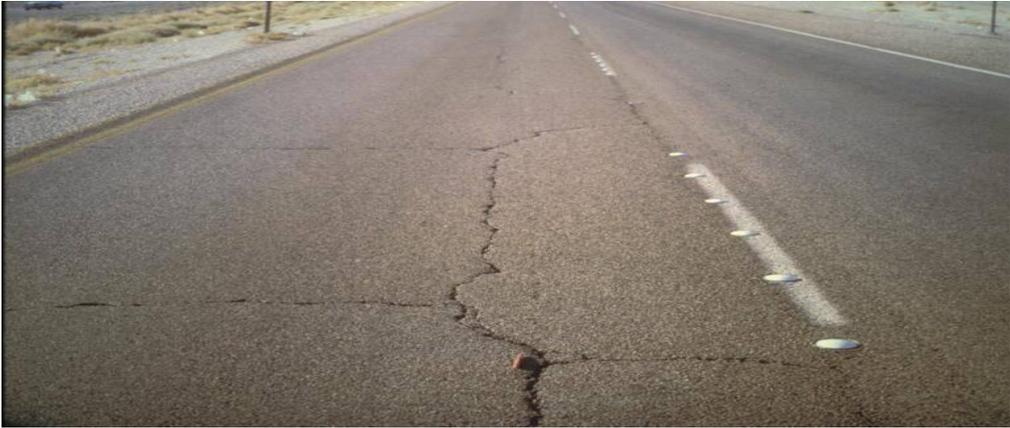
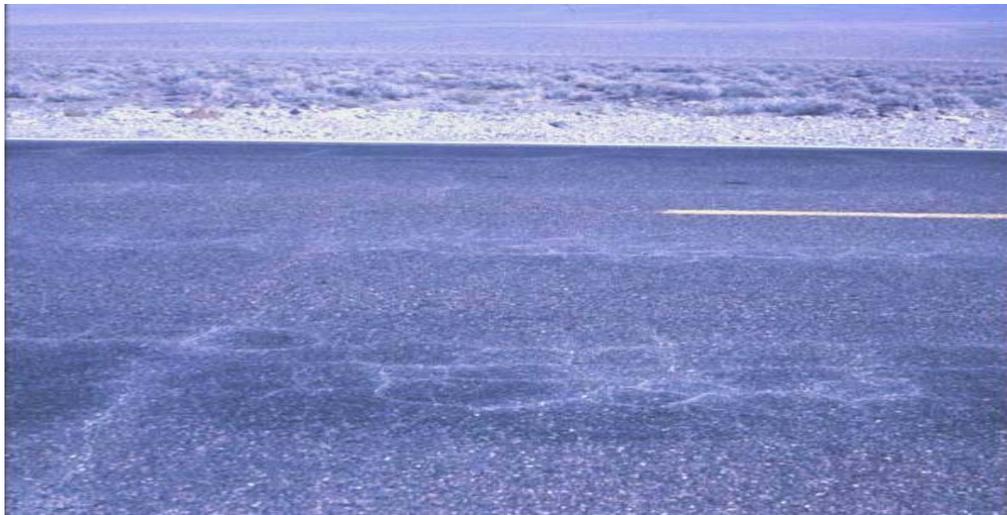
FIGURE 1.2a Common low-volume road distresses.

Five low-volume roads located throughout the state were chosen as demonstration test sections. The roads were age hardened, brittle, and contained distresses such as block, nonwheel path longitudinal, transverse, and fatigue cracking. Raveling was noticeable in some areas. Figure 1.2a shows examples of common distresses evident on these roads.

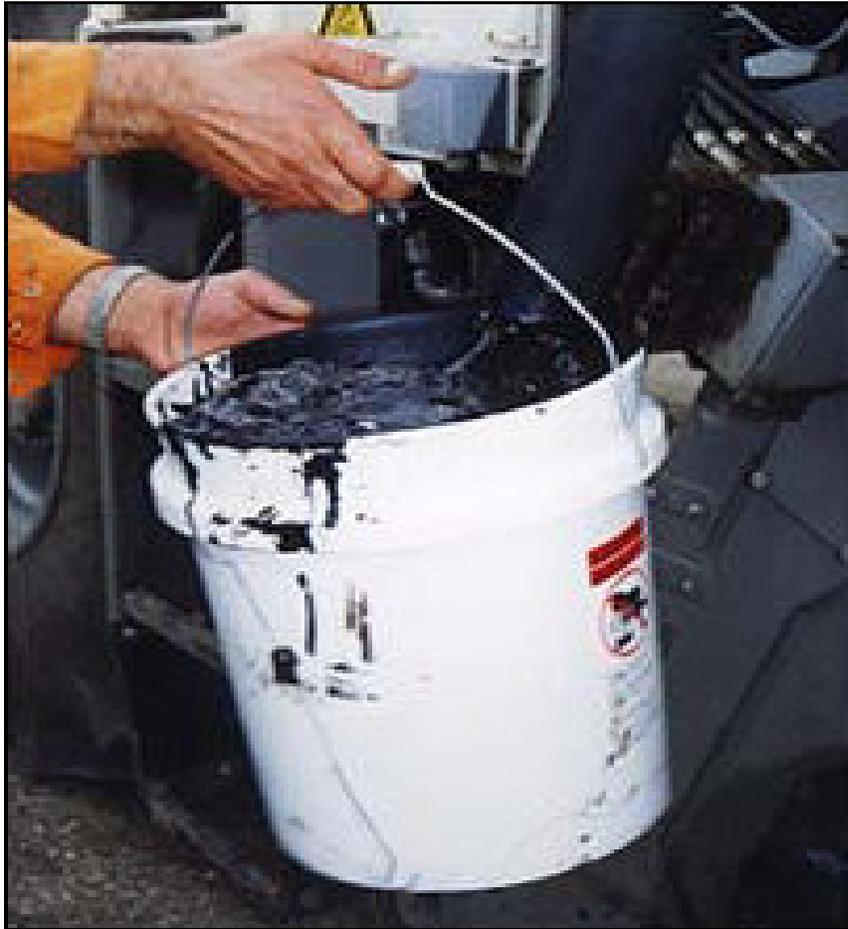
FIGURE 2.6a Foamed asphalt expands 15 to 20 times the volume of materials used separately (2).

Two 1.5 lane mile foamed asphalt test sections were constructed on SR230. This work consisted of a 5 in. deep process whereby the existing asphalt surface and a portion of the underlying base materials were pulverized, graded, moisture conditioned, and compacted prior to foamed asphalt stabilization. Thereafter, the section was stabilized with foamed asphalt and mixed into a homogenous mixture. The homogenous mixture was compacted and finish graded. Figure 2.6b is an example of typical foamed asphalt equipment used in the construction of the foamed asphalt process. NDOT used a two step process for accomplishing the foamed asphalt because the contractor advised that the final homogenous mixture would be more consistent and of better quality.

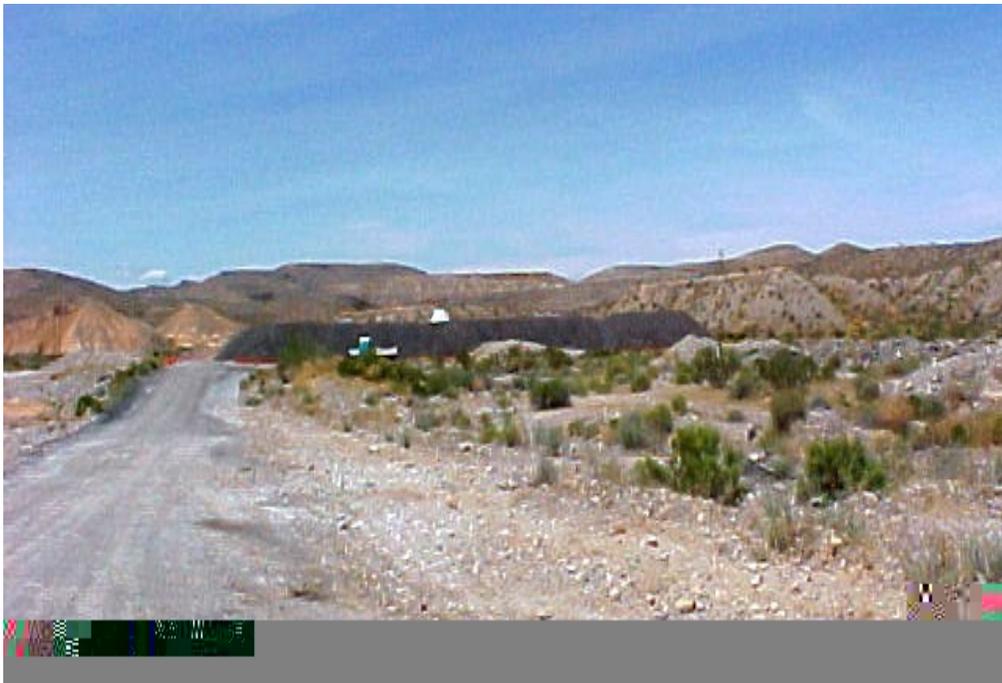
FIGURE 4.2a Stockpiled millings.

The CIR rehabilitation strategy was used with stockpiled millings to construct an improved pavement structure on SR168 (Figure 4.2a). Pre-construction core data revealed that the pavement structure was marginal for CIR operations and the use of recycled millings and chip seal wearing course was recommended. Millings that were leftover from a local interstate project were placed in a windrow in front of the recycle train. The roadway was milled 1 in. to provide for an adequate bond between the existing and new pavement structure. The freshly milled material and windrowed millings from stockpile were recycled using the train and a paver was used to place the 3 in. pavement structure (Figure 4.2b). This project was NDOT's first attempt at using a CIR operation with stockpiled millings for creating an improved pavement structure. Preliminary results are encouraging and this strategy will be used on future projects where logistics are feasible for incorporating stockpiled millings into CIR operations on low-volume roads.

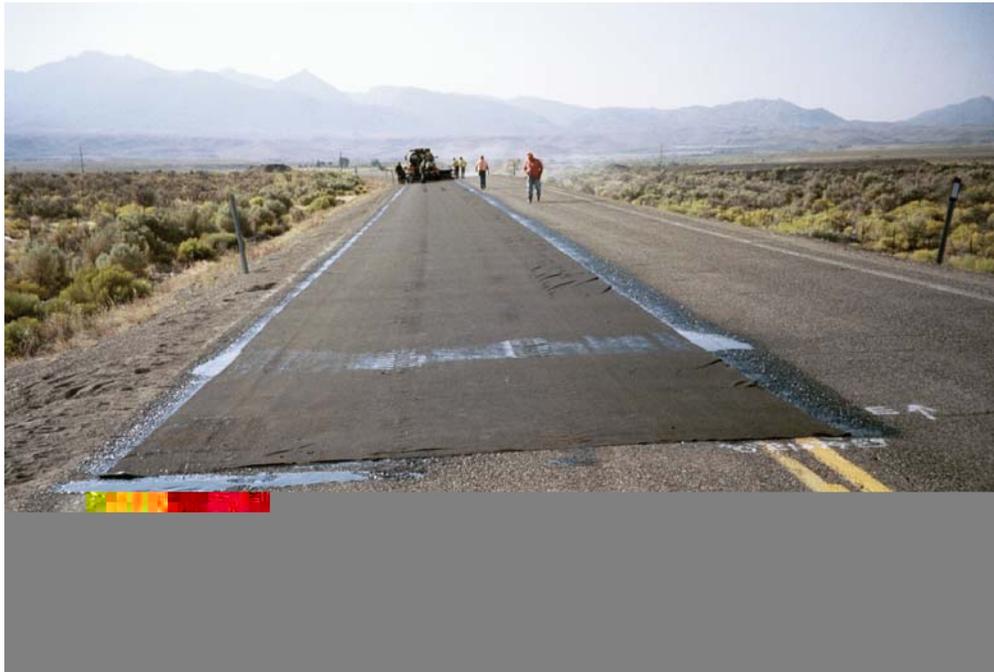
A chip seal can be used in combination with other products such as nonwoven polypropylene geotextile fabric. The fabric is seated in a tack coat and a single or double chip seal is placed on top of the fabric. The fabric acts as a waterproof interlayer that prevents water from penetrating into the pavement structure and also acts as a crack retardant. This strategy was placed on SR230 for a side-by-side comparison with a double chip seal surface treatment without fabric. Figures 5.1a and 5.1b show a nonwoven polypropylene geotextile fabric seated in the tack coat and maintenance personnel placing a chip seal over the fabric.

FIGURE 5.1a Nonwoven polypropylene geotextile fabric seated in tack coat.

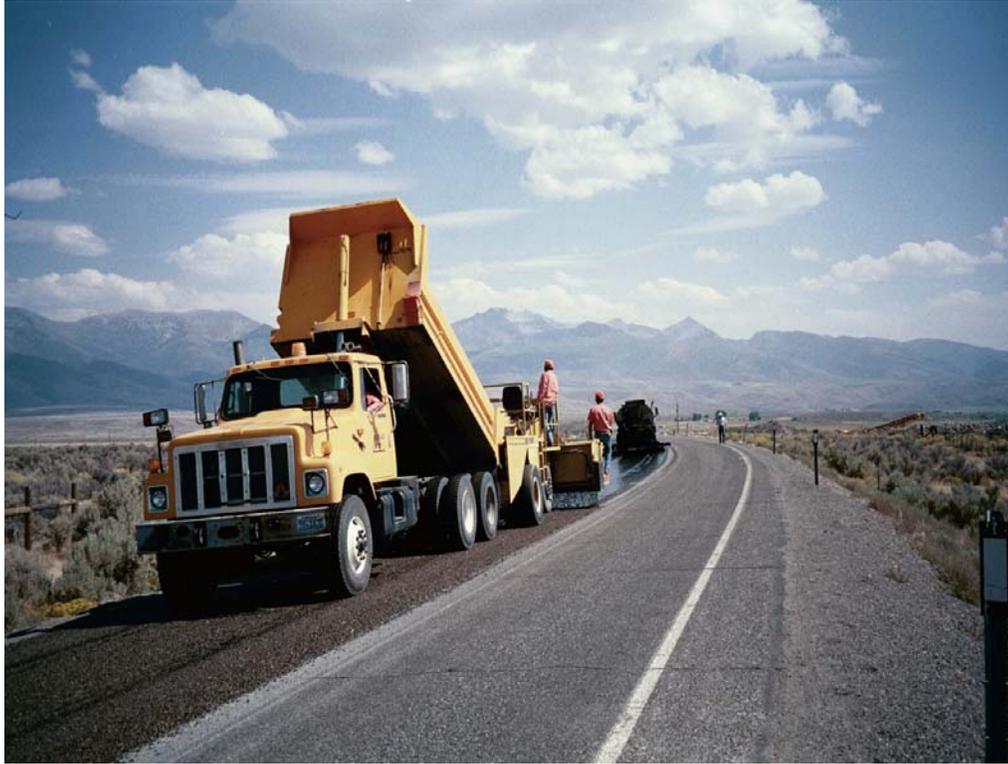
FIGURE 5.1b Maintenance personnel place chip seal.

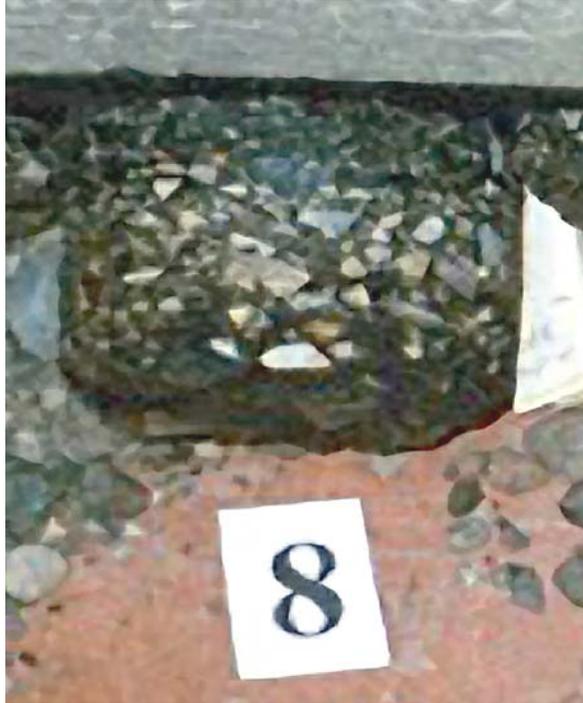
Before Construction: Stripped and Fell Apart
Pavement Condition: Transverse and Fatigue Cracking

3 Years after Construction: Stripped and Fell Apart
Pavement Condition: Good Condition

FIGURE A.3 SR230: 6 in. full depth reclamation with proprietary liquid stabilizer, 1.5 in. hot mix asphalt concrete overlay, and single chip seal.

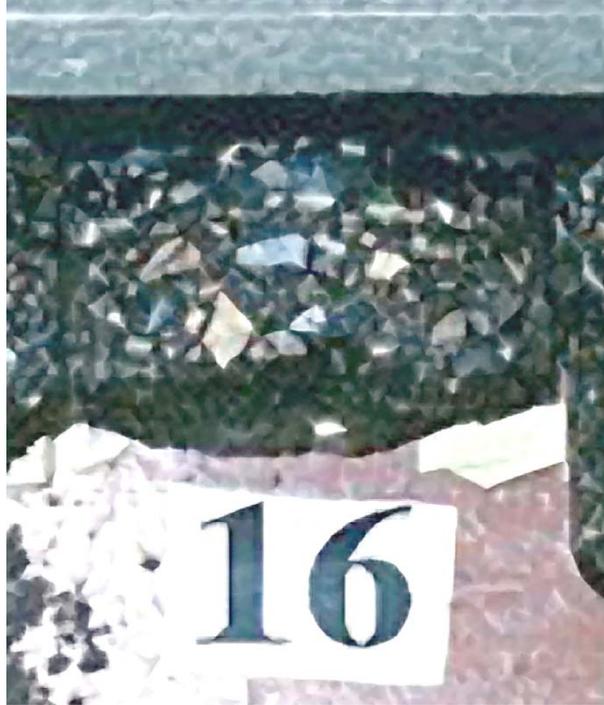
Before Construction: Heavy Stripping
Pavement Condition: High Severity Transverse Cracking

3 Years after Construction: Light to Medium Stripping
Pavement Condition: Low Severity Transverse Cracking

FIGURE A.5 SR230: Full depth reclamation with foamed asphalt and single chip seal (westbound).

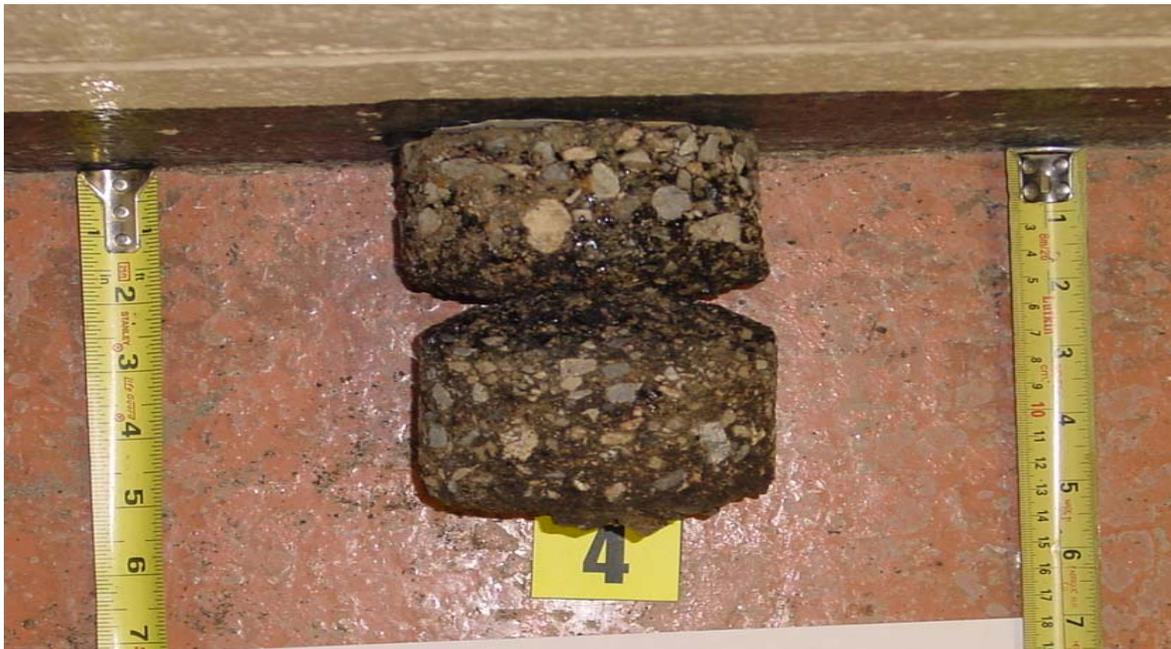
Before Construction: Heavy Stripping and Fell Apart
Pavement Condition: Fatigue Cracking

3 Years after Construction: Delaminated at 2.3 in. with Medium to Heavy Stripping
Pavement Condition: Good Condition

FIGURE A.9 SR230: 2 in. cold mix asphalt concrete with CMS-2S and single chip seal (eastbound).

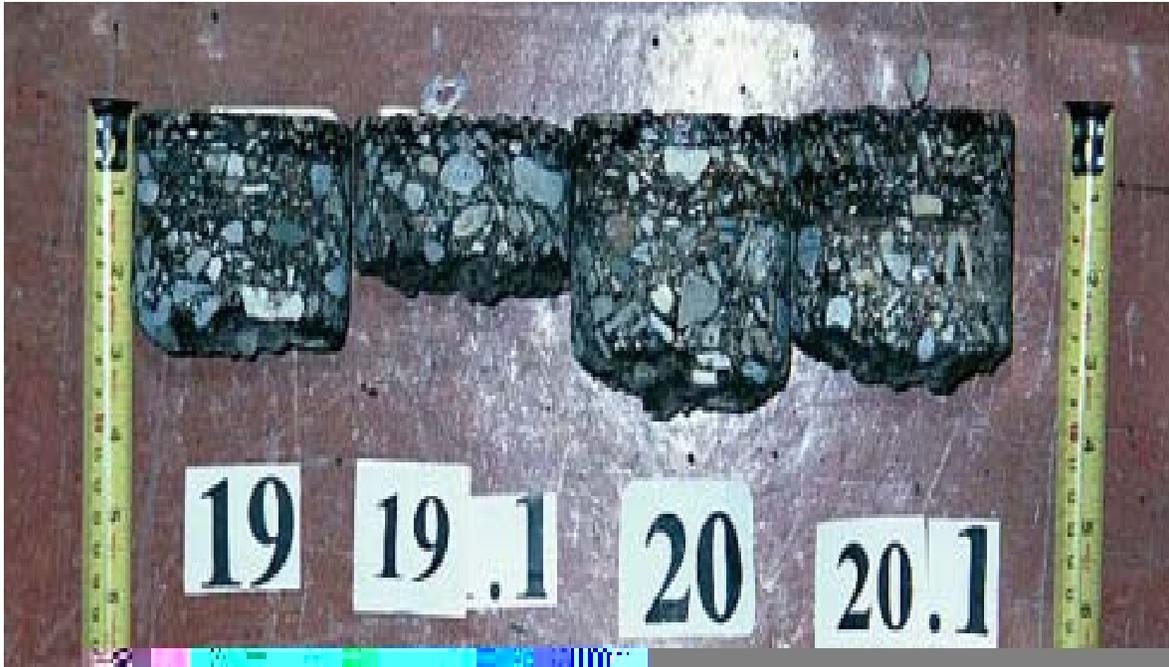
Before Construction: Light Stripping
Pavement Condition: Transverse and Fatigue Cracking

Before Construction: Light Stripping
Pavement Condition: Transverse Cracking

FIGURE A.17 SR892: Before construction.
