American Traffic Safety Services Association

High Friction Surfacing

Robert N. Dingess
President, GTMA

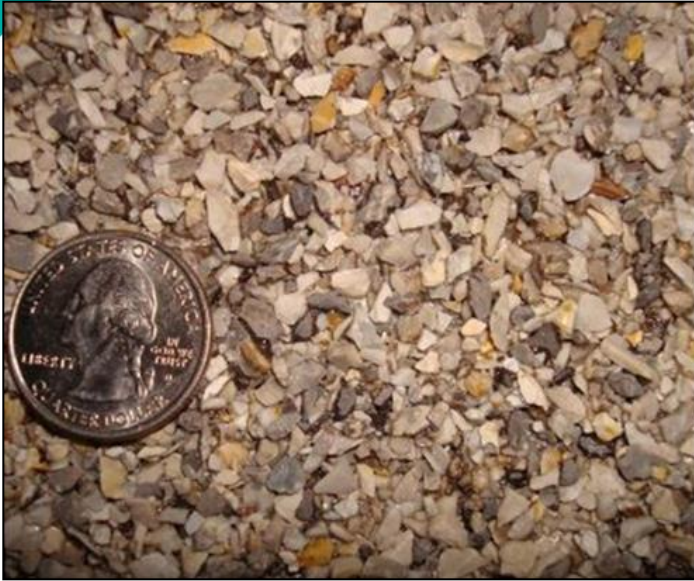
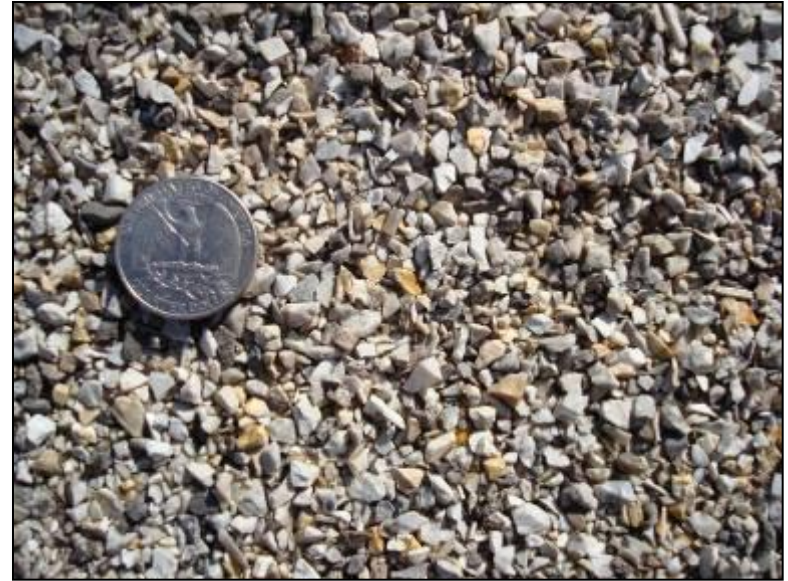
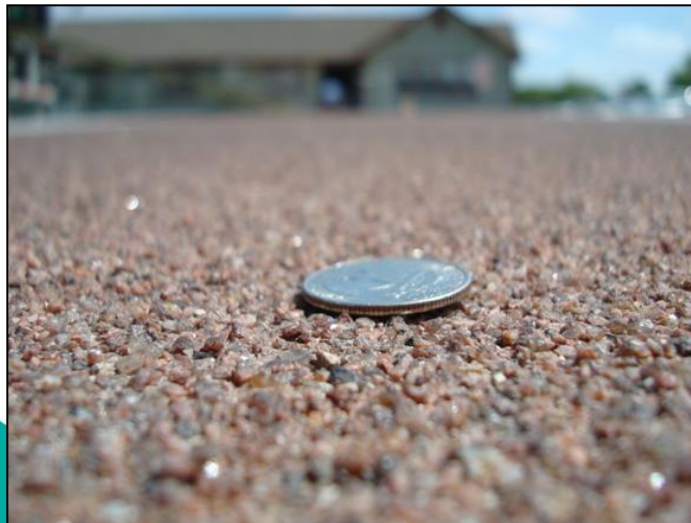
Aggregates That Meet High Friction

- $F_N \geq 65$
- Aggregate with resistance to polishing

Calcined Bauxite

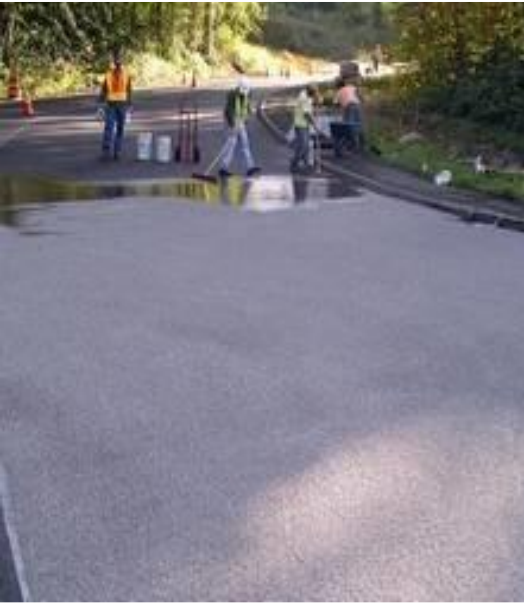
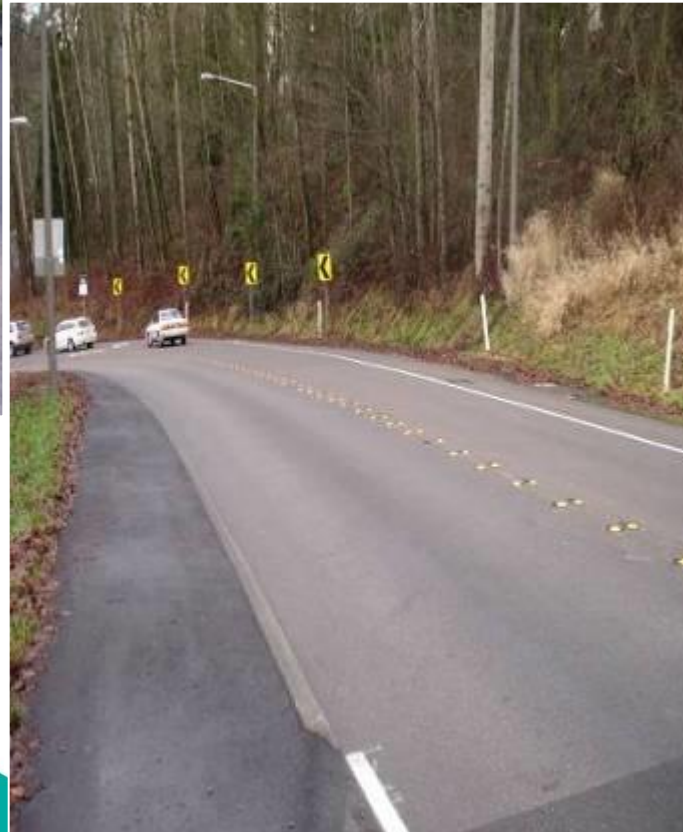
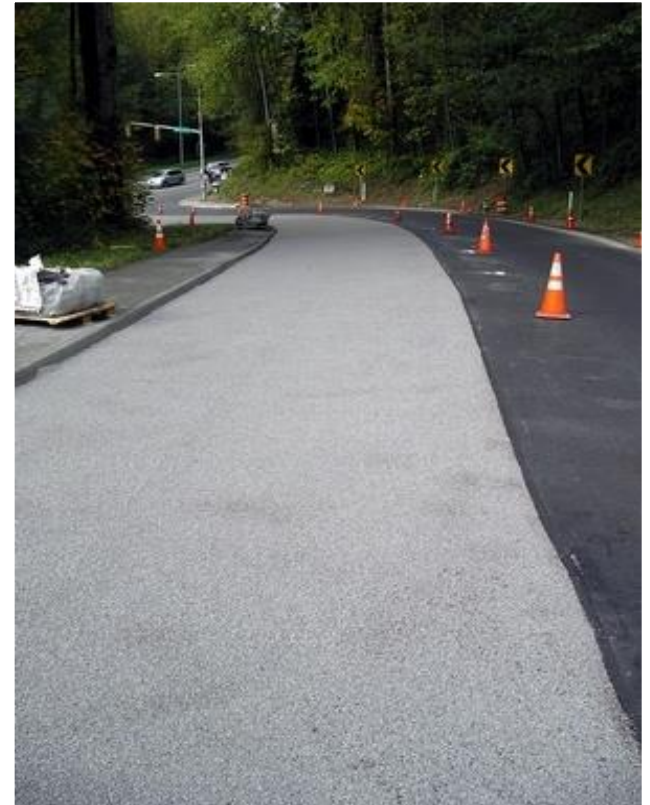
Intersection/Curve: Bellevue, Wash.

Installation of a HFS surface on a horizontal curve. Prior to the installation, this location had **45** accidents.

Installation by Hand

Bellevue, Wash: **45** crashes, **four** rollovers

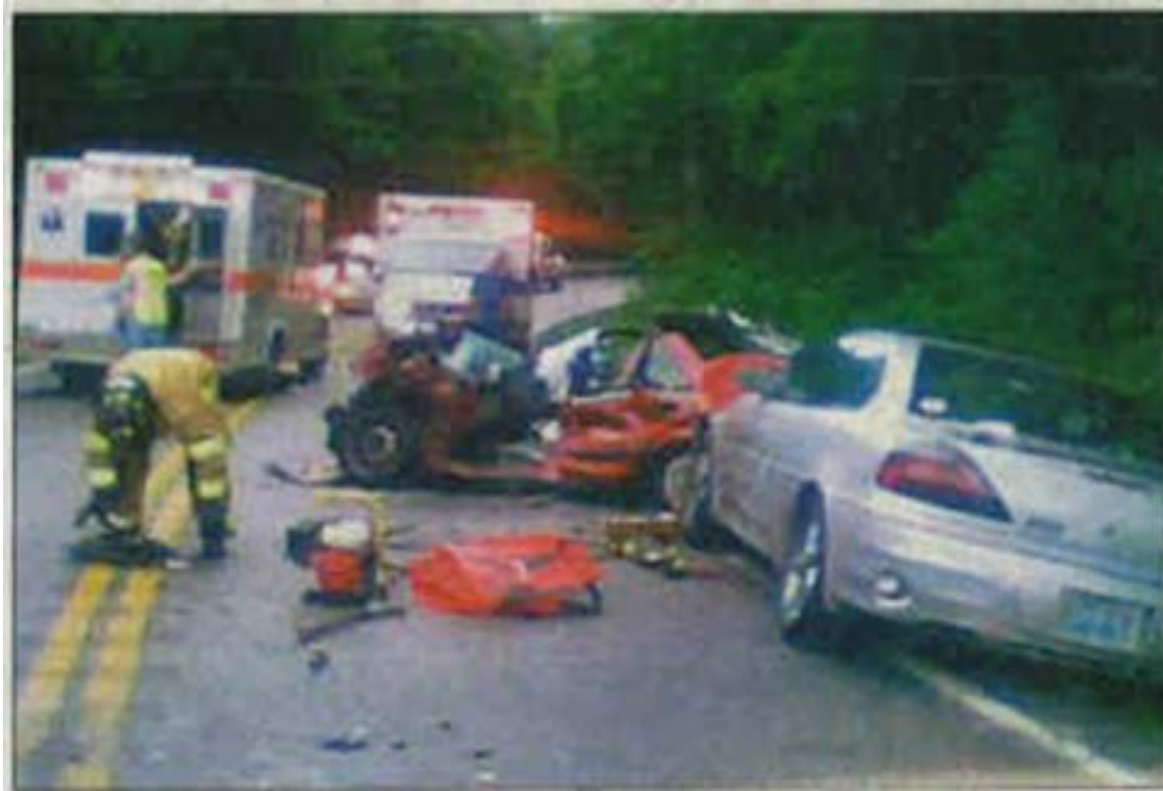
Crews work to clear the roadway after a head-on collision during rush hour Friday on KY- 22 at Bridge Hill. The crash left four people injured. Another crash took place Sunday afternoon.

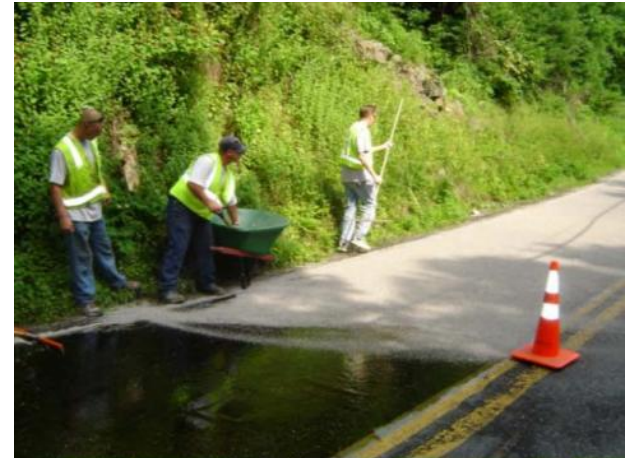
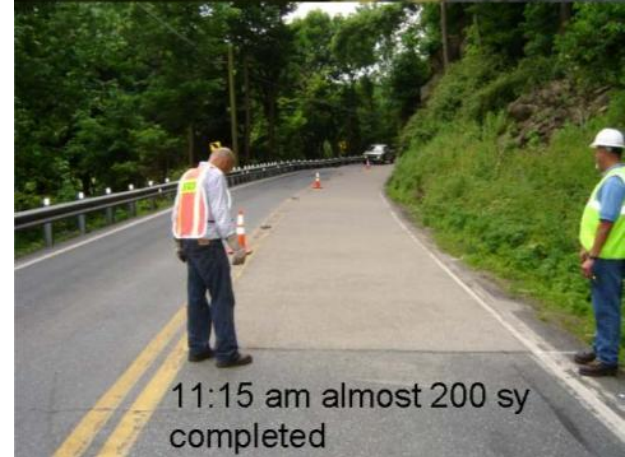
1:00 pm install complete
& 60% power swept

11:15 am almost 200 sy
completed

Since Installation – Zero Crashes
