Effective repair of severely deteriorated prestressed beam ends

Paul Pilarski, P.E., S.E.

Repair of Bridge 27568

US Route 169 over Nine Mile Creek

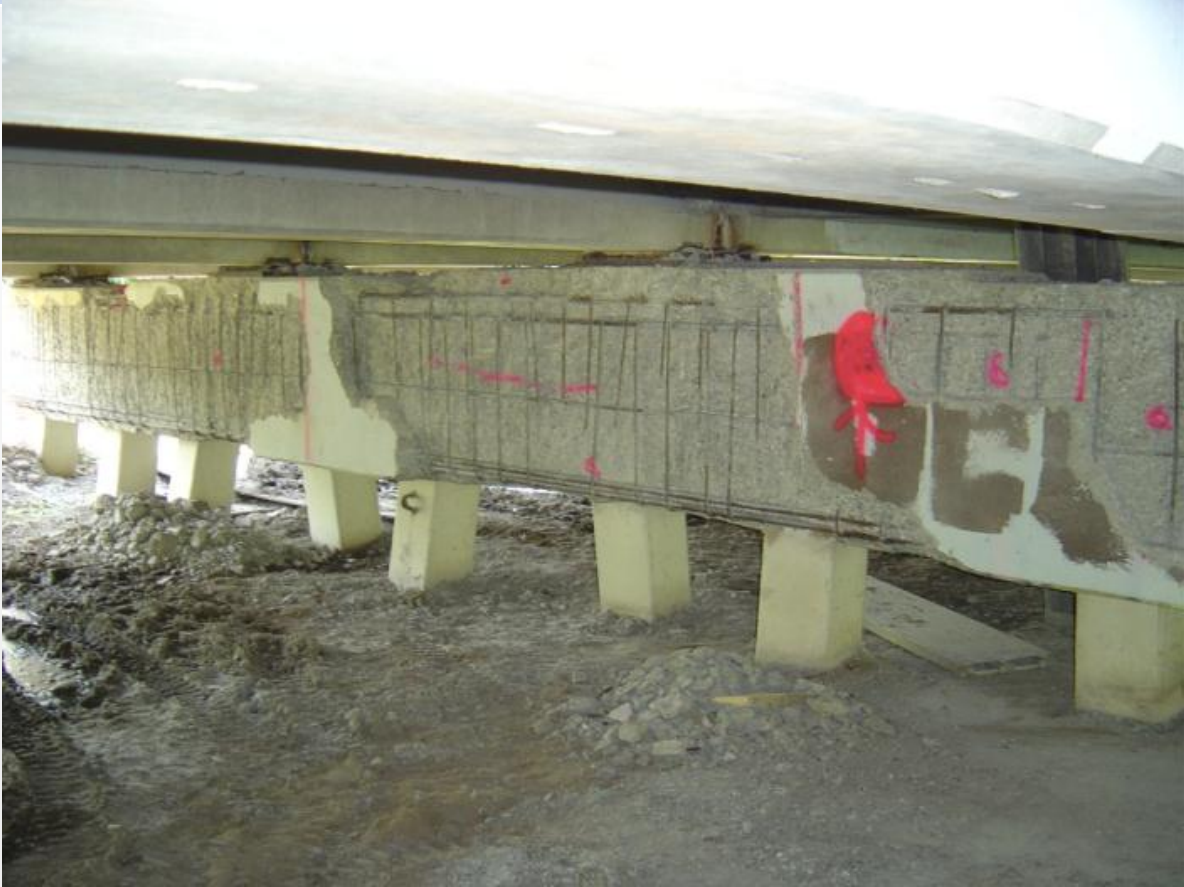
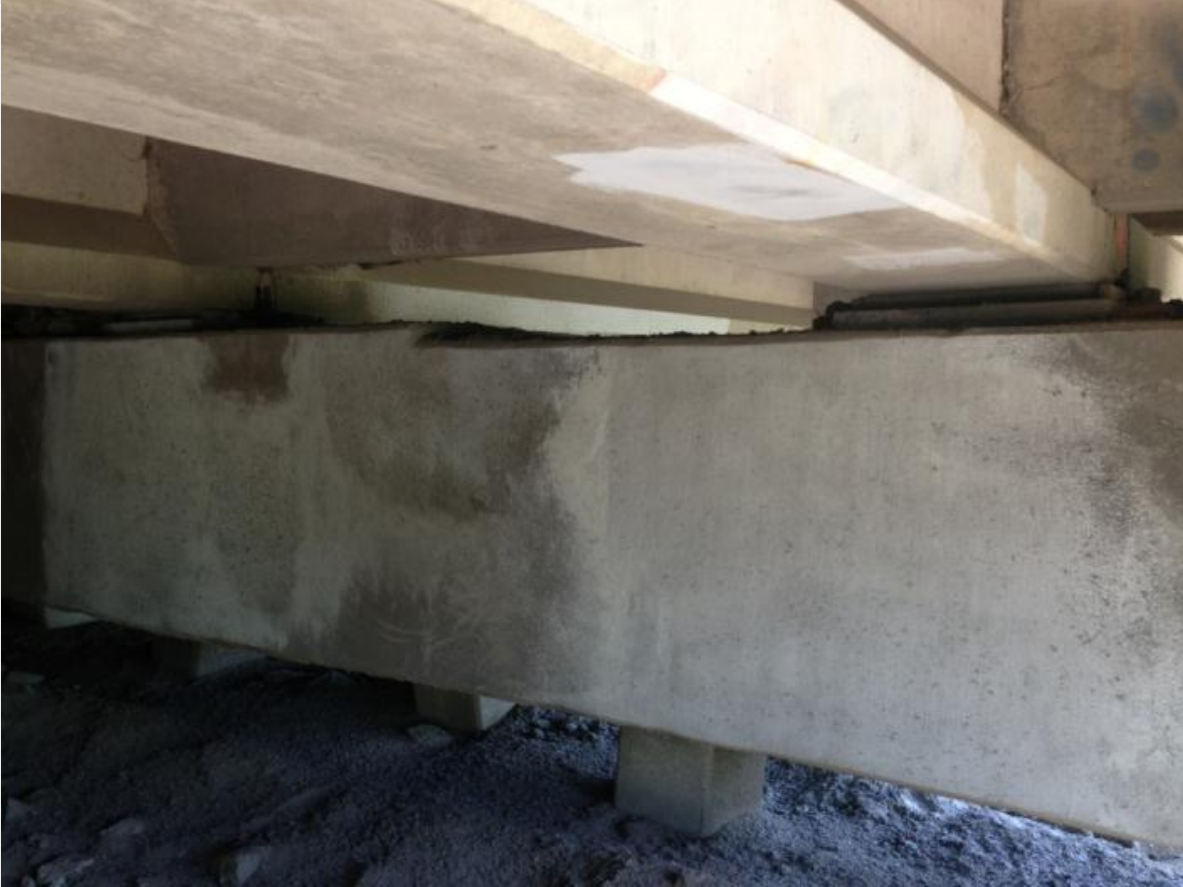
Shotcrete often performed without load relief or temporary support

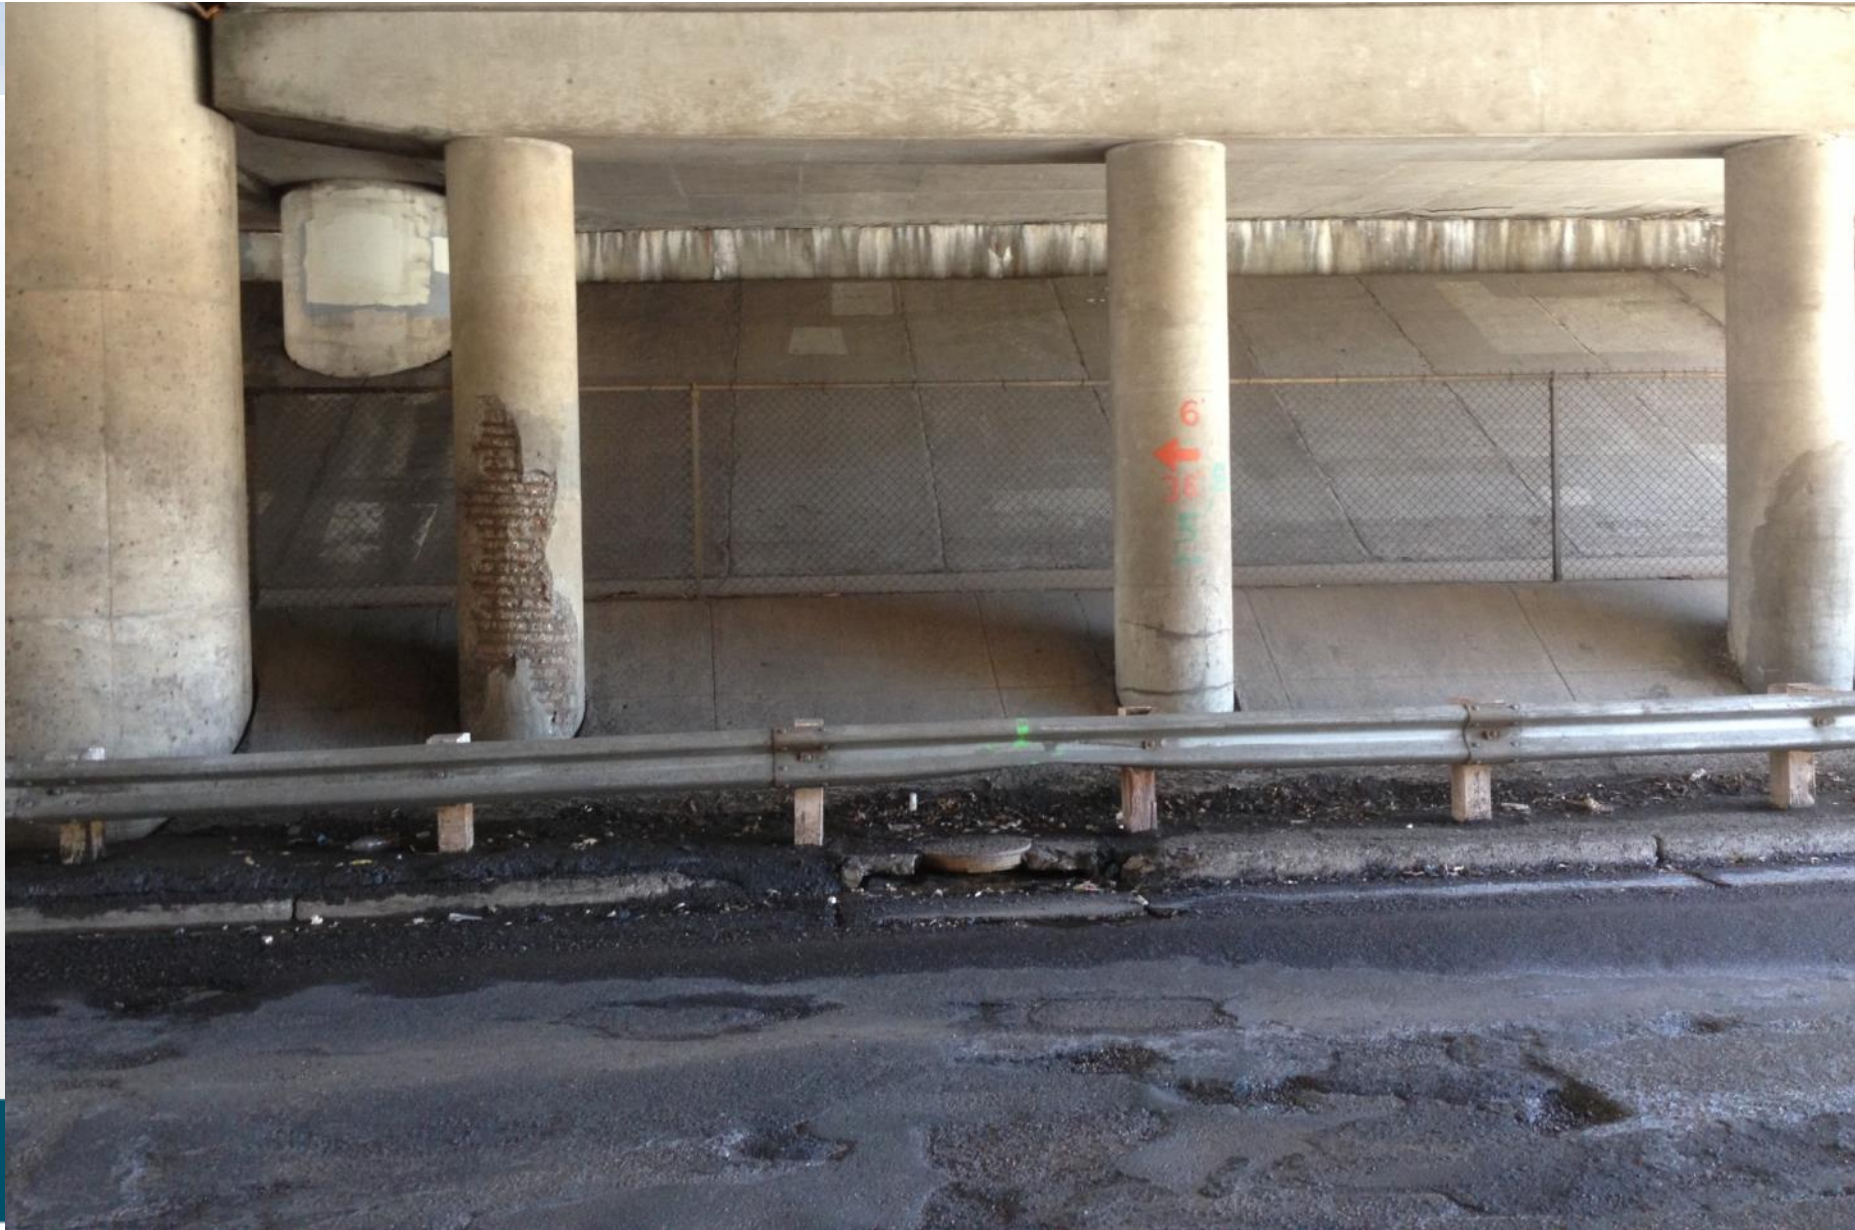
Column repairs (2014 scoping)

unsound removals

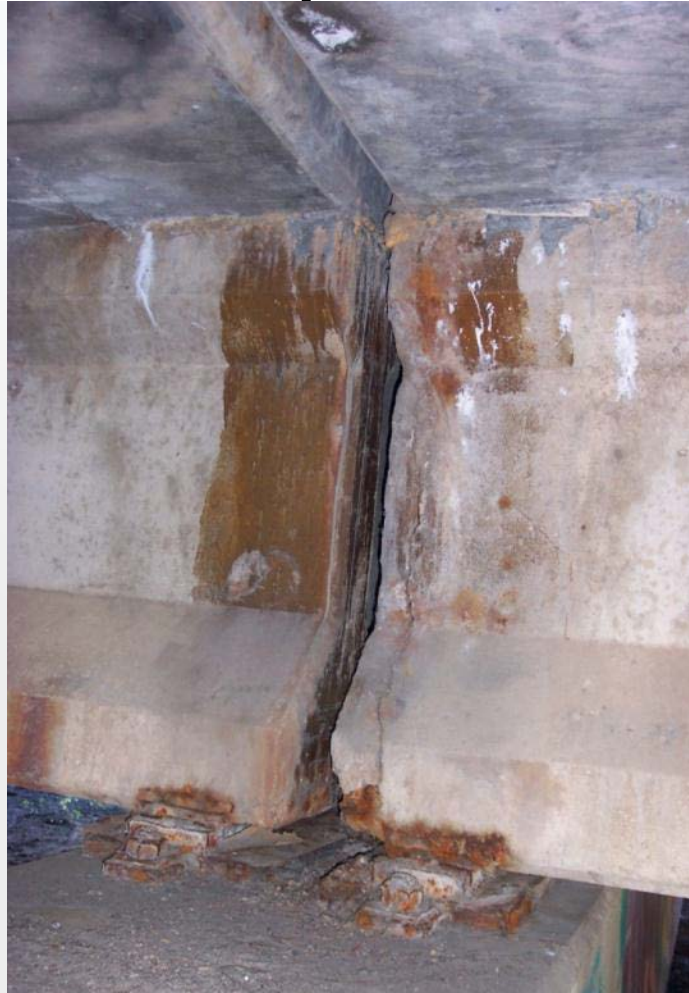
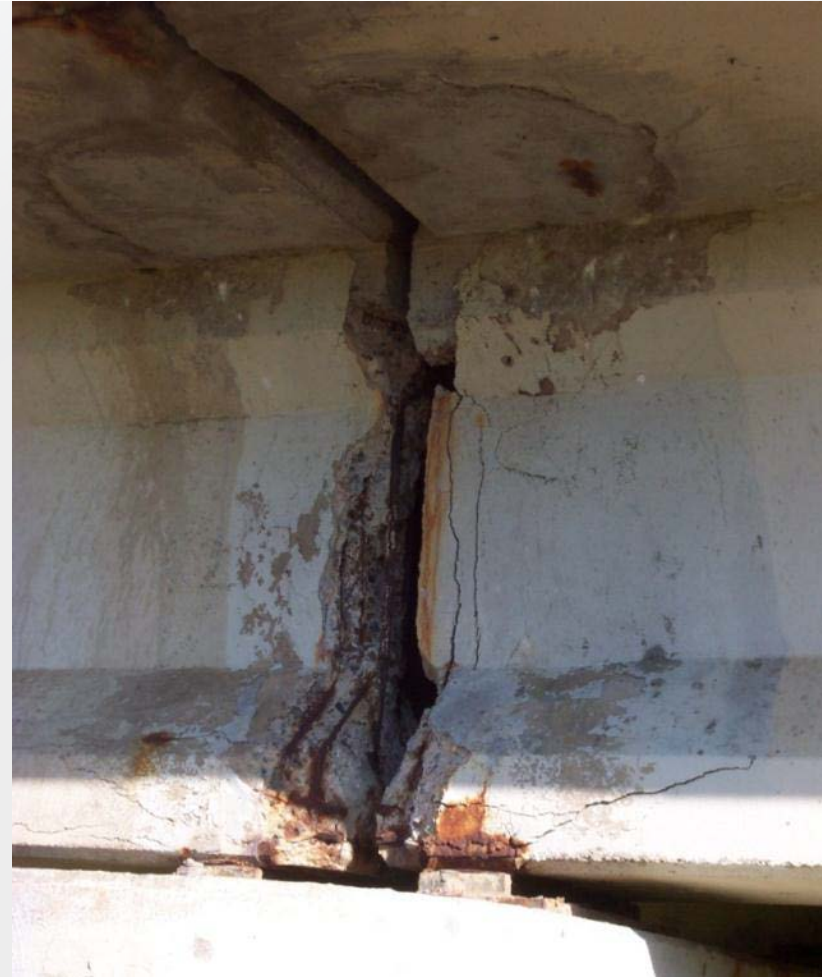
Preservation Scoping 2011: Beam ends at joint locations

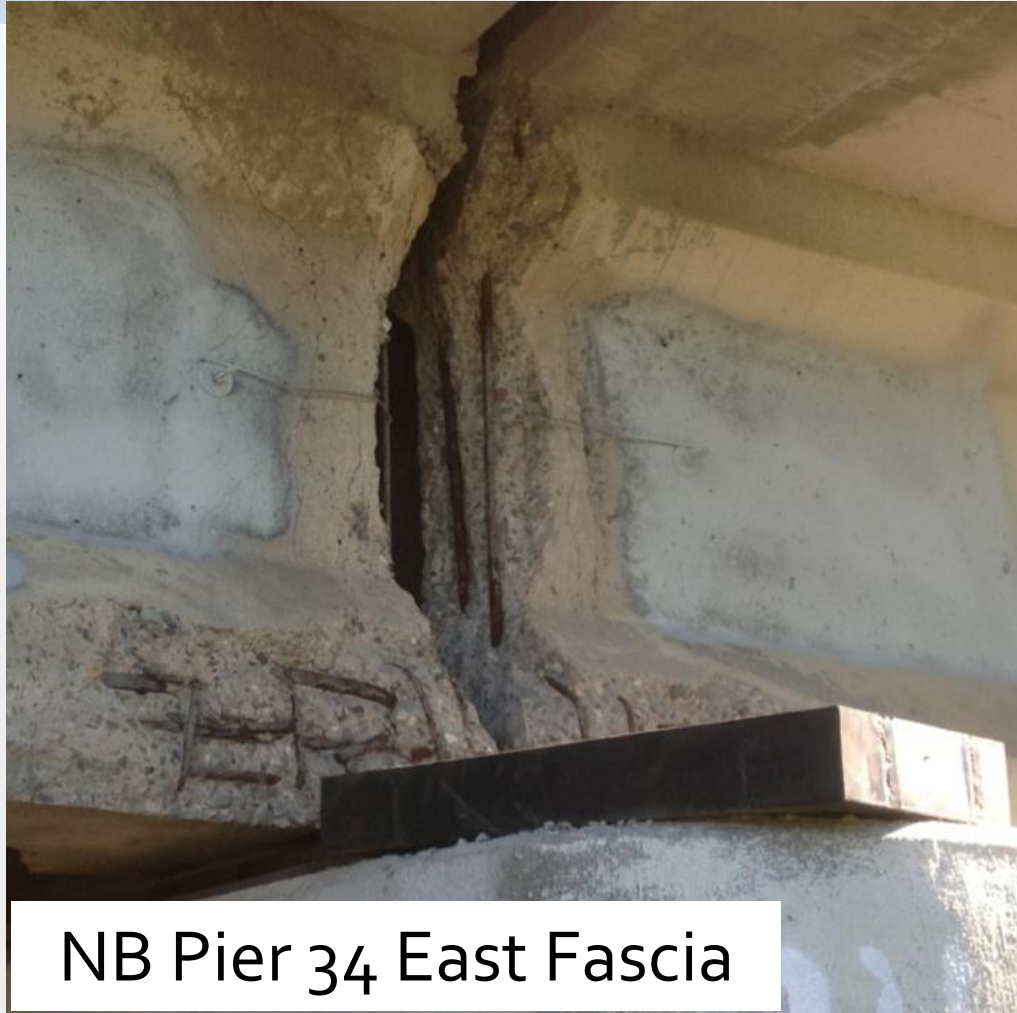
NB Pier 34 East Fascia

Beam End Repairs - Small

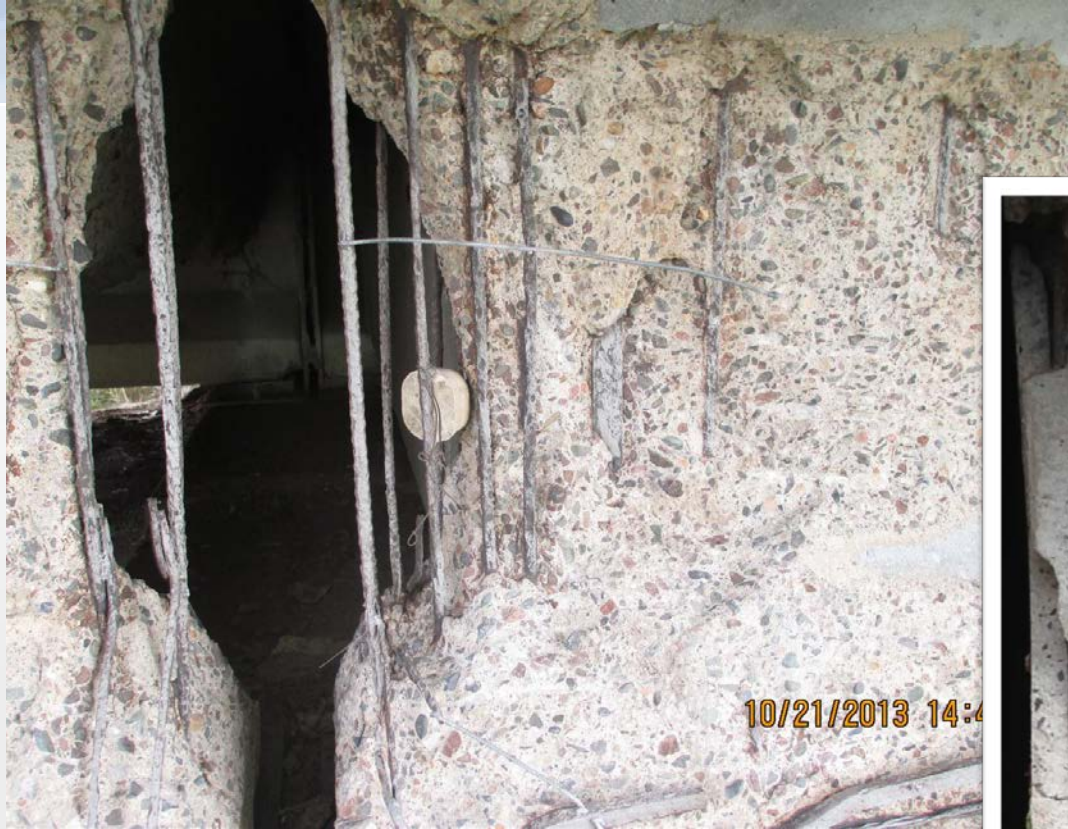
Change of Plan

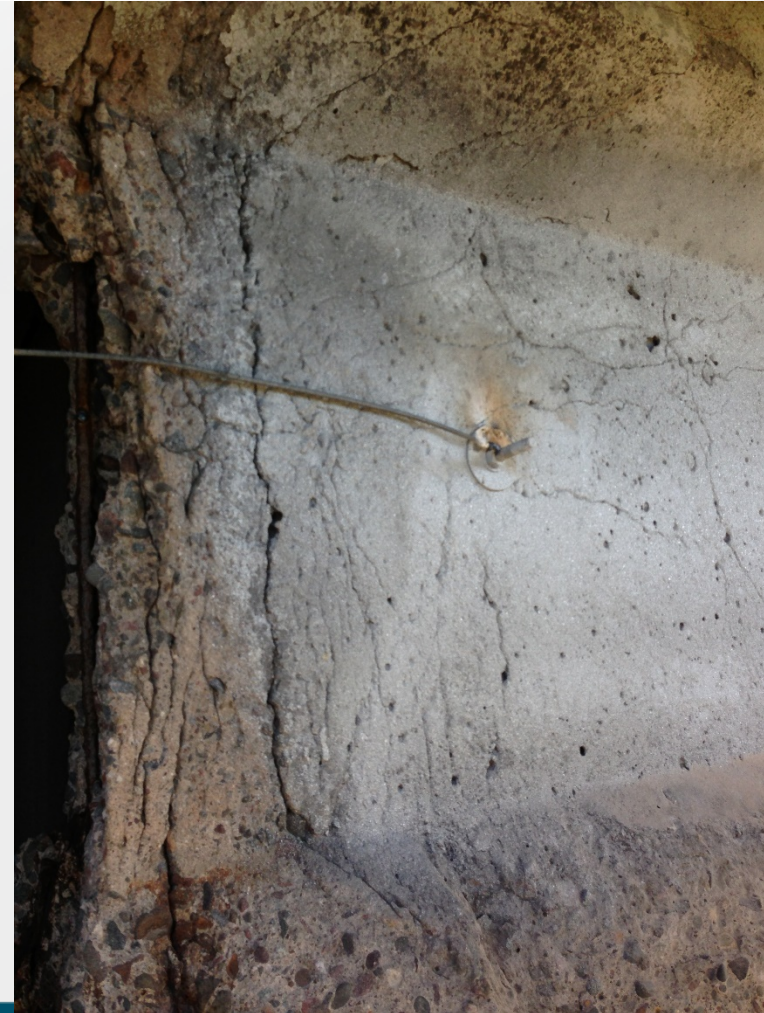
Full DL relief can be detrimental to internal force balance!

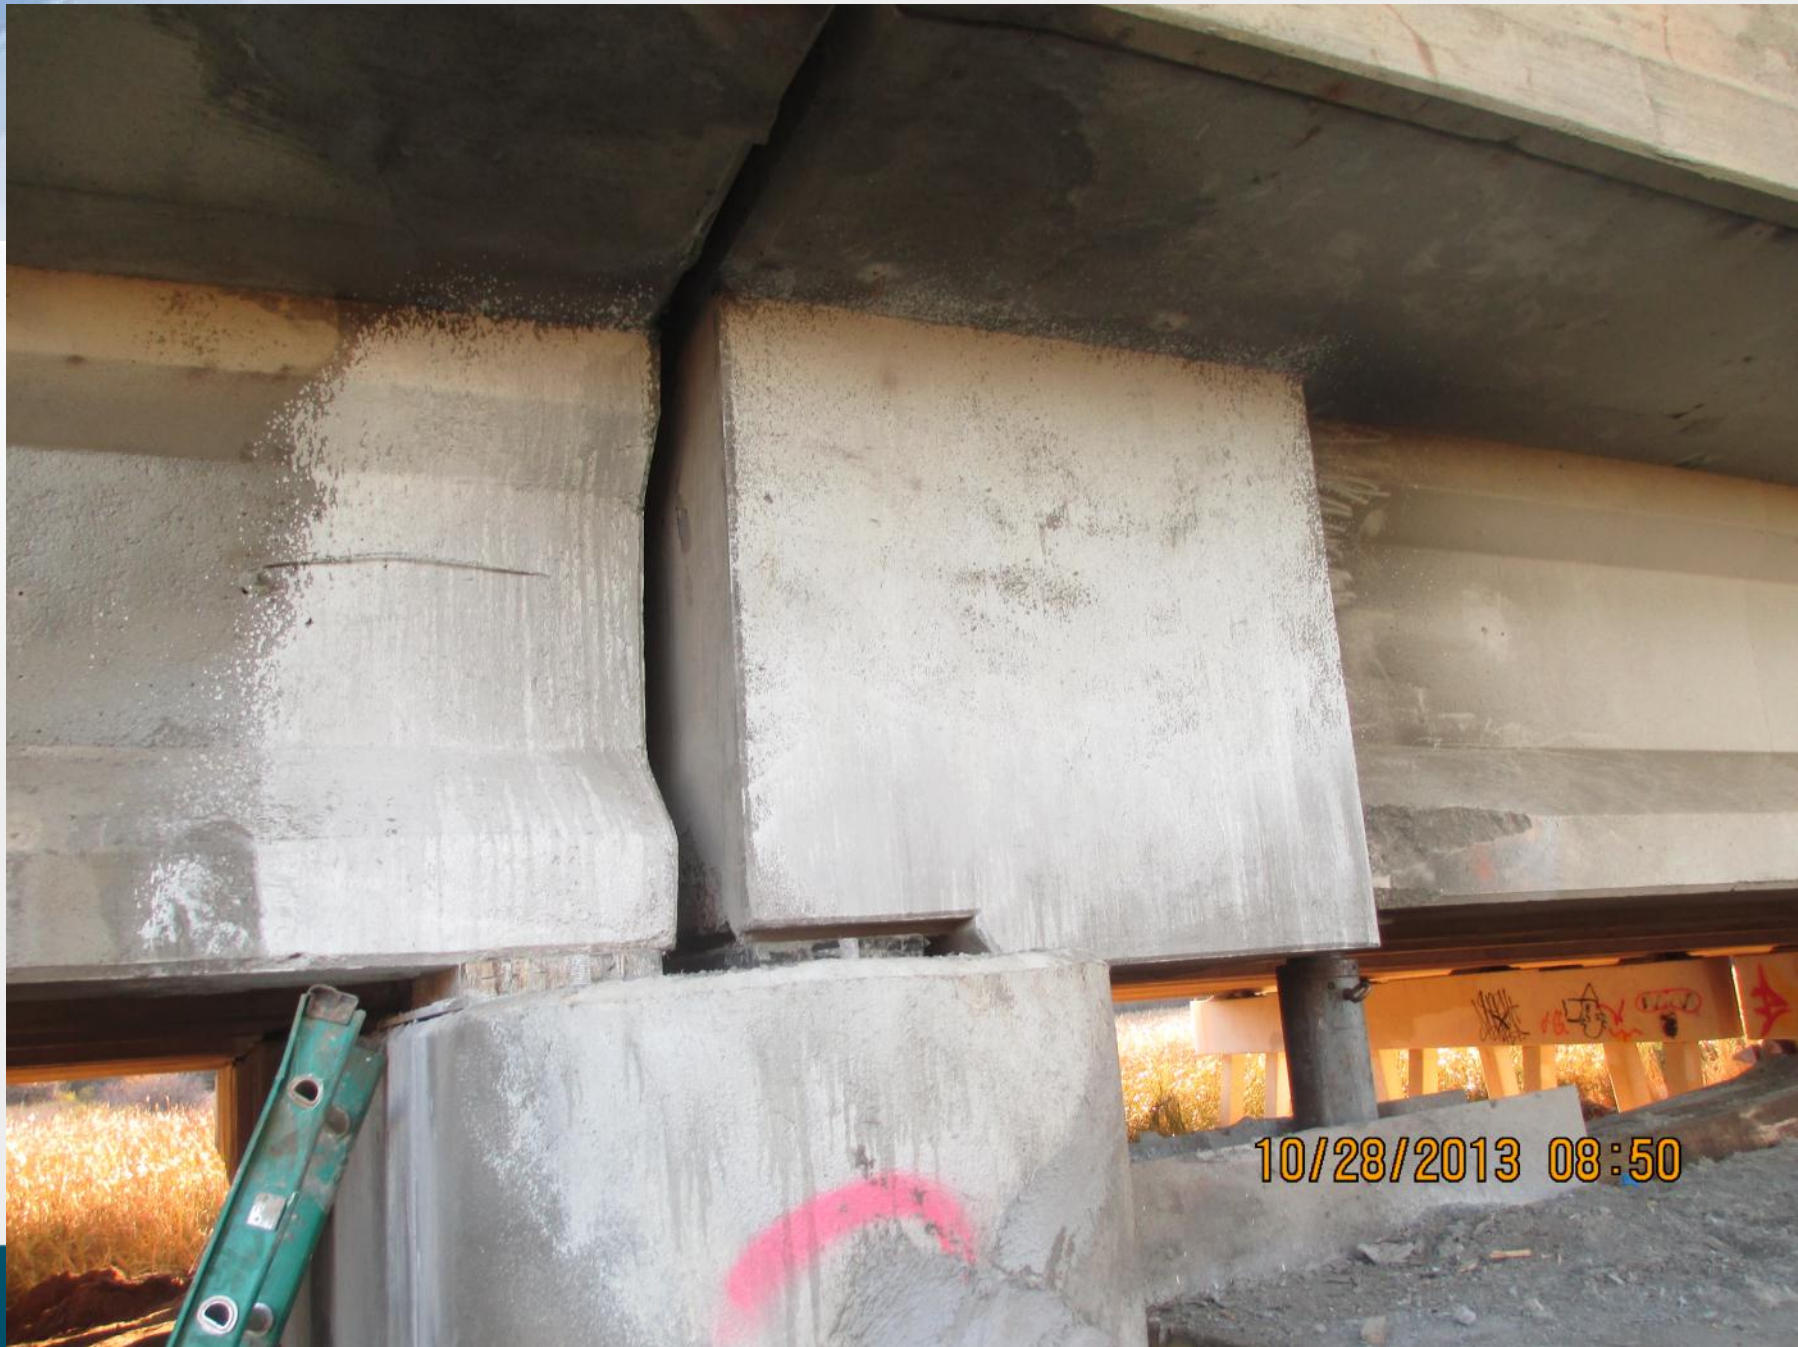
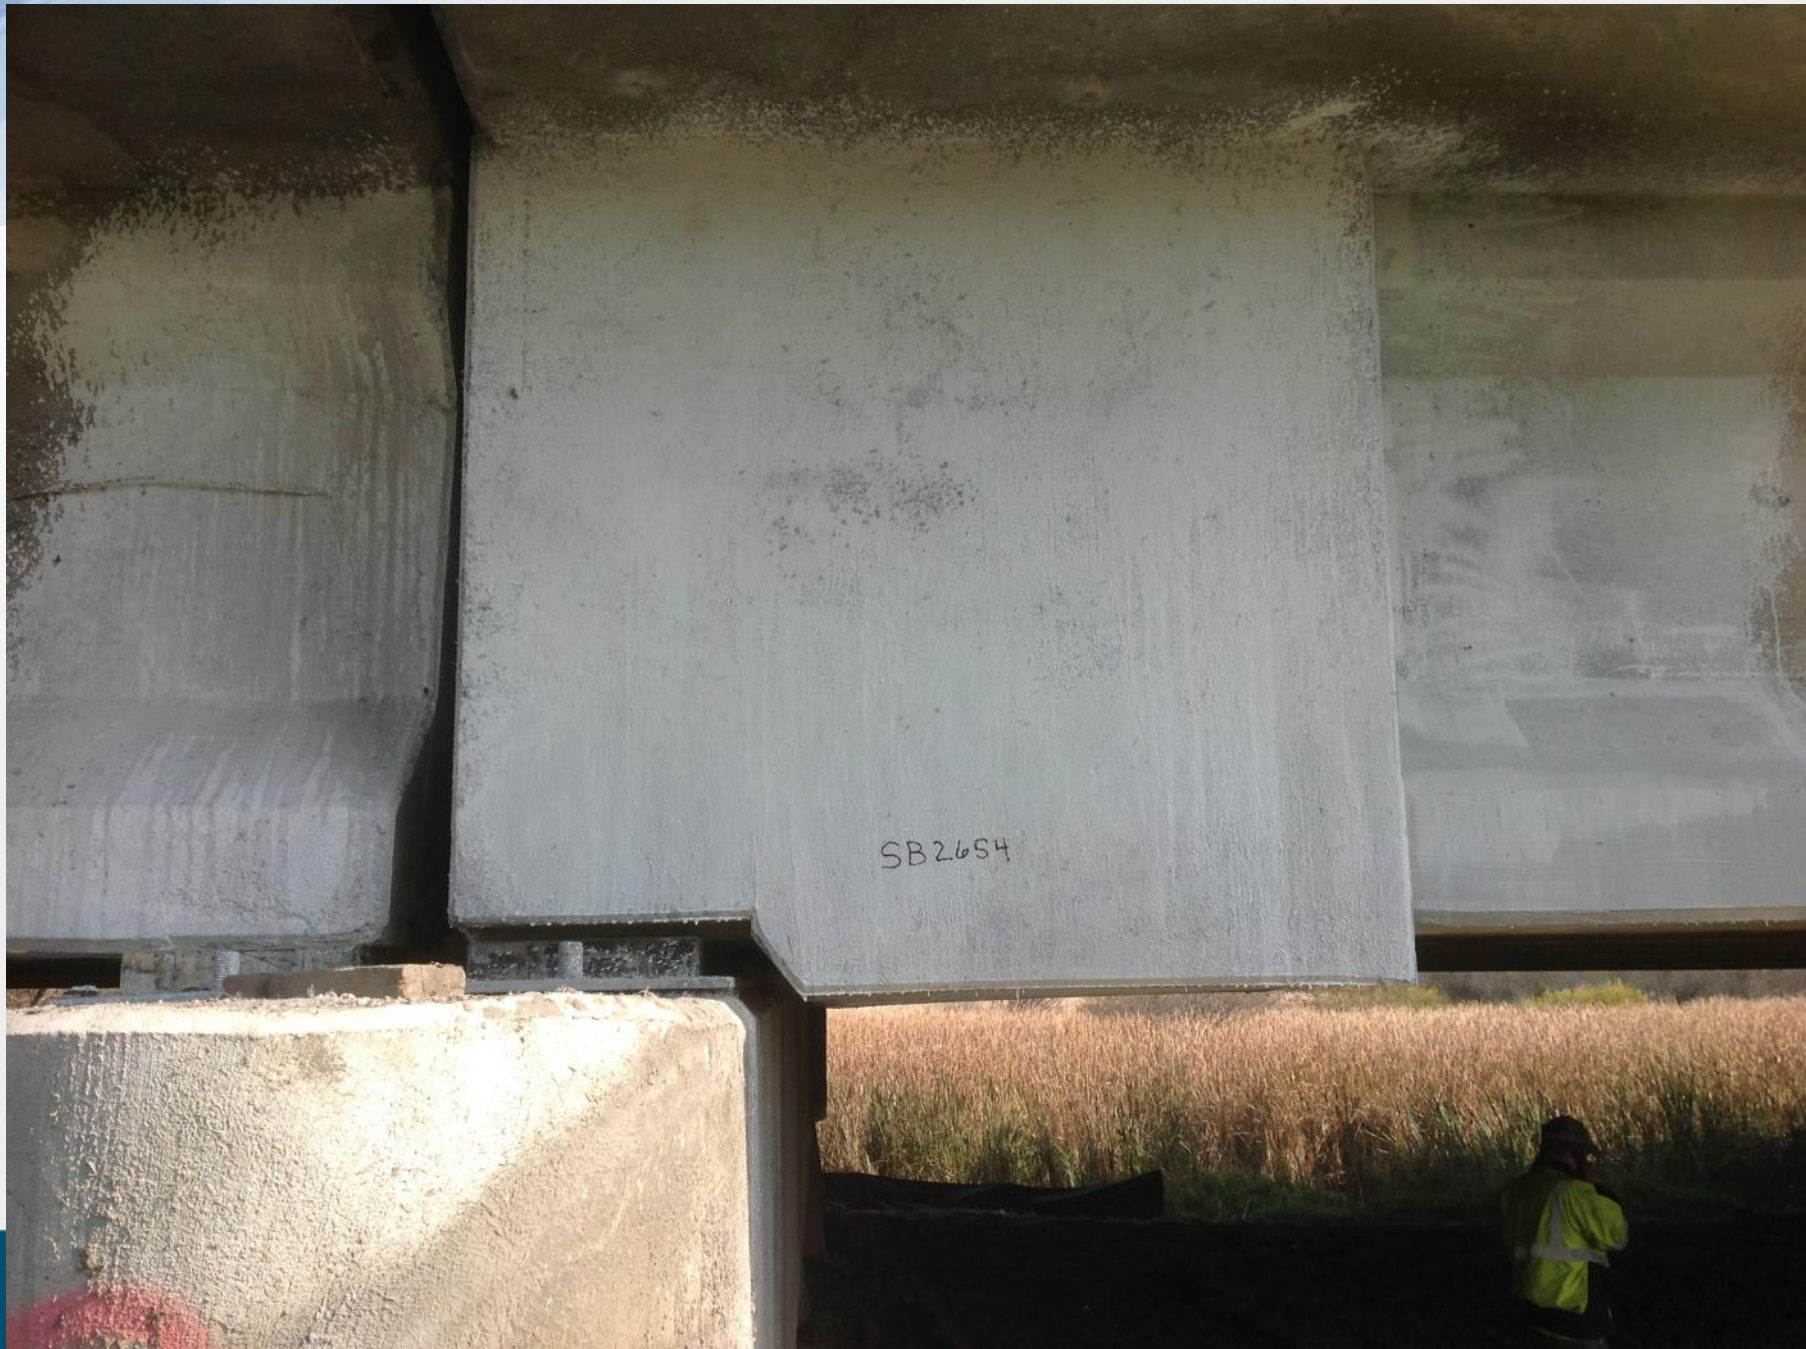
10/28/2013 08:50

Other deteriorated components

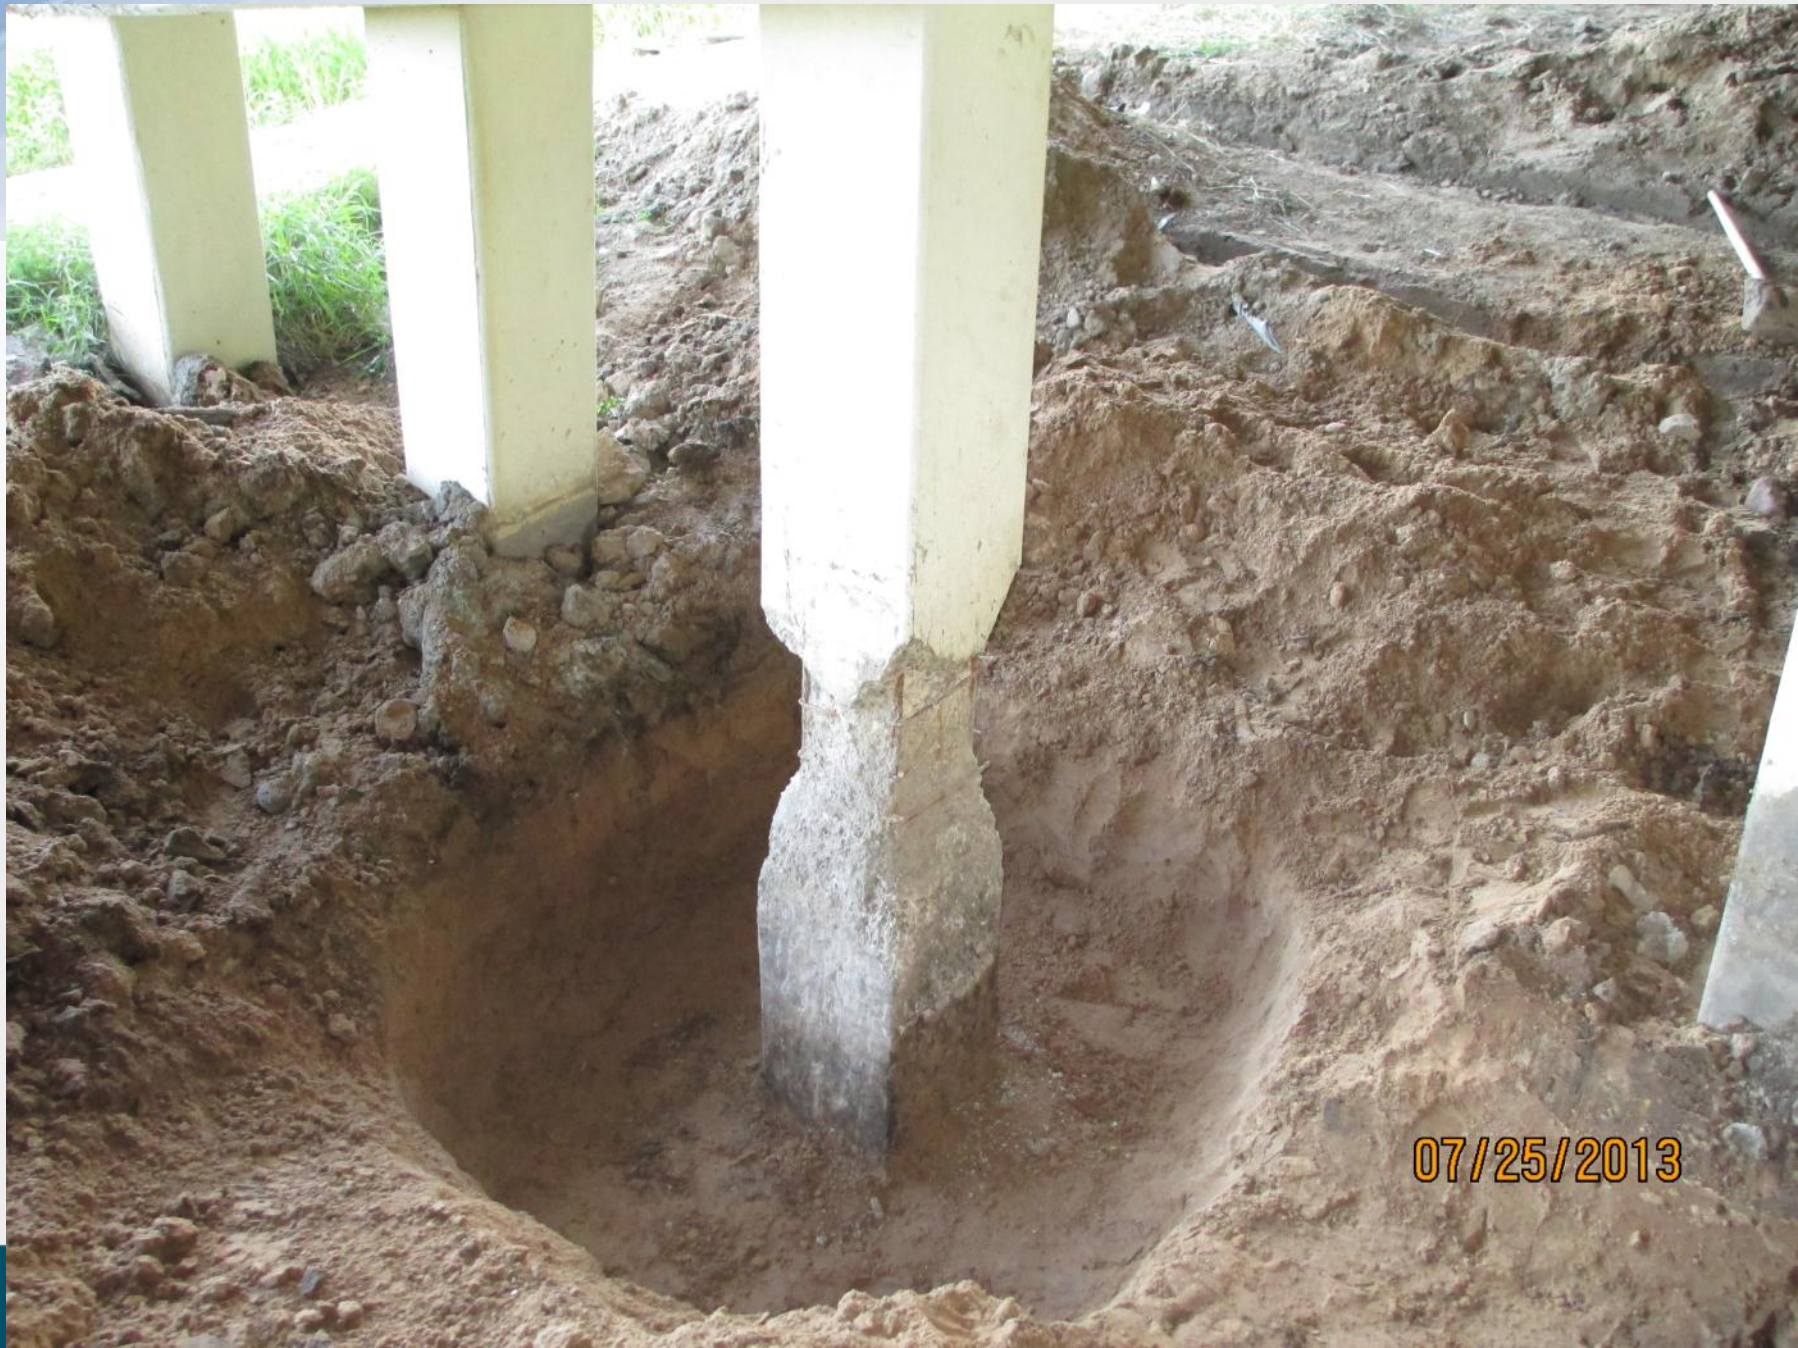
07/25/2013

Pile deterioration

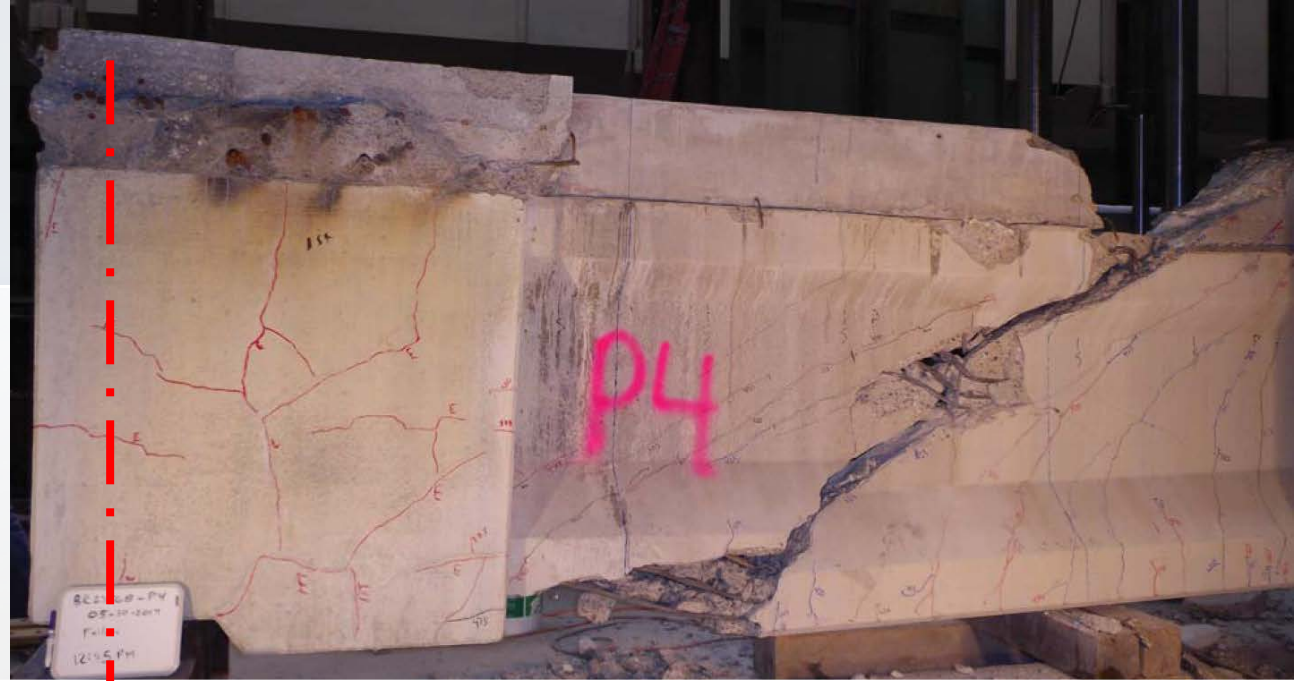
- Peak load = 465 kips
- 1st flexural crack = 300 kips
- 1st web shear crack = 325 kips
