# US 190 MISSISSIPPI RIVER BRIDGE REPAIR, REHABILITATION, AND PAINTING

A COMBINED HIGHWAY/RAILROAD BRIDGE REHABILITATION

Durk Krone, P.E., TRC Engineers, Inc., Baton Rouge, LA

SESSION 3  
APRIL 17, 2019

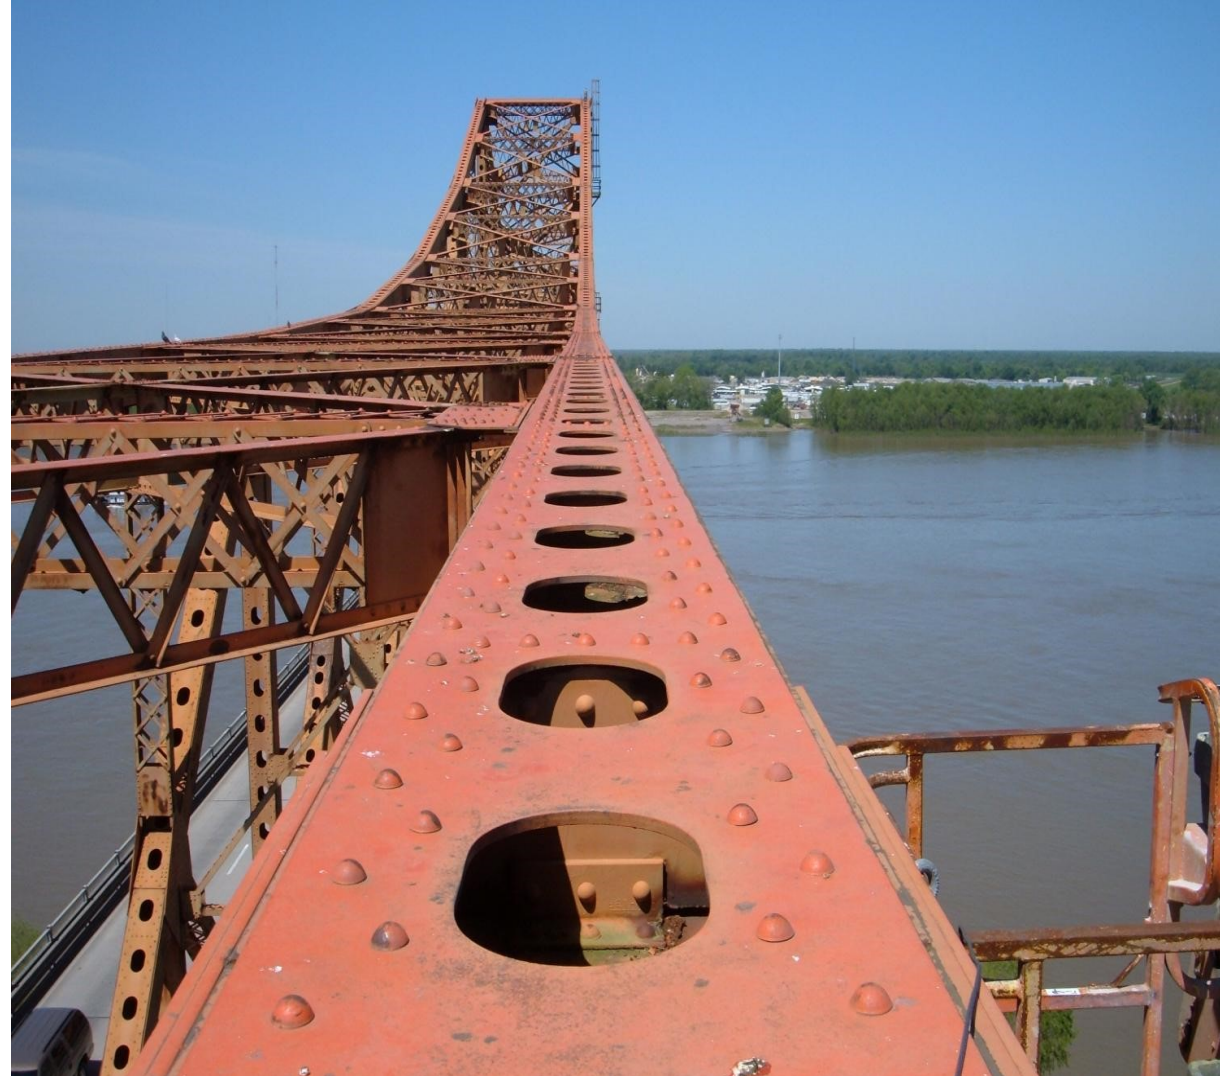
## UPPER CHORD PRIOR TO CLEANING AND PAINTING

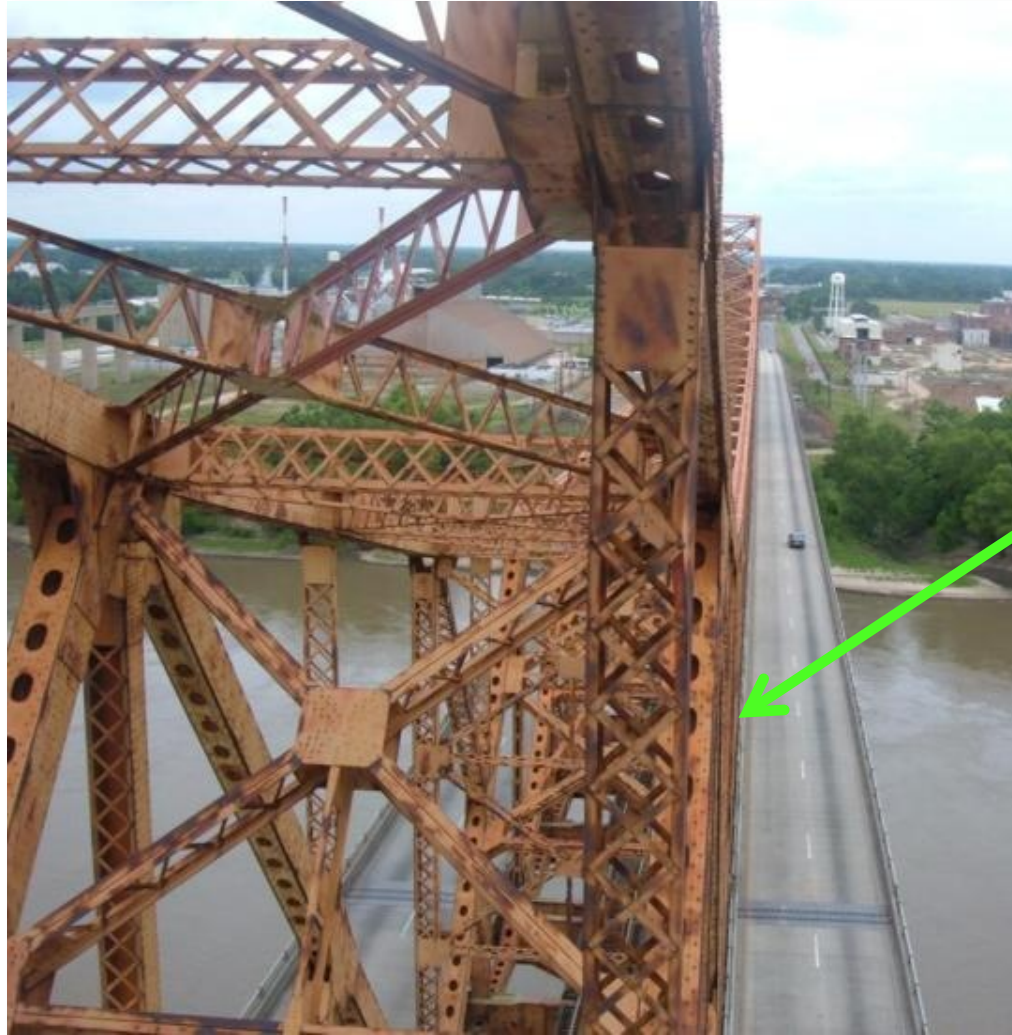
# TRUSS MEMBER DETERIORATION

**VERTICAL TRUSS MEMBERS**

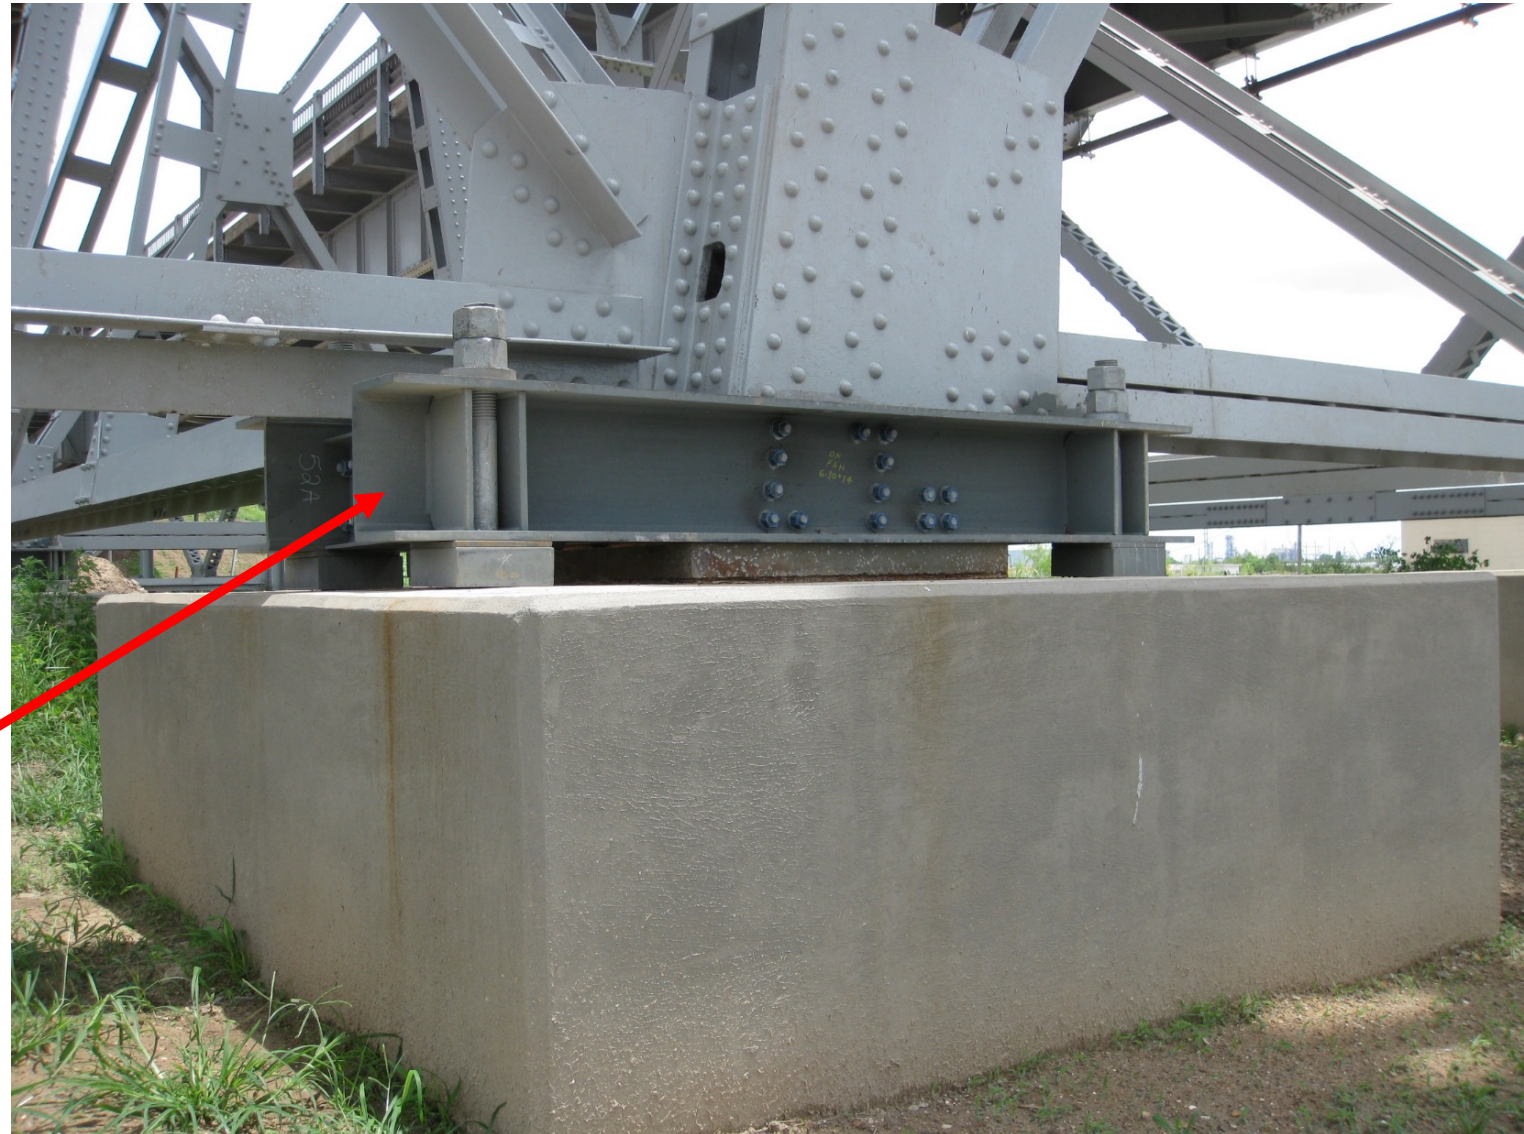
# ANCHOR BOLT REPAIR – TYPE I

**COMPLETED  
REPAIR**

**STRUCTURAL  
FRAMING BEAM**

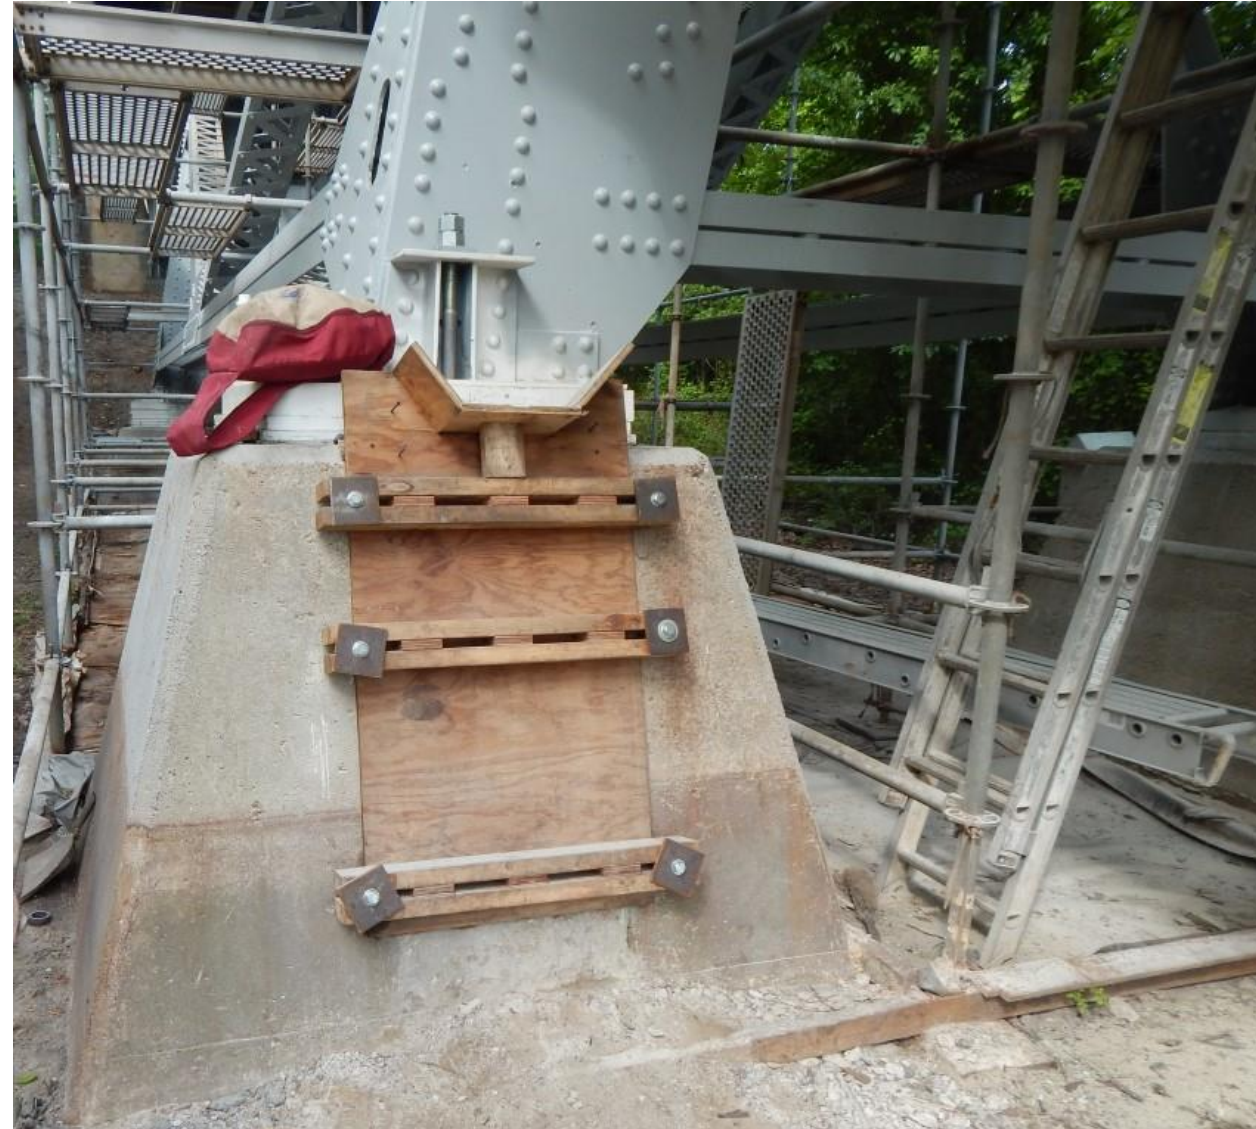
# ANCHOR BOLT REPAIR – TYPE II

## FORMWORK

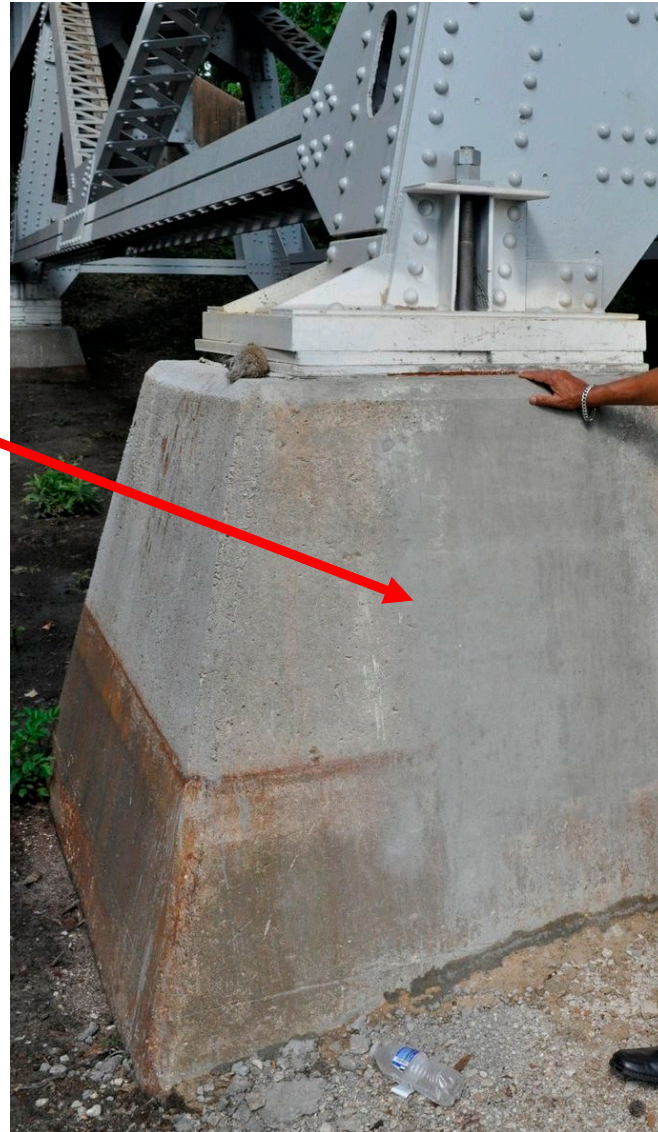
# ANCHOR BOLT REPAIR – TYPE II

**COMPLETED  
REPAIR**

***ADDITIONAL  
AGGREGATE  
EXTENSION  
OF 3/8 PEA  
GRAVEL***

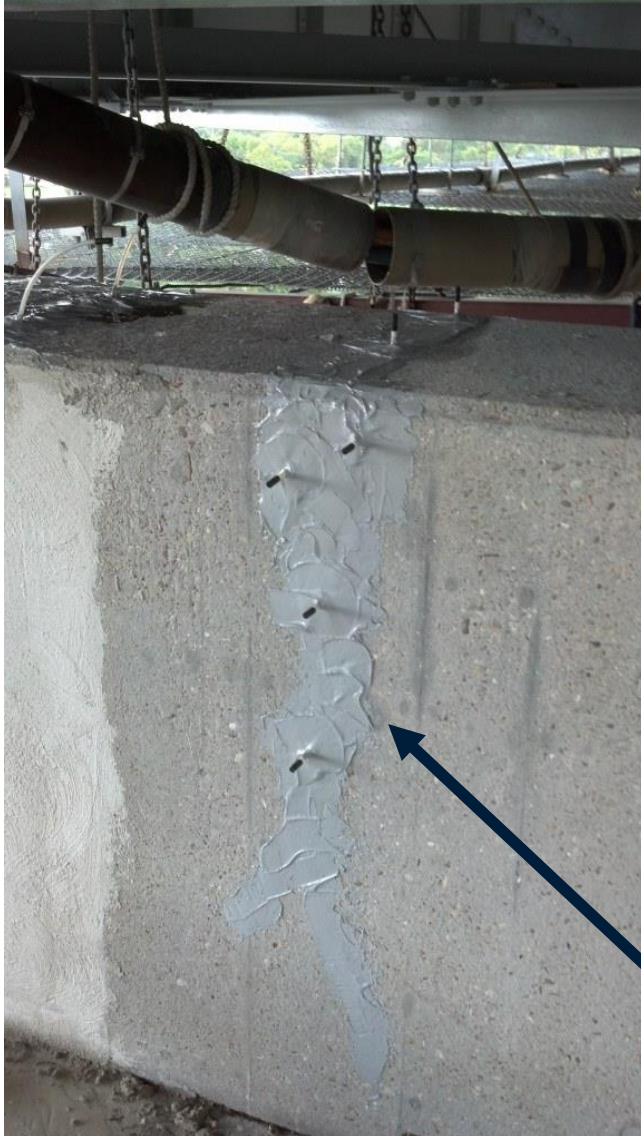
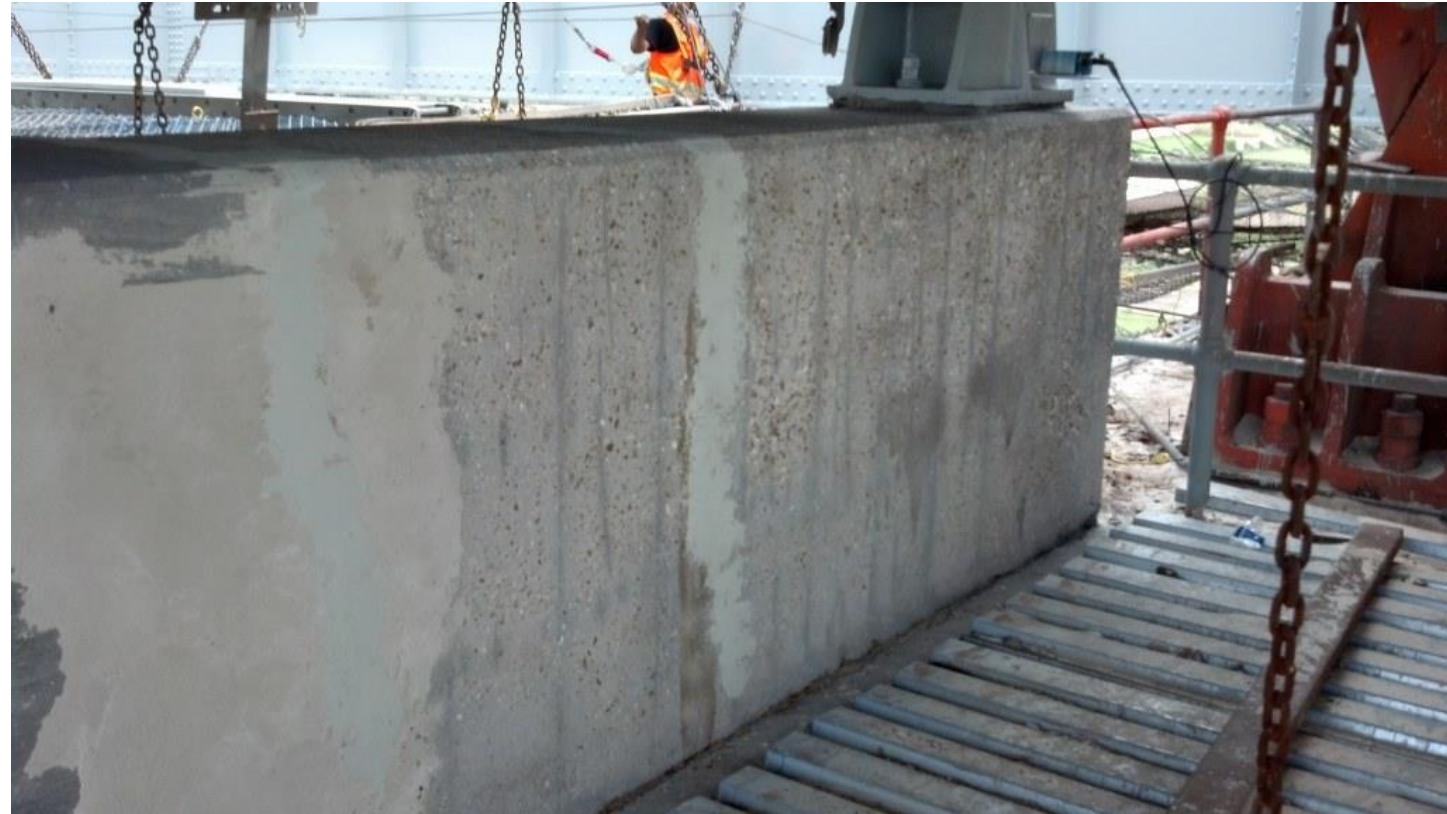
# PEDESTAL REPAIRS AT PIERS 1 & 6

**GROUT  
INJECTION**

**CEMENTITIOUS GROUT**
