SCENIC BRIDGE PRESERVATION

BIG SUR HWY 1 BRIDGES
2013

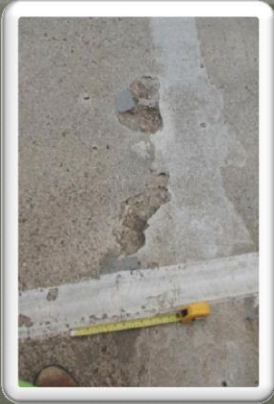
- Rail

- Severe cracking with unsound concrete and spalls with exposed rusted rebar.

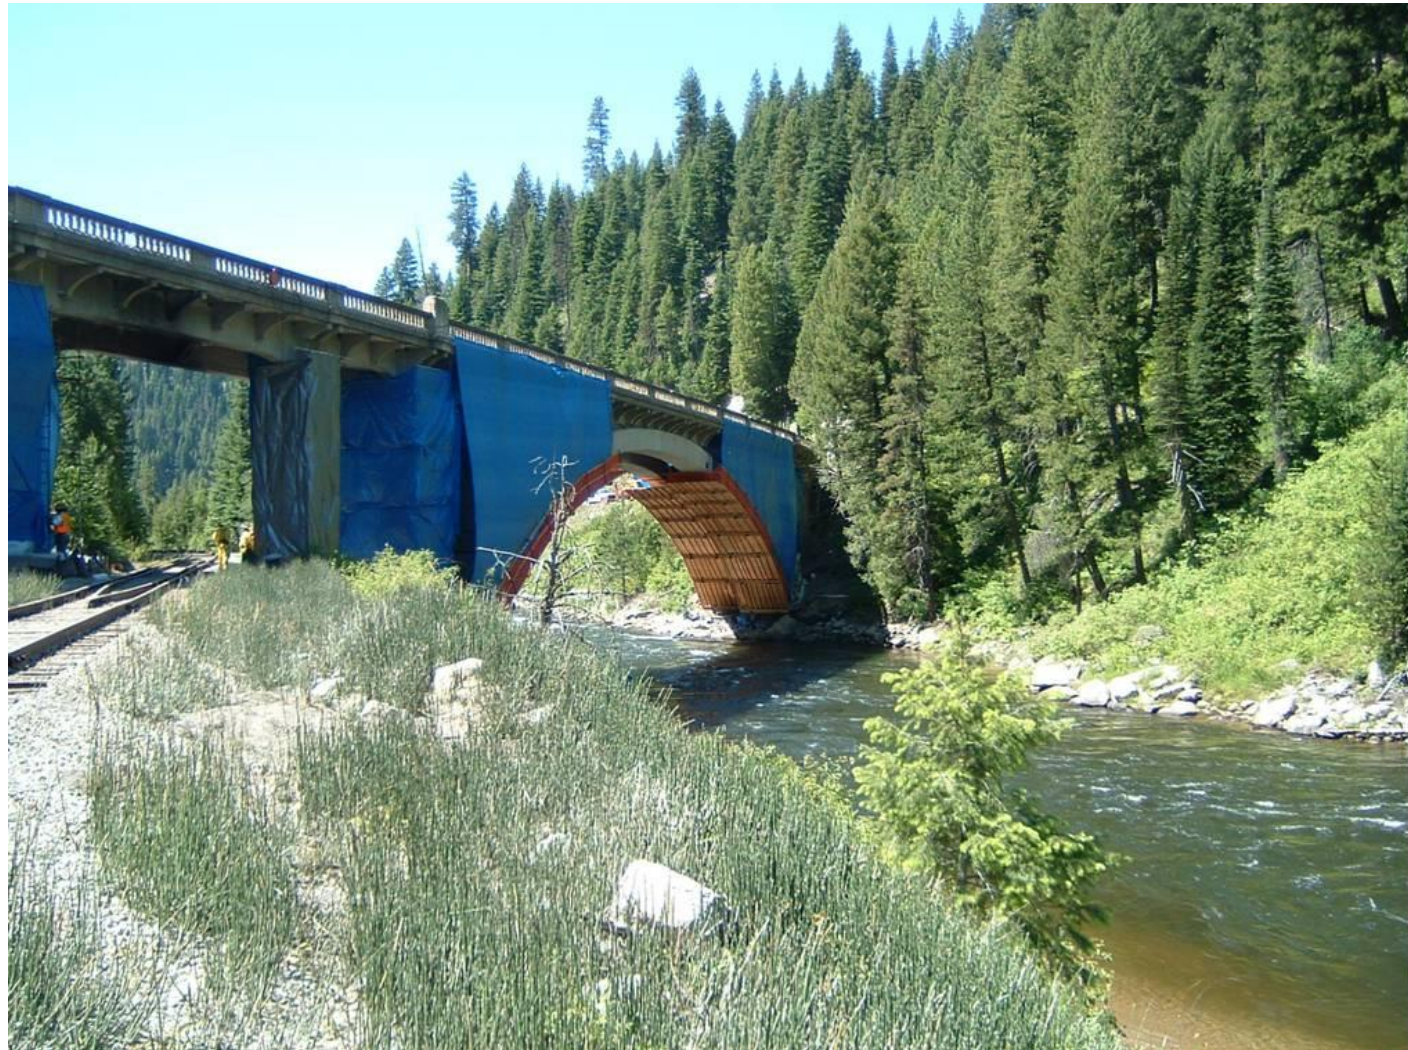
Rainbow Bridge- Idaho

(chloride extraction performed on arch ribs)

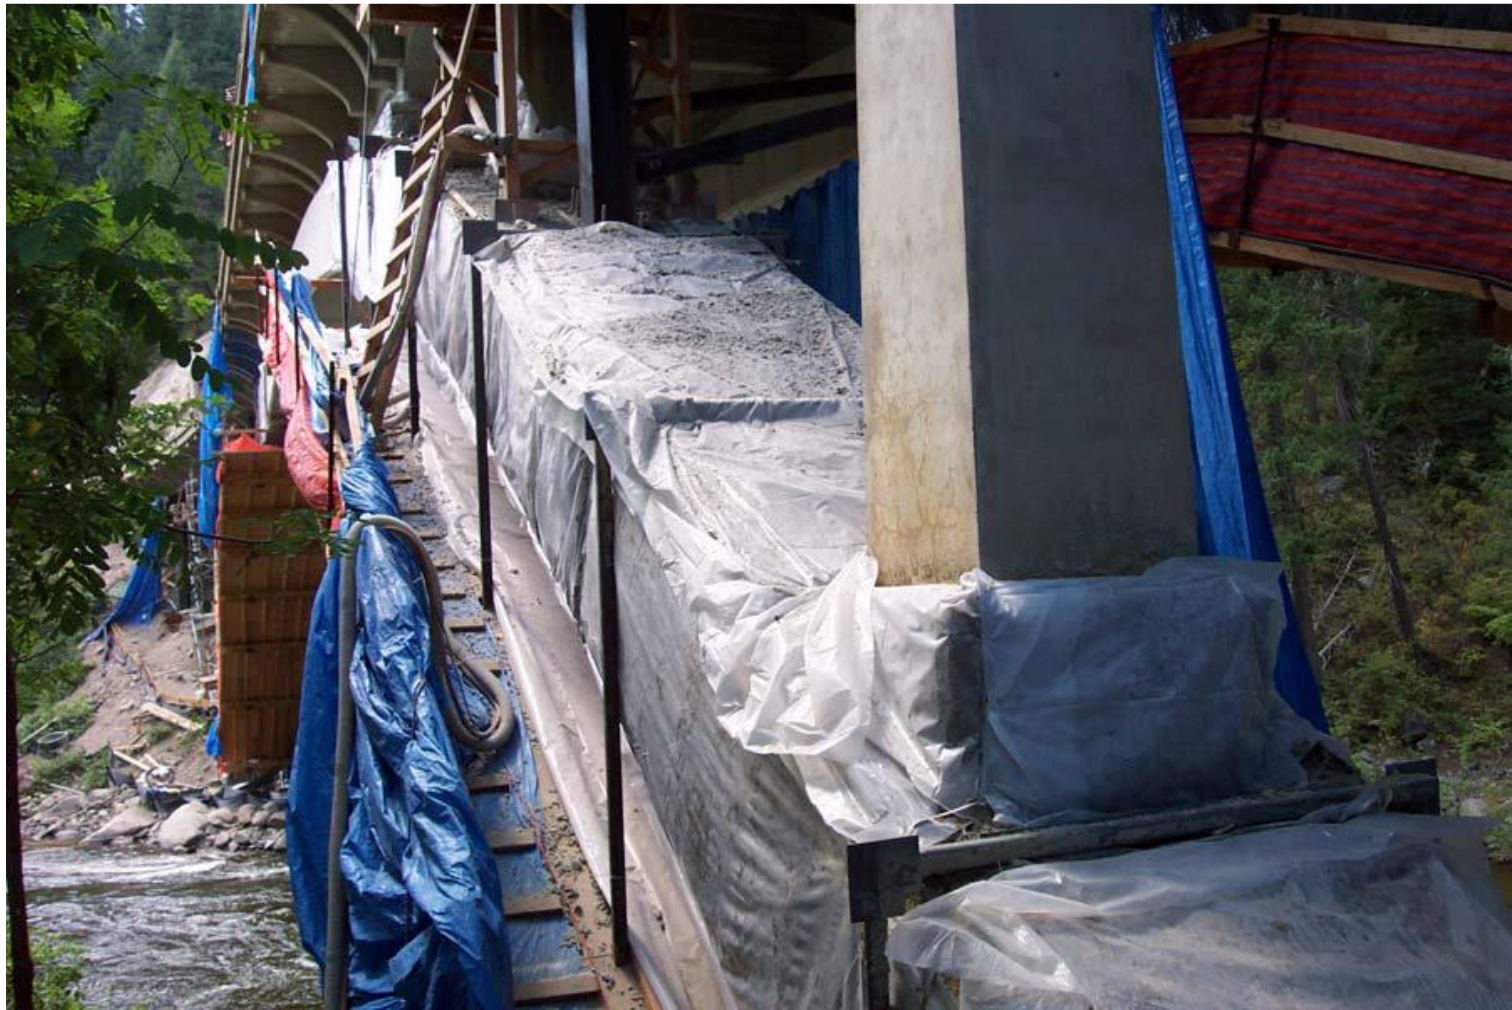
Rainbow Bridge- Idaho

(chloride extraction performed on arch ribs)

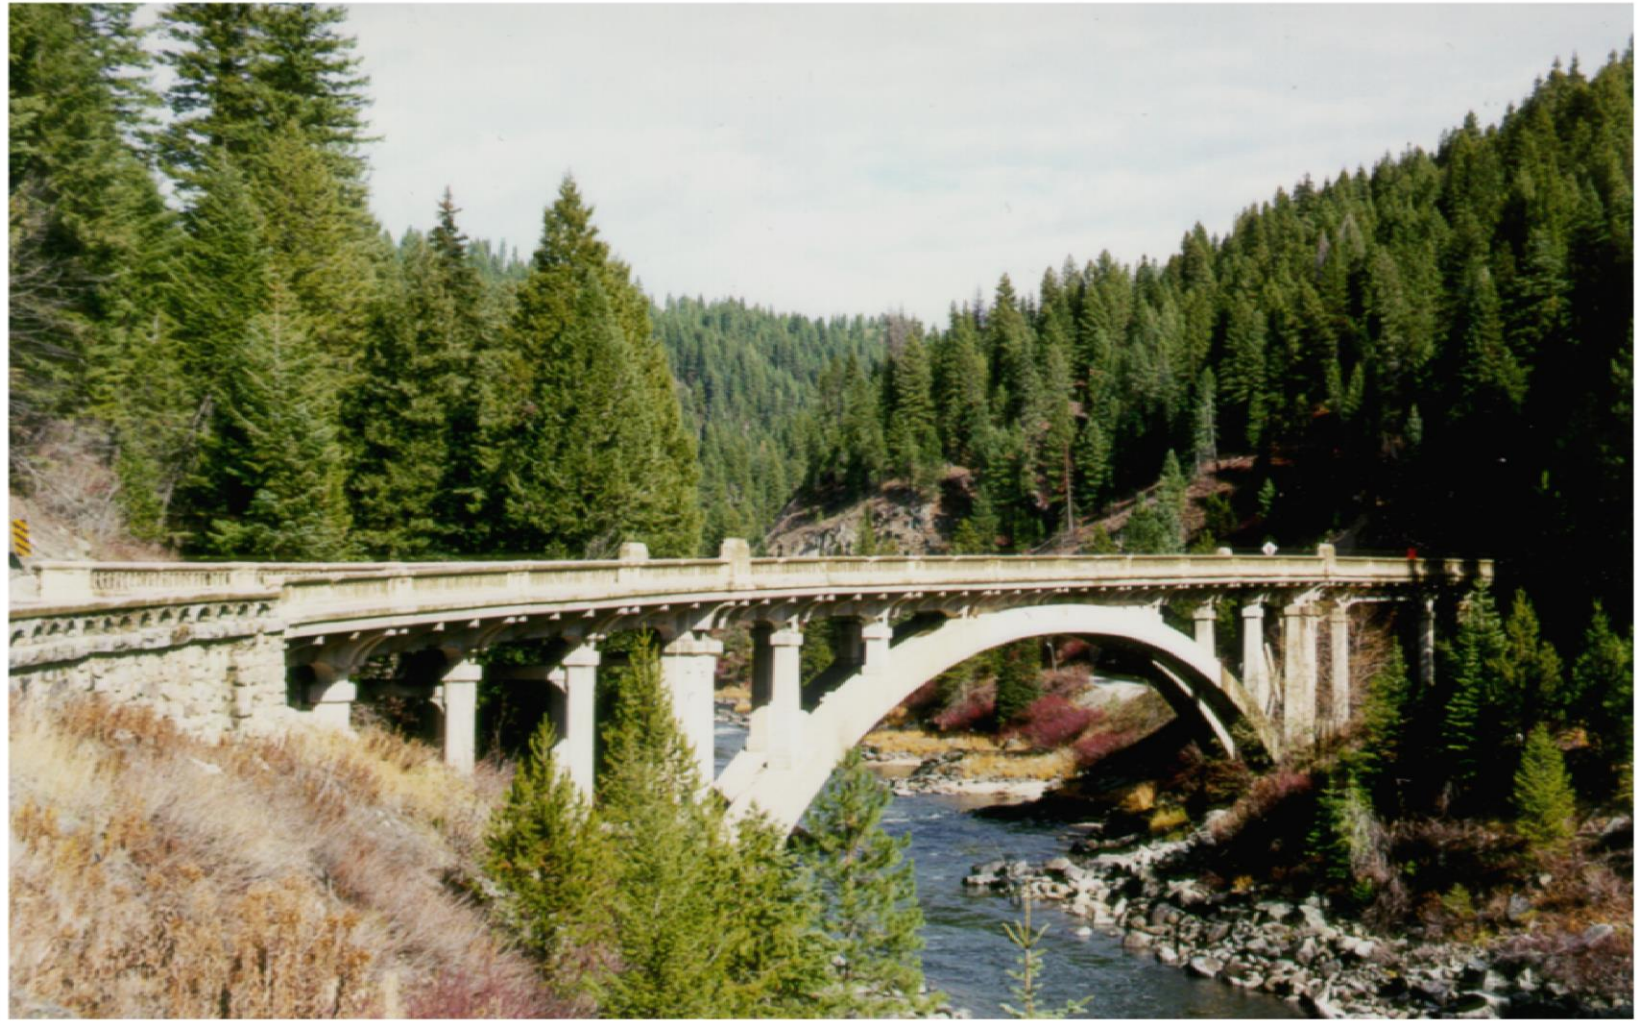
Rainbow Bridge- Idaho

(chloride extraction performed on arch ribs)
